ARBORICULTURAL REPORT

& METHOD STATEMENT

Relating to trees at
Proposed Viaduct Car Park, Hatfield House.

Date: 29/07/10

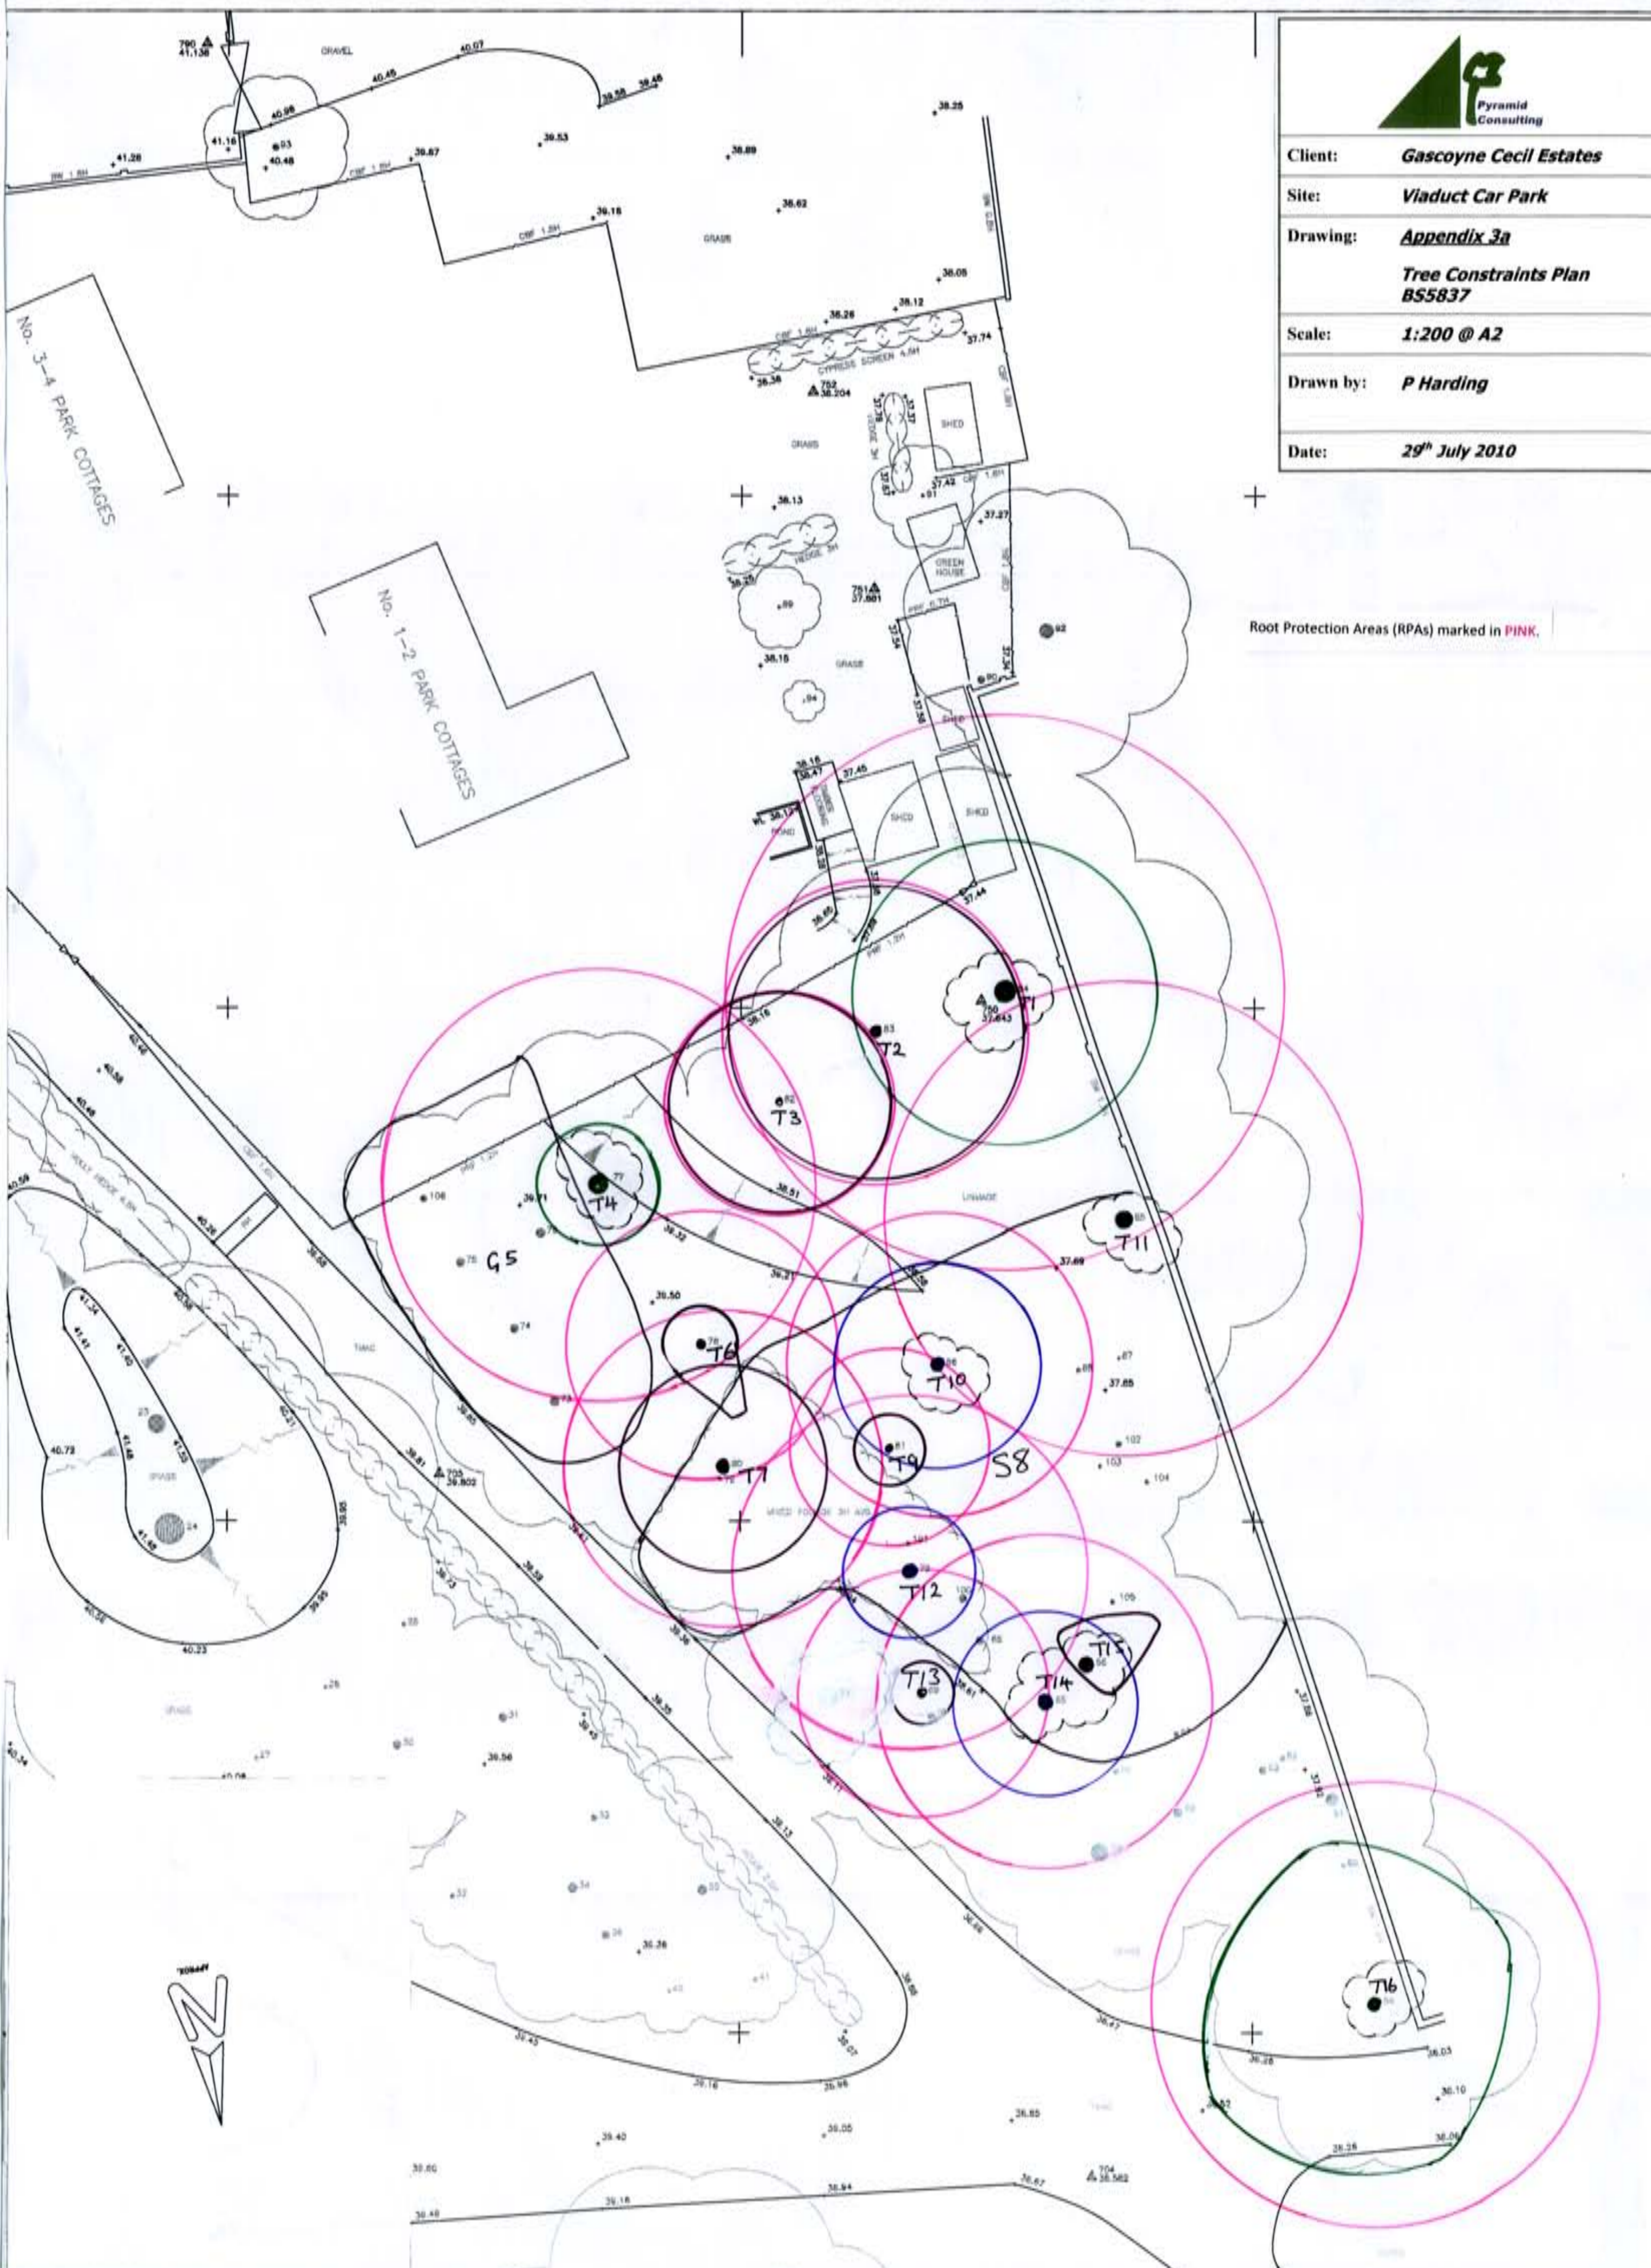
Drawing: **Appendix 3a**
Tree Constraints Plan
BS5837

Root Protection Areas (RPAs) marked in **PINK**.

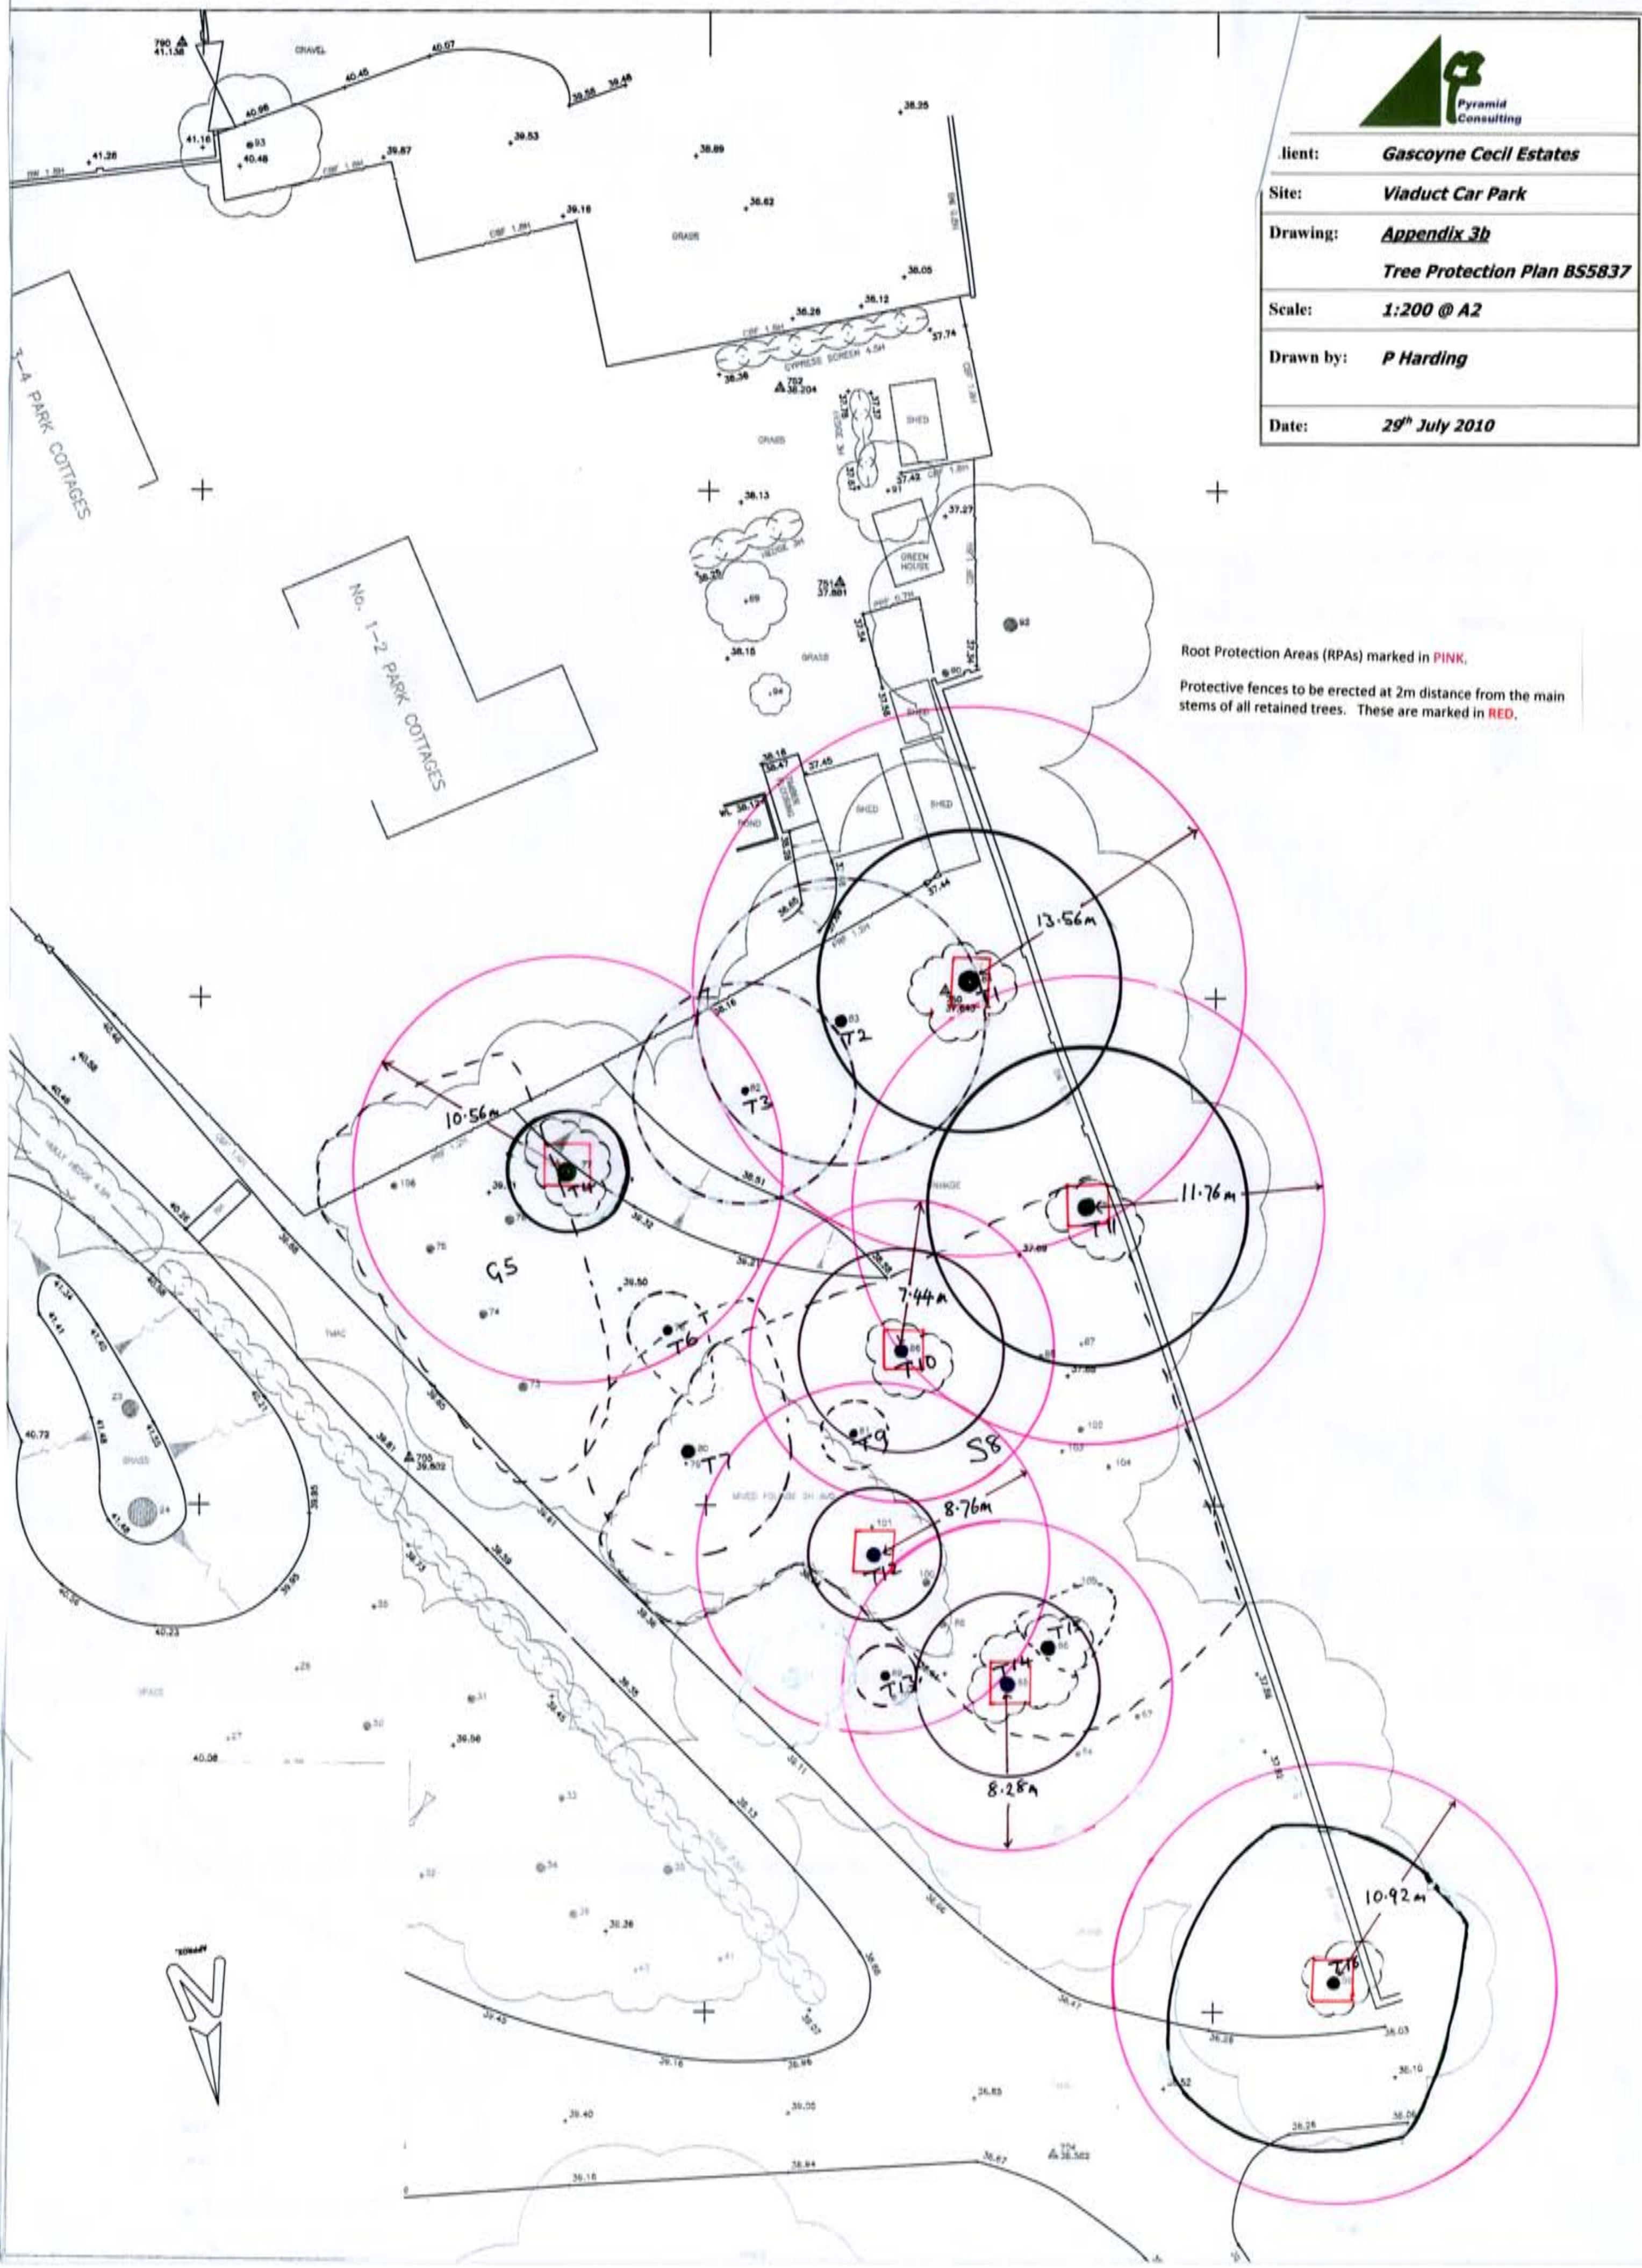
Root Protection Areas (RPAs) marked in **PINK**.
Protective fences to be erected at 2m distance from the main stems of all retained trees. These are marked in **RED**.

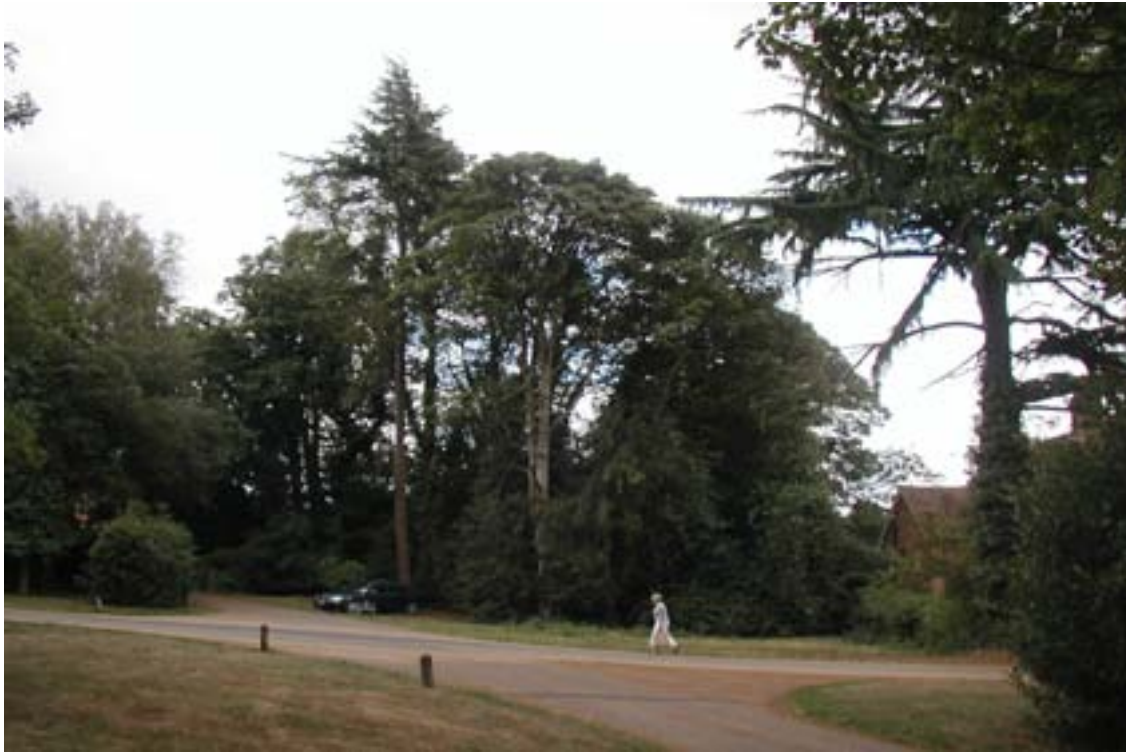
Location of proposed car park

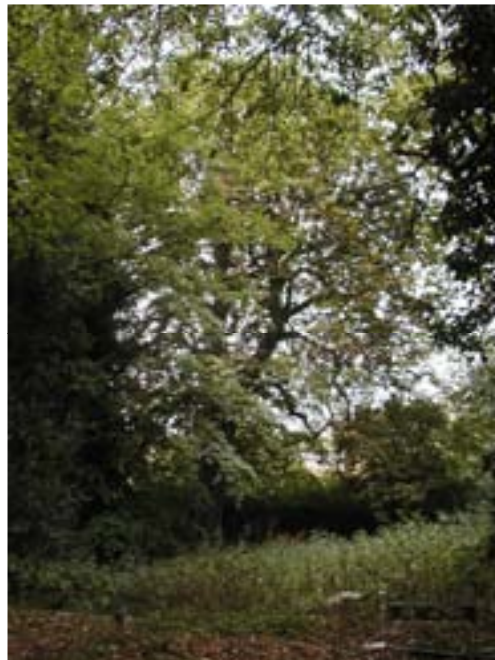
A view into the woodland with T1 in the background
