12 Harpsfield Broadway

Budget Planned Maintenance Schedule

## **12 Harpsfield Broadway - Planned Maintenance Schedule**

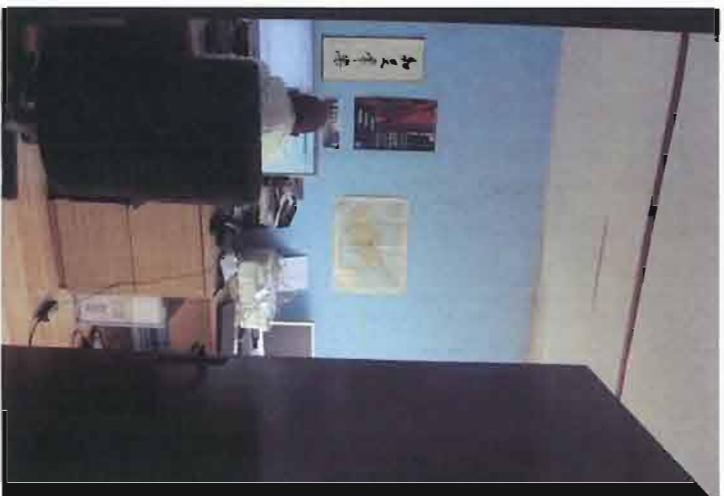
Item	Location	Issue	Risk	Works Required	Priority	Year	Cost (£)
	<b>Second Floor Interior</b>						
1	2 <sup>nd</sup> Floor office area	Water staining to ceiling due to leak to roof – Photo 1	Continued water penetration would cause further damage to structure	Source of leak to be located and remedial works undertaken to repair flat roof.	A	1	As below
	<b>Second Floor Exterior</b>						
2	2 <sup>nd</sup> Floor flat roof	Felt is blowing and cracking, lead flashings pulling out of walls – Photo 2 & 3	Water penetration into building	Roof covering to be renewed, including flashing details	A	1	7,000
3	2 <sup>nd</sup> Floor flat roof	Water tank house in poor condition with side exposed and poor fitting roof cover – Photo 4 & 5	Debris and rodents able to access housing and contaminate the water.	New plywood sides fitted where needed, re felt housing. Re work lead to roof to provide seal at joint.	A	1	810

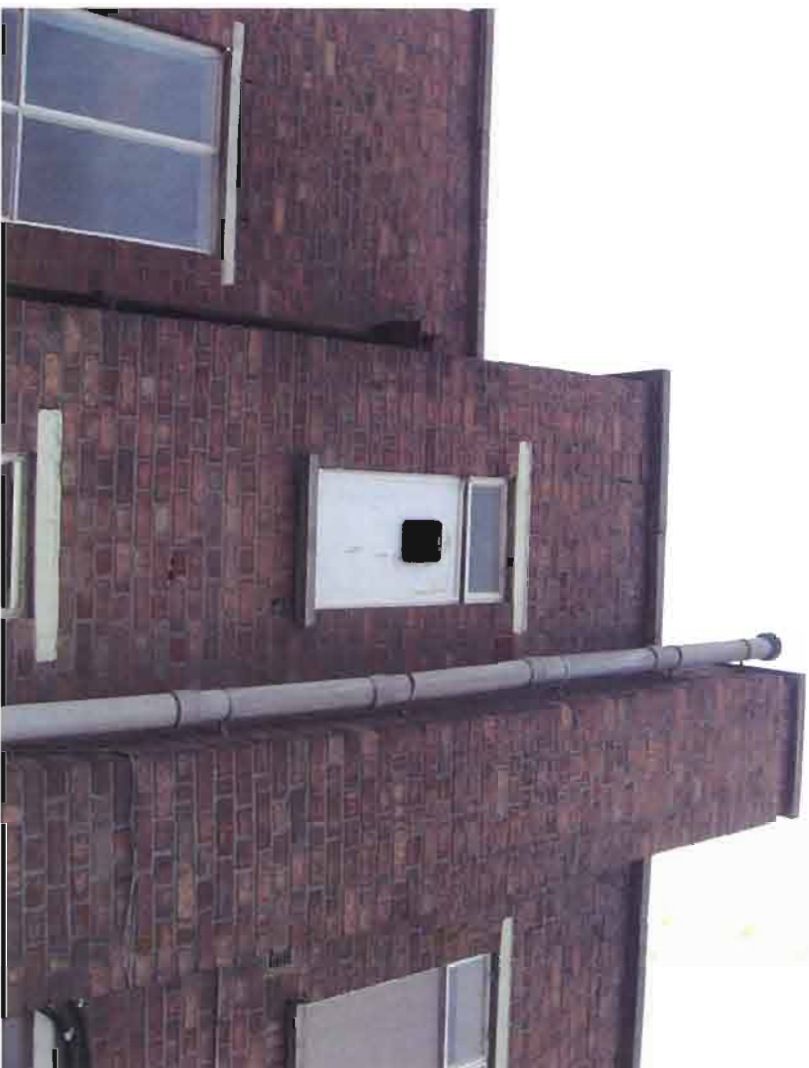
4	2 <sup>nd</sup> Floor flat roof	Redundant Asbestos Flue in situ. Photo - 6	Flue has been broken as stops at low level, and causing asbestos to be released	Redundant asbestos flue to be removed	A	1	Provisional cost of £290
5	2 <sup>nd</sup> Floor flat roof parapet	Render to parapet cracked. Photo 7 & 8	Water penetration to brickwork beneath render migrating into building.	Cracked render to be removed and re rendered.	B	1	580
6	2 <sup>nd</sup> Floor flat roof parapet copings	10 no coping stones loose and cracked	Risk of falling from parapet wall	Copings to be removed replaced with new copings to match and re bedded	A	1	270

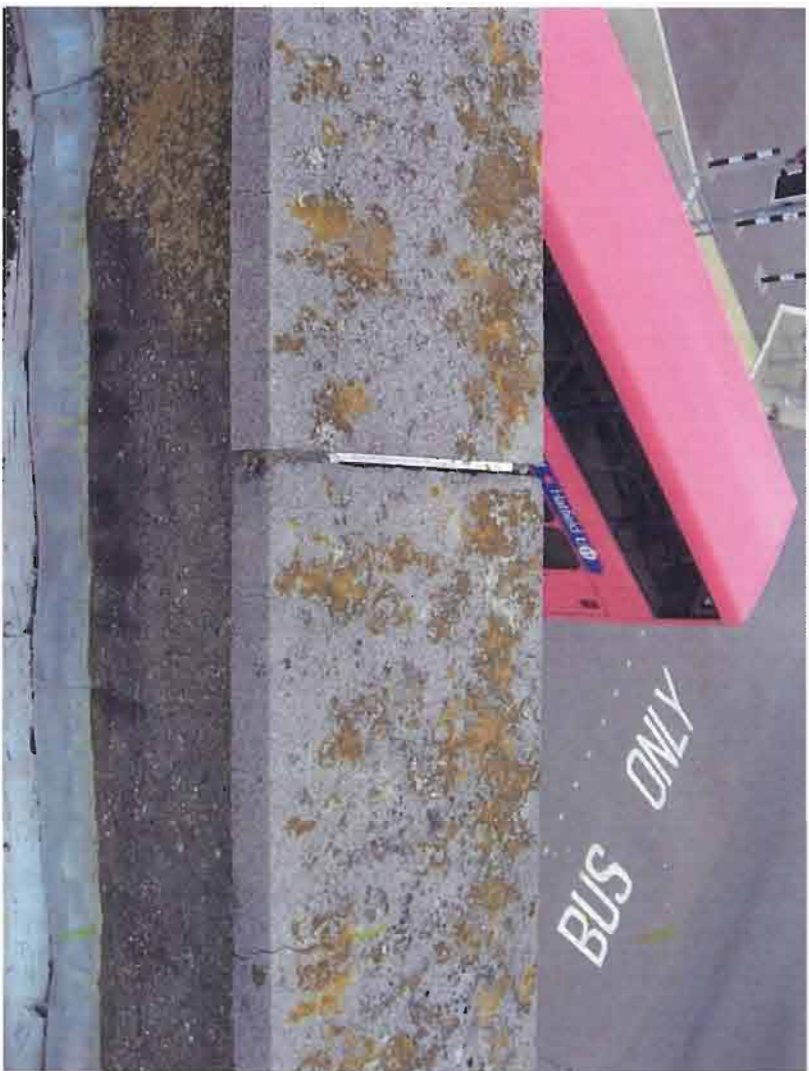
Item	Location	Issue	Risk	Works Required	Priority	Year	Cost (£)
7	2 <sup>nd</sup> Floor flat roof parapet copings	Joints between copings worn. – Photo 9	Copings become loose and do not protect parapet wall beneath. Loose copings become fall risk.	Rake out coping joints and re point.	A	1	810
8	2 <sup>nd</sup> Floor flat roof	Asbestos SVP in situ. – Photo 10	Flue being broken and causing asbestos to be released	Remove asbestos flue and replace with new flue	A	1	Provisional cost of £45 for removal of asbestos – plus £70 for new flue pipe
9	2 <sup>nd</sup> Floor flat roof	Spalling brickwork to chimney stacks – Photo 11 & 12	Brickwork deteriorates and chimneys could fall over	Bricks to be cut out and replaced with new.	B	1	150
10	2 <sup>nd</sup> Floor flat roof	Rainwater hopper full of debris - Photo 13	Water will overflow from hopper and cause staining to walls, and possible damage to structure.	Hopper to be cleaned out.	A	1	50

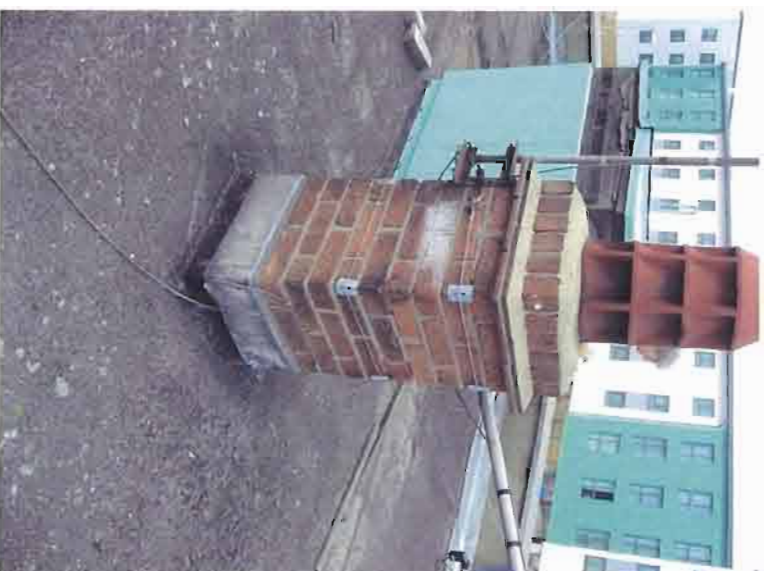
11	2 <sup>nd</sup> Floor flat roof	Loose aerial – Photo 14	Risk of aerial falling and causing damage to roof covering	Replace broken brackets and re erect	B	1	70
12	2 <sup>nd</sup> Floor flat roof	Chimney flaunchings showing signs of cracking – Photo 15 & 16	Water penetration through chimney	Existing flaunchings to be removed and re laid.	B	1	130

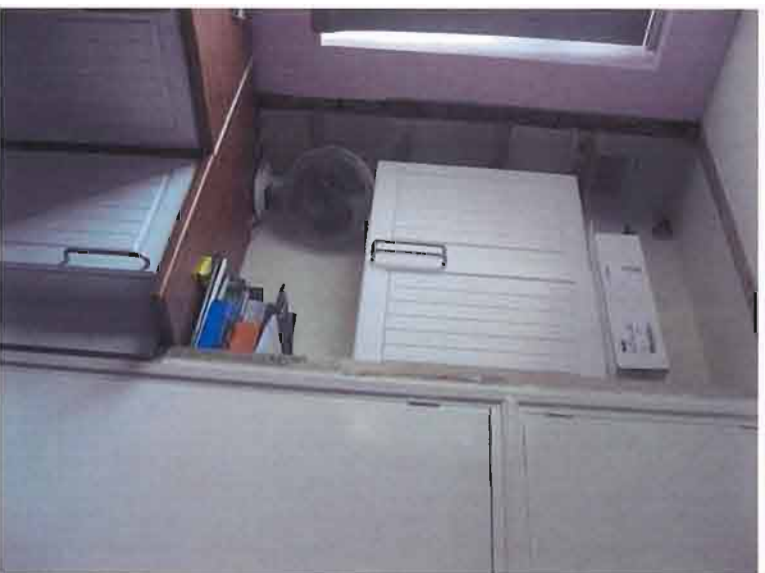
Item	Location	Issue	Risk	Works Required	Priority	Year	Cost (£)
20	1 <sup>st</sup> floor office kitchen	Redecoration needed as cupboard removed from recess – Photo 27	Decorative	Make good damage and re decorate	D	5	1,150
	<b>First Floor Exterior</b>						
21	1 <sup>st</sup> floor office	Corner balcony in need of decoration – Photo 19 & 20	Metal work would deteriorate through exposure to elements	Metal work to be prepared and re painted.	A	1	80
22	1 <sup>st</sup> floor office balconies	Railings in need of decoration – Photo 20 & 21	Metal work would deteriorate through exposure to elements	Metal work to be prepared and re painted.	B	1	80
23	1 <sup>st</sup> floor office balconies	Lead work splitting – Photo 22	Water penetration to structure	Lead work to be replaced	B	1	400
	<b>First Floor Flat roof over, accessed from 1<sup>st</sup> floor office</b>						
24	1 <sup>st</sup> floor roof	Rubbish and old furniture over roof – Photo 28	Ponding of rainwater on roof, damage to roof covering all causing water penetration. Damage to roof surface from impact	Remove rubbish and old furniture	A	1	350

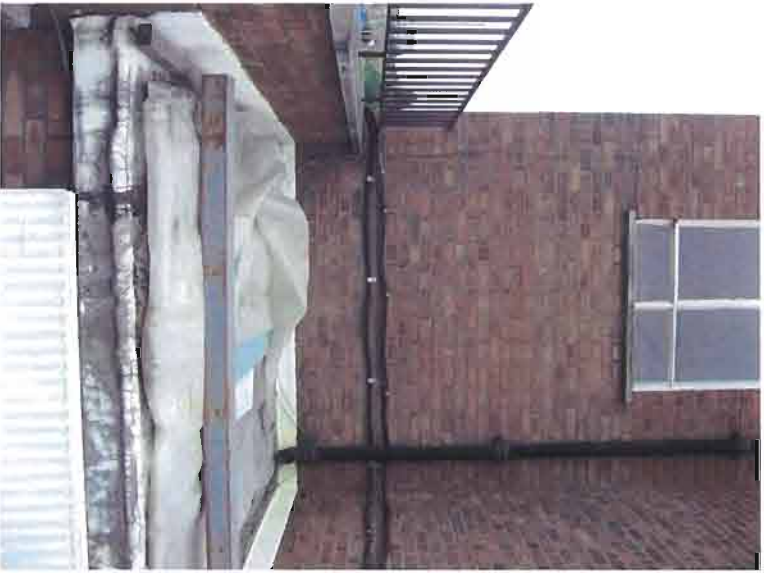
25	1 <sup>st</sup> floor roof/rear elevation – upstands	Cracking forming to upstands – Photo 29 & 30	Water penetration over time	Fill cracks and apply UV repellent paint to prolong life	B	1	1130
26	1 <sup>st</sup> floor roof/rear elevation	Paint to areas of railings becoming thin. – Photo 31 &	Metal work would deteriorate through exposure to elements	Metal work to be prepared and re painted.	B	1	500

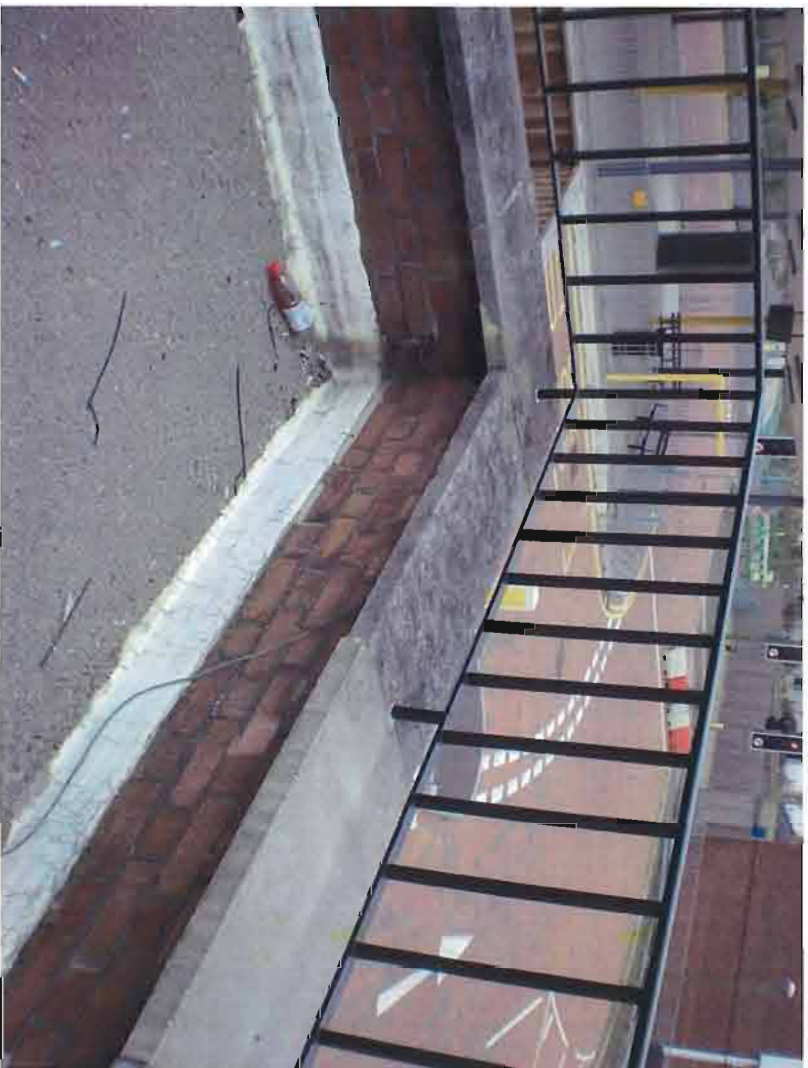
Item	Location	Issue	Risk	Works Required	Priority	Year	Cost (£)
		32					
27	1 <sup>st</sup> floor roof	Corner coping damaged. – Photo 33	Deterioration of coping and wall beneath.	Remove old coping and replace. (Note handrail to be removed to enable replacement to be fitted)	C	3	95
28	1 <sup>st</sup> floor roof	Drainage outlets by polycarbonate roof need cleaning – Photo 34	Rain water over flowing and causing damage to structure beneath	Clean rainwater hoppers	A	1	50
29	1 <sup>st</sup> floor roof	One coping above drain outlet needs replacing	Deterioration of coping and wall beneath.	Remove old coping and replace. (Note handrail to be removed to enable replacement to be fitted)	C	3	95
30	1 <sup>st</sup> floor roof/rear elevation	Lead flashing beneath concrete stairs has failed – Photo 35	Rain water penetrating into ground floor.	Re work or re place lead flashing.	A	1	175
31	1 <sup>st</sup> floor roof/rear elevation	Hairline cracking to concrete stair case – Photo 35	Water penetration to cracking causing concrete to blow.	Concrete staircase to be sealed.	C	2	235

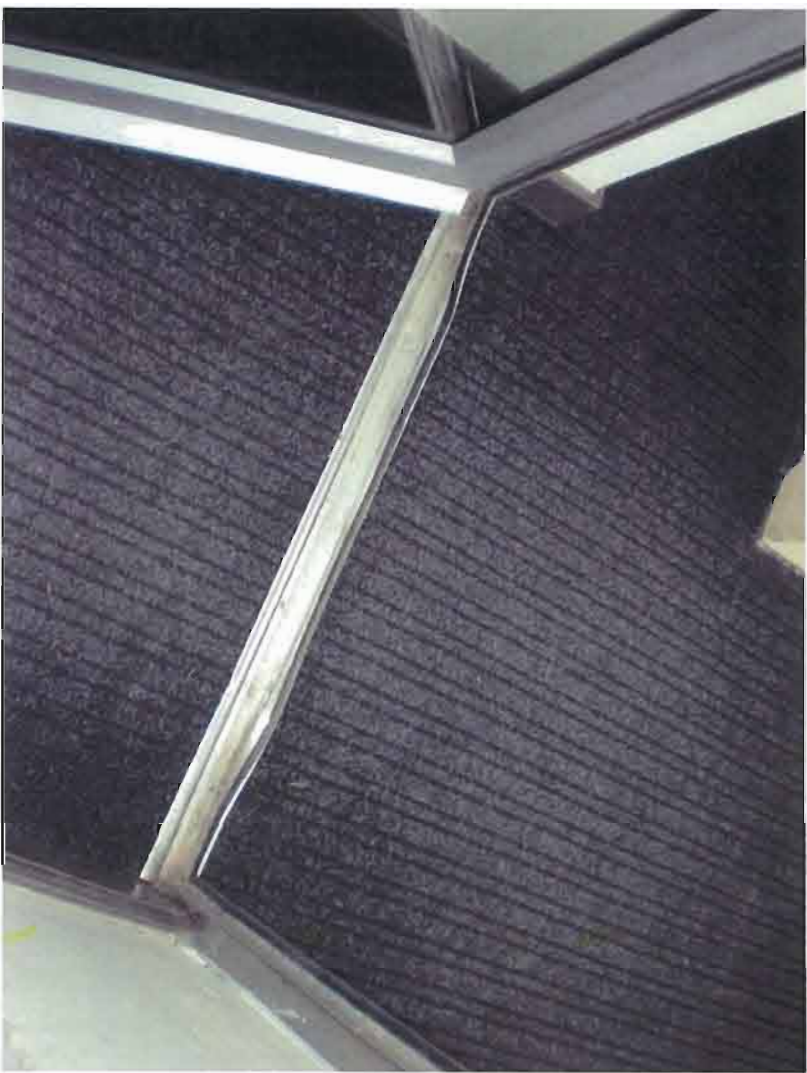
<b>Common Parts</b>							
43	Common Parts	Ground floor 1 <sup>st</sup> quarter landing creaking – Photo 42	Level of creaking will increase	Secure landing to stop creaking	C	3	35
44	Common Parts	Threshold from entrance conservatory to main building is pushed down –	Door not sealing correctly	Replace door threshold bar	C	3	80
