BLUE MOON
PADDOCK
WOODFIELD LANE
ESSENDON

TREE REPORT

(Tree Survey and
Arboricultural Impact Assessment)

| Ref: | PRI19248traia |

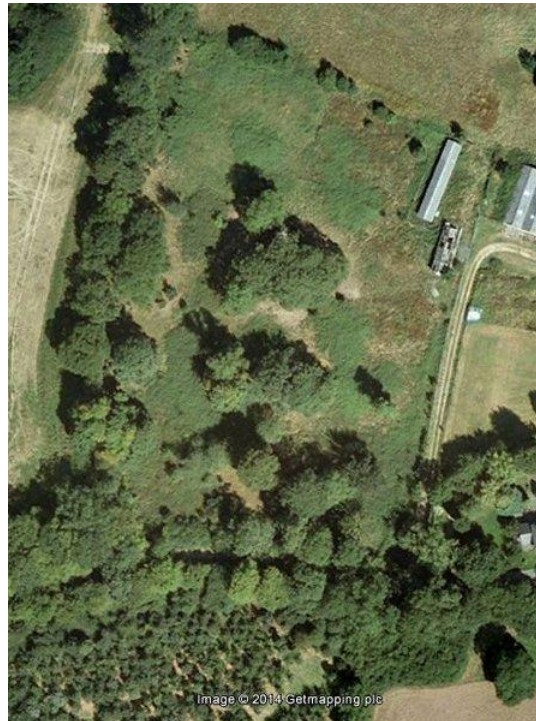
Overview of site included in survey

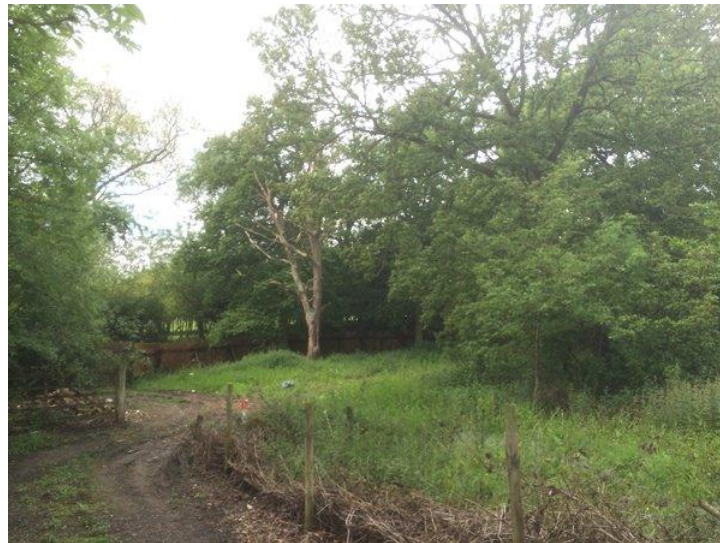
Existing site entrance and track (T1 to right)

| No. | Name | Ht (crown) | Dia (stems) | Canopy spread N E S W | | | | Life stage | ERC | Comments & preliminary recommendations | BS Cat |
|---|--|---|---|---|---|---|---|---|---|--|---|
| T1 | Common Oak (Quercus robur) | 14 (5) | 400 (1) | 3 | 2.5 | 2.5 | 2.5 | OM | <10 | Dead standing tree. Scope to remove poorly attached deadwood and retain for habitat value. | U |

- 7.6. T1 and is a U category dead Oak tree. To reduce the risk of injury or damage from wind-throw or falling branches it is recommended that the tree is 'monolithed' i.e. the tree reduced to leave a 5m habitat stump. The branches and arisings should be retained in a habitat pile near the base of the tree.

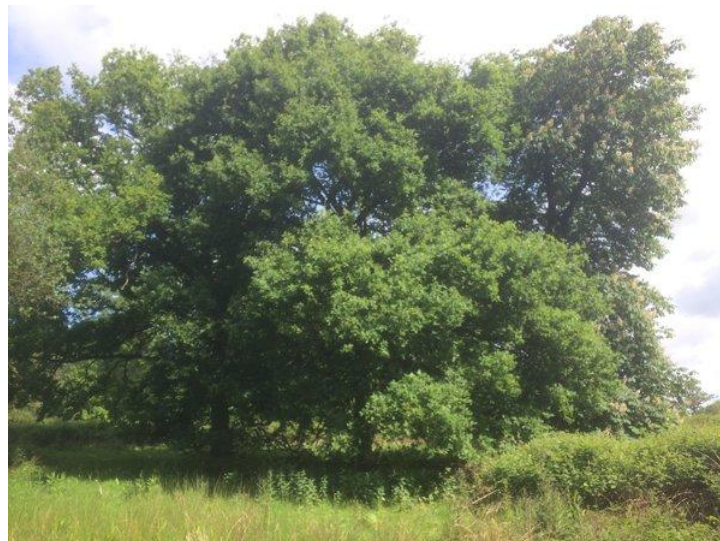
Trees in wooded area at south of site (T11 - 13)

| No. | Name | Ht (crown) | Dia (stems) | Canopy spread N E S W | | | | Life stage | ERC | Comments & preliminary recommendations | BS Cat |
|---|---|---|---|---|---|---|---|---|---|---|---|
| T11 | Horse Chestnut (Aesculus hippocastanum) | 16 (0.5) | 510 (1) | 4 | 4 | 4 | 3 | EM | 20+ | Fair tree no significant visible defects. Shared canopy with adjacent tree. | B2 |
| T12 | Common Oak (Quercus robur) | 15 (1) | 580 (1) | 5 | 5.5 | 9.5 | 7.5 | M | 20+ | Part of wooded group | B2 |
| T13 | Common Oak (Quercus robur) | 15 (1) | 710 (1) | 7 | 8.5 | 7 | 7 | M | 20+ | Part of wooded group | B2 |

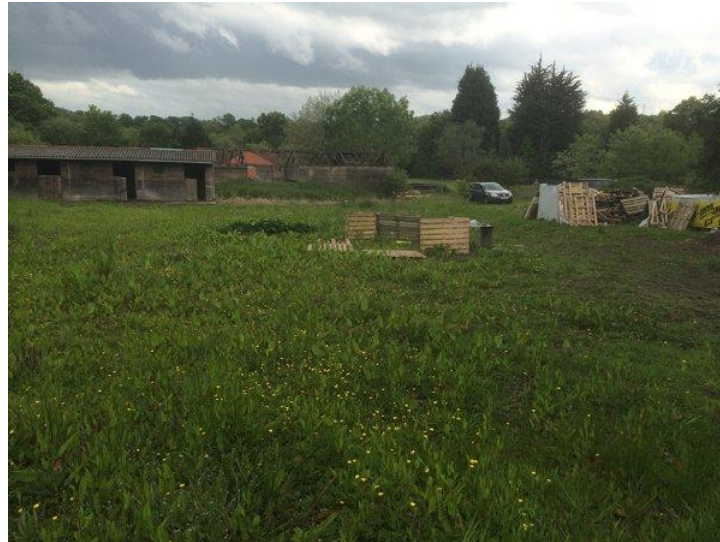
View of dilapidated stable buildings at north east of site.

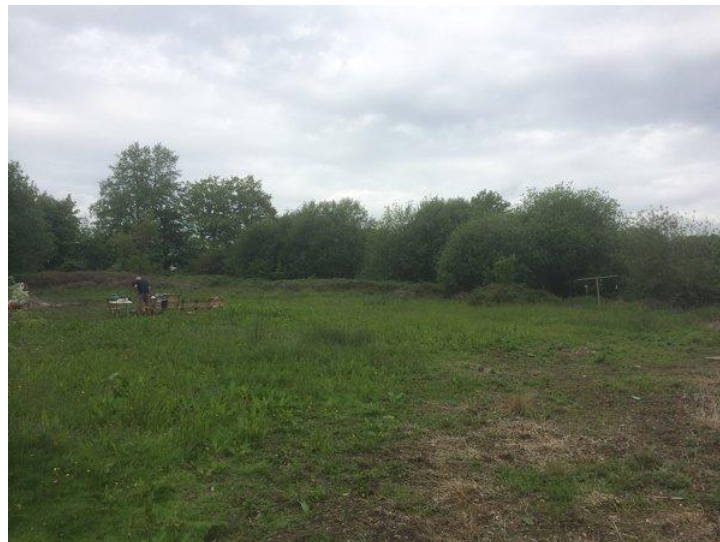
View from stables looking west.

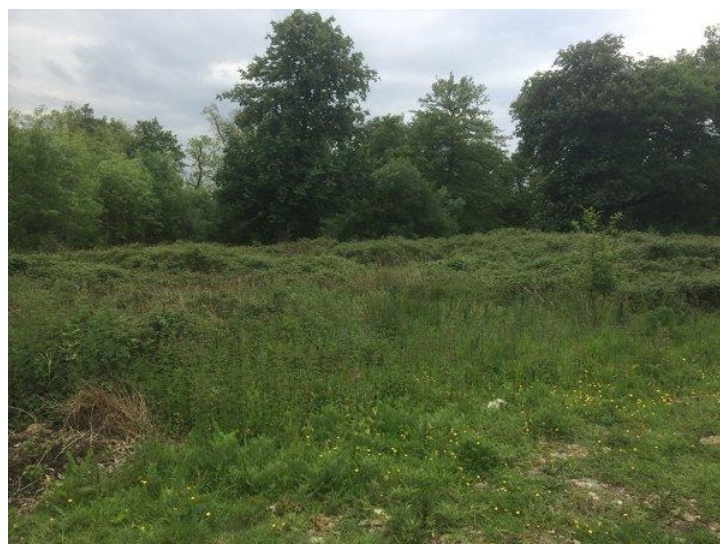
View from north of site looking towards wooded area to south
