EXISTING FIRST FLOOR PLAN - SCALE 1:50

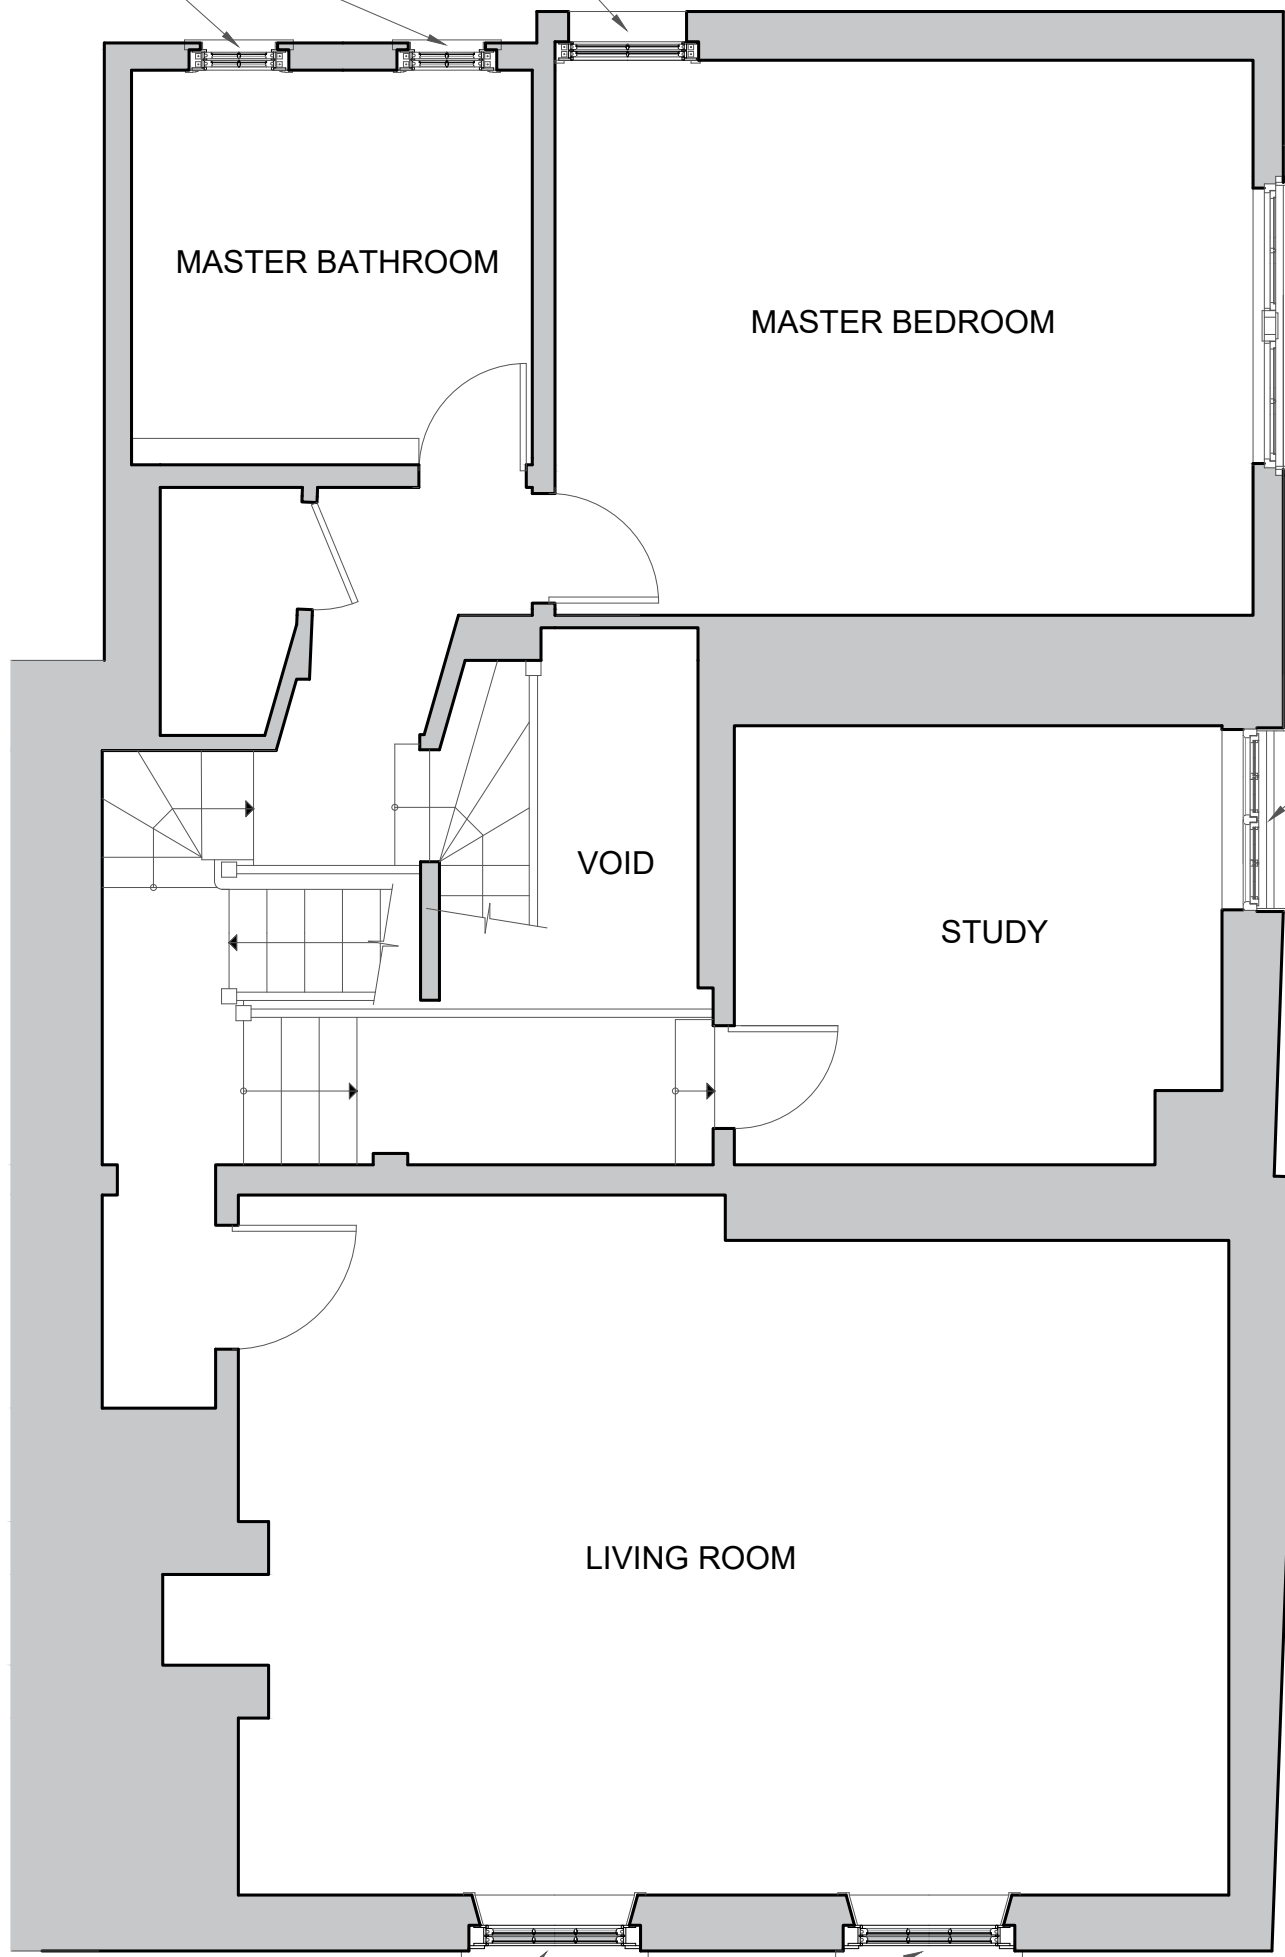
ITEM W11 & W12
Existing box sash windows.
Frames are in reasonable condition
with repairs to frame and cill.
Frames to remain and sashes are
single glazed and to be replaced.

ITEM W10
Existing box sash windows.
Frames are in good condition, with
no obvious repairs. Frames to
remain and sashes are single
glazed and to be replaced.

ITEM W09
Existing flush casement
window opening out. Left hand
leaf is missing after damage
from wind. Frame damaged.
Casement leaves are single
glazed. Entire window renewal

ITEM W08
Existing stormproof casement
window opening out. Frame in
good condition, but a non
original design to the house.
Casement leaves are double
glazed. Entire window renewal.

ITEM W06 & W07
Existing box sash windows. Frames
are in poor condition with splice
repairs required to the pulley stile
and outer jambs. Minor repairs to
cills. Frames to remain and sashes
are single glazed and to be replaced.
