**Level and Crack Monitoring**

**Our Ref: 552624**

**24/08/2020**

Occupier:	<b>Removed for data protection purposes</b>
Address:	<b>10 Hook Lane</b>
Address:	
Town:	<b>Potters Bar</b>
County:	
Post Code:	<b>EN6 4DA</b>
Contact Name	<b>Removed for data protection purposes</b>

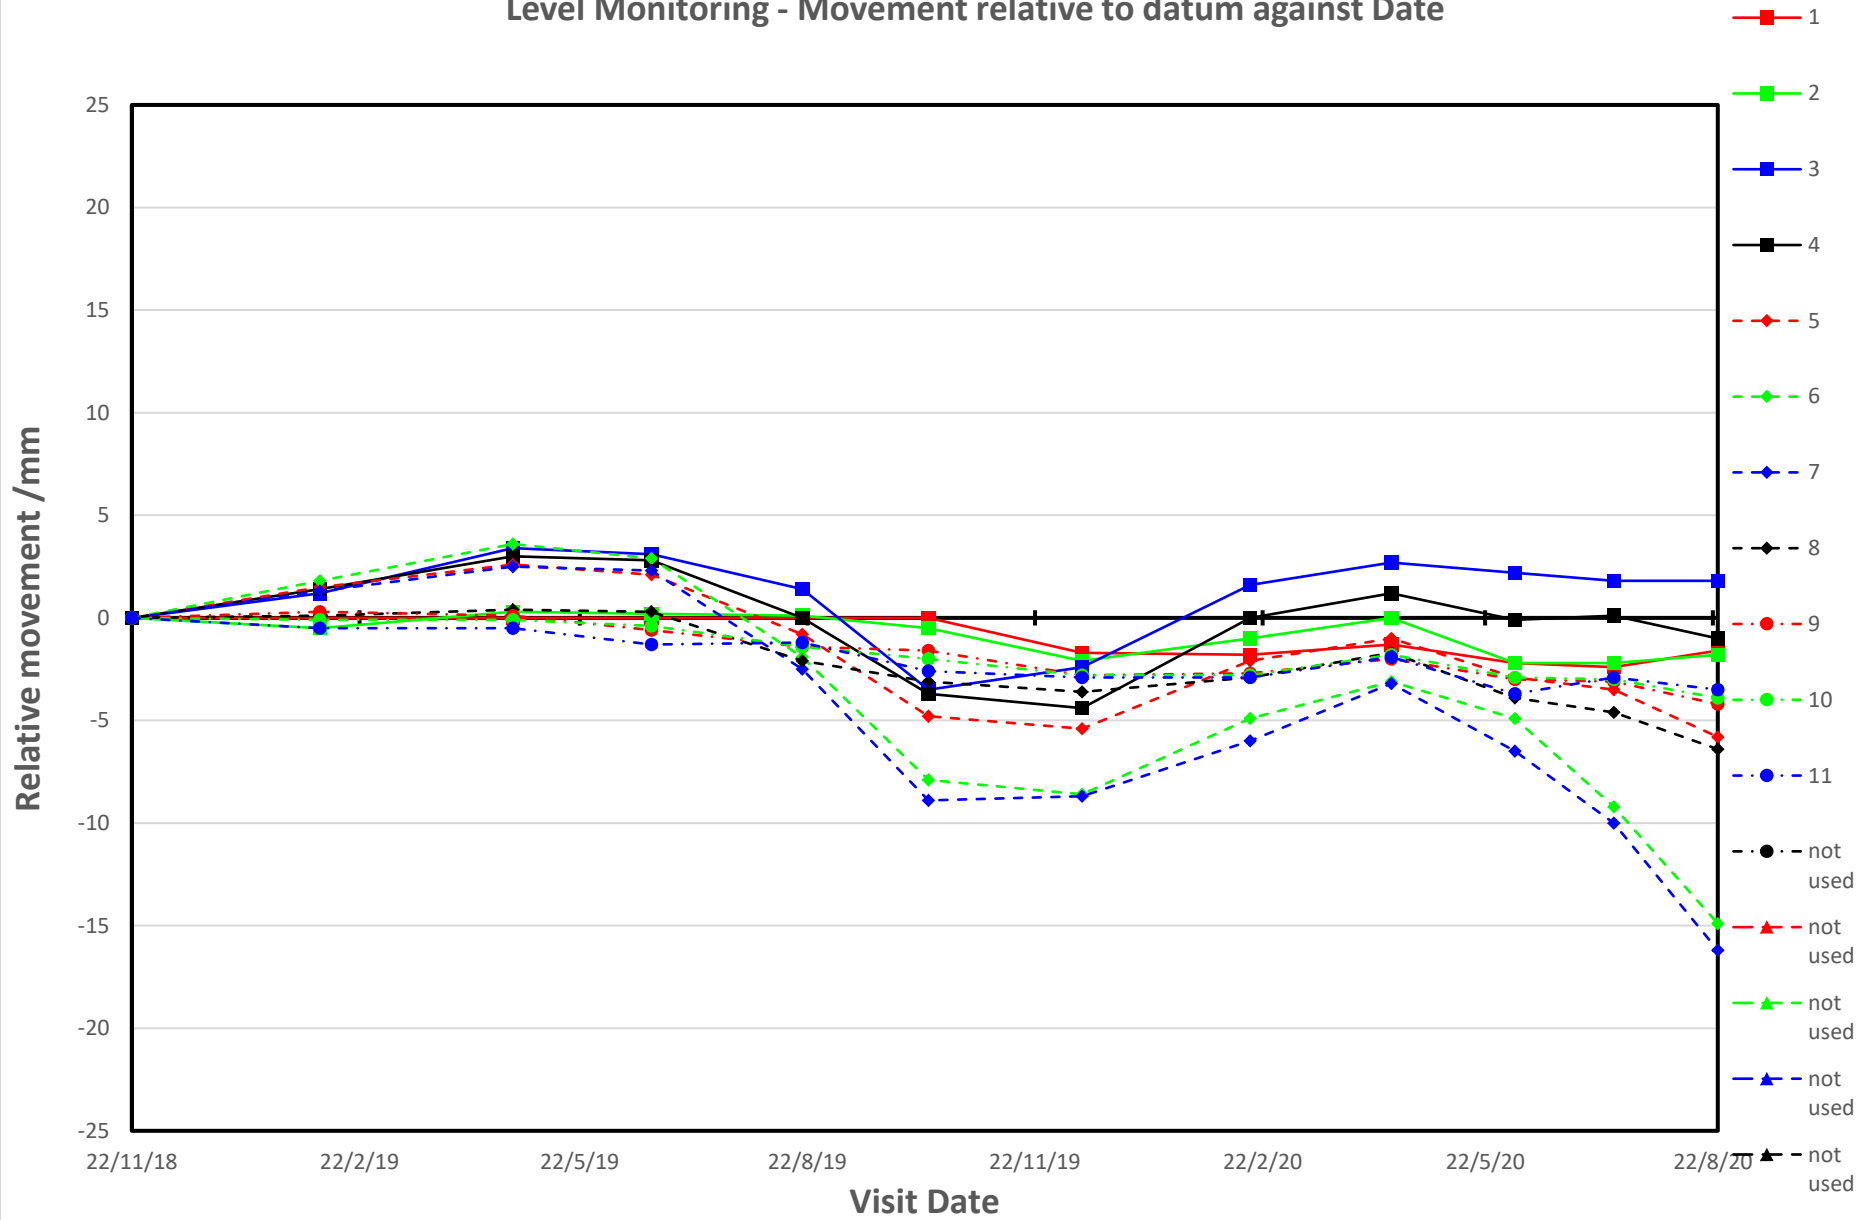
Level Monitoring - Movement relative to datum against Date

Reading Date	22/11/18	6/2/19	25/4/19	20/6/19	20/8/19	10/10/19	11/12/19	17/2/20	14/4/20	3/6/20	13/7/20	24/8/20
Point / Reading	1	2	3	4	5	6	7	8	9	10	11	12
1	10.8355	10.8355	10.8355	10.8355	10.8355	10.8355	10.8338	10.8337	10.8342	10.8333	10.8331	10.8339
2	10.9020	10.9015	10.9023	10.9022	10.9021	10.9015	10.8999	10.9010	10.9020	10.8998	10.8998	10.9002
3	10.8805	10.8817	10.8839	10.8836	10.8819	10.8770	10.8781	10.8821	10.8832	10.8827	10.8823	10.8823
4	10.9270	10.9284	10.9300	10.9298	10.9270	10.9233	10.9226	10.9270	10.9282	10.9269	10.9271	10.9260
5	10.9993	11.0008	11.0019	11.0014	10.9985	10.9945	10.9939	10.9972	10.9983	10.9964	10.9958	10.9935
6	10.9977	10.9995	11.0013	11.0006	10.9958	10.9898	10.9891	10.9928	10.9946	10.9928	10.9885	10.9828
7	11.0159	11.0172	11.0184	11.0182	11.0134	11.0070	11.0072	11.0099	11.0127	11.0094	11.0059	10.9997
8	11.0263	11.0264	11.0267	11.0266	11.0242	11.0232	11.0227	11.0234	11.0246	11.0224	11.0217	11.0199

9	11.0608	11.0611	11.0609	11.0602	11.0594	11.0592	11.0580	11.0581	11.0588	11.0578	11.0577	11.0566
10	11.1132	11.1131	11.1131	11.1128	11.1118	11.1112	11.1104	11.1104	11.1114	11.1103	11.1102	11.1093
11	11.1268	11.1263	11.1263	11.1255	11.1256	11.1242	11.1239	11.1239	11.1249	11.1231	11.1239	11.1233
not used												
not used												
not used												
not used												
not used												
Tech Initials	AH	AH	AH	JY/JH	JL	RB	JL	RB	RB	JL	JL	JL
Level S/N.	520038	520038	520038	522936	522937	522939	522937	522939	522939	521817	521817	521817
