Level and Crack Monitoring

Our Ref: 552624

Date of Issue: 27/10/2020

Occupier:	Removed for data protection purposes
Address:	10 Hook Lane
Address:	
Town:	Potters Bar
County:	
Post Code:	EN6 4DA
Contact Name	Removed for data protection purposes

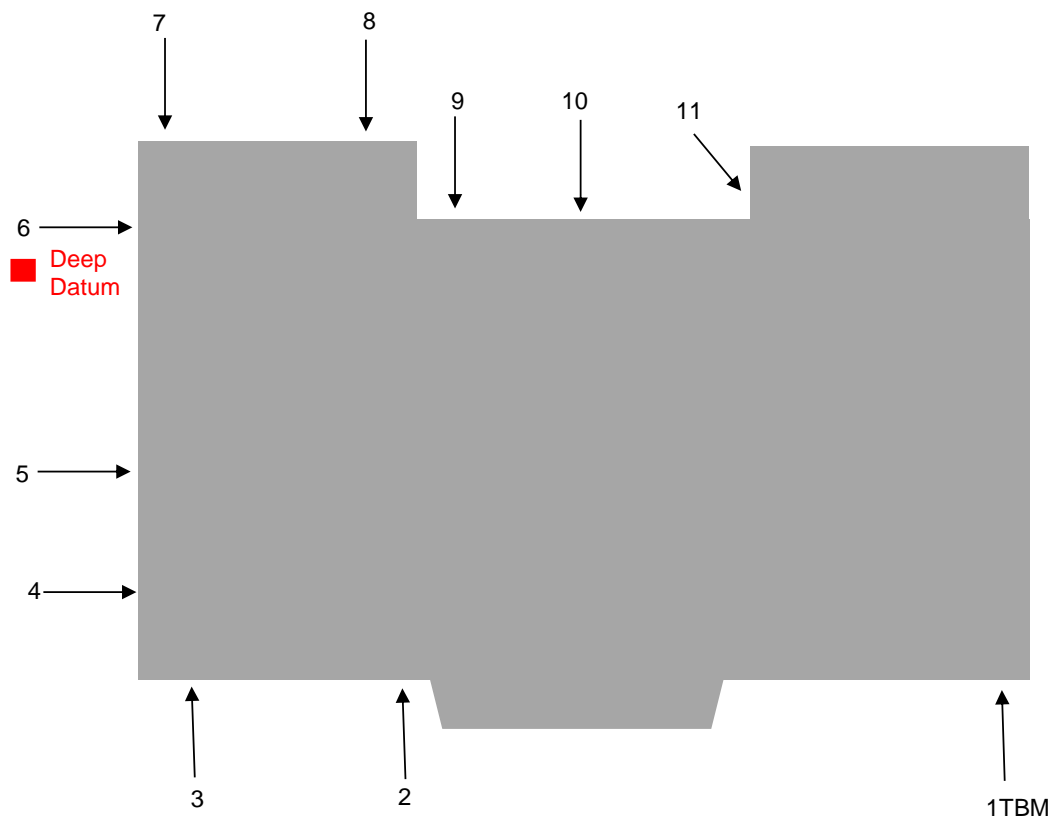
Level and Crack Monitoring - Site Sketch

26/10/2020 No access to point 11 this visit due to clutter
