ARBORICULTURAL ASSESSMENT REPORT

| | Risk Address: | 10 Hook Lane, Northaw, Potters Bar, Hertfordshire, EN6 4DA |
| Refs: | PRI Ref: | 144074 |

| Arborist Name: | Will Hinde | Date: | 16 th March 2020 |

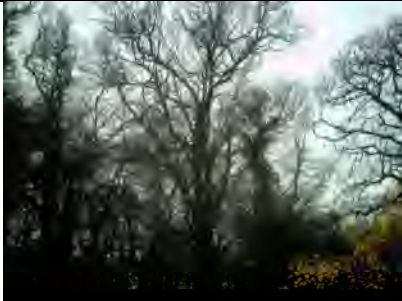
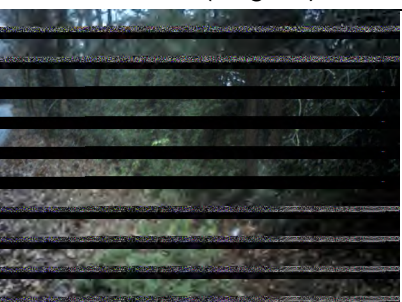
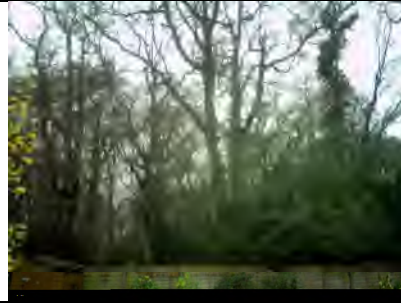
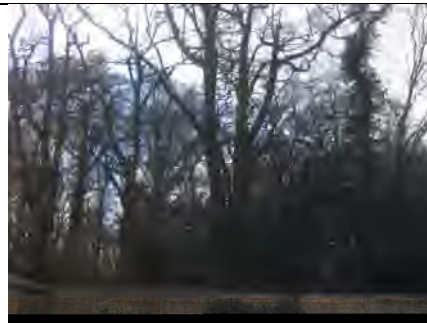
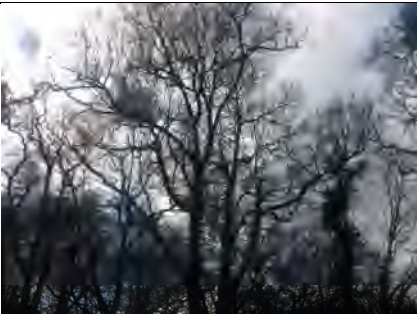
Welwyn Hatfield DC has confirmed that the implicated Oak trees T4 and T5 are subject to a Tree Preservation Order but there are no Conservation controls.

| Tree No | Common Name | Age Class | Condition | Height (m) | Crown Spread (m) | Stem diam. (mm) | Dist to bldg. (m) | Roots Implicated | Pruning history | Recommendation | Tree work constraints | Notes | Owner address | Owner |
|---|---|---|---|---|---|---|---|---|---|---|---|---|--|---|
| T4 | Oak (English) 2020 | Mature | Good | 28 | 20 | 1000* | 18.0 | Y | No significant past tree works. | Fell and treat stump | | Situated on edge of ditch, near side to PH property but est. 6m beyond PH fence. Twin stem from 3m. | Welwyn Hatfield District Council | LA |

| <p>T3 - Oak (English)</p> | <p>T4 - Oak (English)</p> |

| Tree No: | Species | Works Required |
|---|---|---|
| T4 | Oak (English) 2020 | Fell and treat stump |

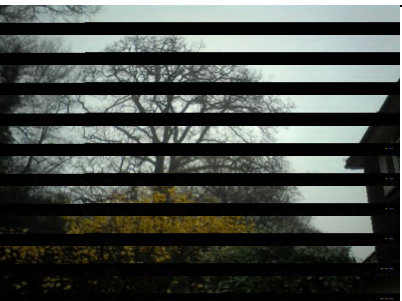
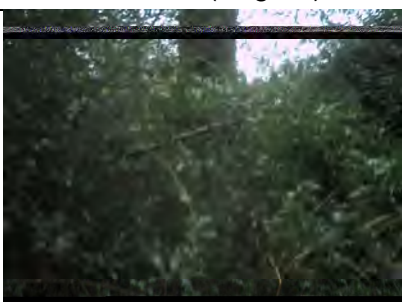
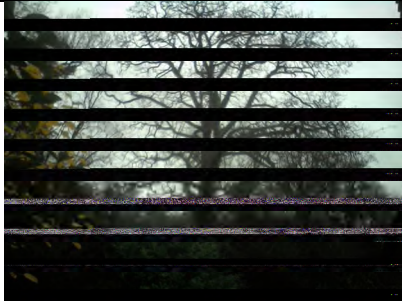
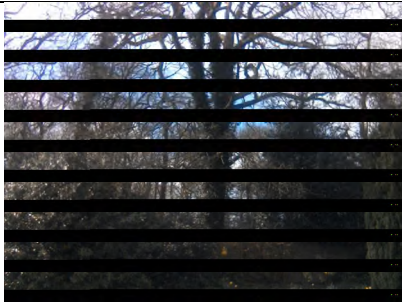
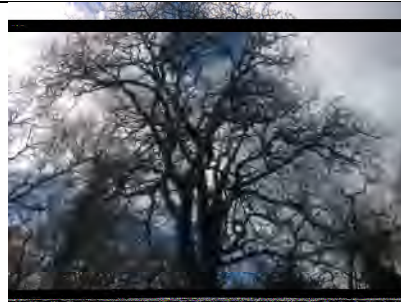
| Tree No | Common Name | Age Class | Condition | Height (m) | Crown Spread (m) | Stem diam. (mm) | Dist to bldg. (m) | Roots Implicated | Pruning history | Recommendation | Tree work constraints | Notes | Owner address | Owner |
|---|---|---|---|---|---|---|---|---|---|---|---|---|--|---|
| T5 | Oak (English) 2020 | Mature | Good | 25.5 | 20 | 1100* | 20 | Y | No significant past tree works. | Fell and treat stump | | Situated on edge of ditch, near side to PH property but 1.7m beyond PH fence. | Welwyn Hatfield District Council | LA |

| <p>T5 - Oak (English)</p> | <p>T3 - Oak (English)</p> |

| Tree No: | Species | Works Required |
|---|---|---|
| T5 | Oak (English) 2020 | Fell and treat stump |

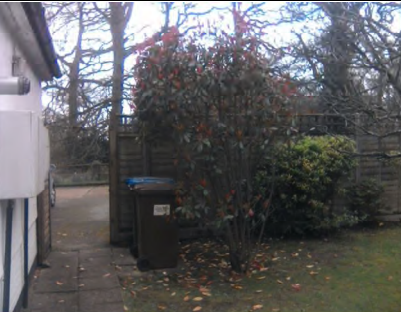
| Tree No | Common Name | Age Class | Condition | Height (m) | Crown Spread (m) | Stem diam. (mm) | Dist to bldg. (m) | Roots Implicated | Pruning history | Recommendation | Tree work constraints | Notes | Owner address | Owner |
|---|---|---|---|---|---|---|---|---|---|---|---|--|---|---|
| S1 | Photinia | Early Mature | Good | 2.3 | 1.50 | 30 | 2.4 | N | Subject to past management. | Fell and treat stump. | Access through side/rear gate. | Multistem. Implicated due to size and location. | 10 Hook Lane, Potters Bar, EN6 4DA | PH |

| <p>T9 - Hazel (Common)</p> | <p>S1 - Photinia</p> |

| Tree No: | Species | Works Required |
|---|---|---|
| S1 | Photinia | Fell and treat stump |

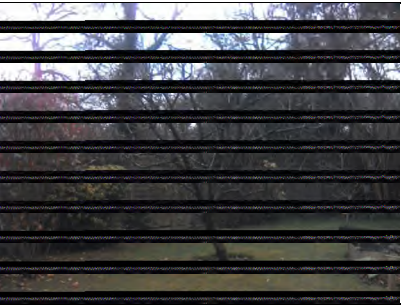
| Tree No | Common Name | Age Class | Condition | Height (m) | Crown Spread (m) | Stem diam. (mm) | Dist to bldg. (m) | Roots Implicated | Pruning history | Recommendation | Tree work constraints | Notes | Owner address | Owner |
|---|---|---|---|---|---|---|---|---|---|---|---|--|---|---|
| T10 | Apple | Mature | Good | 2.4 | 2.50 | 170 | 4.8 | Y | Subject to recent management. | Fell and treat stump. | Access through side/rear gate. | | 10 Hook Lane, Potters Bar, EN6 4DA | PH |

| <p>T10 - Apple</p> | <p>SG1 - Mixed species shrubs</p> |

| Tree No: | Species | Works Required |
|---|---|---|
| T10 | Apple | Fell and treat stump |
