# **DISCHARGE OF CONDITION**

## **COMET HOTEL, HATFIELD**

# COMET HOTEL, HATFIELD CRITTALL WINDOW SURVEY

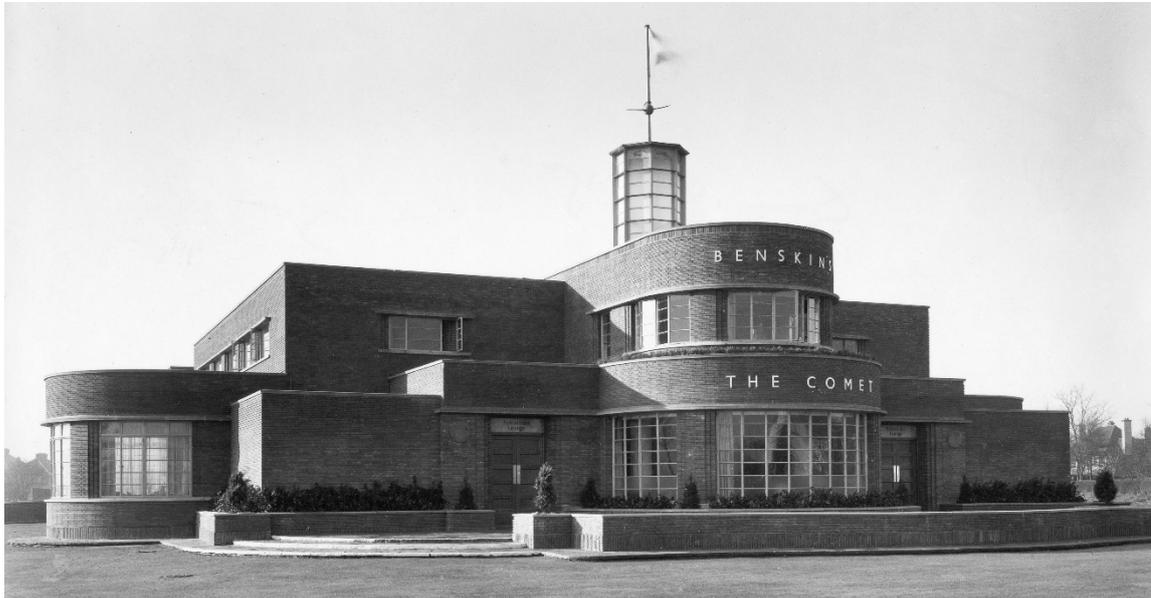
- 2.4 A number of windows within the building are later insertions (GW2, GW 7, GW8, GW12 and GW13). These windows have no value and detract from the building due to their lack of subdivision, which does not follow the established pattern across the building. A number of the doors, GD4, GD3 and GD2, are also later replacements. The original doors to these locations would have been timber doors, matching the detailing of GD 5, as shown below (Figure 1). GD 5 also appears to be a replacement of the original door, although it is of the correct detailing. Figure 1 also shows that the lower panes of the windows within the front curved block are slightly opaque. Today, these panes have been painted over, completely obscuring them, which also detracts from their appearance.

Figure 1 – 1937 photograph showing historic timber doors and blocks where the later windows (GW7, 8, 12 and 13) were inserted.
