Heritage Statement

**Oshwal Centre,
Coopers Lane Road
Northaw EN6 4DG**

November 2017

Saloria Architects Ltd

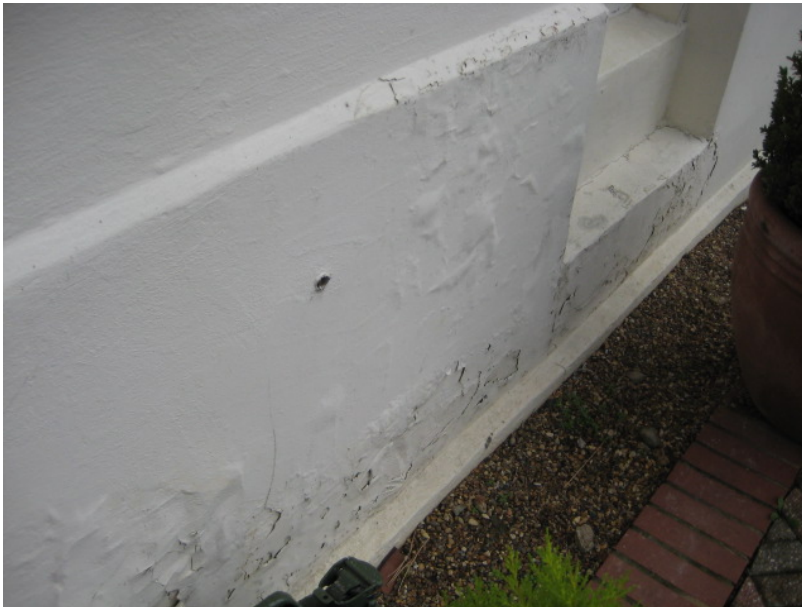
detail of the existing plaster damaged by water ingress

5.2 The proposed refurbishment aims to make good the external walls and preserve the appearance of the house for the future. The existing plaster will be replaced by rendered plaster to replicate the materials found on site.

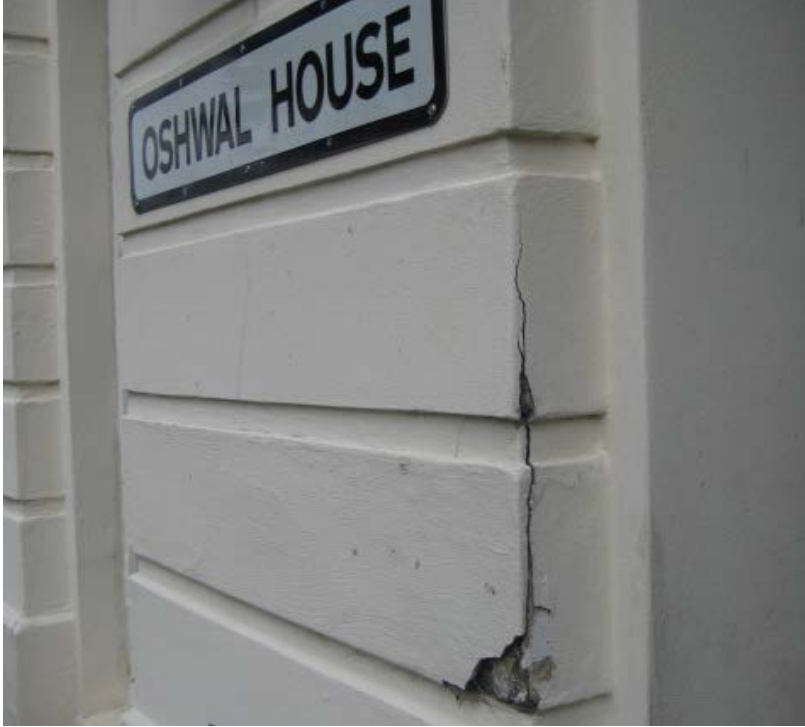
detail of the existing plaster damaged by cracks

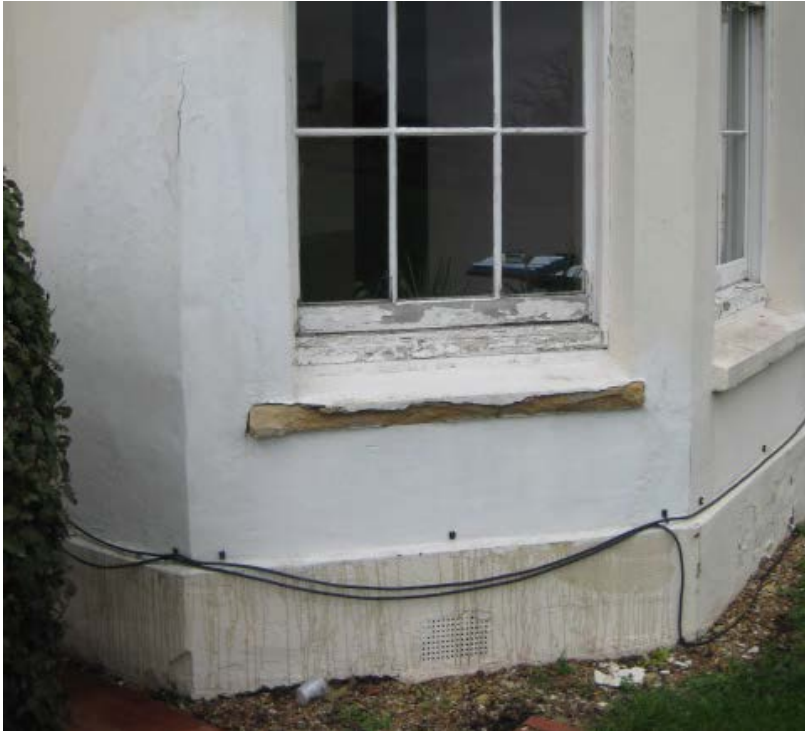
detail of the existing exterior sills to be repaired

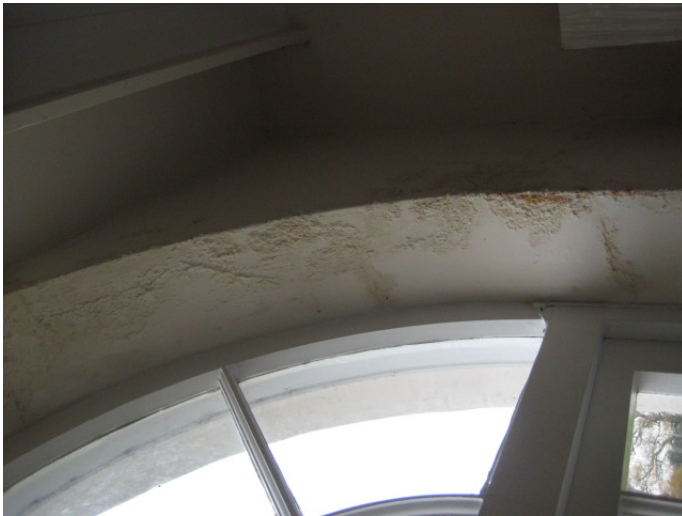
- 5.5 At time of writing all the timber window frames are in a poor condition. This is principally due to the decay of the timber exacerbated by high levels of moisture, which appears to be caused by some structural defects and is in turn affecting surrounding areas. In many cases, as illustrated in the photos above, the wall adjacent to the timber is suffering from damp. In other cases, we have found water pooling on the timber itself. These problems have been heightened by the damaged paint finishes on the timber which has allowed the frame itself to absorb excessive moisture.

detail of the existing plaster damaged by water ingress, which has caused the timber to decay

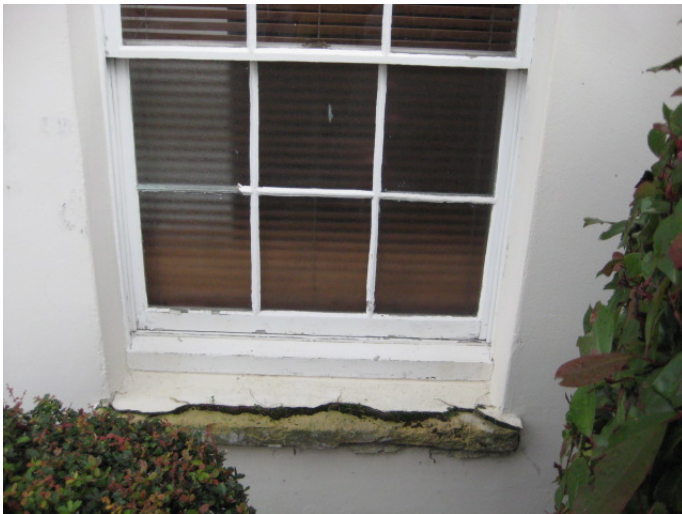
detail of the external part of the window frame damaged by water ingress

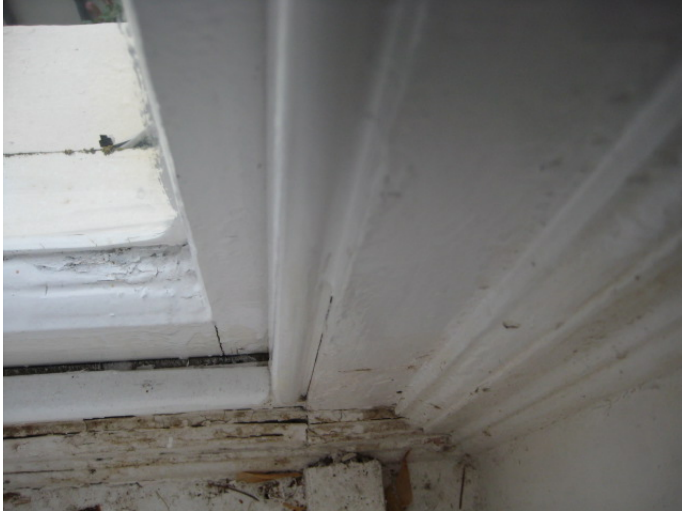
detail of the existing window frames damaged by water ingress, fungus and rot.

- 5.6 Water ingress into the timber has led to the spread of moulds, timber fungi and root rot which means the level of repair or restoration action would be tantamount to replacement, and therefore cannot be considered an appropriate course of action. Although the proposed general external refurbishment will certainly remove the source of the dampness by the replacement of the defective render, the decay of the frames is at a level at which any chemical treatment may not be effective at halting further decay where existing timber might possibly be retained.
