Heritage Statement

**Annex 1 (R09) - to support the
refurbishment of the render and
the windows of Oshwal House
(6/2018/0137/LB & 6/2018/0136)**

**Oshwal Centre,
Coopers Lane Road
Northaw EN6 4DG**

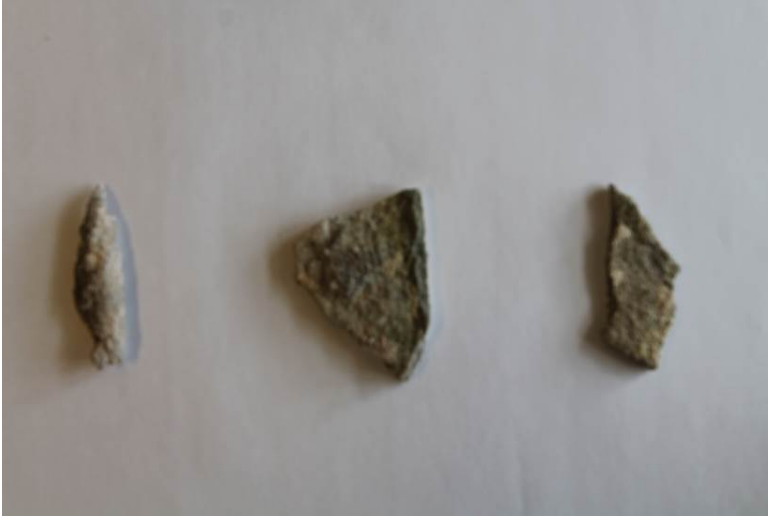
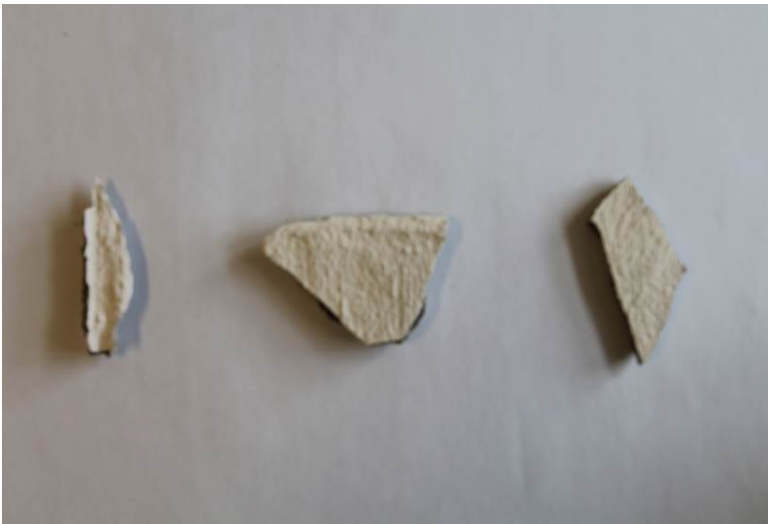
1.0: sample 1 – cement render (the samples were taken from part of the building where the render was visibly damaged or already fallen. That not to have an invasive approach)

1.1: sample 1 – cement render (the samples were taken from part of the building where the render was visibly damaged or already fallen. That not to have an invasive approach)

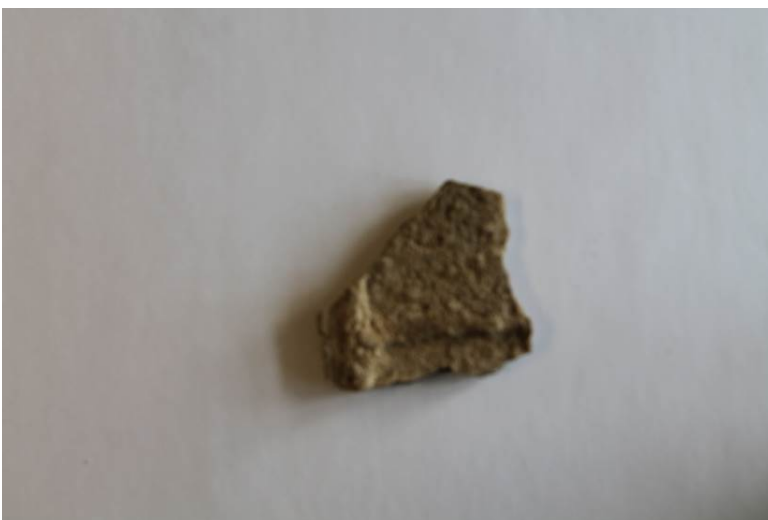
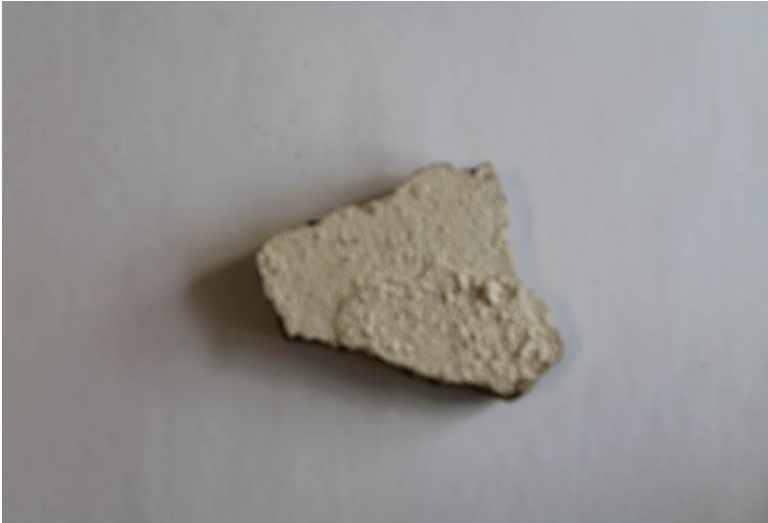
2.0: sample 2 – lime render (the samples were taken from part of the building where the render was visibly damaged or already fallen. That not to have an invasive approach)

2.1: sample 2 – lime render
(the samples were taken from part of the building where the render was visibly damaged or already fallen. That not to have an invasive approach)

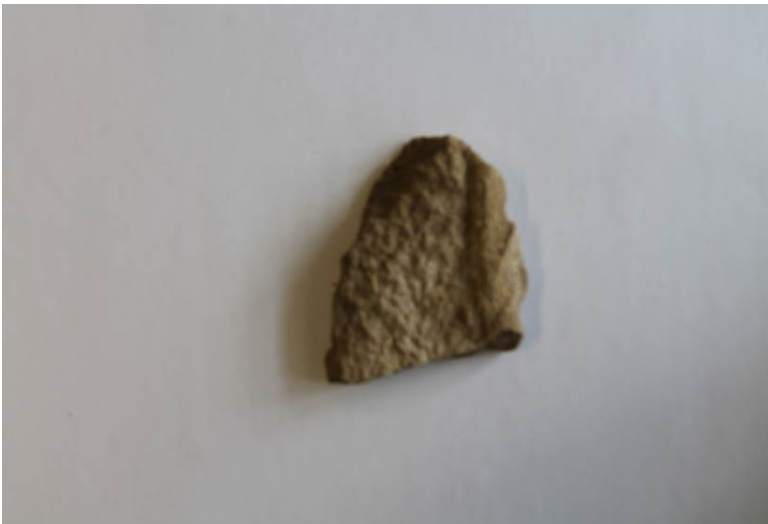
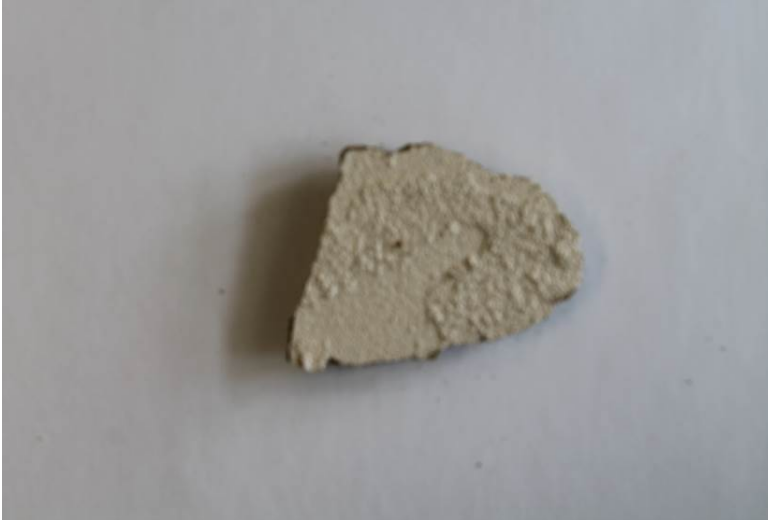
3.0: sample 3 – lime render
(the samples were taken from part of the building where the render was visibly damaged or already fallen. That not to have an invasive approach)

3.1: sample 3 – lime render
(the samples were taken from part of the building where the render was visibly damaged or already fallen. That not to have an invasive approach)

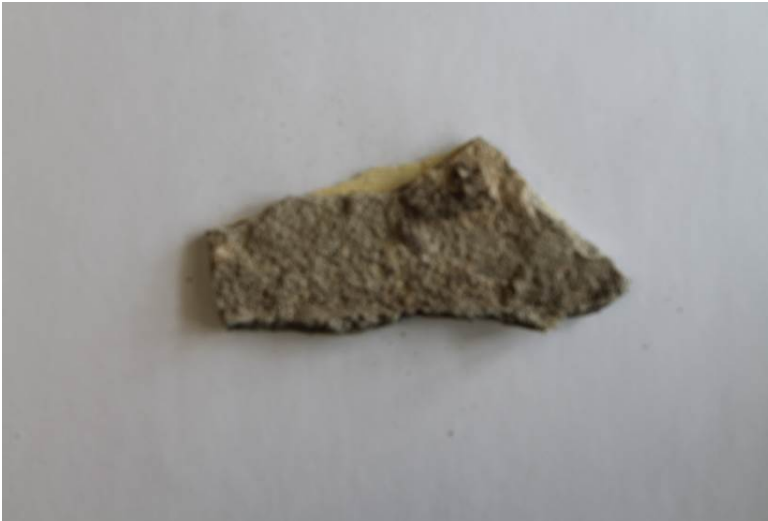
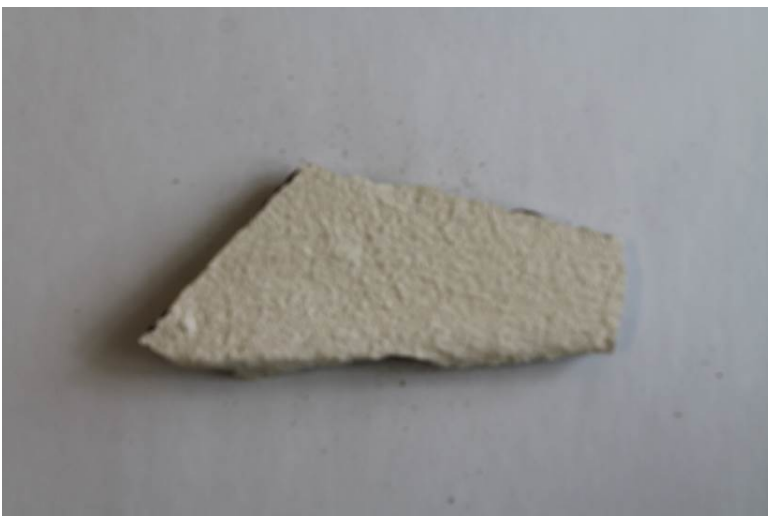
4.0: sample 4 – cement render (the samples were taken from part of the building where the render was visibly damaged or already fallen. That not to have an invasive approach)

4.1: sample 4 – cement render (the samples were taken from part of the building where the render was visibly damaged or already fallen. That not to have an invasive approach)

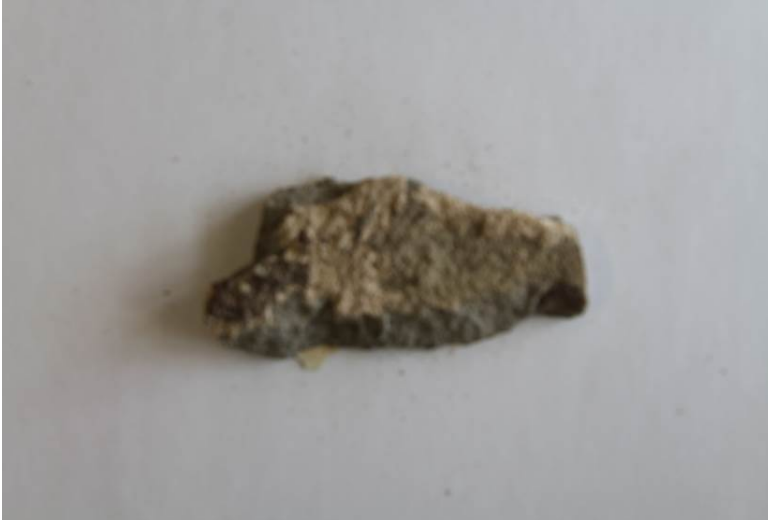
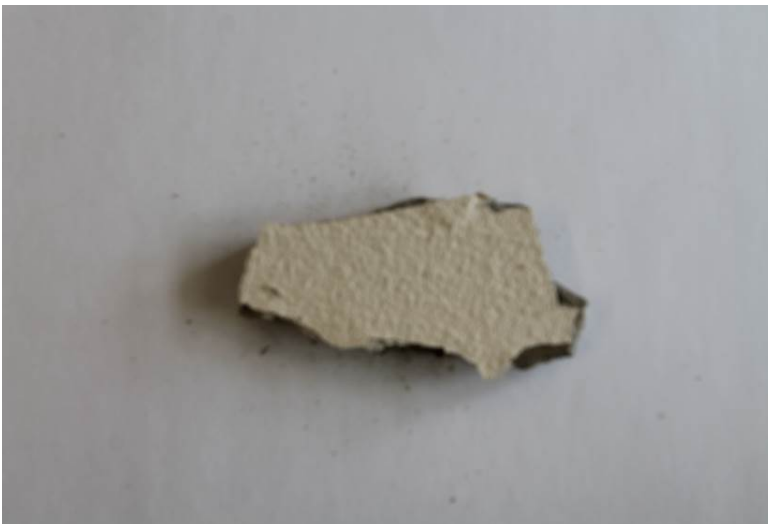
5.0: sample 5 – cement render (the samples were taken from part of the building where the render was visibly damaged or already fallen. That not to have an invasive approach)

5.1: sample 5 – cement render (the samples were taken from part of the building where the render was visibly damaged or already fallen. That not to have an invasive approach)

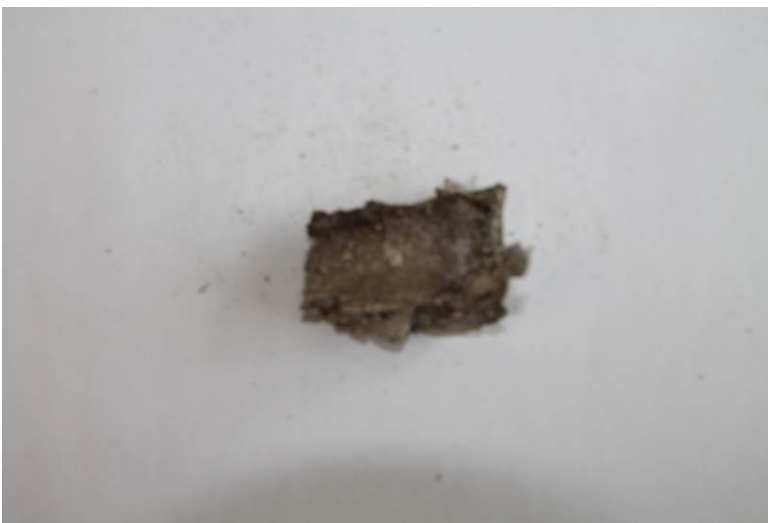
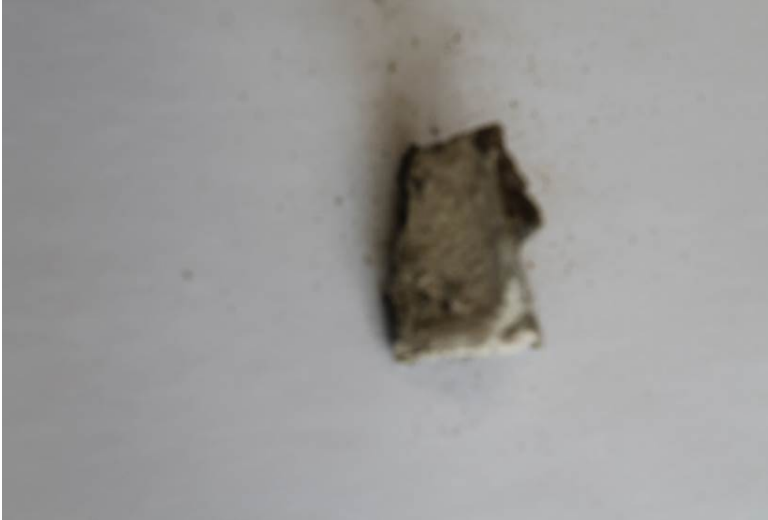
6.0: sample 6 – cement render (the samples were taken from part of the building where the render was visibly damaged or already fallen. That not to have an invasive approach)

6.1: sample 6 – cement render (the samples were taken from part of the building where the render was visibly damaged or already fallen. That not to have an invasive approach)

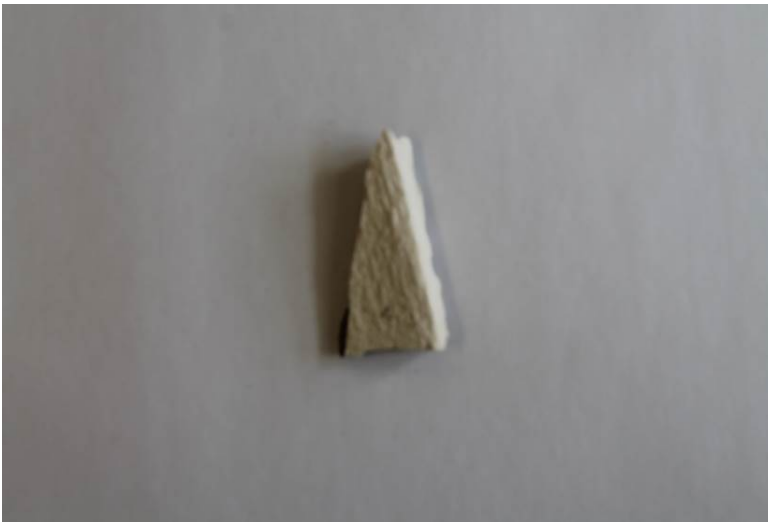
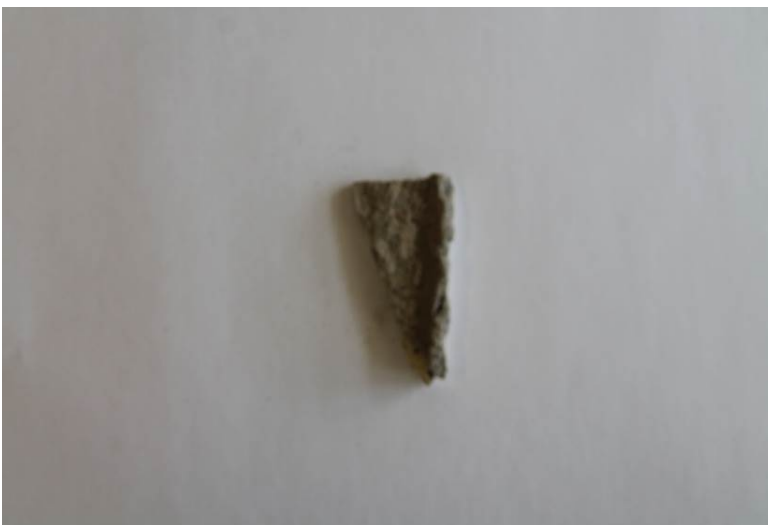
7.0: sample 7 – cement render (the samples were taken from part of the building where the render was visibly damaged or already fallen. That not to have an invasive approach)

7.1: sample 7 – cement render (the samples were taken from part of the building where the render was visibly damaged or already fallen. That not to have an invasive approach)

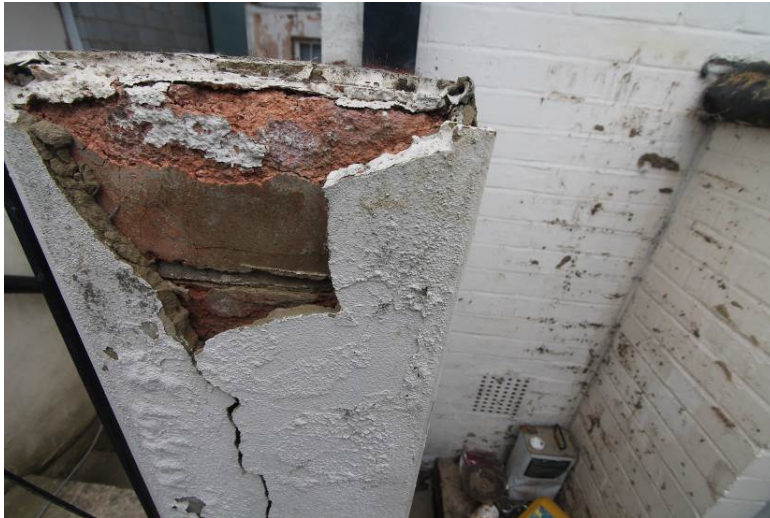
- 2.5 furthermore the zone where we found the lime render the situation underneath the render was worse than expected and water and ice started to damage the bricks.

8.0 – (7762) –
Point for sample 2 on dwg
6842-77-P0. area with
lime render

- 2.6 The nature of the paint (a sort of thick film) has been already clarified in the appendices on the first Heritage Statement. The paint (see especially sample No.2) not only does not permit to the render to transpire, it also prevents to proceed to a visual assessment and separation of the areas with lime render and cement render.

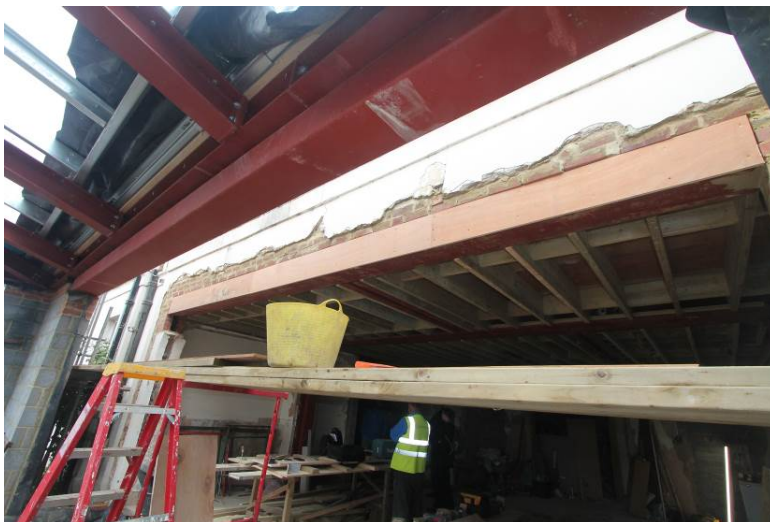
9.0 – (5656) –
Area A on dwg 6842-77-P0
area with lime render

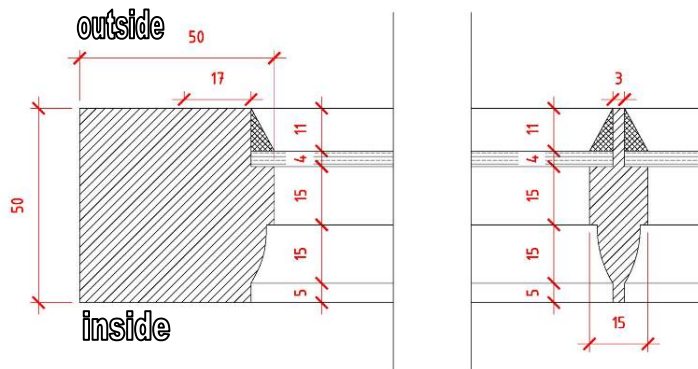
- 2.10 Drawing 6842-78-P0 report the same numbering of the drawing 6842-74-P0 (already submitted).
- 2.11 A second thorough analysis on the window has been carried out. The windows Nos.1, 2, 3, 12, 13, 14, 15, 16, 17, 18, 20, 21, 22, 23, 24, 25, 26, 38, 39 ,40 ,41, 42, 43, 44, 45, 46, 47, 48 are single glazed with timber frame. The frame has been found to be Scottish pine tree, which matches with other building built at the same era (early Victorian age). The frames are in a general good condition and only some minor parts need to be replaced (especially at the first floor).

Existing section of the frame (windows listed in point 2.11) and the muntin (image not in scale) (abstract of details from the survey and drawing attached to application 6-2018-0136-LB).

- 2.16 The new findings have at this point changed the approach to the refurbishment of the windows. For the windows listed in point 2.11 it is proposed to restore the existing frame with as less changes as possible (just rotten parts). It is also proposed to replace the single glaze (4mm) with a very thin double glaze (4-6-4) to improve the energy efficiency of the building.
- 2.17 For the windows listed in point 2.12 it is proposed to replace the frame with a new frame. The new frame will be the same which has been approved for the single storey rear extension. It is also proposed to replace the single glaze (4mm) with a very thin double glaze (4-6-4) to improve the energy efficiency of the building.
