Forest Lodge
The Ridgeway
Cuffley
Hertfordshire

Survey of cracking in garage
and recommendation for amelioration

Heave / settlement damage
Tree survey

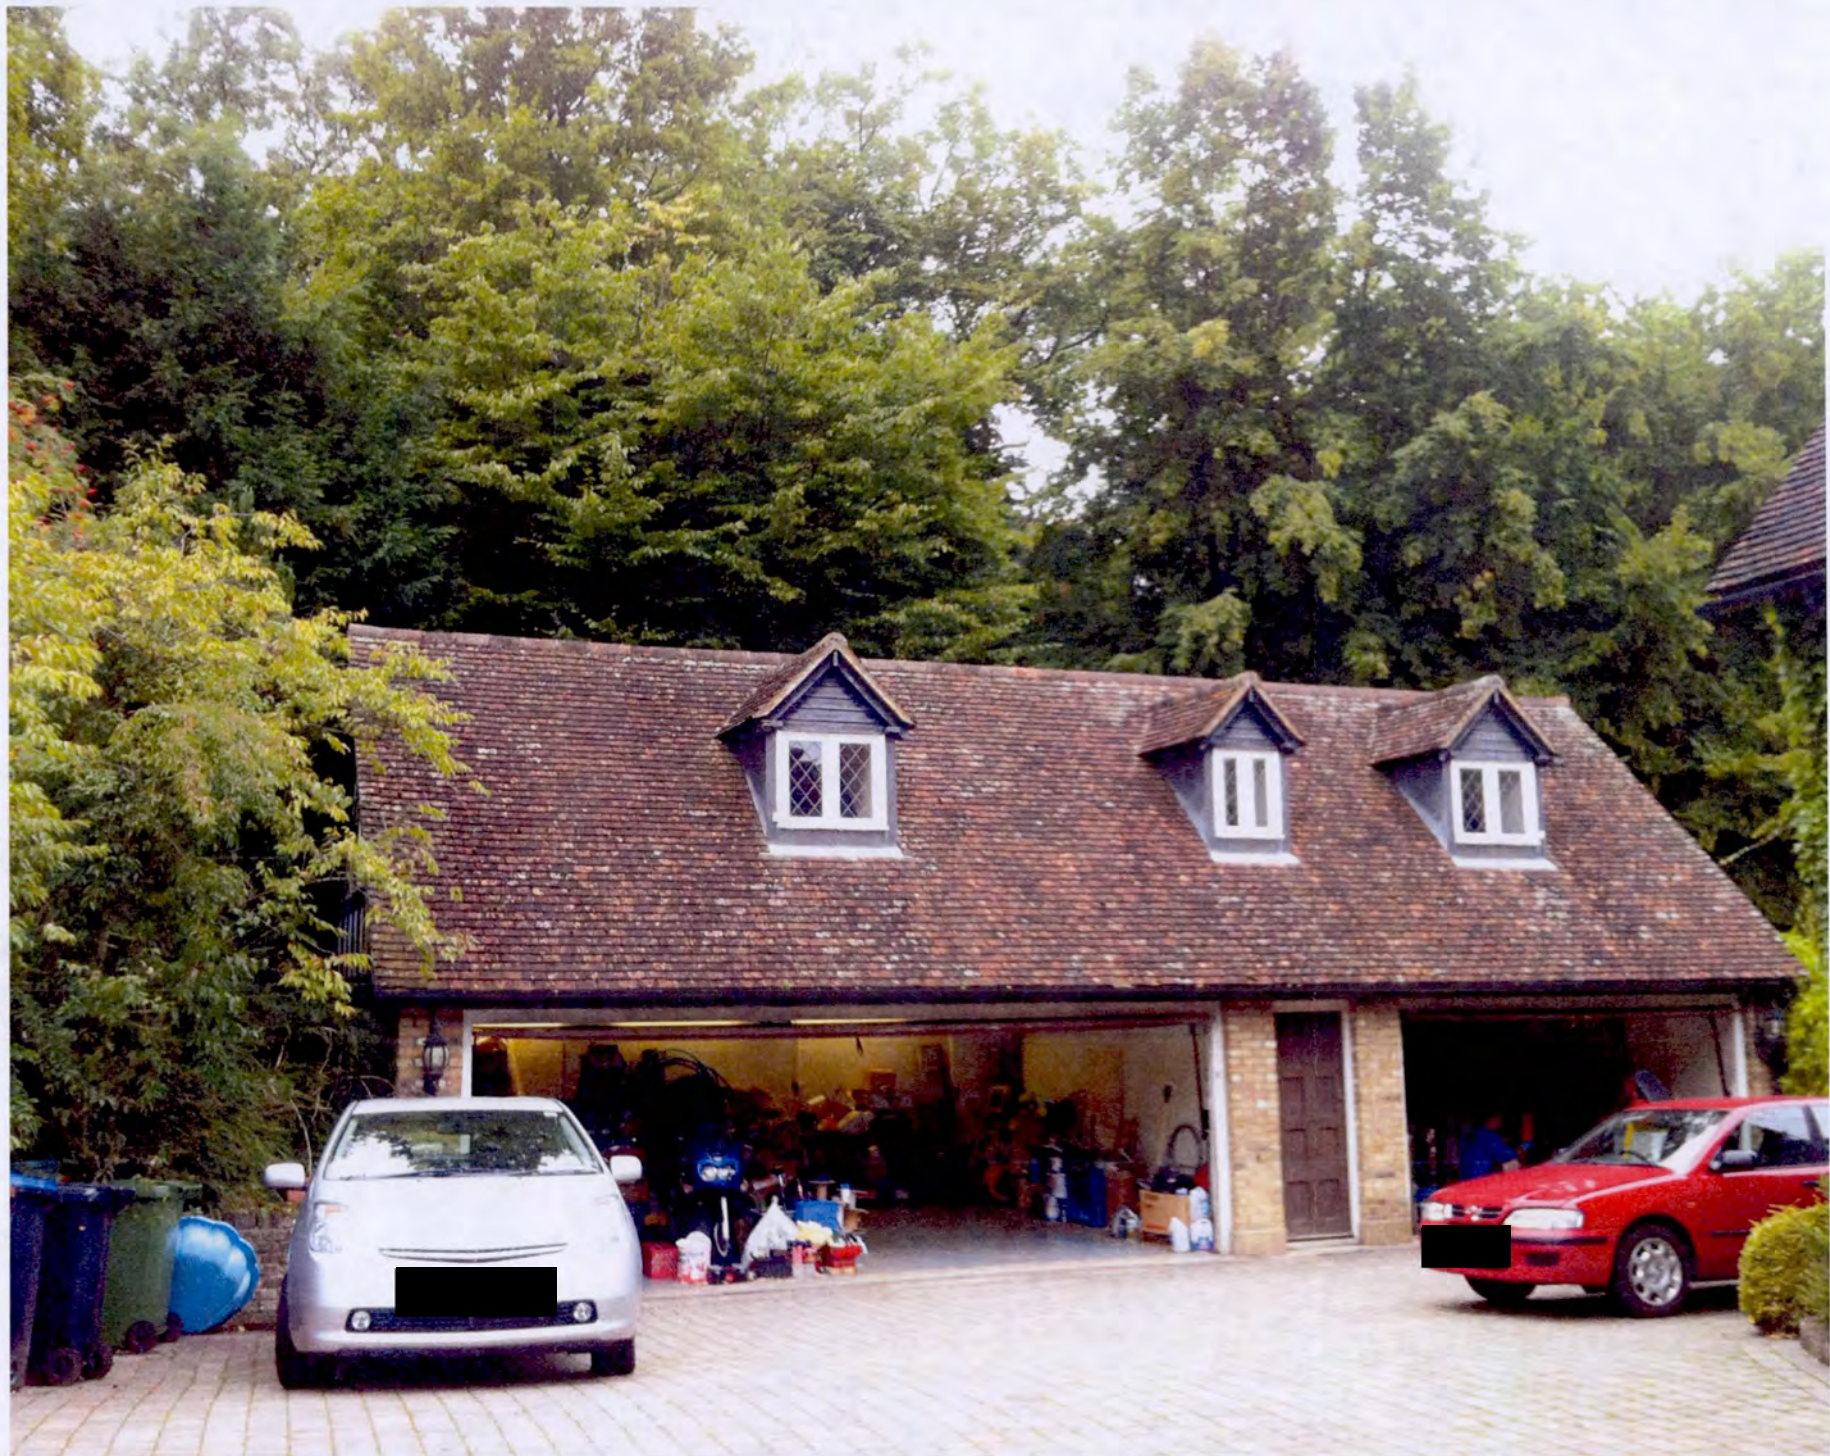
There are ten beech trees within approximately 11 metres of the building, which as a group can be expected to contribute to a greater effect on the subsoil than would a single tree. There are additional trees at a greater distance.

The extent and distribution of the cracking within the rear wall of the garage demonstrates that the removal of moisture from the clay subsoil is causing shrinking of that clay subsoil along the entire rear wall foundation.

The absence of cracking in the two end walls other than at the junction with the rear wall is as may be expected from a wide distribution of beech trees to the rear.

The absence of cracking in the two end walls, other than close to the junction with the rear wall confirms that the shrinkage of the clay is not caused by the smaller Leylandii hedging plants. These would be more likely to result in cracking of the rear wall close to the ends only with a lesser effect near to its centre. This pattern is not evidenced; therefore it may be considered that the Leylandii hedging is not a significant cause of the damage.

Outline of garage block

Leylandii hedge

Numerous beech trees

1. the beech trees within approximately 11 metres be removed and
2. the Leylandii be kept as a trimmed hedging plant at the boundary.
3. the subsoil be allowed to recover over several years following tree removal during which time the cracks in the building may close up.
4. remedial works to the garage be undertaken only after recovery has ended.
