**HEALTH AND SAFETY
ARBORICULTURAL REPORT**

OUR REFERENCE	AC.2018.136
CLIENT	Mr Mohammad Osman of Amber Housing
SITE	St Audrey's, Church Street, Old Hatfield, Hertfordshire, AL9 5AR
SURVEY & REPORT BY	Mr I S Tom Thompson BSc. (Hons.) Arb. MSc. (eFor) MArborA
DATE	2 nd August 2018
DATE OF INSPECTION	20 th July 2018

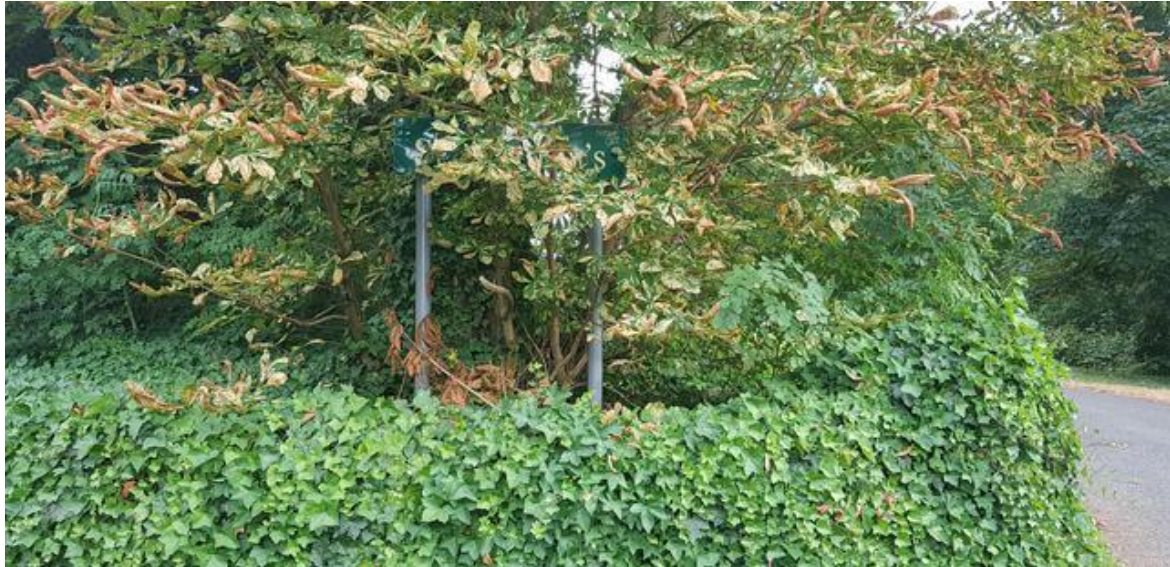
- 3.1.1** The trees were all located in the grounds of St Audrey's on Church Street Hatfield. There were a number of them along the road frontage, immediately behind a 2m tall retaining wall, see Images 1 and 2. The structural integrity of the wall was being assessed by an appropriate professional, but the trees' condition needed to be assessed as there was a public highway adjacent to the wall, so it was a high target area.

Image 1 Trees along road frontage behind retaining wall, near to entrance

3.3.14 Finally, the basal growth from T268 should be cut back to allow people to see the sign for St Audrey's, see Image 1.

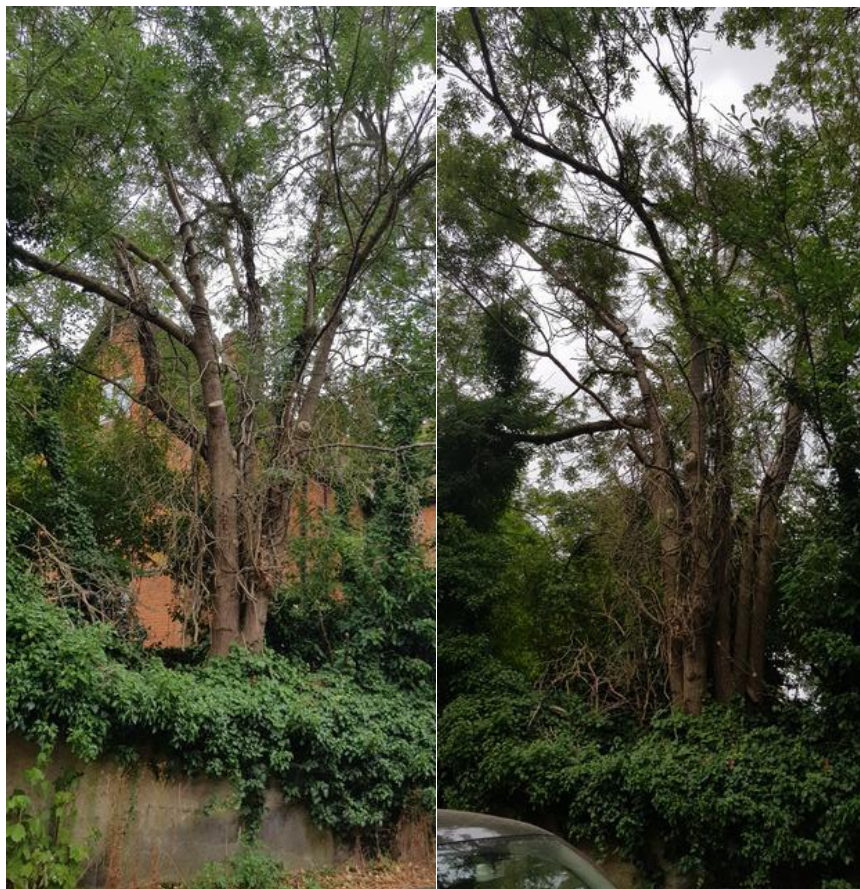
Image 2 Trees further down the retaining wall

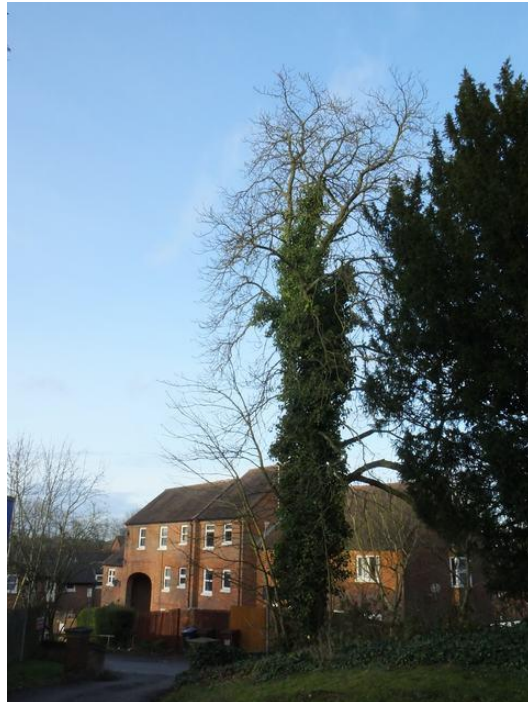
3.3.1 T268 is a large horse chestnut tree immediately adjacent to the main driveway and Church Street. It has minor cavities and suckering as well as fibre buckling and tight unions with included bark. The ivy has been severed on this tree. It has a severe leaf miner infestation.

Image 3 T268, by the entrance

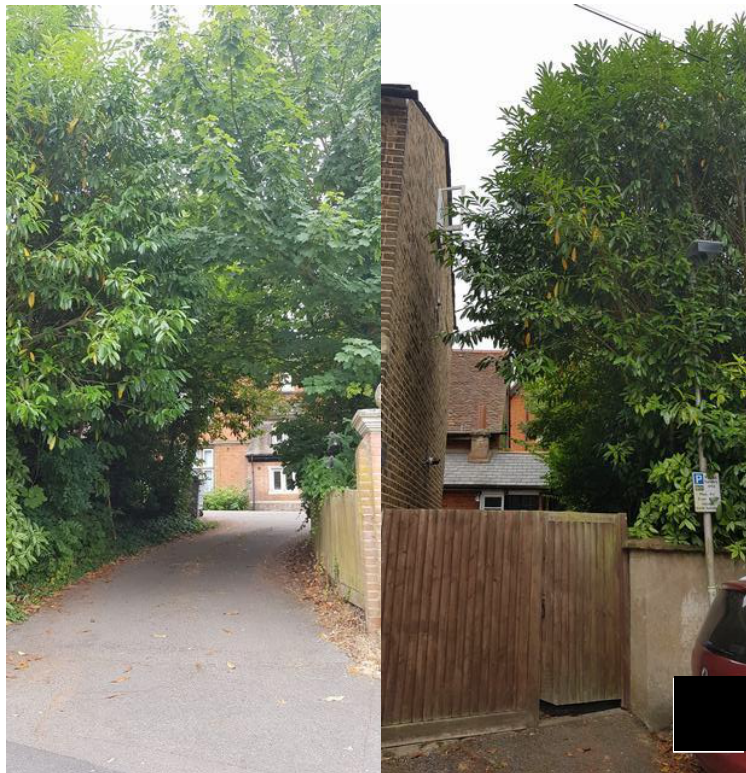
Image 4 T270A, adjacent to Church Street

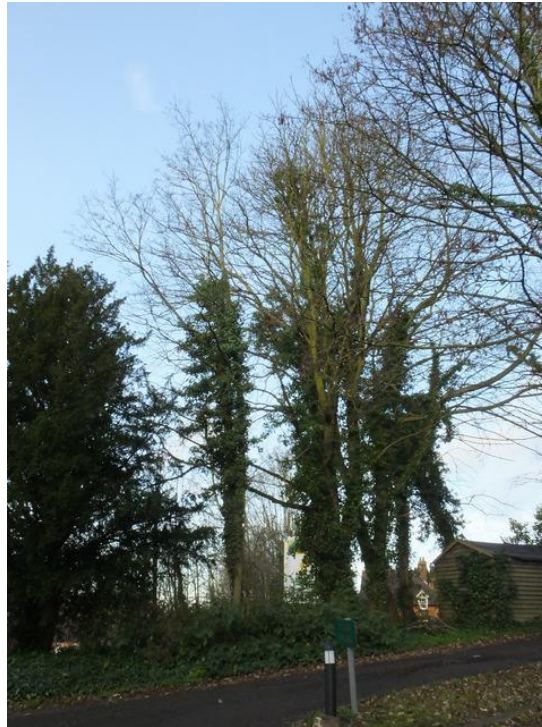
Image 5 T270 to T273 viewed from the grounds of St Audrey's

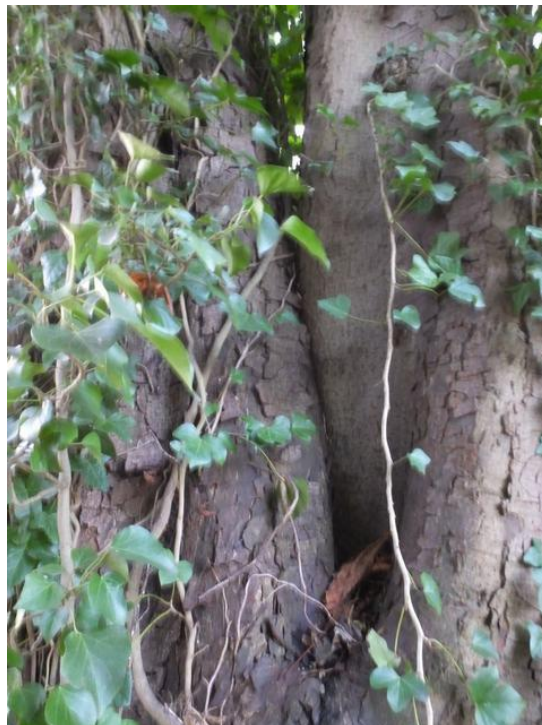
Image 6 Tight union with included bark on T270A

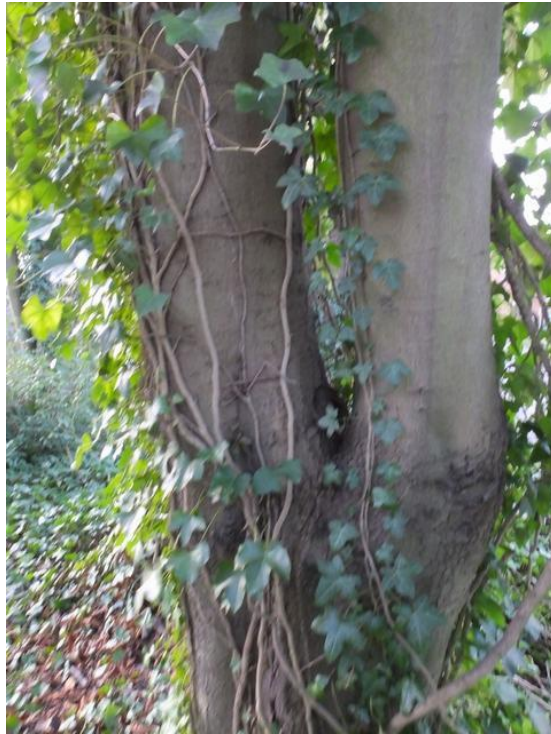
Image 7 **Tight unions with included bark on T271**

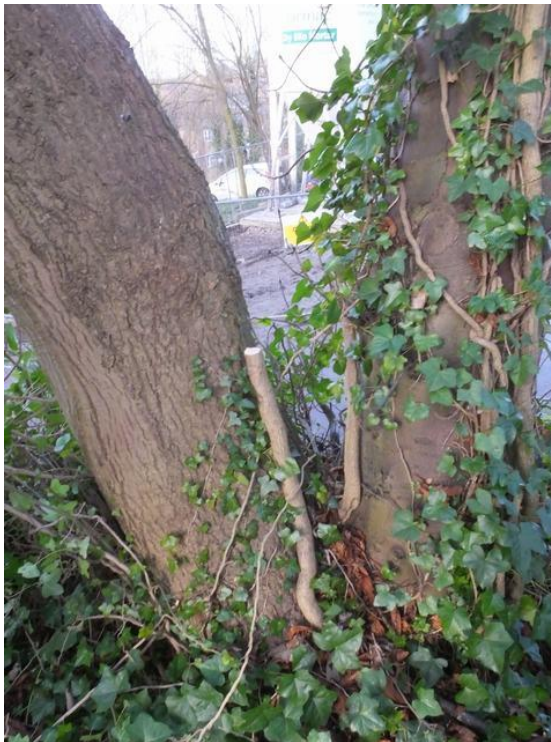
Image 8 **T272 and T273, joined at the base**

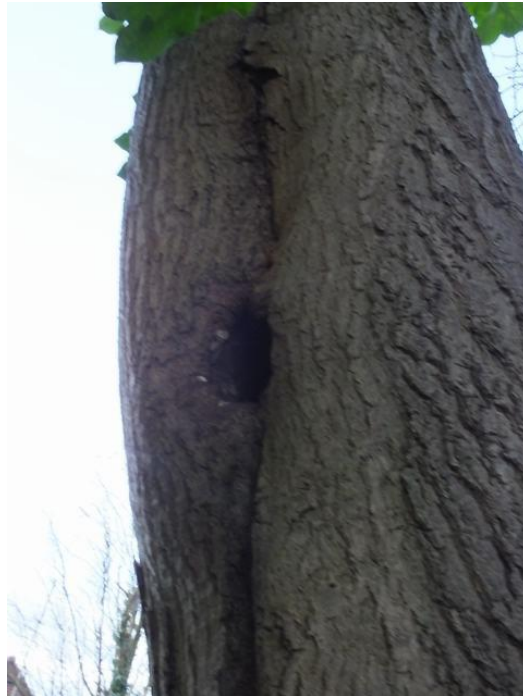
Image 9 Persistent crack and cavity on T272

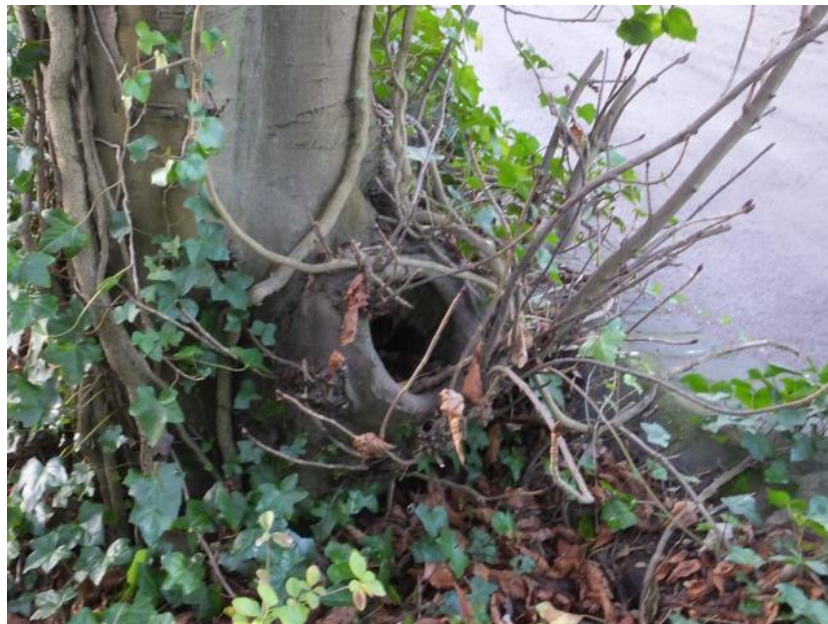
Image 10 Basal cavity on T273

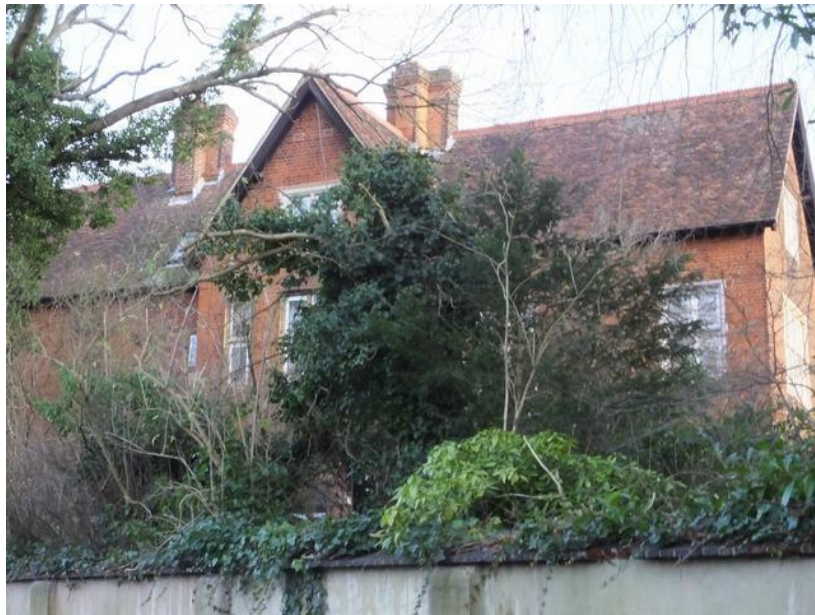
Image 11 T277, a stump covered with ivy but with leader snapped and hung up

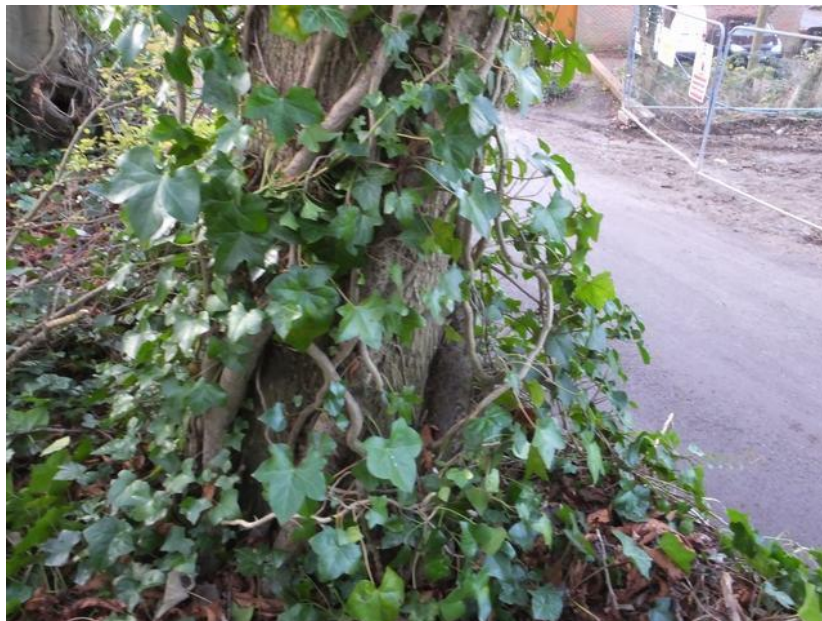
Image 12 T274, growing over the top of the retaining wall

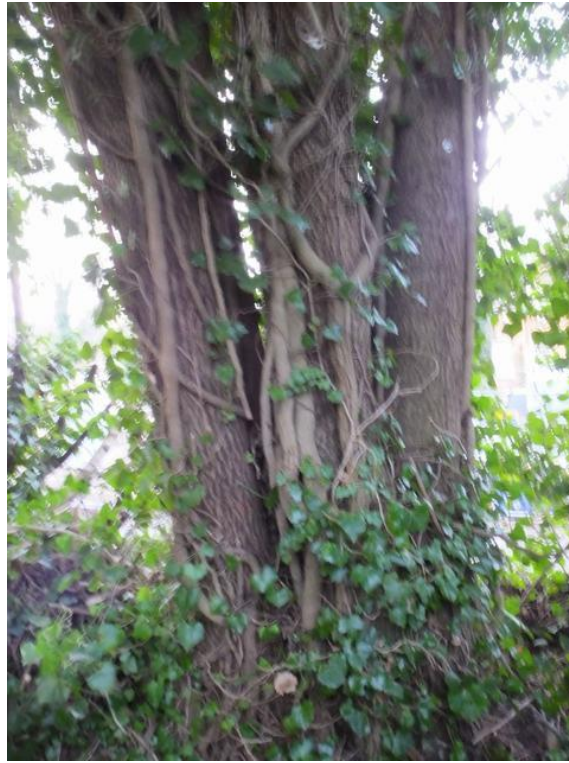
- 3.3.3** T278 is a large ash trees, that is close to the road so is recommended for the removal of deadwood.
- 3.3.4** T281, another large ash tree is recommended for at the very least the deadwood to be taken out, as it is close to the driveway and road. This tree is in terminal decline and it is only a matter of time before it dies completely. Other options are to pollard the tree or to coppice it, removing the main trunk and seeing what if anything re-emerges from the roots.

Image 13 T281 with multiple stems, some dead or decayed with Daldinia

- 4.1.1** 3.3.9 T278 is a large ash trees, that is close to the road so is recommended for the removal of deadwood.
- 4.1.2** T281, another large ash tree is recommended for at the very least the deadwood to be taken out, as it is close to the driveway and road. Alternatively, this tree could be pollarded or coppiced.

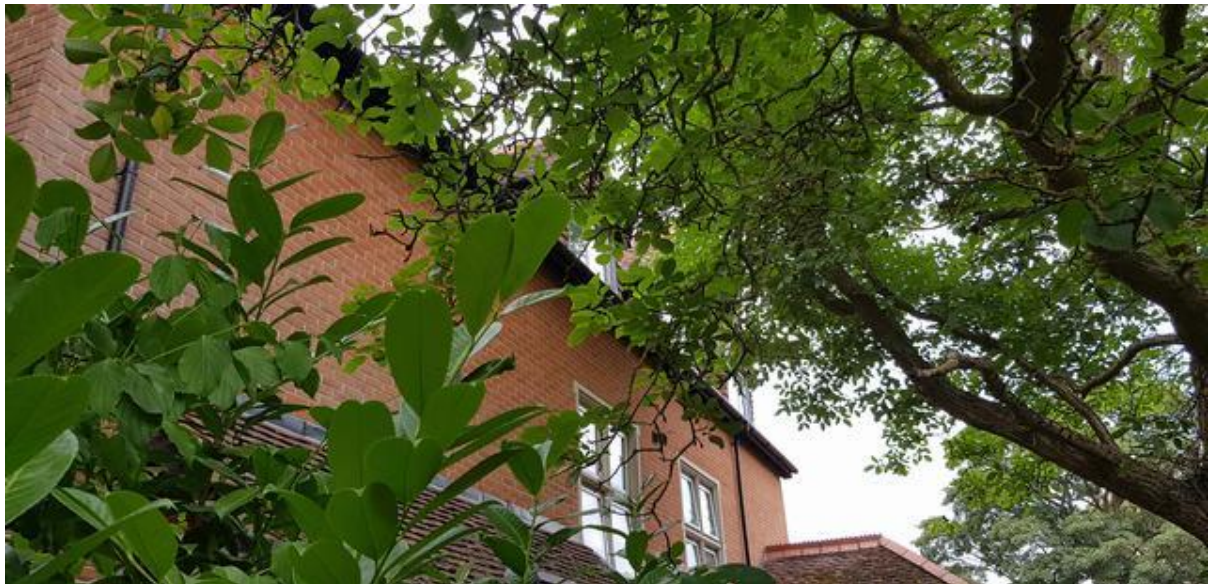
- 3.3.7** T286 is a large declining walnut tree growing adjacent to the main building. This tree has minor deadwood, damaged branches and fallen branches on the ground. There is also evidence of damage to the roots which is likely to have occurred when the main building was constructed, see Image 14. This tree is recommended for cutting back from the building by at least 2-3m to allow sufficient light into the adjacent room.

Image 14 T286, declining walnut tree adjacent to main building (left) & root damage

- 4.1.6** T286 is a large declining walnut tree growing adjacent to the main building. This tree is recommended for cutting back from the building by at least 2-3m to allow sufficient light into the adjacent room.

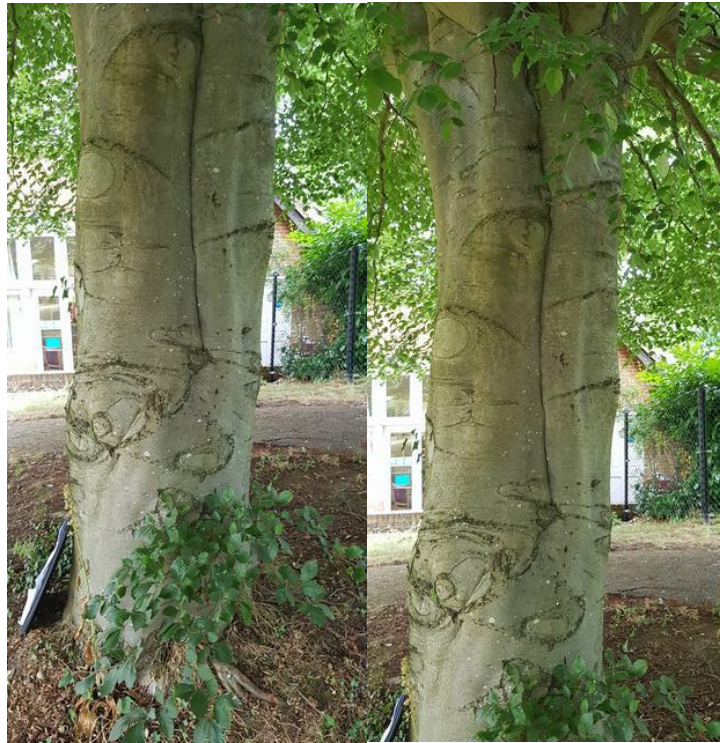
- 3.3.8** T288 is a large beech tree that is growing adjacent to the main building. This tree has twin stems and they have included bark. Over time these stems have fused together to create a strong union, see Image 15. This tree is recommended for cutting back from the building by at least 2-3m to allow sufficient light into the adjacent room.

Image 15 T288, with fused stems

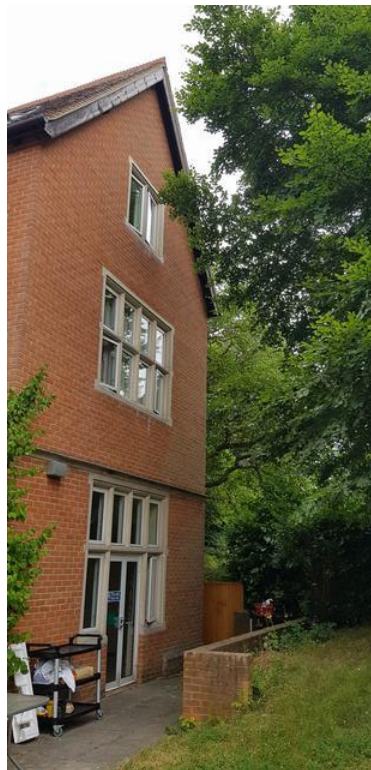
Image 16 T288 close to the building, recommended to be cut back to clear the building by 2-3m

- 4.1.7** T288 is a large beech tree that is growing adjacent to the main building. This tree is recommended for cutting back from the building by at least 2-3m to allow sufficient light into the adjacent room.

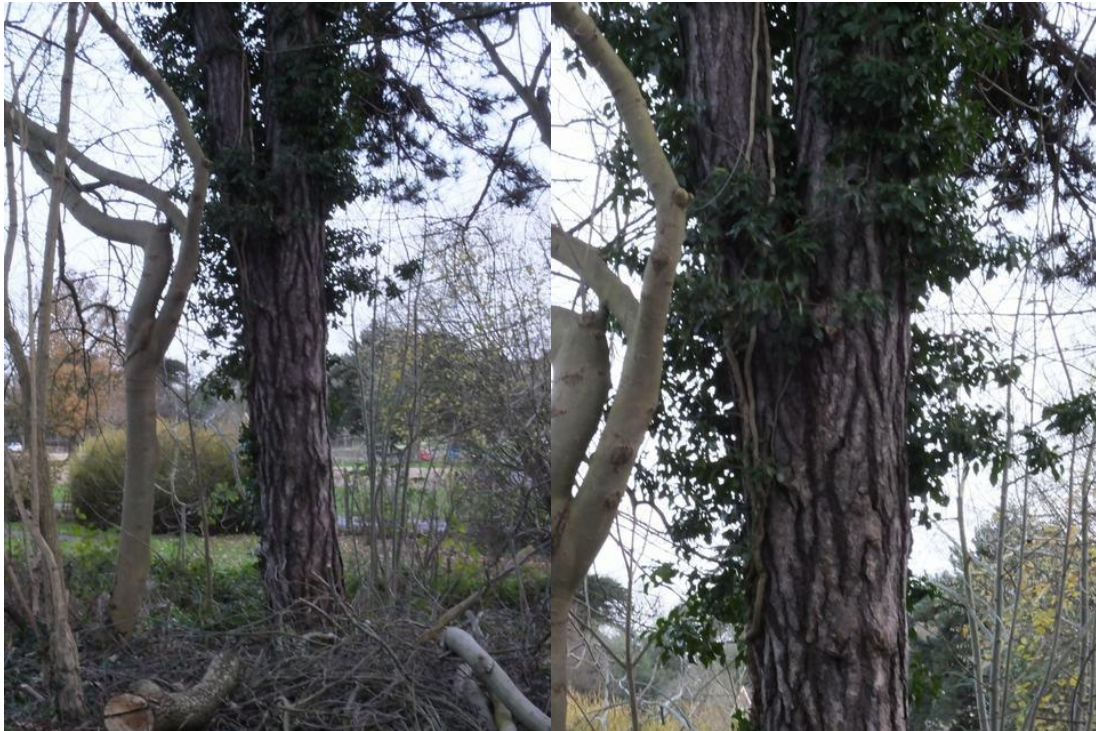
- 3.3.9** T293 is a large Corsican pine with twin stems from around 4m. There is a tight union between the stems with included bark and a persistent crack running down from this point. This tree should be put on a frequent inspection regime to monitor the extent of this defect.

Image 17 T293 with tight union with included bark
