**Tree Wall Damage
Report**

OUR REFERENCE	AC.2021.572
CLIENT	Mr Mohammad Osman
SITE	St Audrey's, Church Street, Old Hatfield, Hertfordshire, AL9 5AR
SURVEY & REPORT BY	Mr I S Thompson (known as Tom) BSc. (Hons.) Arb. MSc. (eFor) MArborA
DATE	4th November 2021
DATE OF INSPECTION	18th December 2021

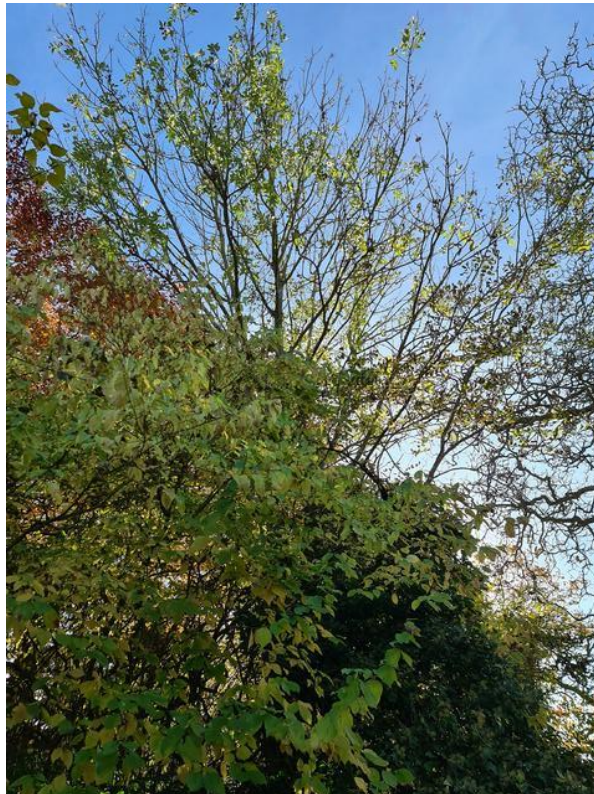
- 3.3** T 308 was a multi stemmed ash tree, see Image 1, It was growing on top of the wall, see Image 6 and 7. It had four stems with stem diameters of 25 cm, 22 cm, 20 cm, 14 cm. There were two stems either side of some wire, which appeared to be a historic site boundary fence, see Image 8. This would indicate that this is a genuine boundary tree.

- 3.4** It had a low stem on St Audreys' side which was covered with dense ivy. There were tight unions with included bark. There was ivy establishing on the other stems. It had a crown spread of 6 m, 3 m, 4 m, and 4 m to the four cardinal points. There was crown suppression from beech tree to the east and walnut to the west.

Image 1 T308 the multi stemmed ash tree with T310 front left in the foreground.

- 4.8** It is considered that the best course of action is to remove this tree.
- 4.9** The joint owners of the tree should be contacted to inform them of the situation and get their agreement. This should be agreeable to them given the situation. They may be unwilling to share the cost, but that is a separate conversation.

- 6.1 Contact the neighboring landowners to inform them of your plans
- 6.2 Remove the ash tree T308 prior to the commencement of the wall construction.
- 6.3 Cut back T310 to the the rear of the existing wall, to enable construction access.
- 6.3 Install a gutter hedgehog or similar product in the adjacent gutters.
- 6.4 Re-inspected all retained trees within the next three years.

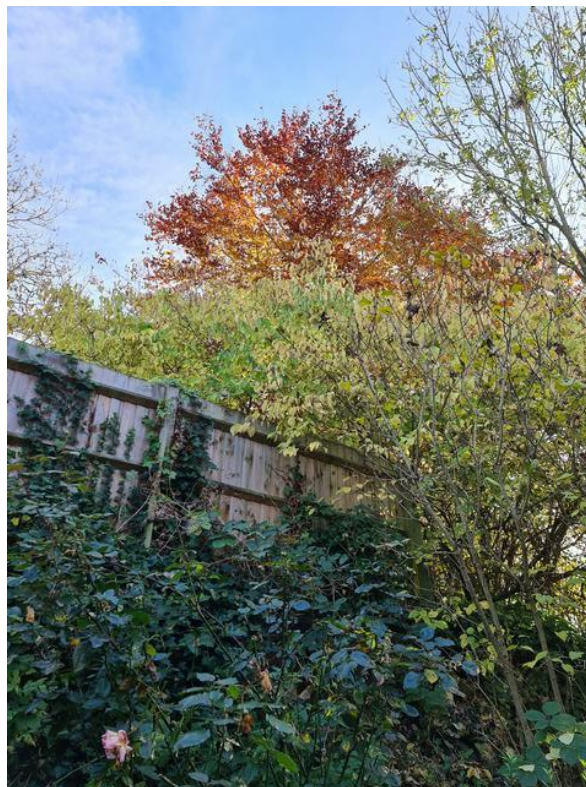
- 3.5** T309 was a copper beech tree which was growing in adjacent property, 8 m from the boundary, see image 2. There were no significant observations.

Image 2 T309 the copper beech tree at the rear.

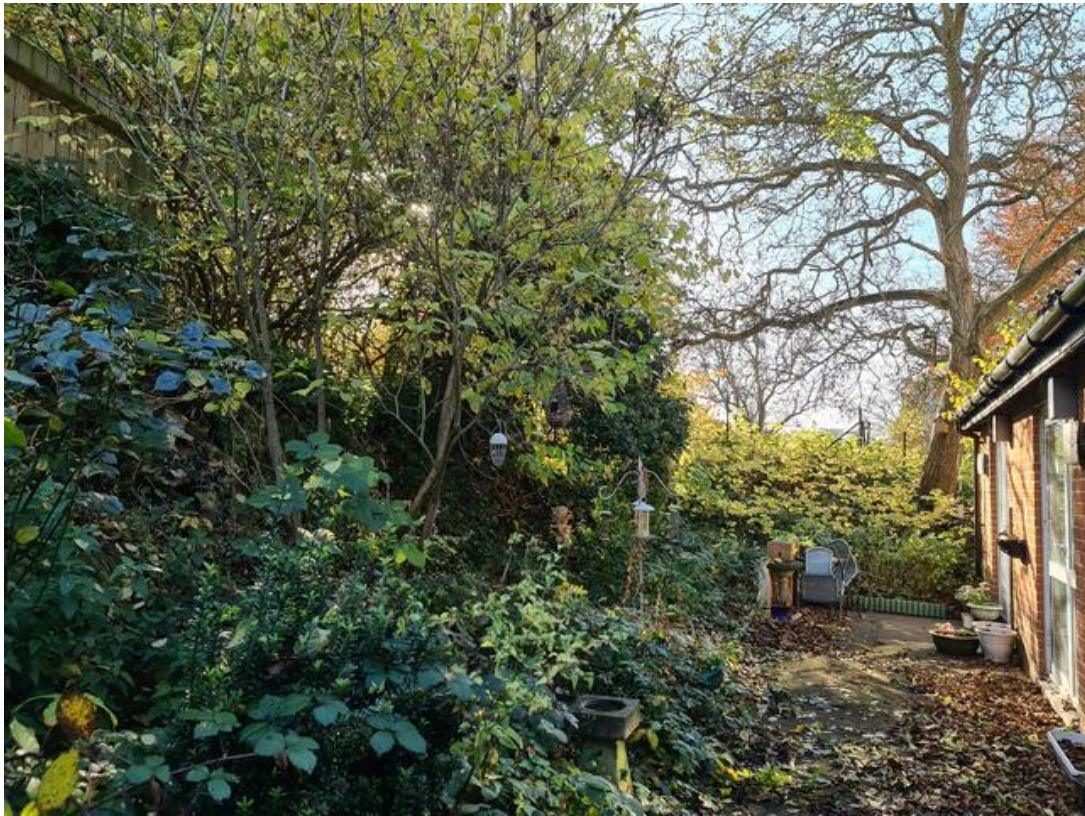
- 3.6** T286 was a walnut tree in the grounds of St Audreys, see Image 3. It is 9 m away from the wall. It had sustained historic damage to its roots and had minor cavities and minor deadwood and was exhibiting crown dieback. It also had branch stubs from previous pruning operations. All these were recorded in previous surveys. It had also been previously cut back from the building.

Image 3 T386 the walnut tree that is regularly inspected.

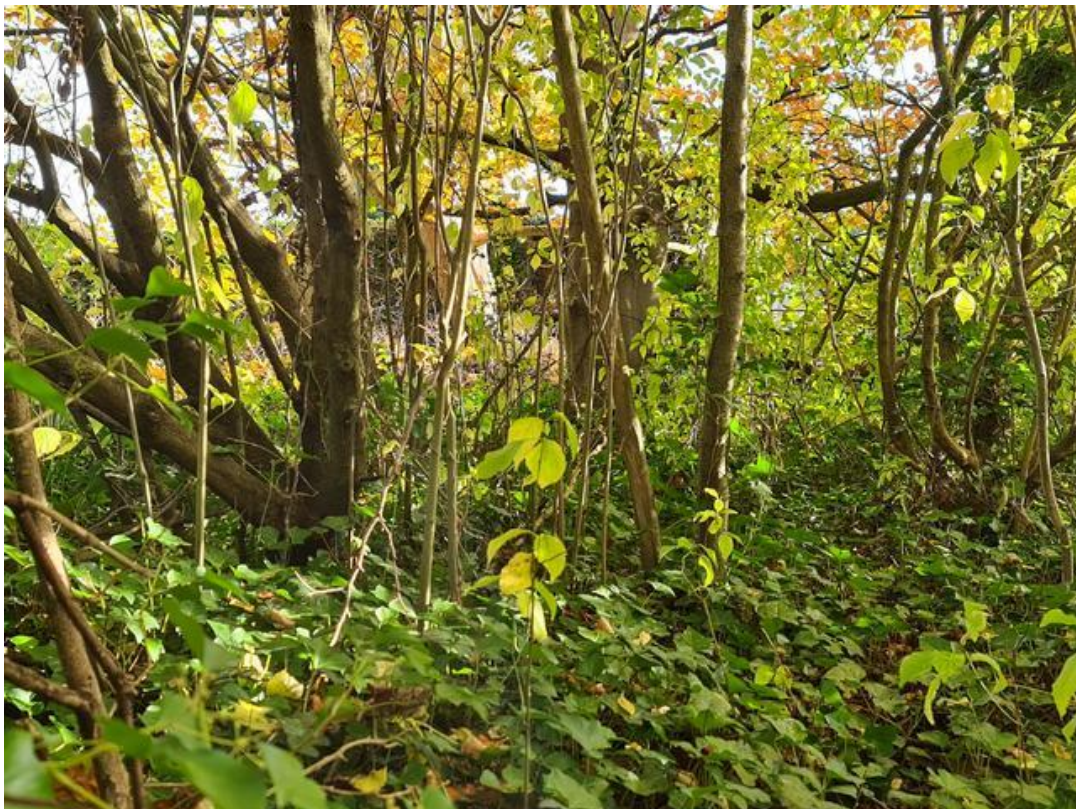
- 3.7** T310 was a semi mature multi stemmed dogwood, see image 4. It was located in the adjacent land, just 3.5 m back from the boundary. It had five stems with an average of 10 cm stem diameter. It was a low spreading multi stemmed shrub. It has a low crown that extends over the boundary into St Audreys. It had a crown spread of 4 m, 2 m, 2 m, and 4 m to the four cardinal points. It had tight unions and included bark.
- 3.8** T311 was a semi mature multi stemmed dogwood, see image 5. It was located in the adjacent land, just 2.5 m back from the boundary. It had five stems with an average of 5 cm stem diameter. It had a crown spread of 3 m, 2 m, 3 m, 3 m to the four cardinal points. It had tight unions and included bark.

- 4.13** The crown of T310 extends over the boundary and into St Audrey's This hangs down quite low. This causes a potential obstruction to the use of the garden area, but more significantly to work access for the wall construction. This tree is recommended to have any overhanging branches cut back to the boundary. I would suggest going to the back of the existing wall, to allow sufficient access for all the construction activities.

Image 4 T310 a multi stemmed dogwood.

- 5.4** The crown of T310 I would recommend being cut to the rear of the existing wall, to allow sufficient access for all the construction activities.

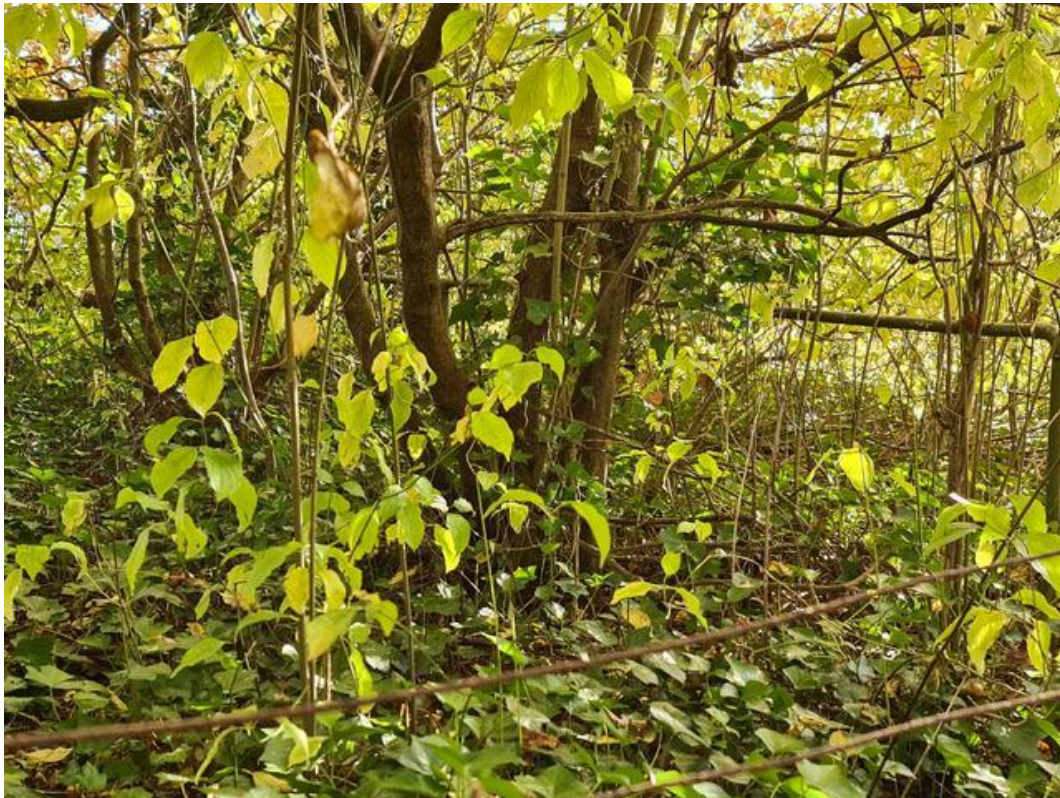
- 4.12** The two dogwoods are closer. T311 is too small to be considered in relation to BS5837. T310 would be a consideration but would only be a C1 category tree. The mitigation measures would be that only handheld tools would be used within its RPA. Only handheld tools are being used in the construction of the new wall.

Image 5 T311 a multi stemmed dogwood.

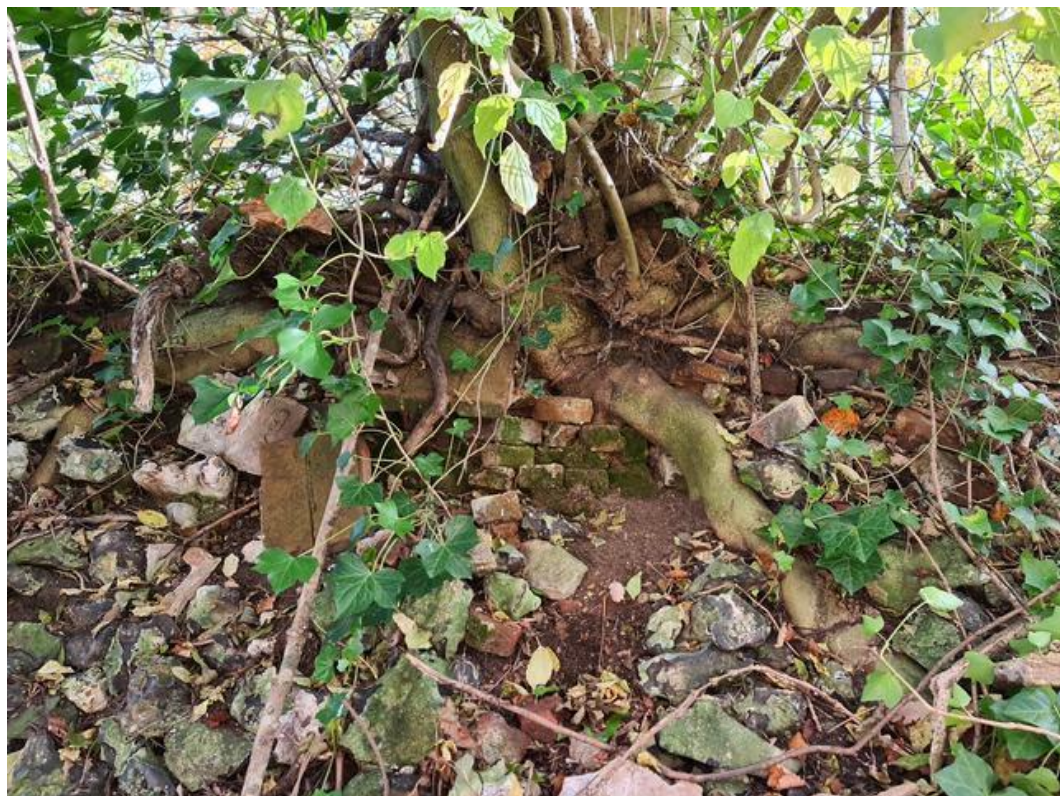
- 4.5** I consider that it would be impossible to remove the existing dry-stone wall without impacting on this tree's roots and in all likelihood destabilising the tree, leading to its failure or partial failure.

Image 6 T308 the ash tree growing on top of the existing wall.

- 5.1** T308 the ash tree should be removed prior to any construction activity relating to the wall is undertaken.
- 5.2** I consider that it would be impossible to remove the existing dry-stone wall without impacting on this tree's roots and in all likelihood destabilising the tree, leading to its failure or partial failure.

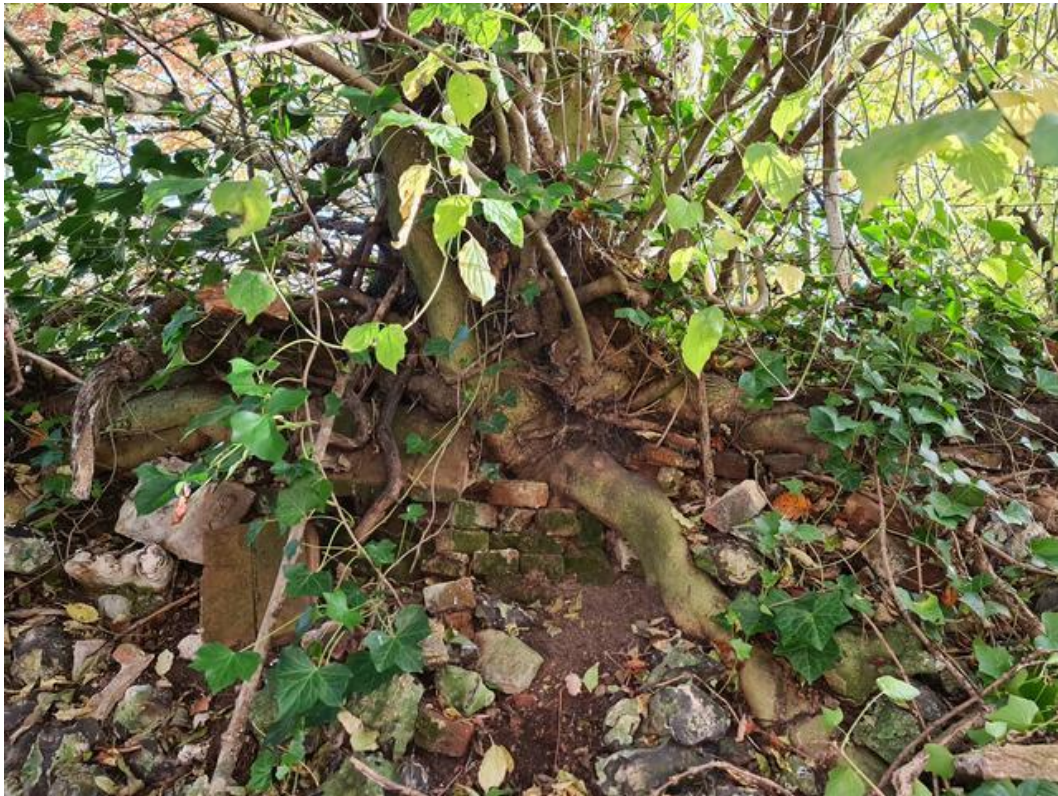
Image 7 T308 the multi stemmed ash tree growing on top of the existing wall.

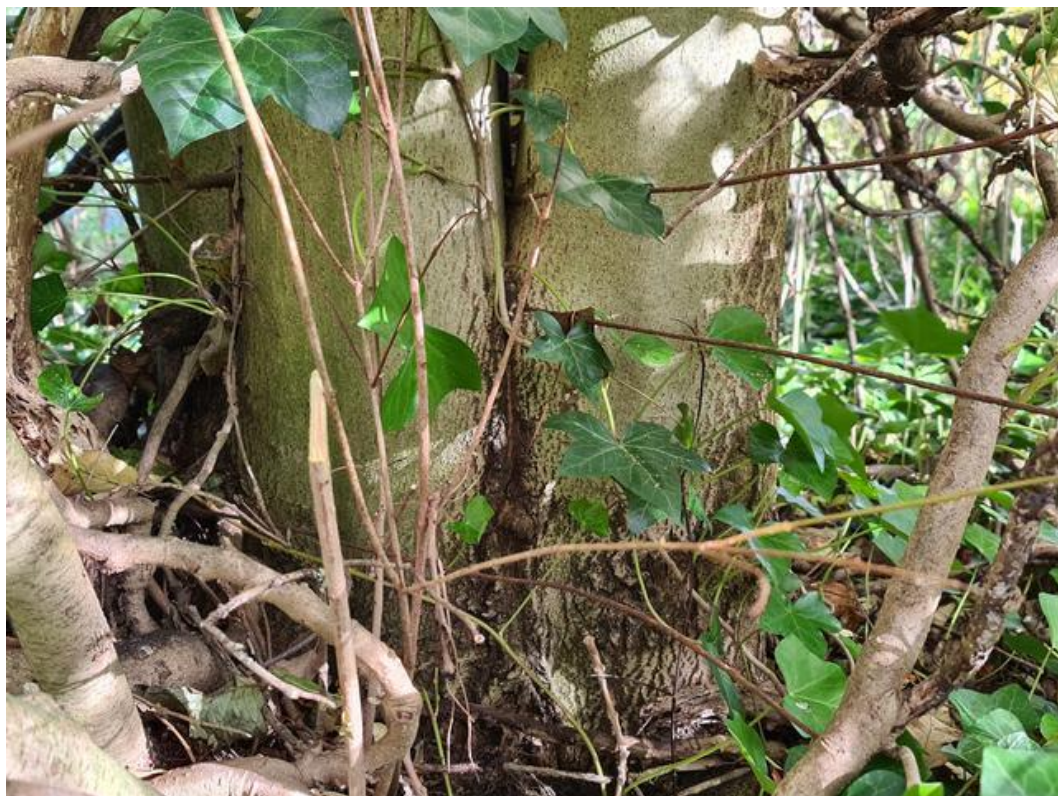
- 4.1** The ash tree T308 is growing right on the boundary. As such it is considered to be a genuine boundary tree. This means that its seed germinated, or it was planted on or as part of the boundary.

Image 8 T308 multi stemmed ash tree with two stems growing both side of wall.

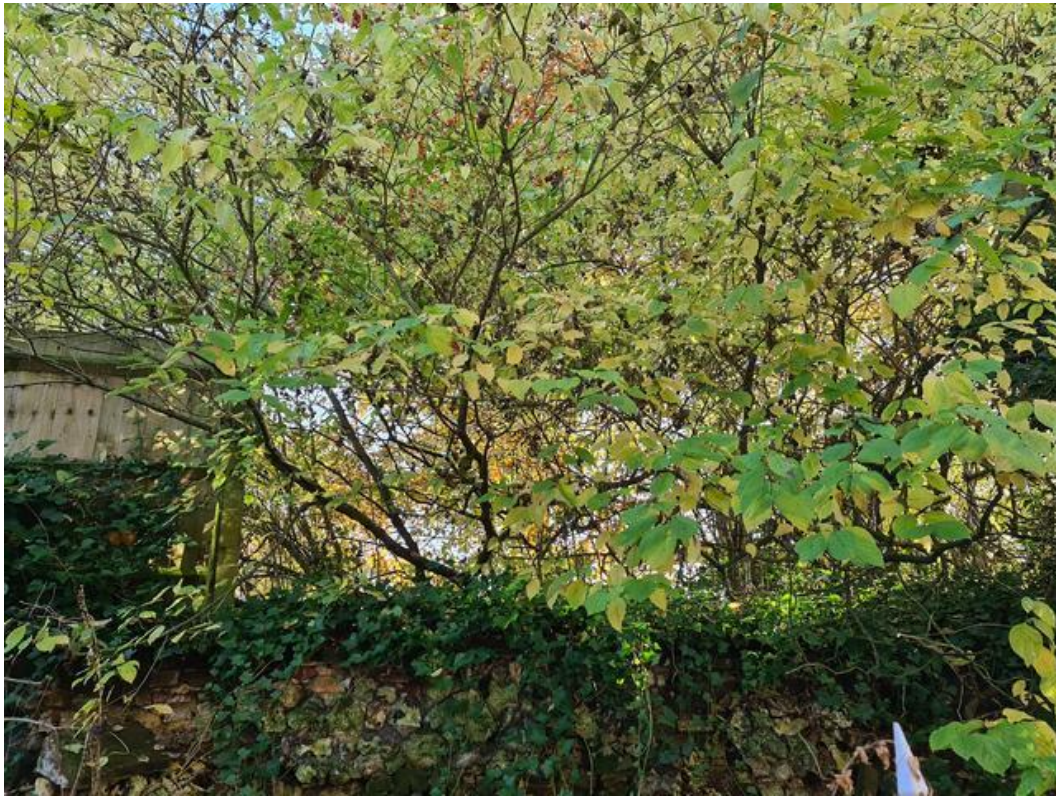
Image 9 T9 (left) T10 centre and T11 (right) viewed from park to the rear.

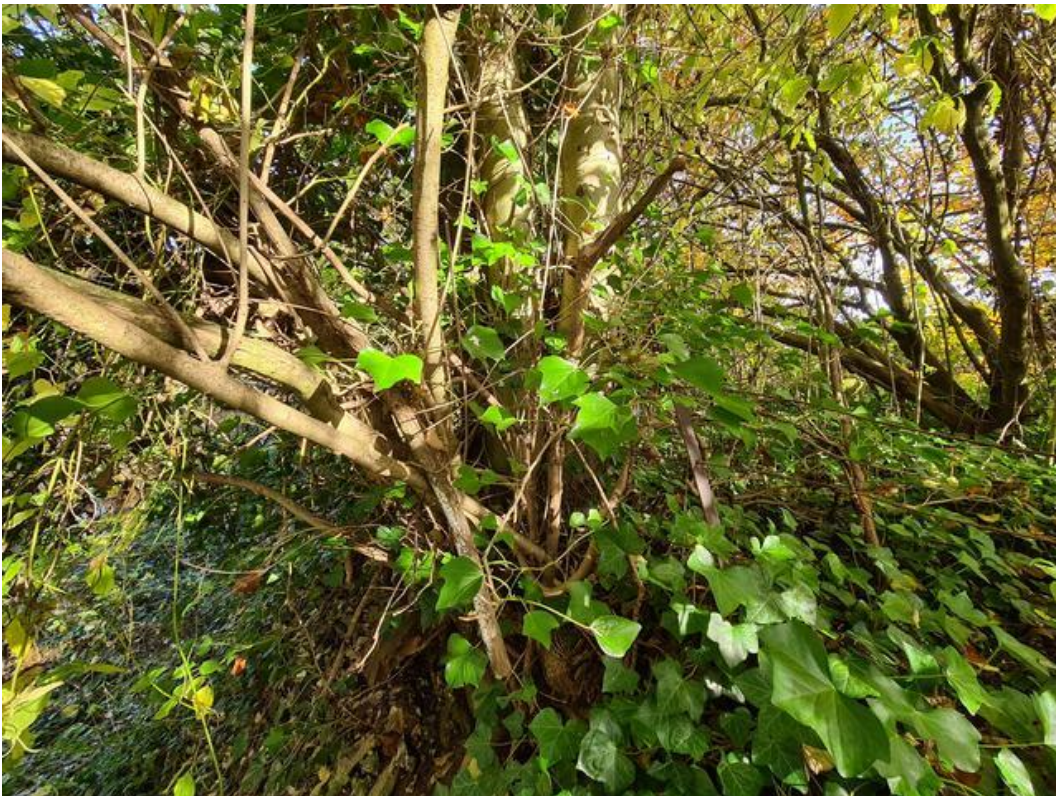
Image 10 T11 viewed from the rear garden showing distance to building.
