Project Name: <b>Comet Way Hatfield</b>	Project Number:	Date: <b>13/06/2018</b>	Contact:	
--	-----------------	----------------------------	----------	--

#### Survey 1 - S3 downstream to HD1002

#### Survey 2 - S3 upstream to S4

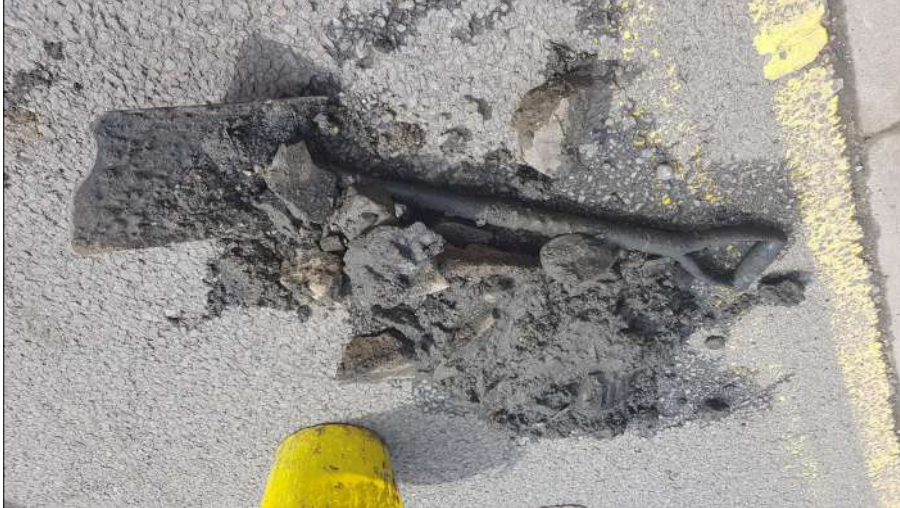
Please see photos attached showing some of the debris removed from manhole S3. This included a shovel which was blocking the outlet. Approximately 1-2 tonnes of waste was removed from the manhole and drain runs.

Photo: Hatfield 4.jpg  
 0m, General condition photograph

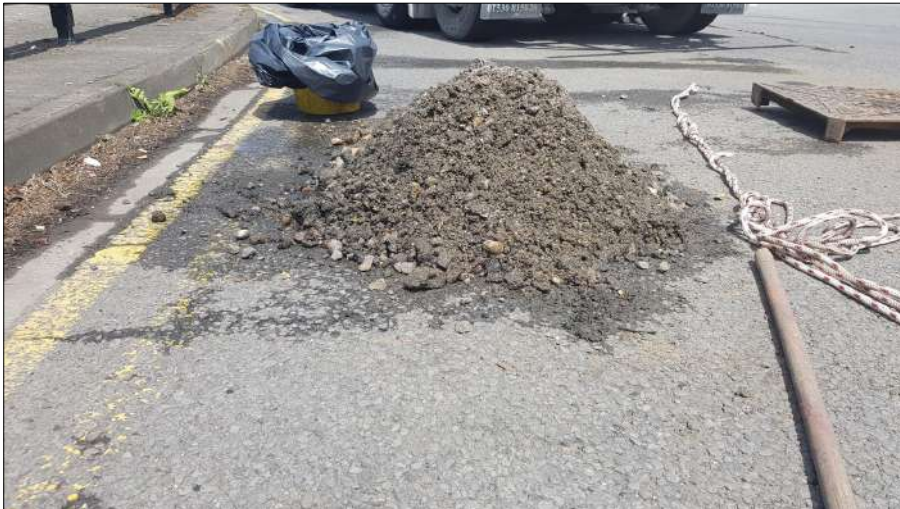
Photo: Hatfield 2.jpg  
 0m, General condition photograph

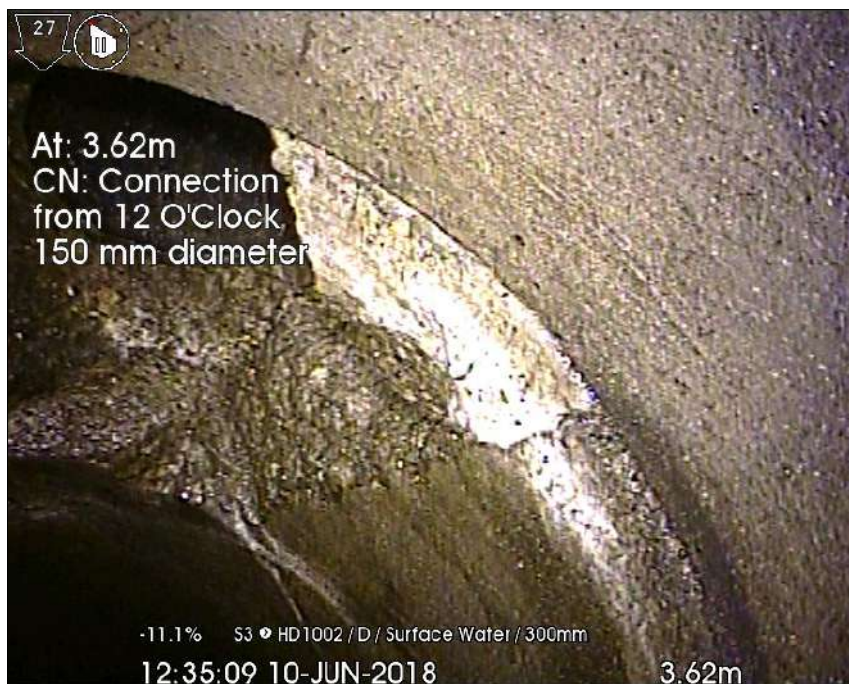
Photo: 1 - S3 downstream to HD1002\_3-62m\_123509.jpg  
 3.62m, CN: Connection from 12 O'Clock 150 mm diameter

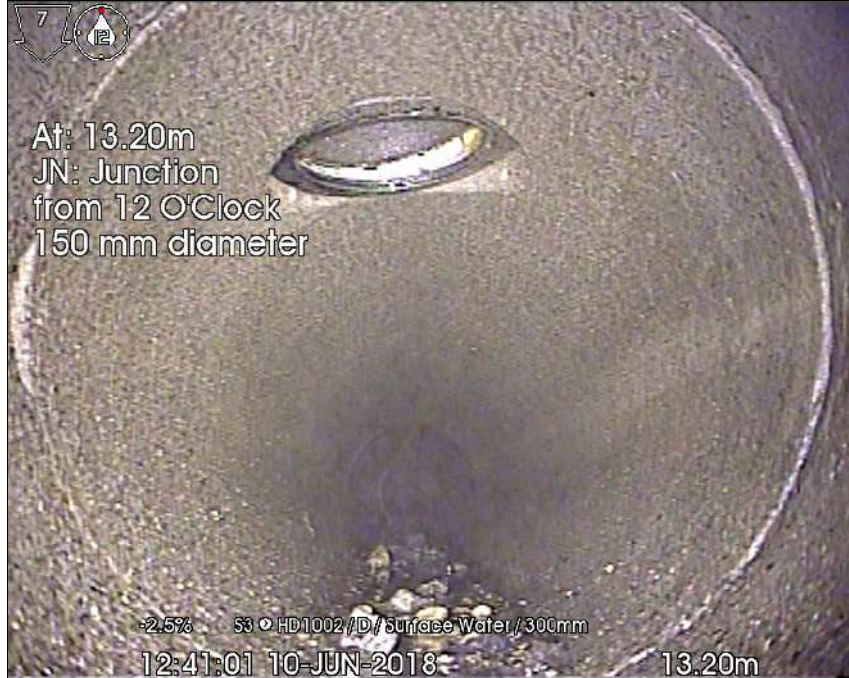
Photo: 1 - S3 downstream to HD1002\_13-20m\_124101.jpg  
 13.2m, JN: Junction from 12 O'Clock 150 mm diameter

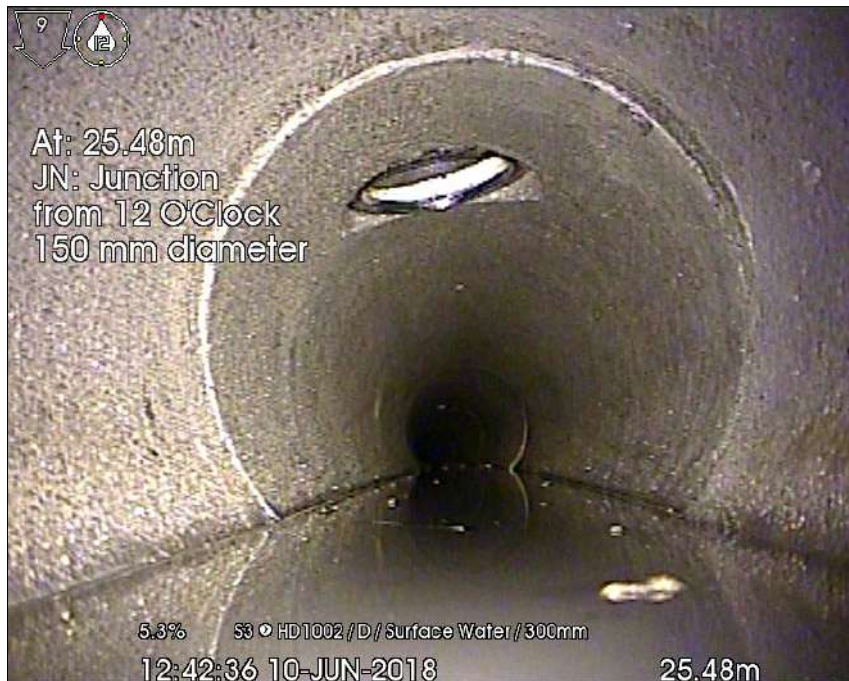
Photo: 1 - S3 downstream to HD1002\_25-48m\_124236.jpg  
 25.48m, JN: Junction from 12 O'Clock 150 mm diameter

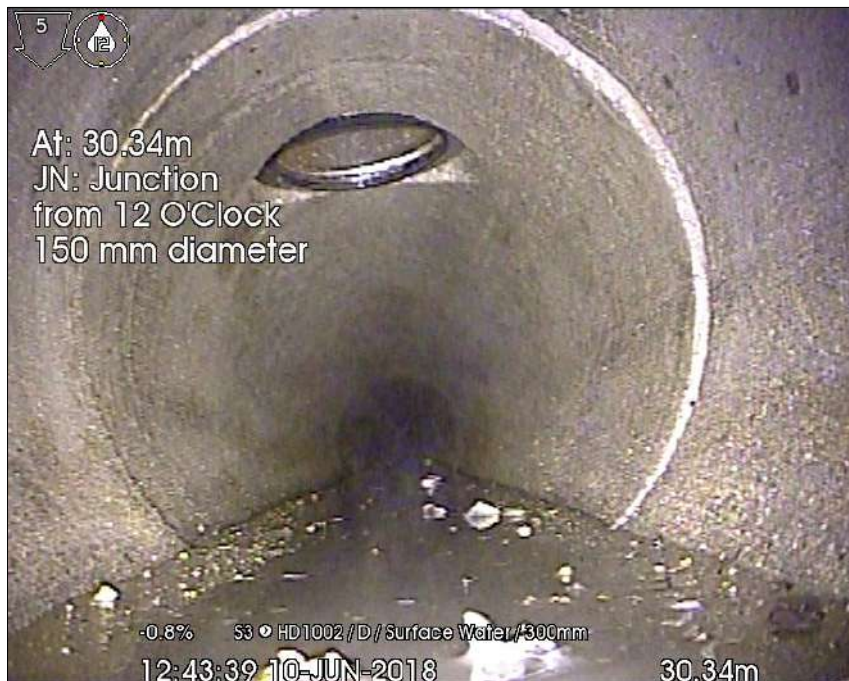
Photo: 1 - S3 downstream to HD1002\_30-34m\_124339.jpg  
 30.34m, JN: Junction from 12 O'Clock 150 mm diameter

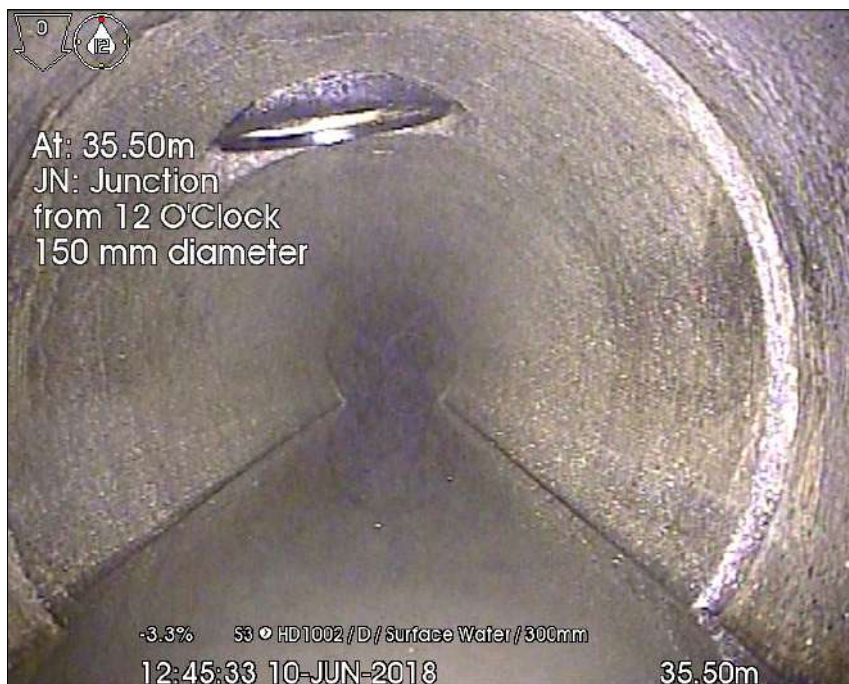
Photo: 1 - S3 downstream to HD1002\_35-50m\_124533.jpg  
 35.5m, JN: Junction from 12 O'Clock 150 mm diameter

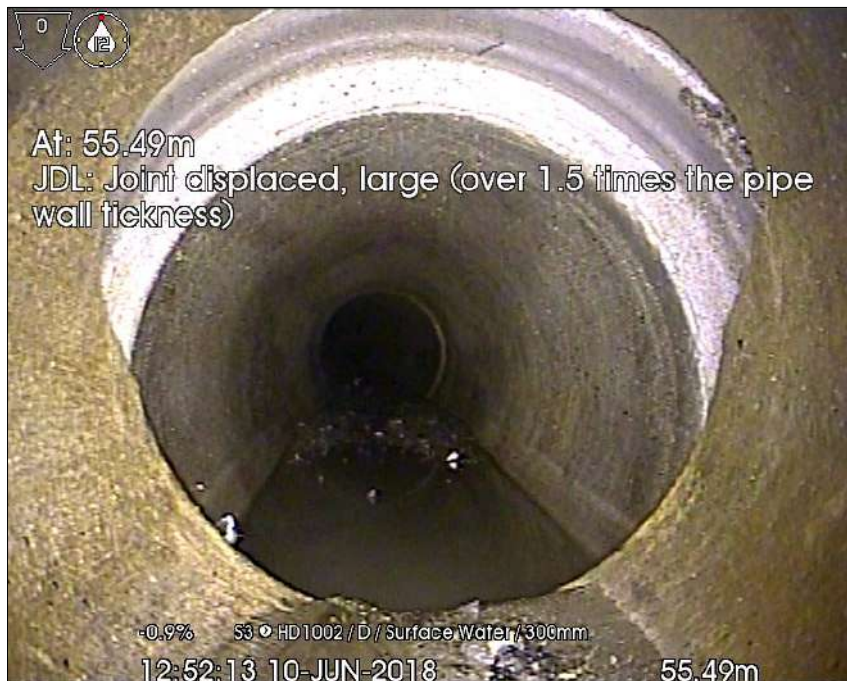
This drain run is structurally sound, however we had to abandon the survey at 55 metres due to a large displaced joint (this was also shown on the previous CCTV from the other direction) There is also a 10% silt/debris level in areas which we recommend is cleansed at the next opportunity. Due to the amount of stone etc that was present within the system upon arrival permitted time on the highway was quickly eaten up and therefore this run could not be cleansed fully, however a final jet was carried out prior to departing.

Photo: 1 - S3 downstream to HD1002\_55-49m\_125213.jpg  
 55.49m, JDL: Joint displaced, large (over 1.5 times the pipe wall tickness)

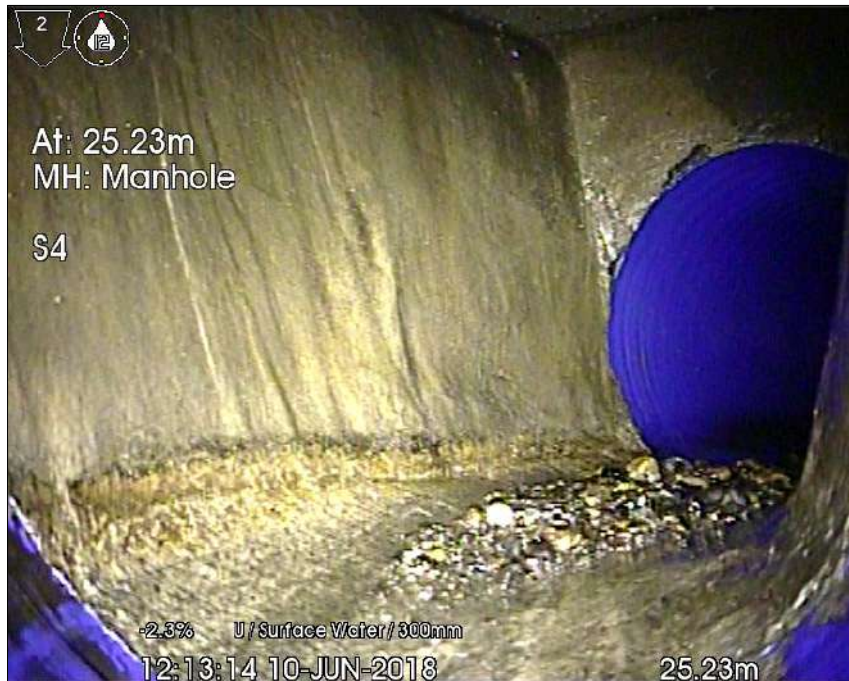
Photo: 2 - S3 upstream to S4\_25-23m\_121314.jpg  
25.23m, MH: Manhole S4

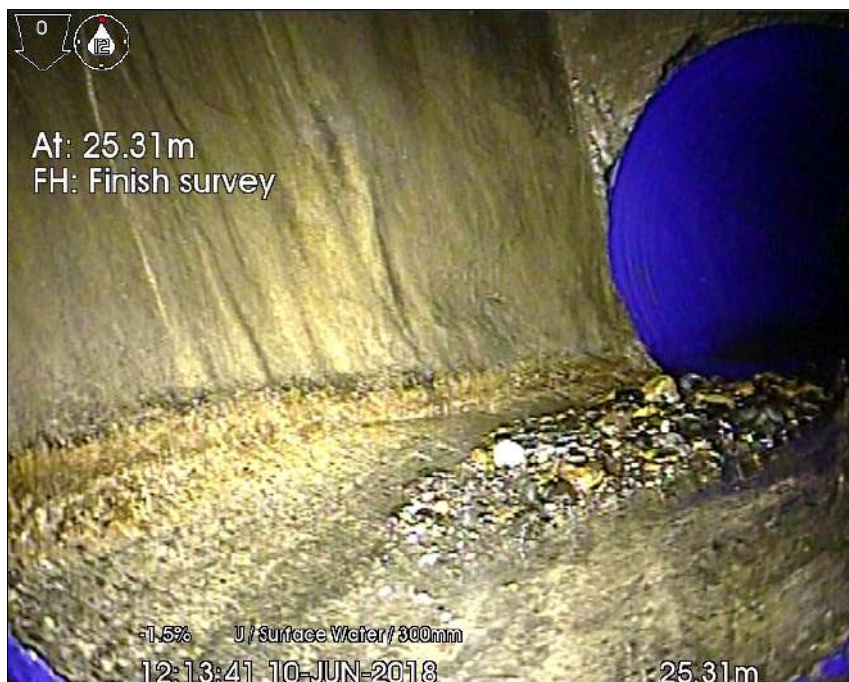
Photo: 2 - S3 upstream to S4\_25-31m\_121341.jpg  
25.31m, FH: Finish survey

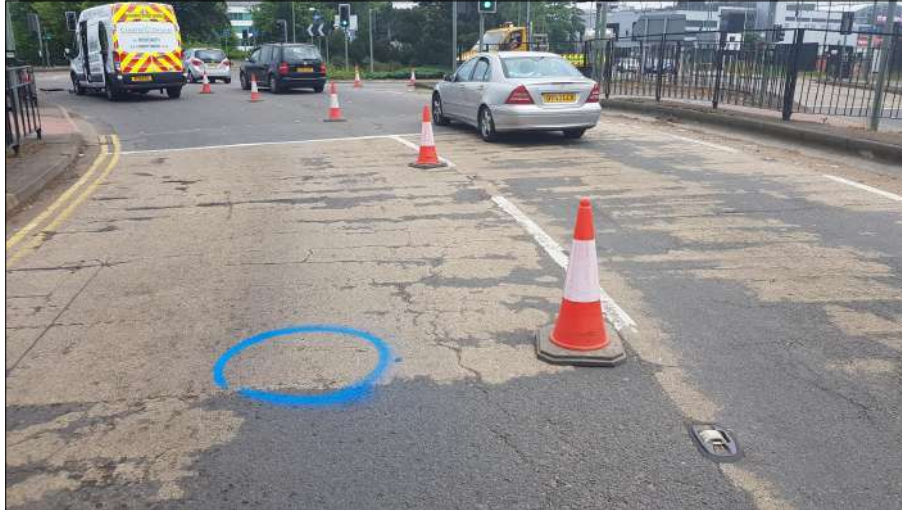
This drain run is structurally sound and in good order. Manhole S4 was however found to be buried. Sonar tracing was carried out with the location area of the manhole being marked with blue paint.

There is also a photo showing the location on the buried manhole S4

Photo: Hatfield 3.jpg  
25.32m, General condition photograph
