Project Name: Comet Way Hatfield	Project Number:	Date: 13/06/2018	Contact:	
--	-----------------	----------------------------	----------	--

Survey 1 - S3 downstream to HD1002

Survey 2 - S3 upstream to S4

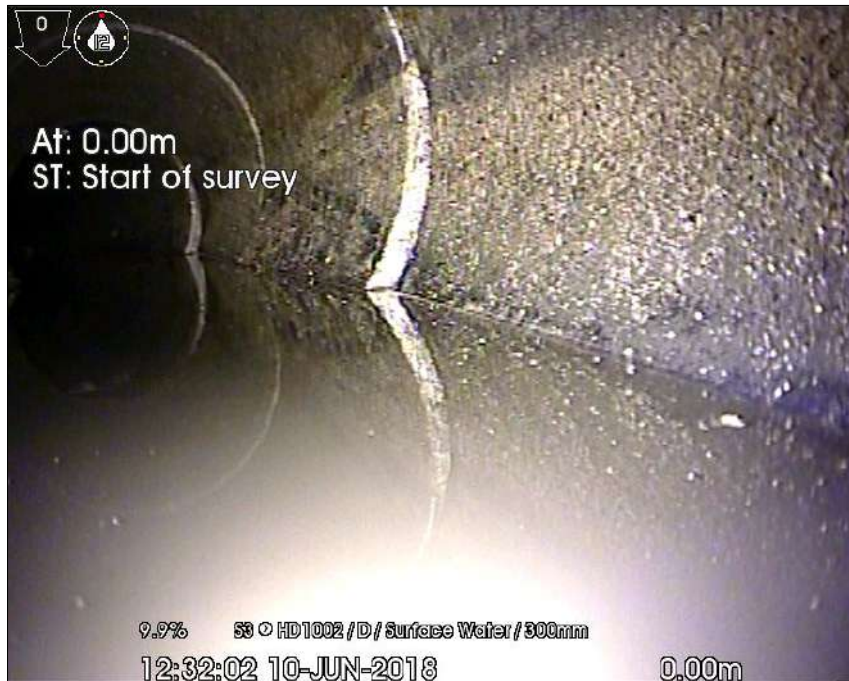
Photo: 1 - S3 downstream to HD1002_0-00m_123202.jpg
0m, ST: Start of survey

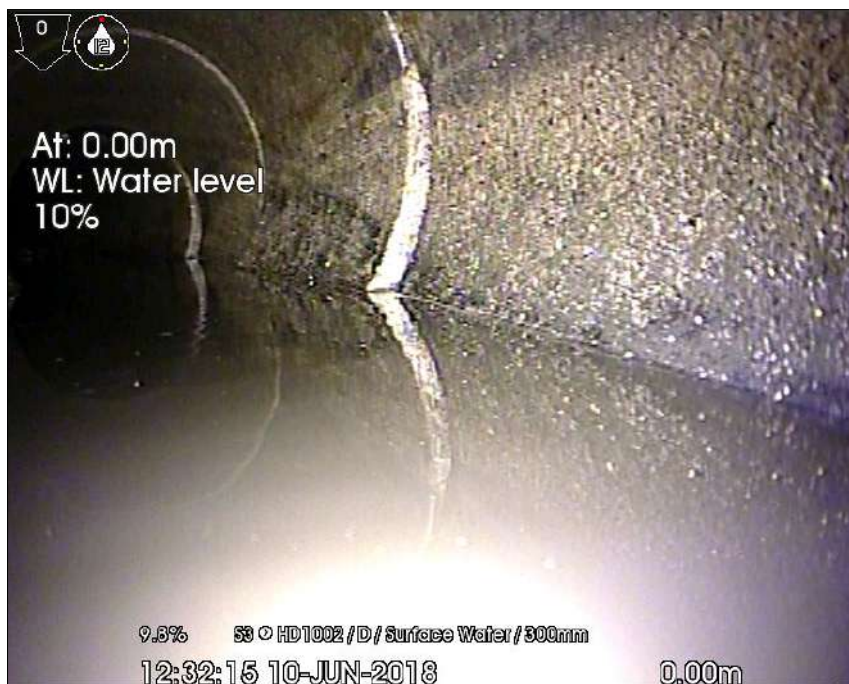
This drain run is structurally sound, however we had to abandon the survey at 55 metres due to a large displaced joint (this was also shown on the previous CCTV from the other direction) There is also a 10% silt/debris level in areas which we recommend is cleansed at the next opportunity. Due to the amount of stone etc that was present within the system upon arrival permitted time on the highway was quickly eaten up and therefore this run could not be cleansed fully, however a final jet was carried out prior to departing.

Photo: 1 - S3 downstream to HD1002_0-00m_123215.jpg
0m, WL: Water level 10%

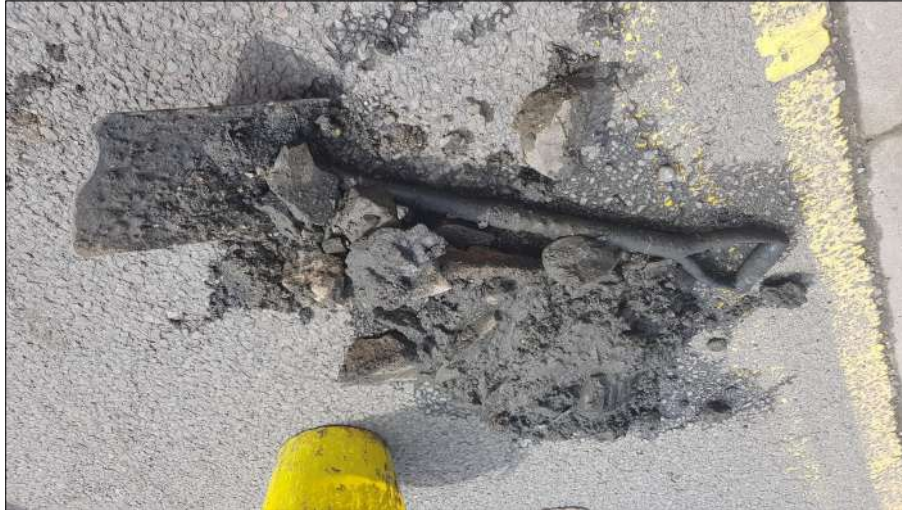
Photo: Hatfield 4.jpg
 0m, General condition photograph

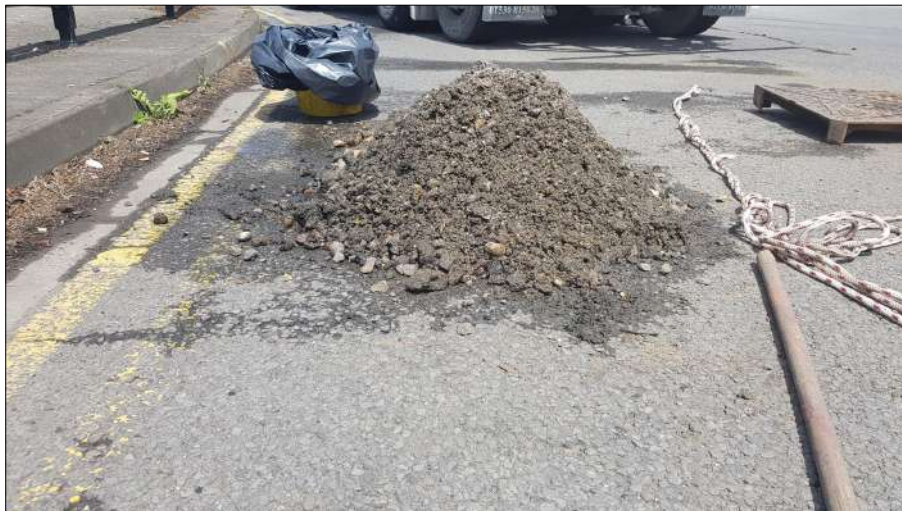
Photo: Hatfield 2.jpg
 0m, General condition photograph

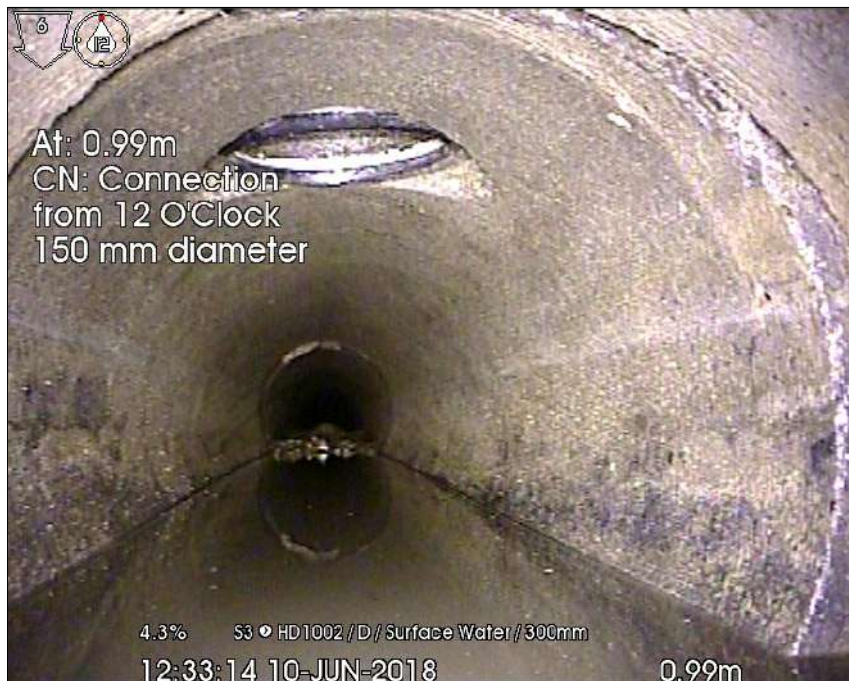
Photo: 1 - S3 downstream to HD1002_0-99m_123314.jpg
 0.99m, CN: Connection from 12 O'Clock 150 mm diameter

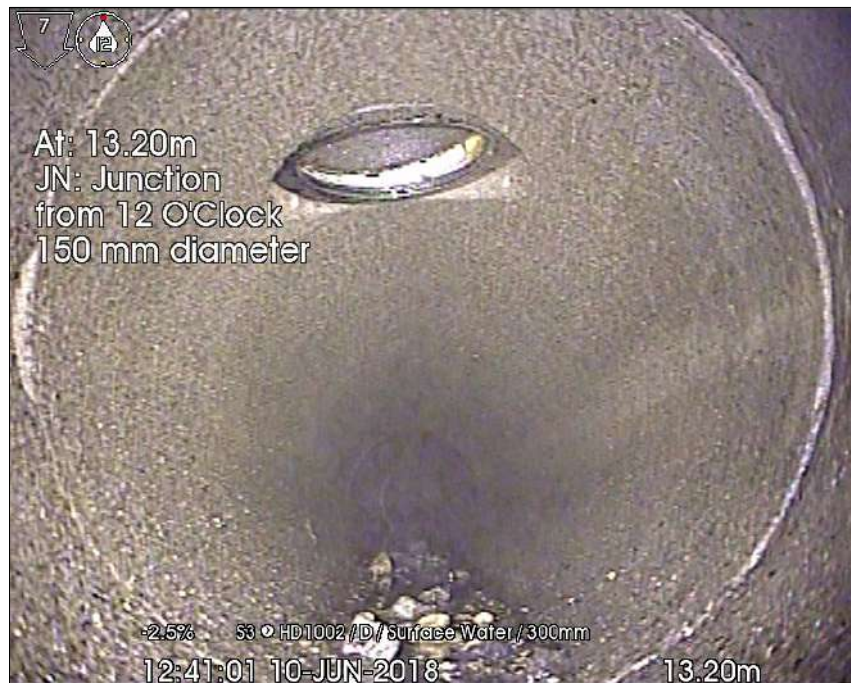
Photo: 1 - S3 downstream to HD1002_13-20m_124101.jpg
 13.2m, JN: Junction from 12 O'Clock 150 mm diameter

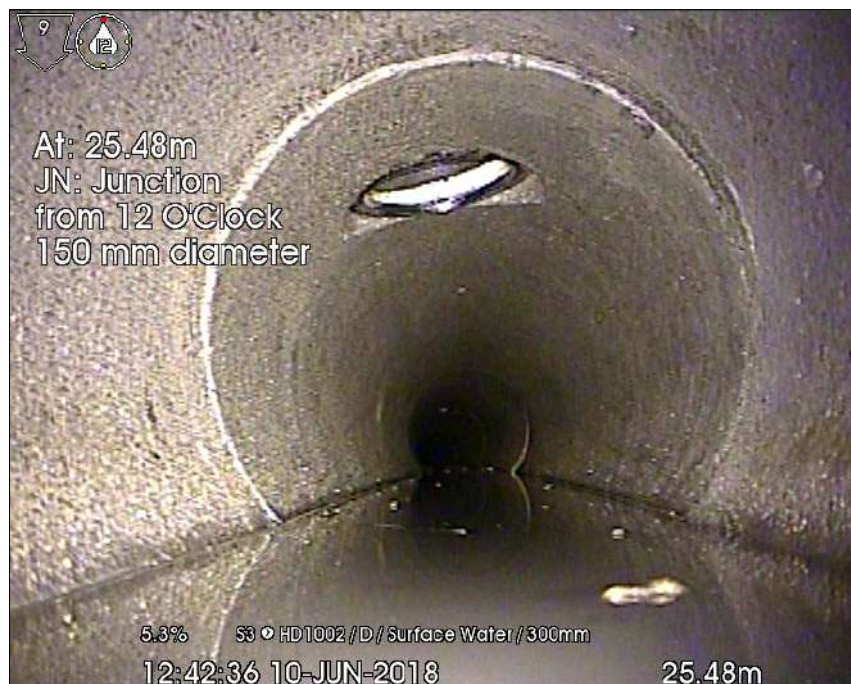
Photo: 1 - S3 downstream to HD1002_25-48m_124236.jpg
 25.48m, JN: Junction from 12 O'Clock 150 mm diameter

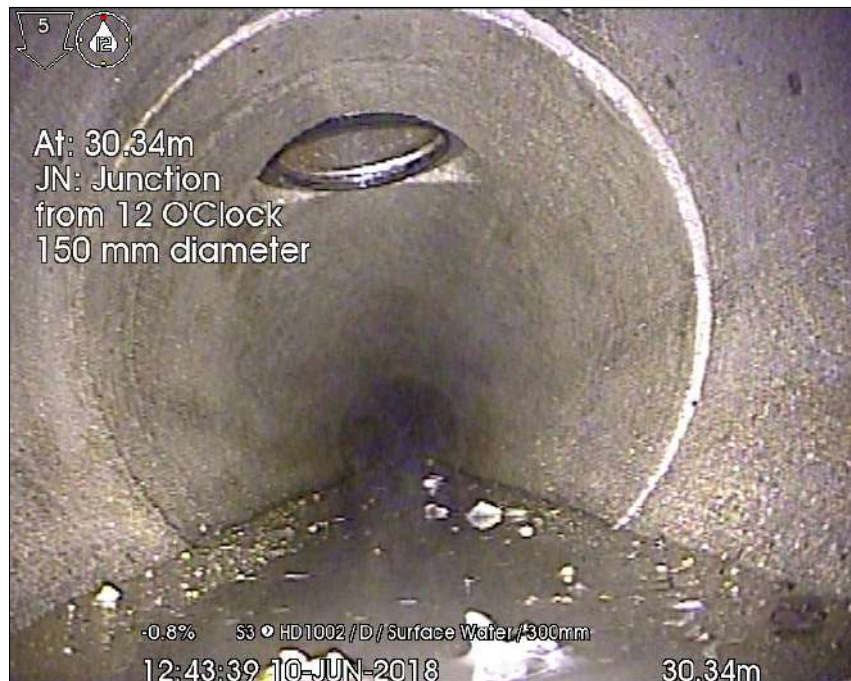
Photo: 1 - S3 downstream to HD1002_30-34m_124339.jpg
 30.34m, JN: Junction from 12 O'Clock 150 mm diameter

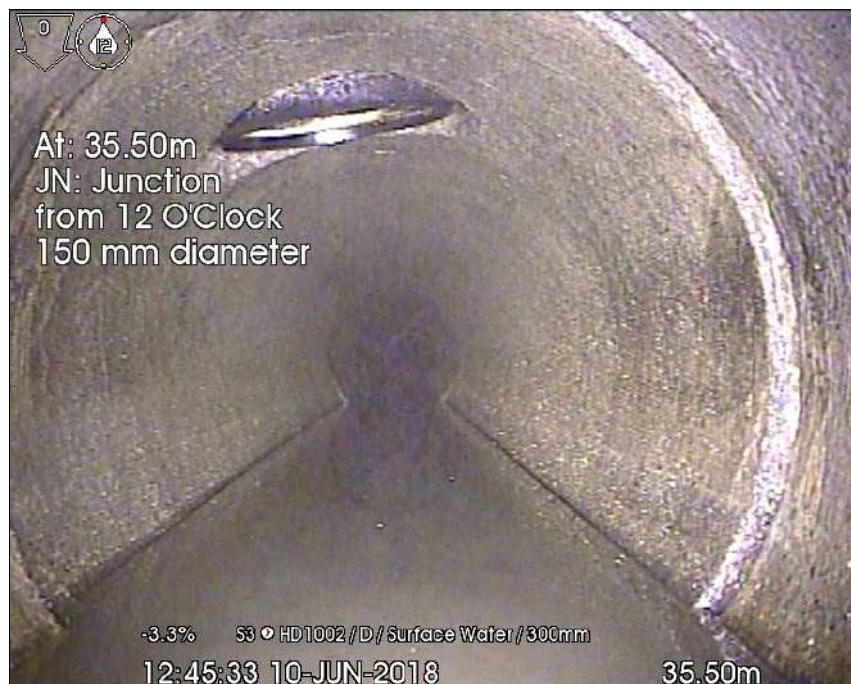
Photo: 1 - S3 downstream to HD1002_35-50m_124533.jpg
 35.5m, JN: Junction from 12 O'Clock 150 mm diameter

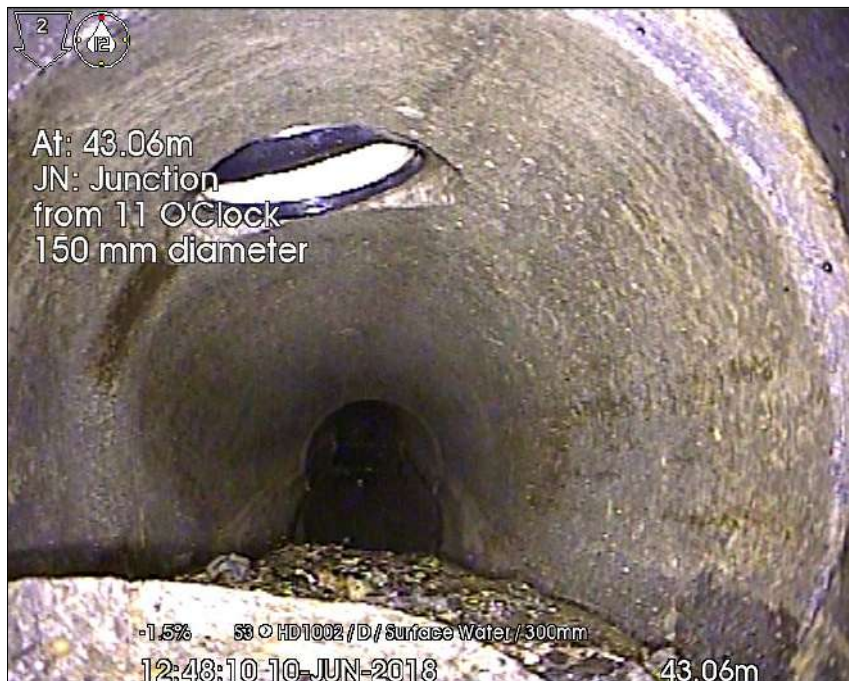
Photo: 1 - S3 downstream to HD1002_43-06m_124810.jpg
 43.06m, JN: Junction from 11 O'Clock 150 mm diameter

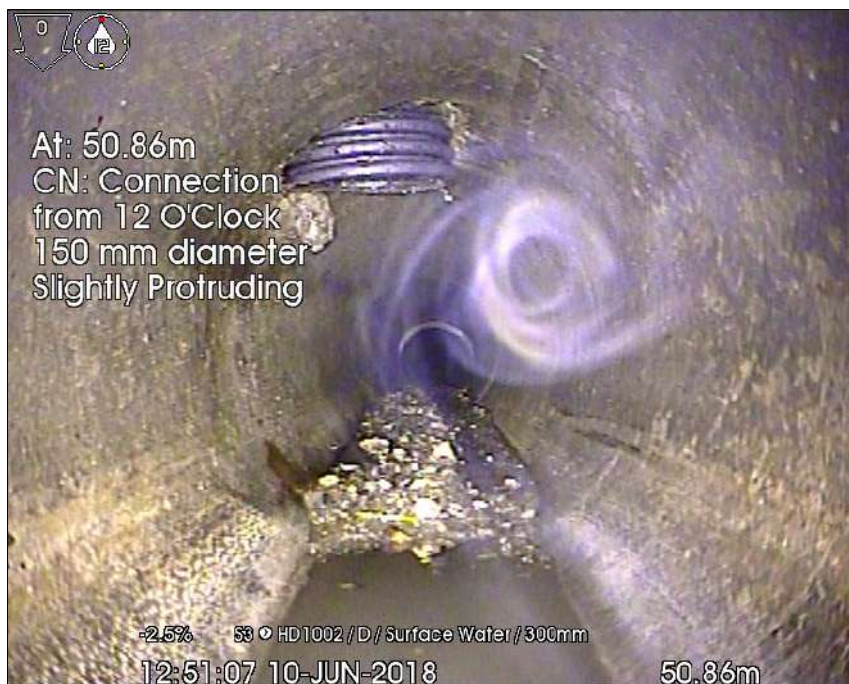
Photo: 1 - S3 downstream to HD1002_50-86m_125107.jpg
 50.86m, CN: Connection from 12 O'Clock 150 mm diameter Slightly Protruding

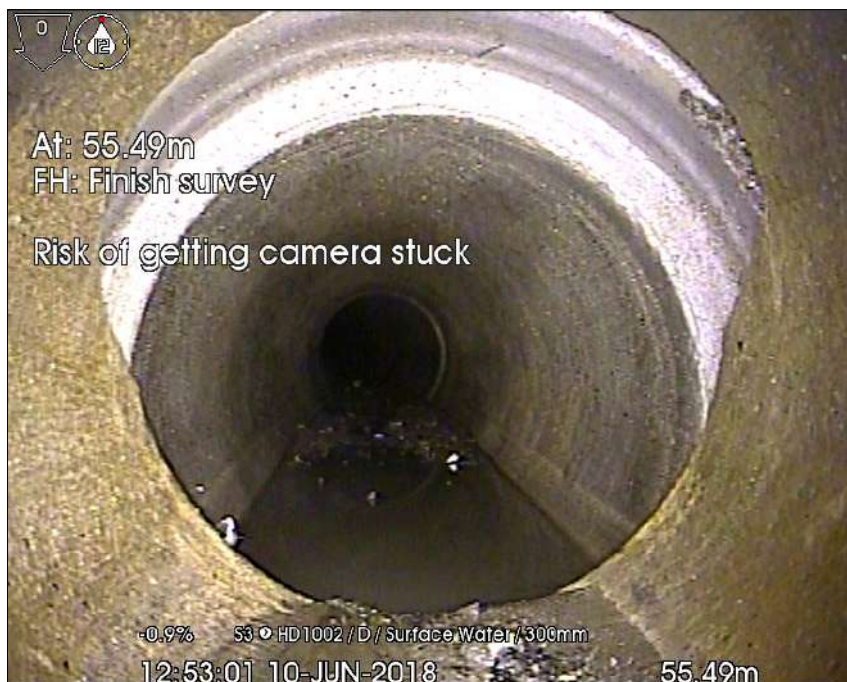
Photo: 1 - S3 downstream to HD1002_55-49m_125301.jpg
 55.49m, FH: Finish survey Risk of getting camera stuck

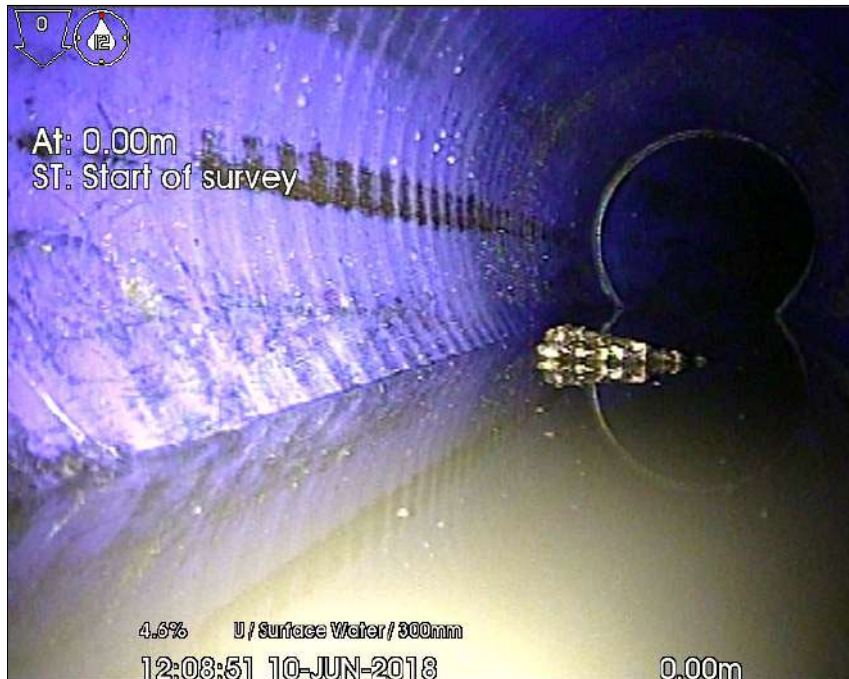
Photo: 2 - S3 upstream to S4_0-00m_120851.jpg
0m, ST: Start of survey

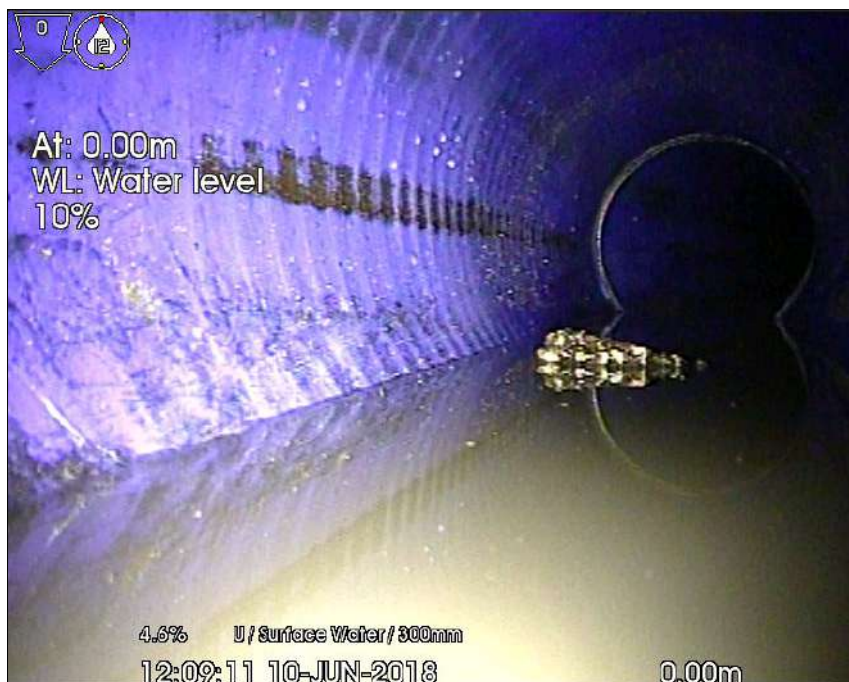
Photo: 2 - S3 upstream to S4_0-00m_120911.jpg
0m, WL: Water level 10%

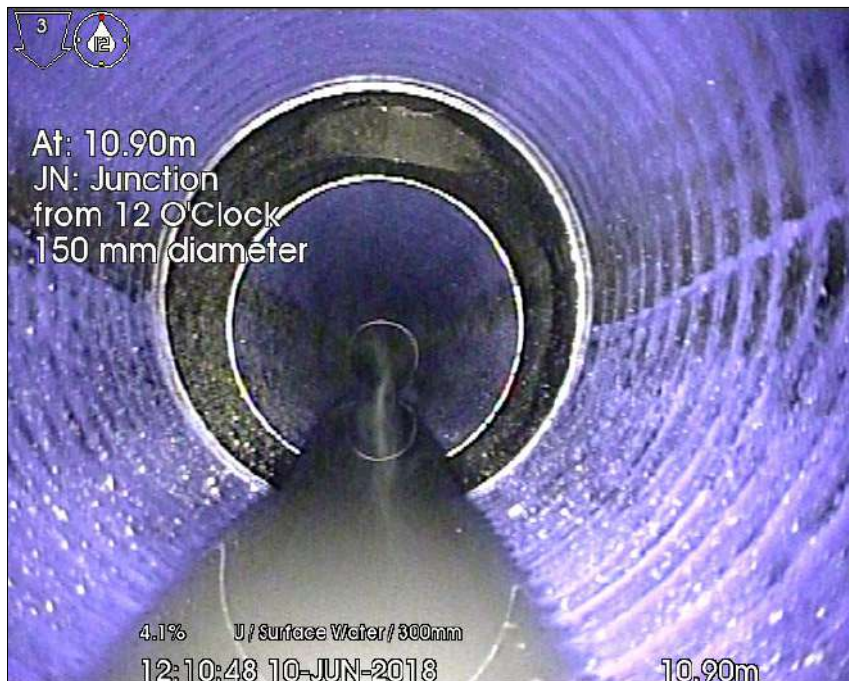
Photo: 2 - S3 upstream to S4_10-90m_121048.jpg
 10.9m, JN: Junction from 12 O'Clock 150 mm diameter

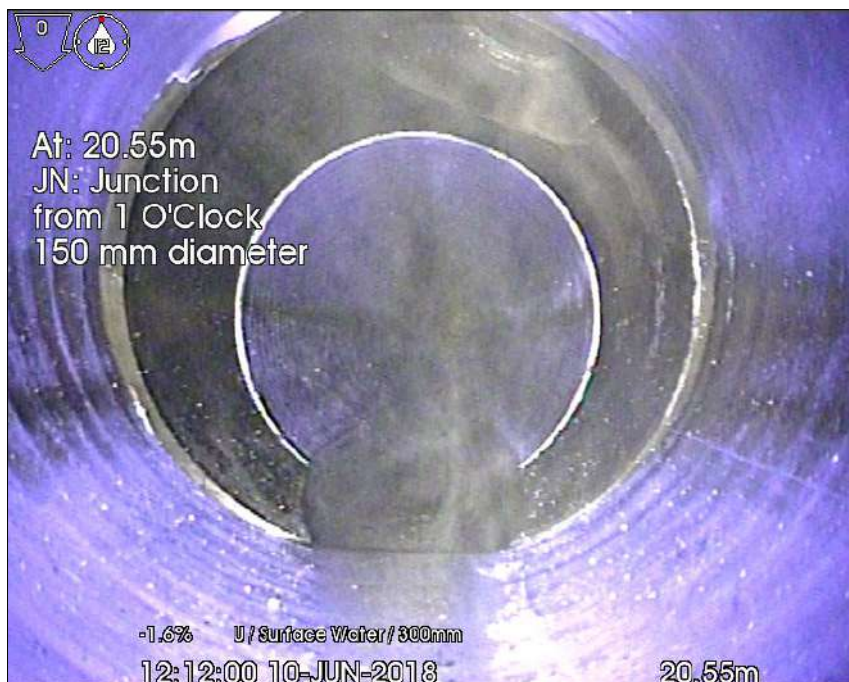
Photo: 2 - S3 upstream to S4_20-55m_121200.jpg
 20.55m, JN: Junction from 1 O'Clock 150 mm diameter

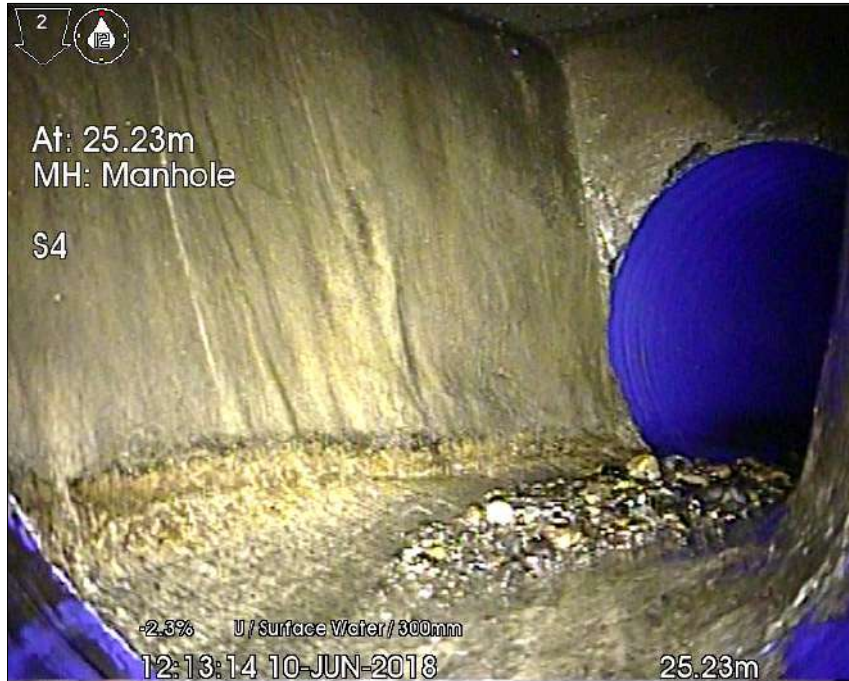
This drain run is structurally sound and in good order. Manhole S4 was however found to be buried. Sonar tracing was carried out with the location area of the manhole being marked with blue paint.

Photo: 2 - S3 upstream to S4_25-23m_121314.jpg
 25.23m, MH: Manhole S4

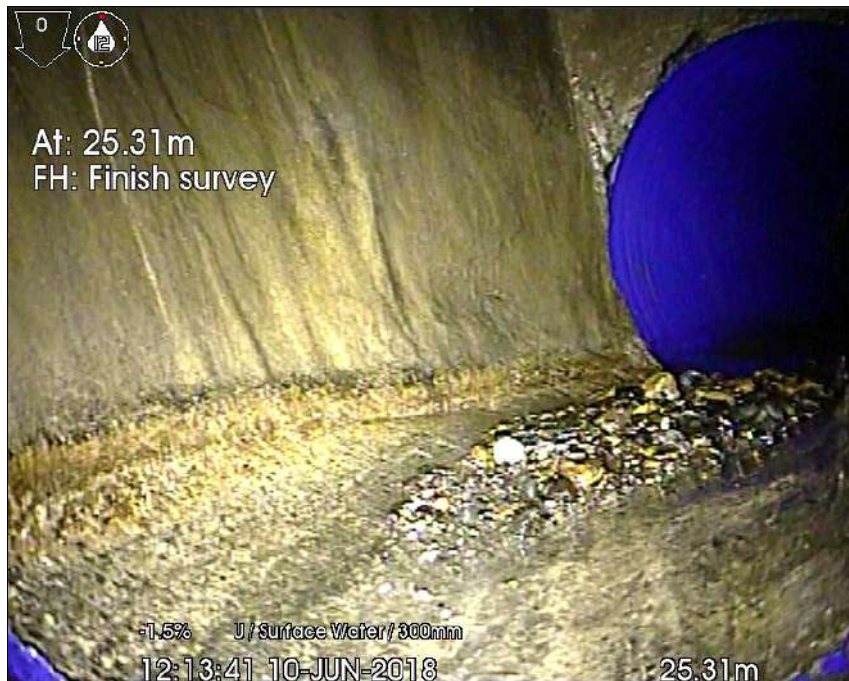
Photo: 2 - S3 upstream to S4_25-31m_121341.jpg
 25.31m, FH: Finish survey

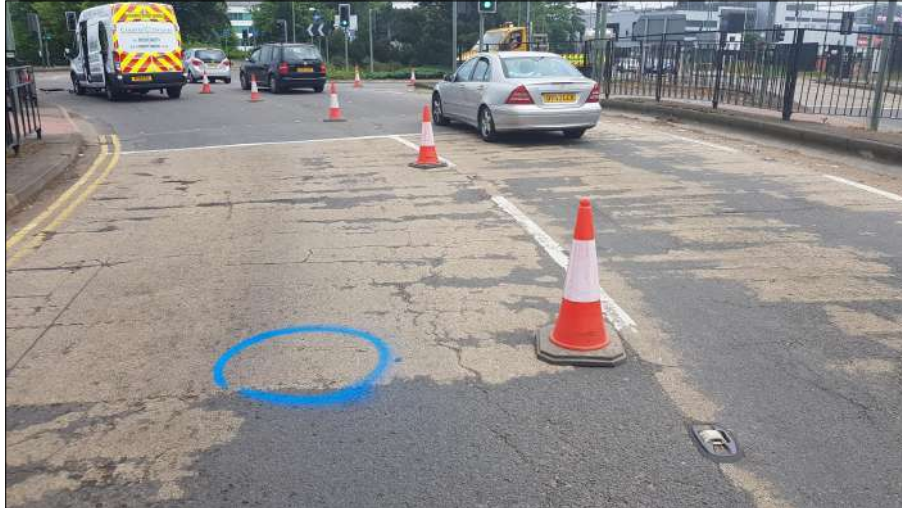
Photo: Hatfield 3.jpg
25.32m, General condition photograph
