Engineers Report

Risk Address 6 Orchard Close
Cuffley, Potters Bar
Hertfordshire
EN6 3QD

360 Reference DLG-SH-19-001241
Claim Refence 068795442

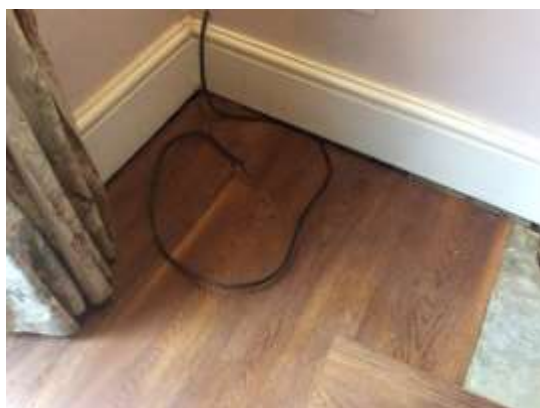
Internally the damage is less evident but there is a suggestion that the floor slab has started to drop towards the rear of the structure with gaps evident between the wooden floor finish and plastered walls. Within the study damage has been observed to the walls and ceiling area, with tapered cracking to the plasterworks as well as dropping of the floor away from the skirting line to the rear of the room.

Dropping of the floor in study

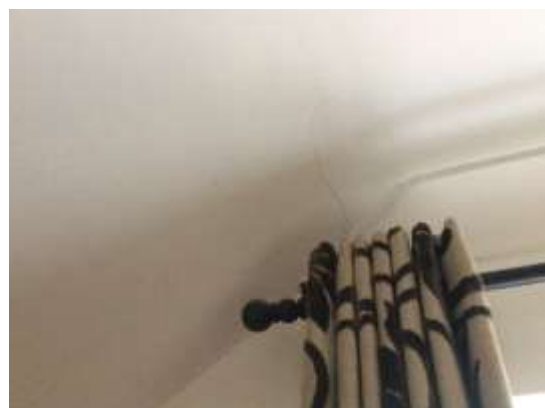
Internal cracking

All the indications from the evidence obtained suggest that the damage results from subsidence of the site upon which the property stands. Live roots in firm active clays have led to cyclical shrinkage and expansion below the foundations of the property, which together have led to consequent building movement and damage.

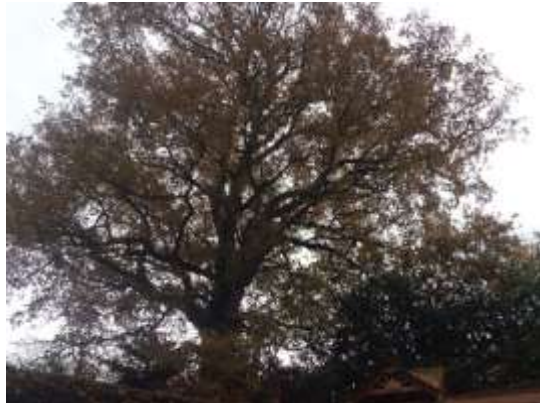
Neighbouring tree

To the rear of the property within the domestic neighbouring gardens there are several large and mature broadleaf trees including a significant Oak tree, all within influencing distance to the property. At this stage we do not know whether there is any protection order in place.

This influence and movement is consistent, as the clay continues to change volume in the presence of the tree identified, thus the problem continues.

The optimum solution in this instance would be to remove the cause of the problem, allowing the property to recover stability immediately thereafter.

- Site investigations to obtain root identification, soils analysis and check drainage provisions to be instructed.
- Instruct and Arborist to provide a professional report to enable an informed assessment for tree removal application.
- Update all parties on a regular basis.
- Provide a schedule of work for repairs to be considered.

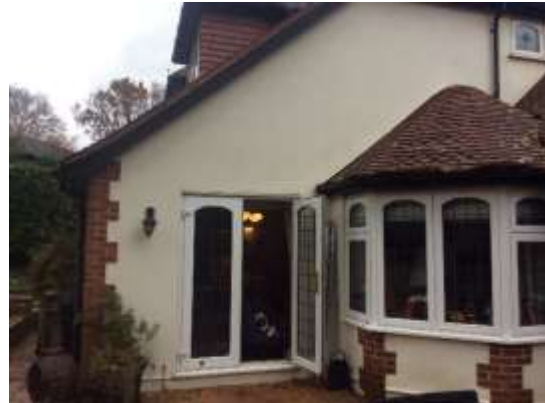
The damage and movement are focused to the rear of the property within the study area that forms part of the original structure as well as the first floor landing area also to the rear.

Rear of property
