Project-informationProject name :
37200367 - Queenswood School, HatProject Number :
37200367Contact :
Emma DoughtyDate :
22/05/2017

Draincare Ltd has been requested to undertake an investigation of the drainage at the above site.

OUTLINE DRAINAGE PLAN A – QUEENSWOOD SCHOOL

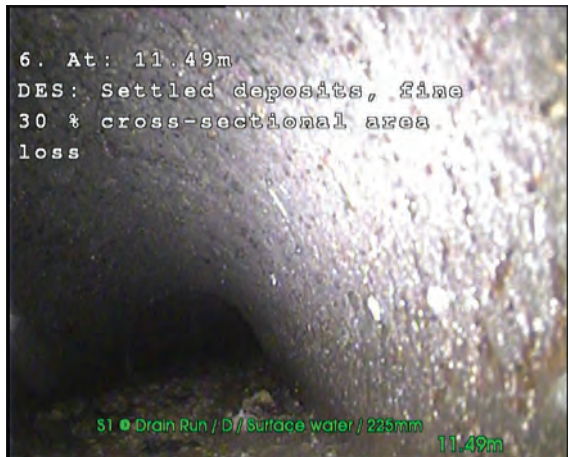
1:120	Position	Code	Observation	Photo	Grade
Depth: 1.1					
	0.00	MH	Start node type, manhole reference number: S1		(Constr) 0
	0.00	WL	Water level 0 % of the vertical dimension		(Serv) 0
	0.00	DES	Settled deposits, fine 20 % cross-sectional area loss (removed)		(Serv) 3
	3.89	LR	Line deviates right		(Serv) 0
	8.45	DES	Settled deposits, fine 20 % cross-sectional area loss (removed)		(Serv) 3
	11.49	DES	Settled deposits, fine 30 % cross-sectional area loss (removed)	2_2_7_A.jpg	(Serv) 4
	14.08	SA	Survey abandoned - Unable to pass silt		(Misc) 0

Photo: 2_2_7_A.jpg, 00:01:12
 11.49m, Settled deposits, fine 30 % cross-sectional area loss
 (removed)

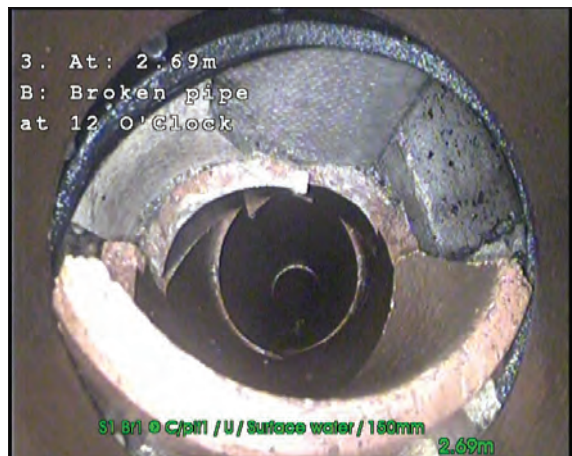
The pipework running upstream from branch 1 (Br1) within manhole S1 towards a Catchpit (C/Pit1) was found to contain broken pipework, as shown in photos on page 9 & page 11.

1:50	Position	Code	Observation	Photo	Grade
Depth: 1.1					
	 	MH	Start node type, manhole reference number: S1 Br1		(Constr) 0
	0.00	WL	Water level 0 % of the vertical dimension		(Serv) 0
	2.69	B	Broken pipe, from 12 O'Clock to 12 O'Clock	5_5_22_A.jpg	(Struct) 4
	2.69	SA	Survey abandoned - Unable to pass broken pipe		(Misc) 0

Photo: 5_5_22_A.jpg, 00:00:26
2.69m, Broken pipe, from 12 O'Clock to 12 O'Clock

- 1) Undertake an excavation approximately 2.7m upstream from Br1 within manhole S1, to allow the necessary remedial works to be undertaken to repair the broken pipework found within.
- 2) Undertake High Pressure Jetting works, with the use of a combination lorry jetter/tanker unit, to the ditch outfall pipe located underneath the concrete entrance, in an attempt to remove all debris build up (silt) from the pipework.

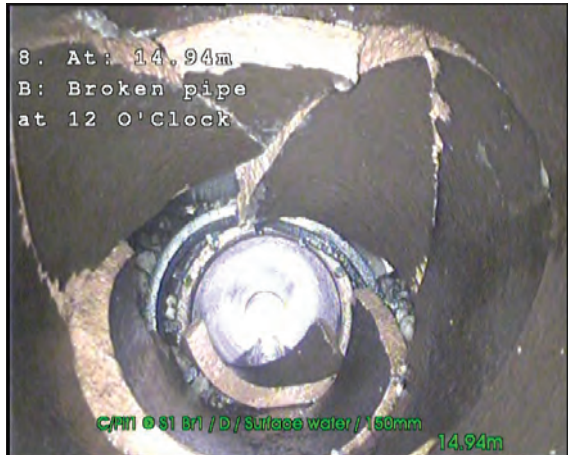
0.00	CP	Start node type, catchpit reference number: C/Pit1		(Constr) 0
	0.00	WL	Water level 0 % of the vertical dimension		(Serv) 0
	0.00	FM	Fracture, multiple, from 12 O'Clock to 12 O'Clock		(Struct) 3
	0.43	JN	Junction from 3 O'Clock diameter: 150 mm - RWDP		(Constr) 0
	2.17	RTJ	Roots, tap at joint		(Serv) 3
	2.19	SR	Sealing ring intruding from 9 O'Clock to 3 O'Clock		(Constr) 1
	5.53	FM	Fracture, multiple, from 12 O'Clock to 12 O'Clock		(Struct) 3
	14.94	B	Broken pipe, from 12 O'Clock to 12 O'Clock	6_6_31_A.jpg	(Struct) 4
	14.94	SA	Survey abandoned - Unable to pass broken pipe		(Misc) 0

Photo: 6_6_31_A.jpg, 00:01:28
 14.94m, Broken pipe, from 12 O'Clock to 12 O'Clock

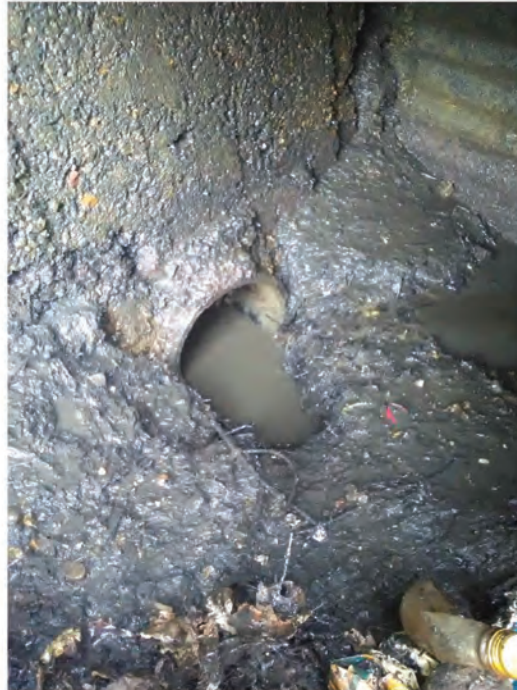
The outfall pipe of the ditch was exposed during CCTV works, as shown in Image A on page 16.

Image A:- View of the exposed outfall pipe from ditch

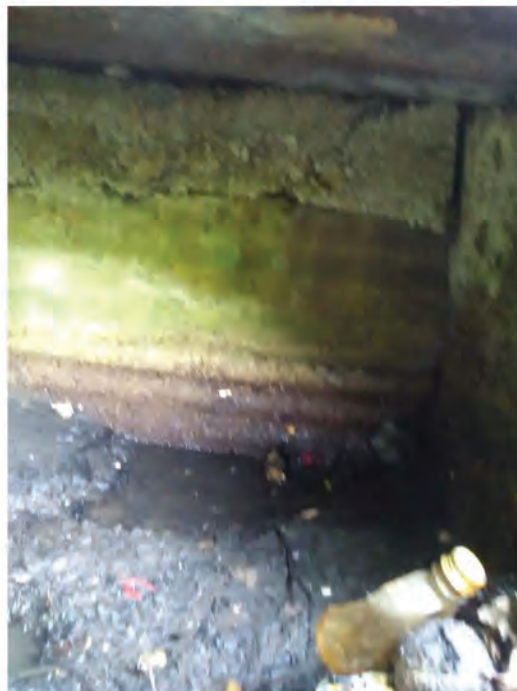
The ditch outfall pipe underneath the concrete entrance was found to be full of silt, as shown in Image B on page 16.

Image B:- View of outfall from ditch under concrete entrance
