Client name: Shell UK Oil Products Limited

Site Location: Shell Welwyn Garden

Validation Sampling

2. Borehole Decommissioning Photographic Log

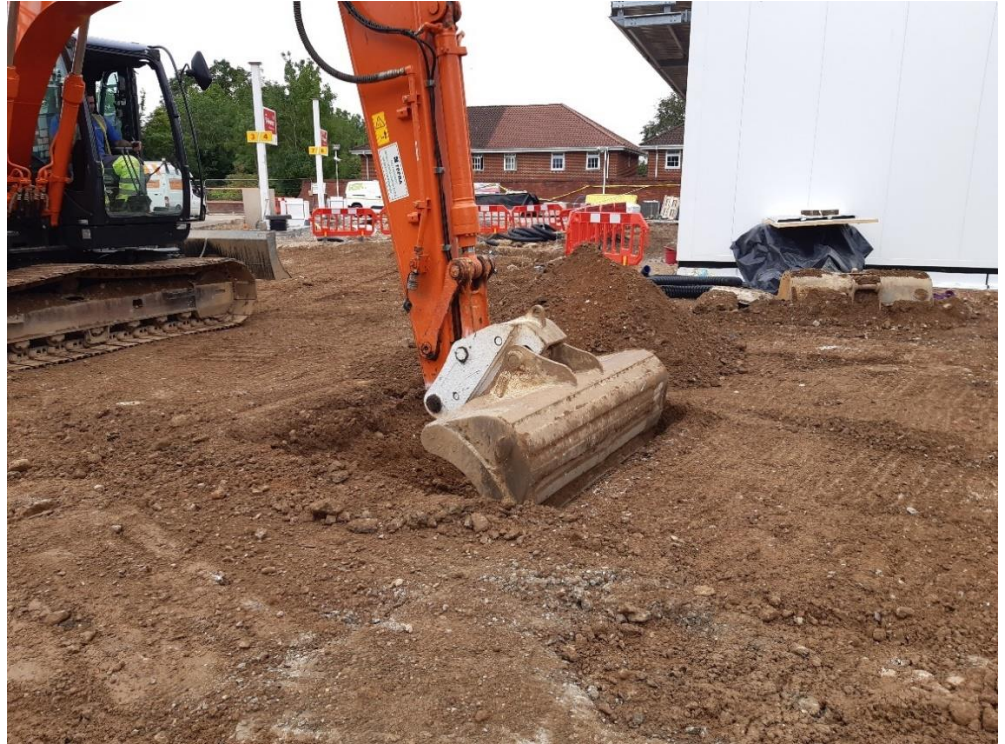
Photo No.
37

Description:
Trial pit to investigate asbestos 'hotspot' at VS14

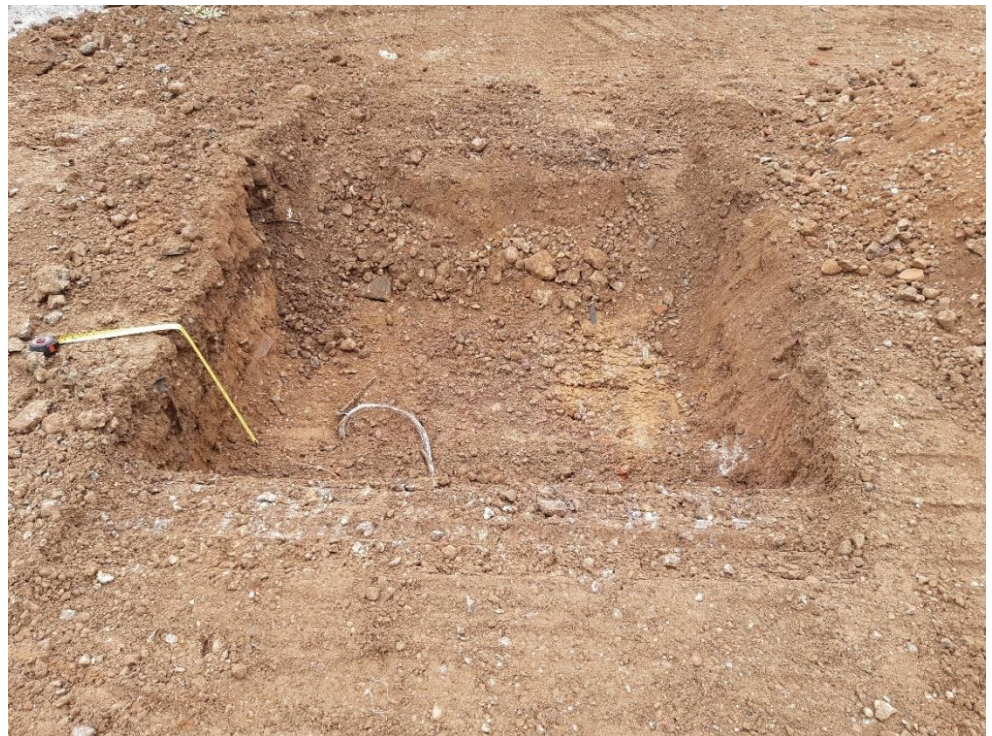
Photo No.
38

Description:
Trial pit to investigate asbestos 'hotspot' at VS14 (samples V14A-V14E)

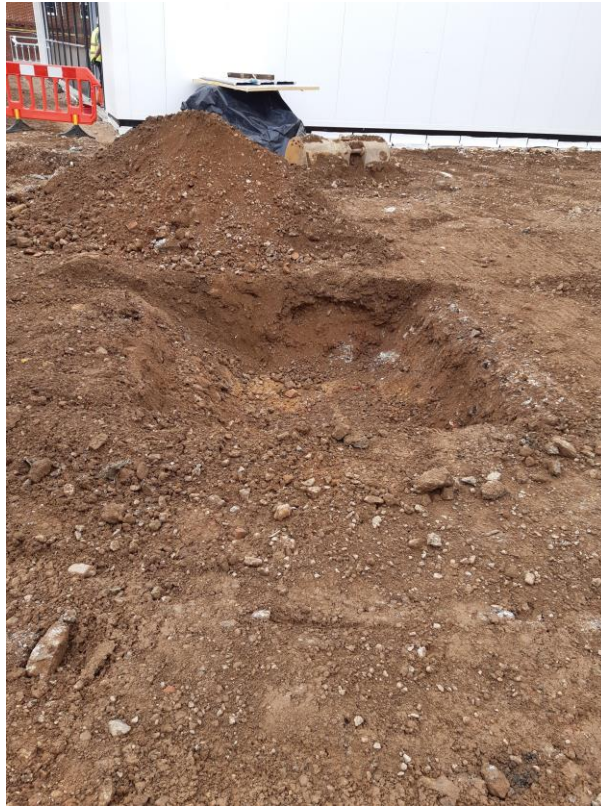
Photo No.
39

Trial pit to investigate asbestos 'hotspot' at VS14 showing proximity to new shop (white wall to rear)

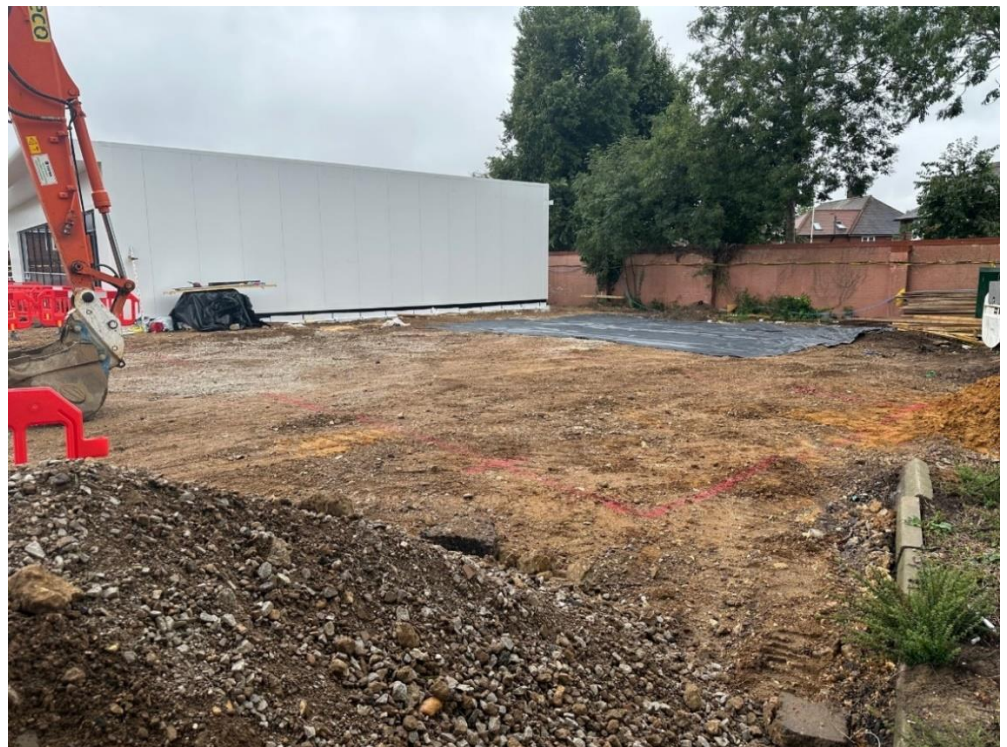
Photo No.
40

Area prepared for asbestos hotspot delineation in permeable paving area with ground protection in background for excavated material stockpiling

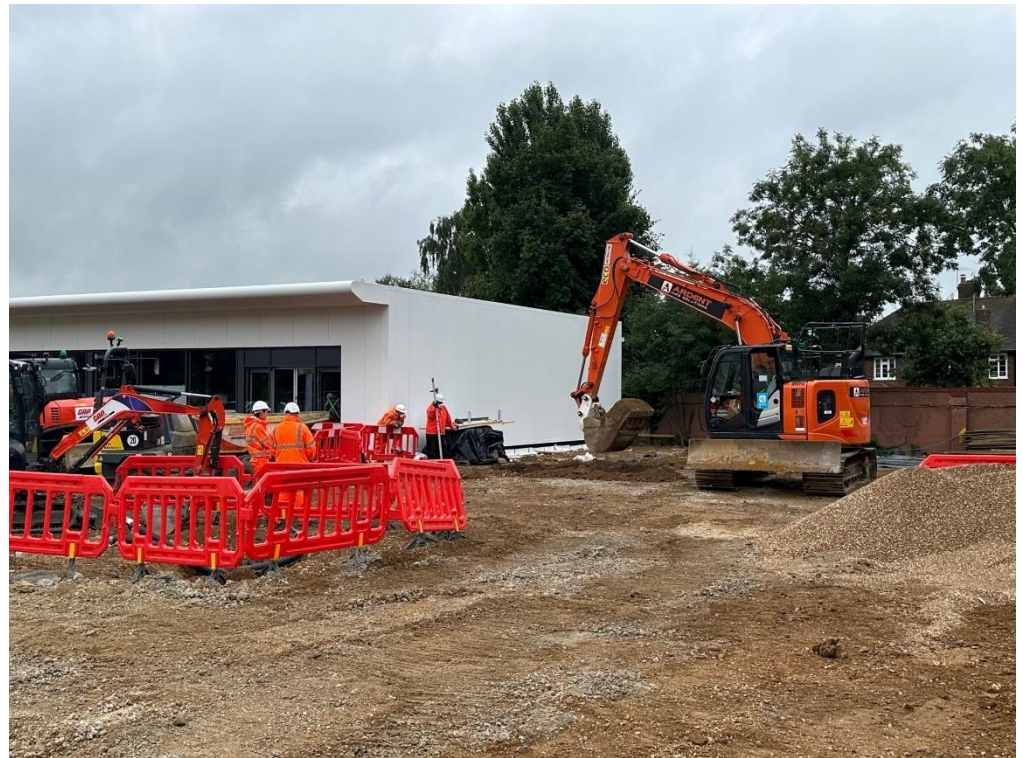
Photo No.
41

Asbestos in air monitoring during excavation of permeable paving / French drain installation area

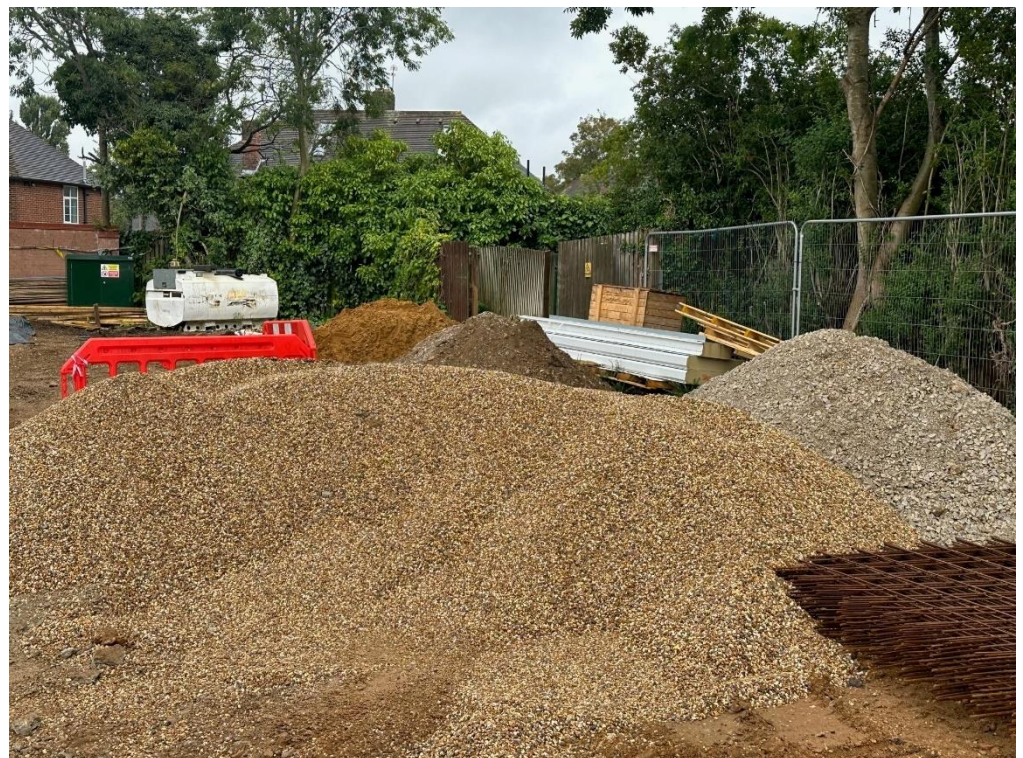
Photo No.
42

Imported fill stockpiles

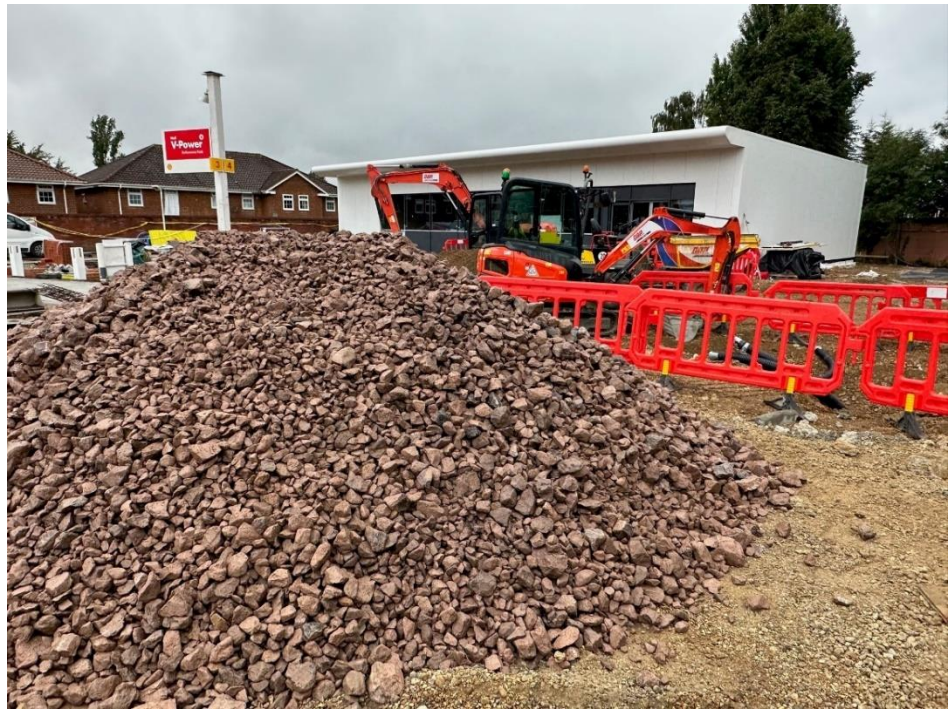
Photo No.
43

Description:
Imported fill stockpile and shop progress

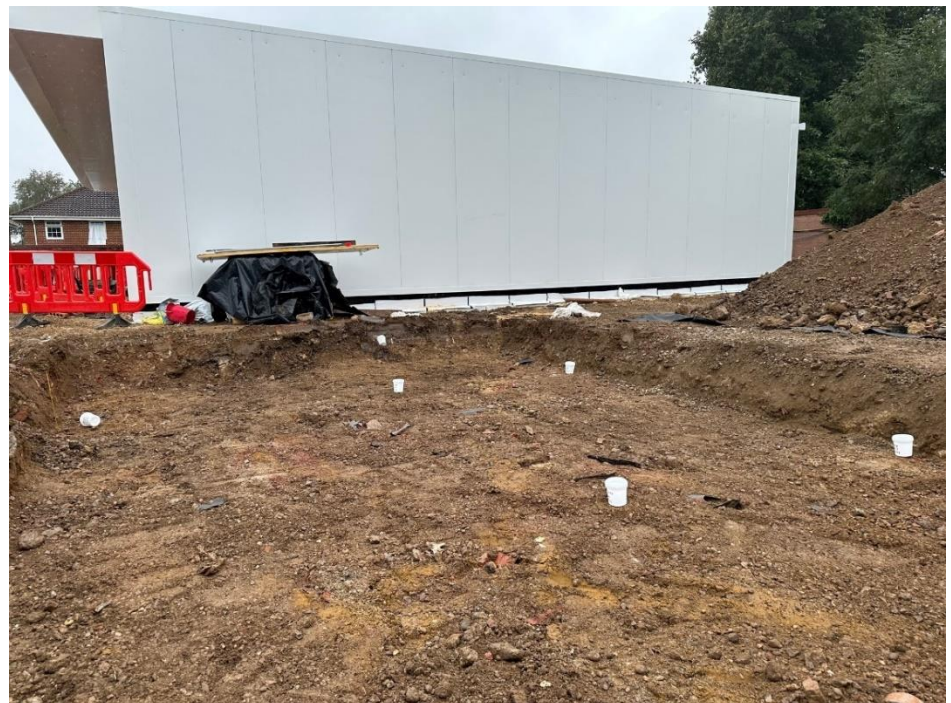
Photo No.
44

Description:
Validation sampling at final foundation levels in permeable paving area
(samples VS14F-K)

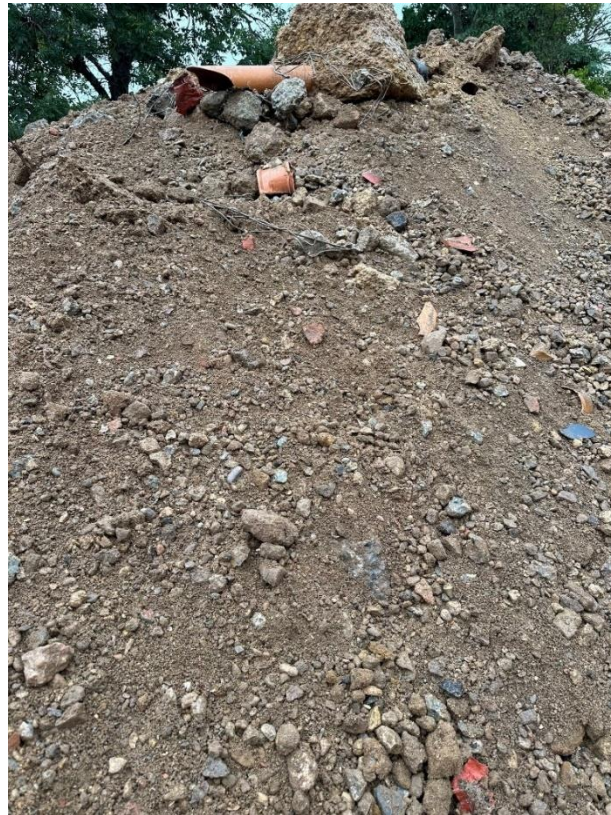
Photo No.
45 **Date:**
08/08/23

Description:
Stockpile SP1 of arisings from permeable paving excavation

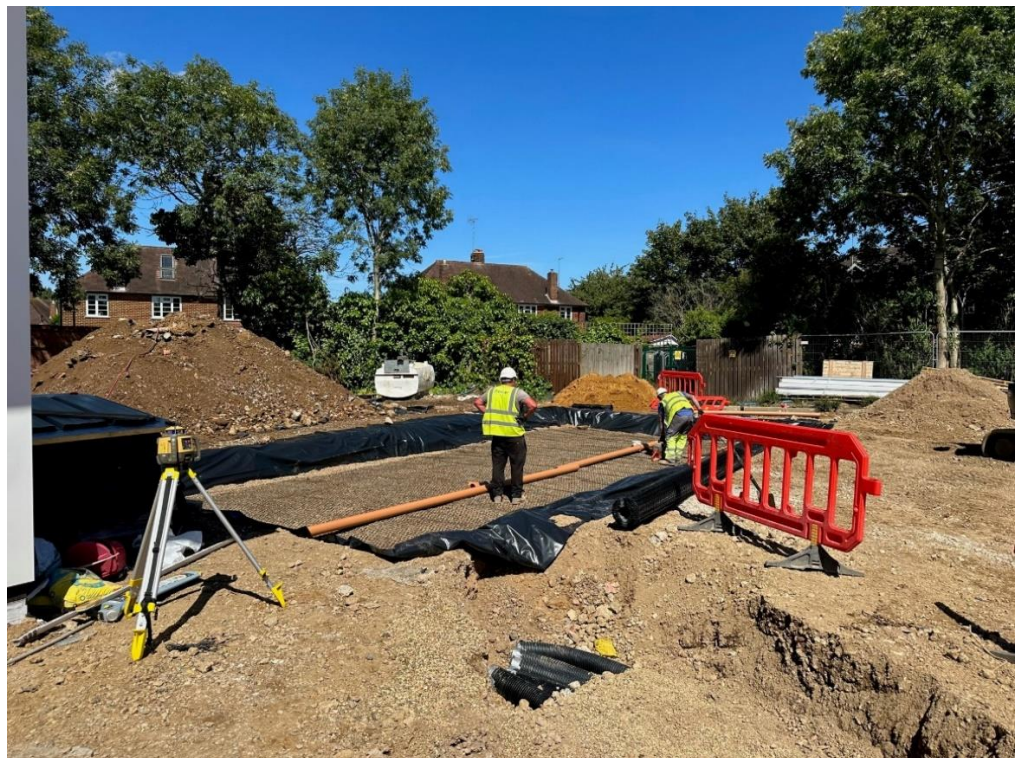
Photo No.
46 **Date:**
09/08/23

Description:
Permeable paving area preparation showing membrane liner and French drain installation. Stockpile dampening spray system shown to rear of excavation prior to removal from site.

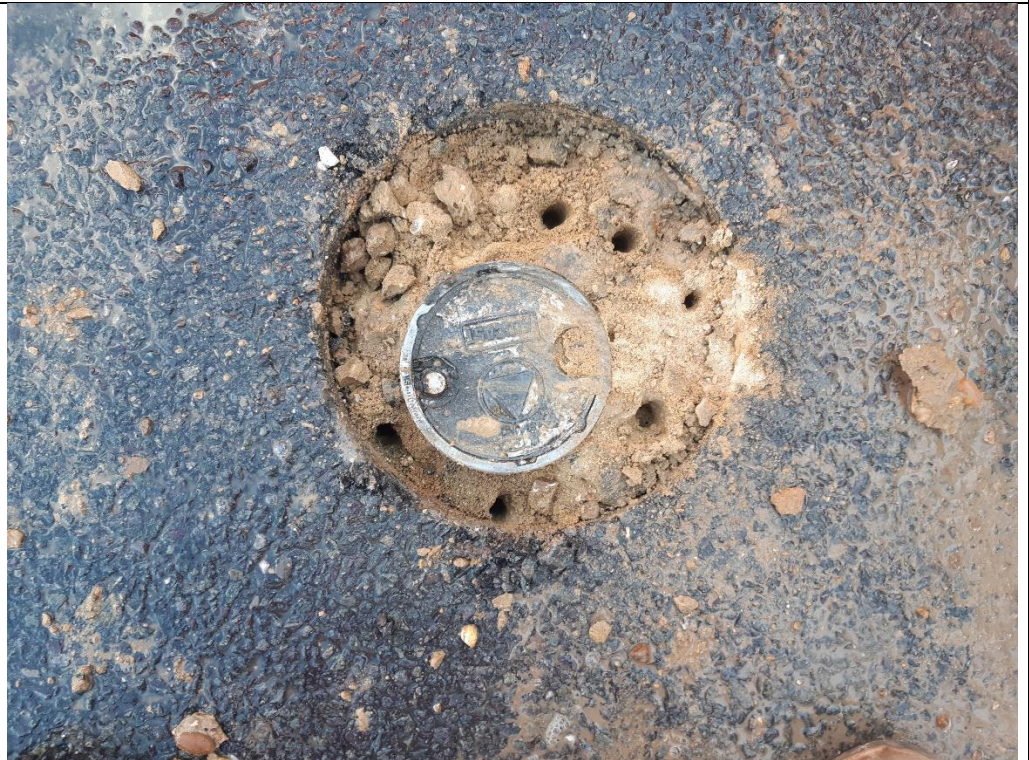
Photo No.
1

Description:
VP01 – pre headworks removal

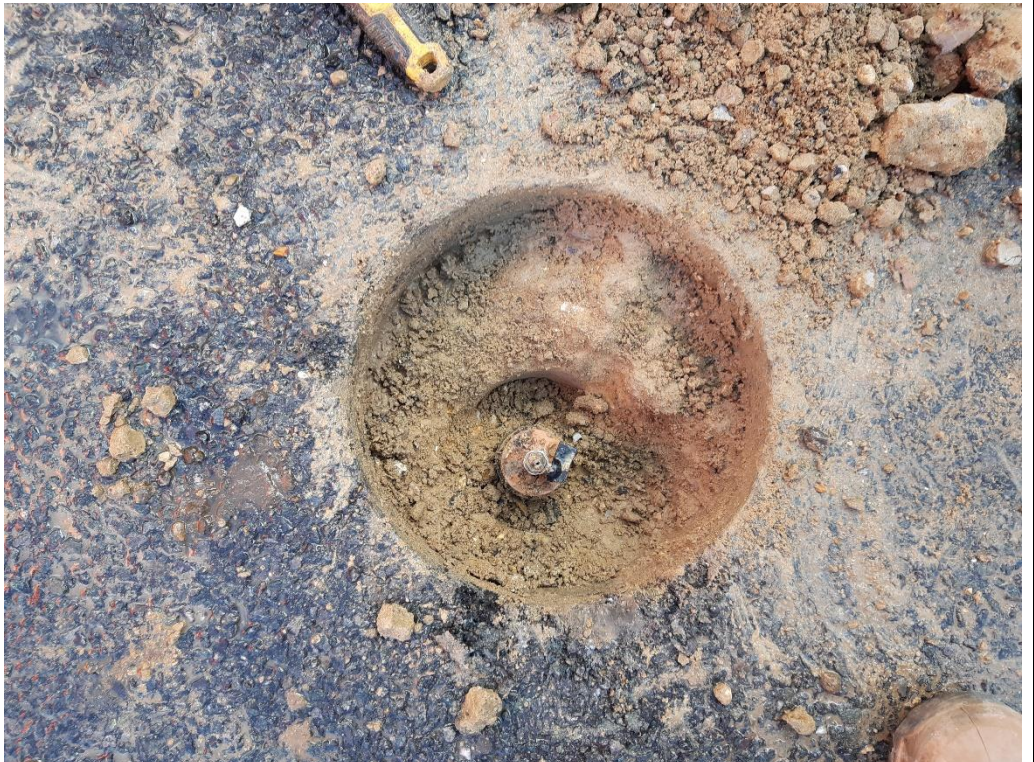
Photo No.
2

Description:
VP01 – post headworks removal prior to grouting

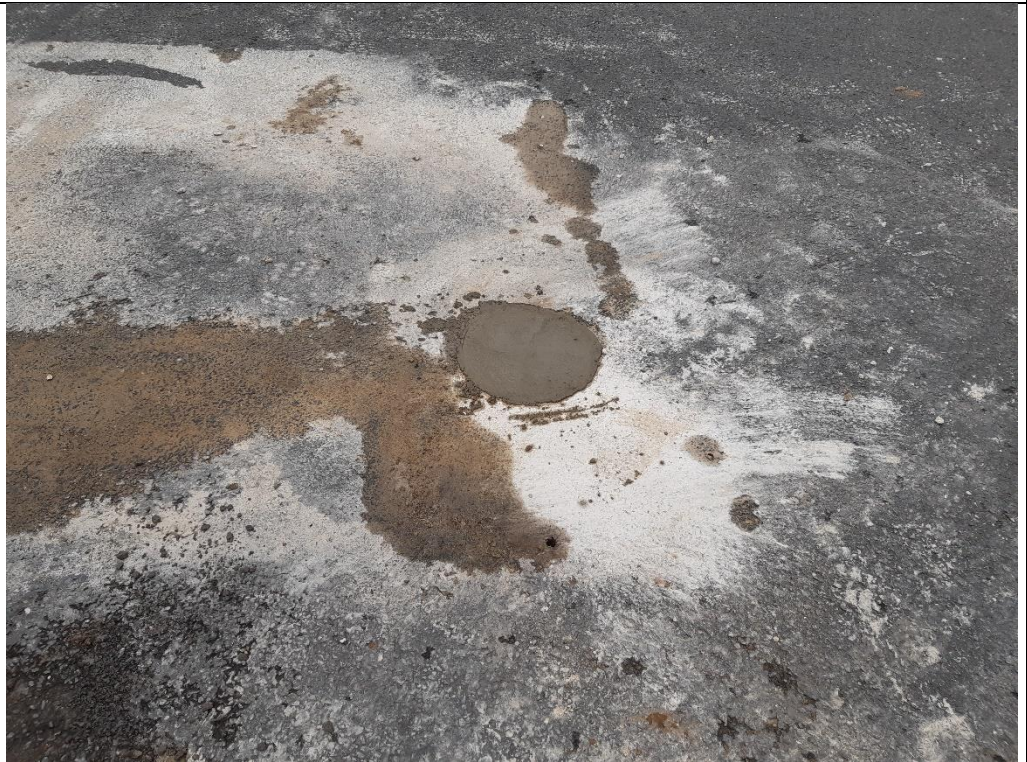
Photo No.
3 **Date:**
25/04/23

Description:
VP01 – post grouting and cement reinstatement

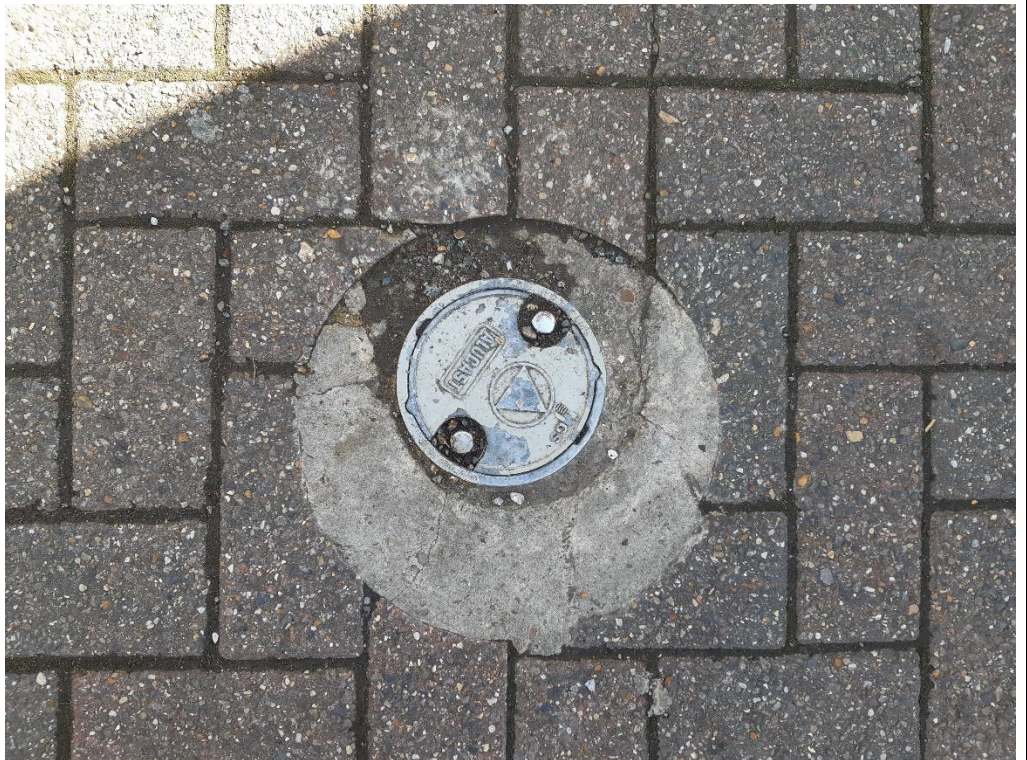
Photo No.
4 **Date:**
25/04/23

Description:
MW101 – pre headworks removal

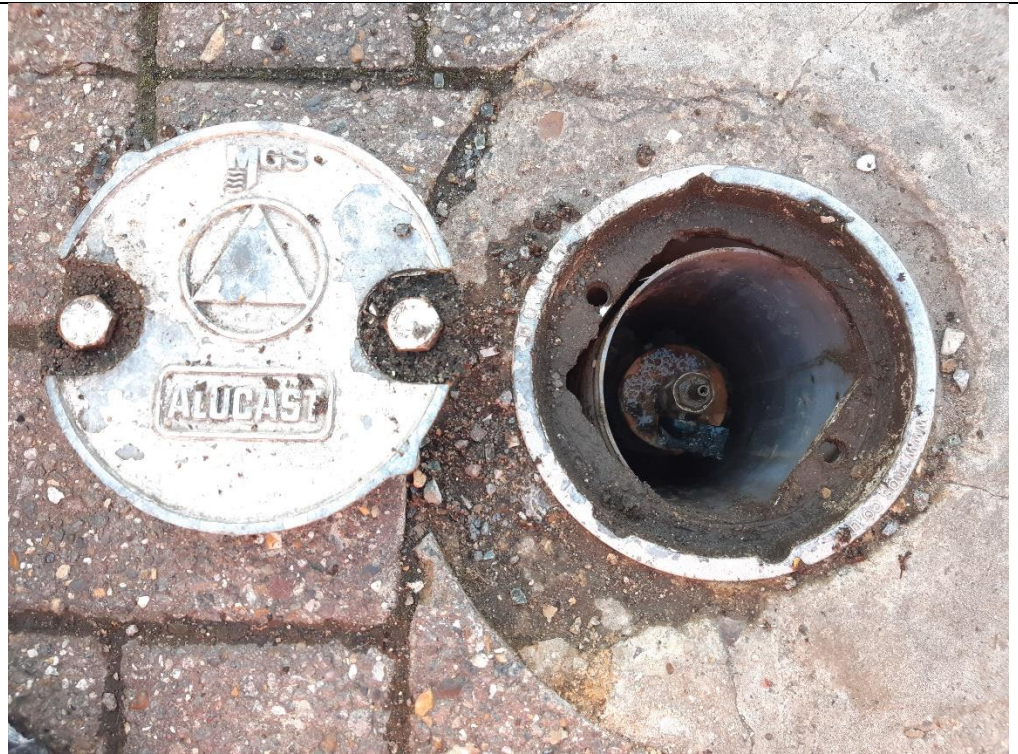
Photo No.
5

Description:
MW101 – pre grouting

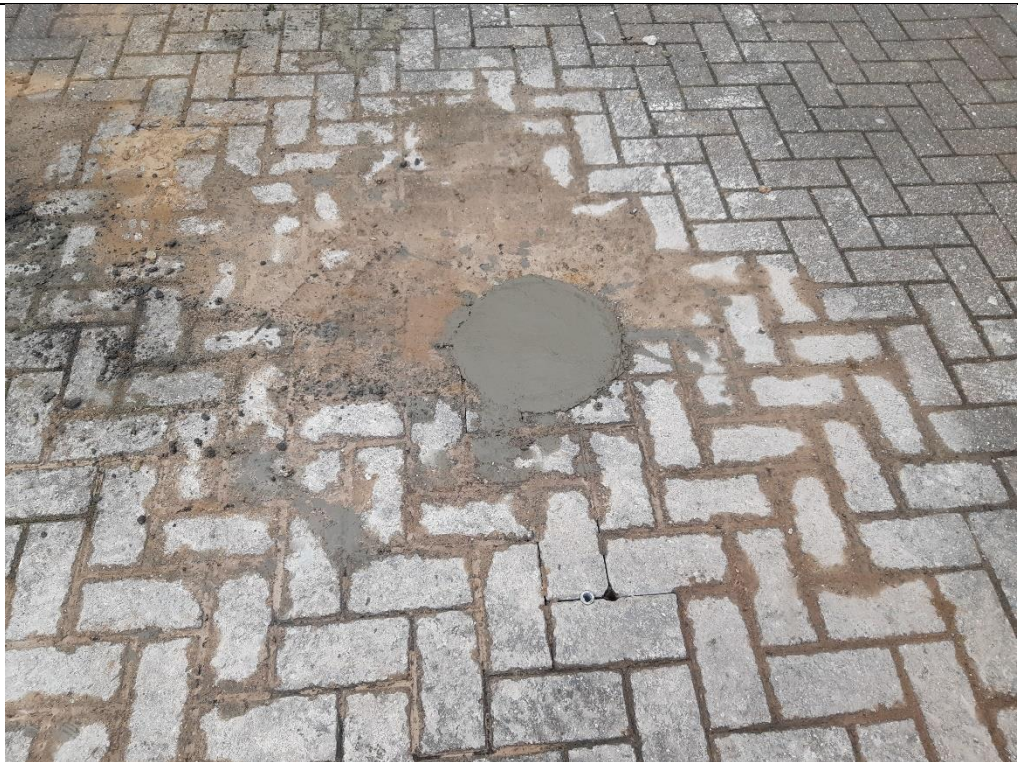
Photo No.
6

Description:
MW101 – post grouting and cement reinstatement
