Our Ref 24100/JL/JL

Date: 10 April 2024

Re: Chestnut Farm Barn, Woodfield Lane, Hatfield

We visited the above property, at your request, on 5th March 2024 to undertake a structural appraisal with respect to the proposed conversion of the existing Barn into a residential dwelling.

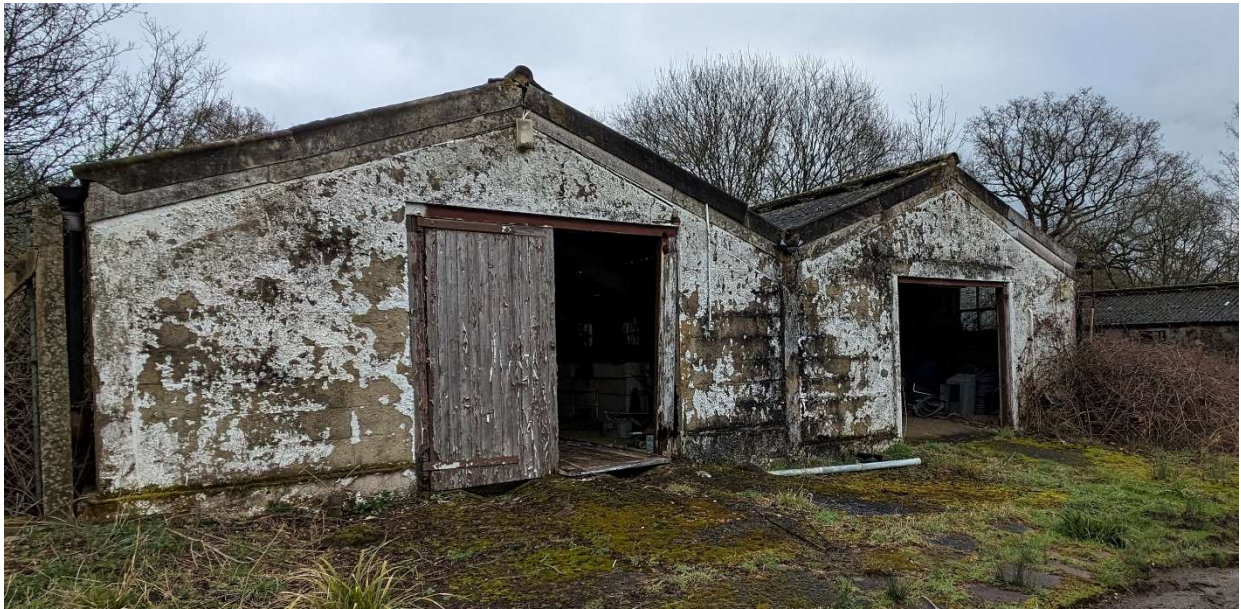
The Barn was originally a pig shed and is now currently used for storage. Photograph 1 shows the front elevation.

Photograph 1 View on Barn from front.

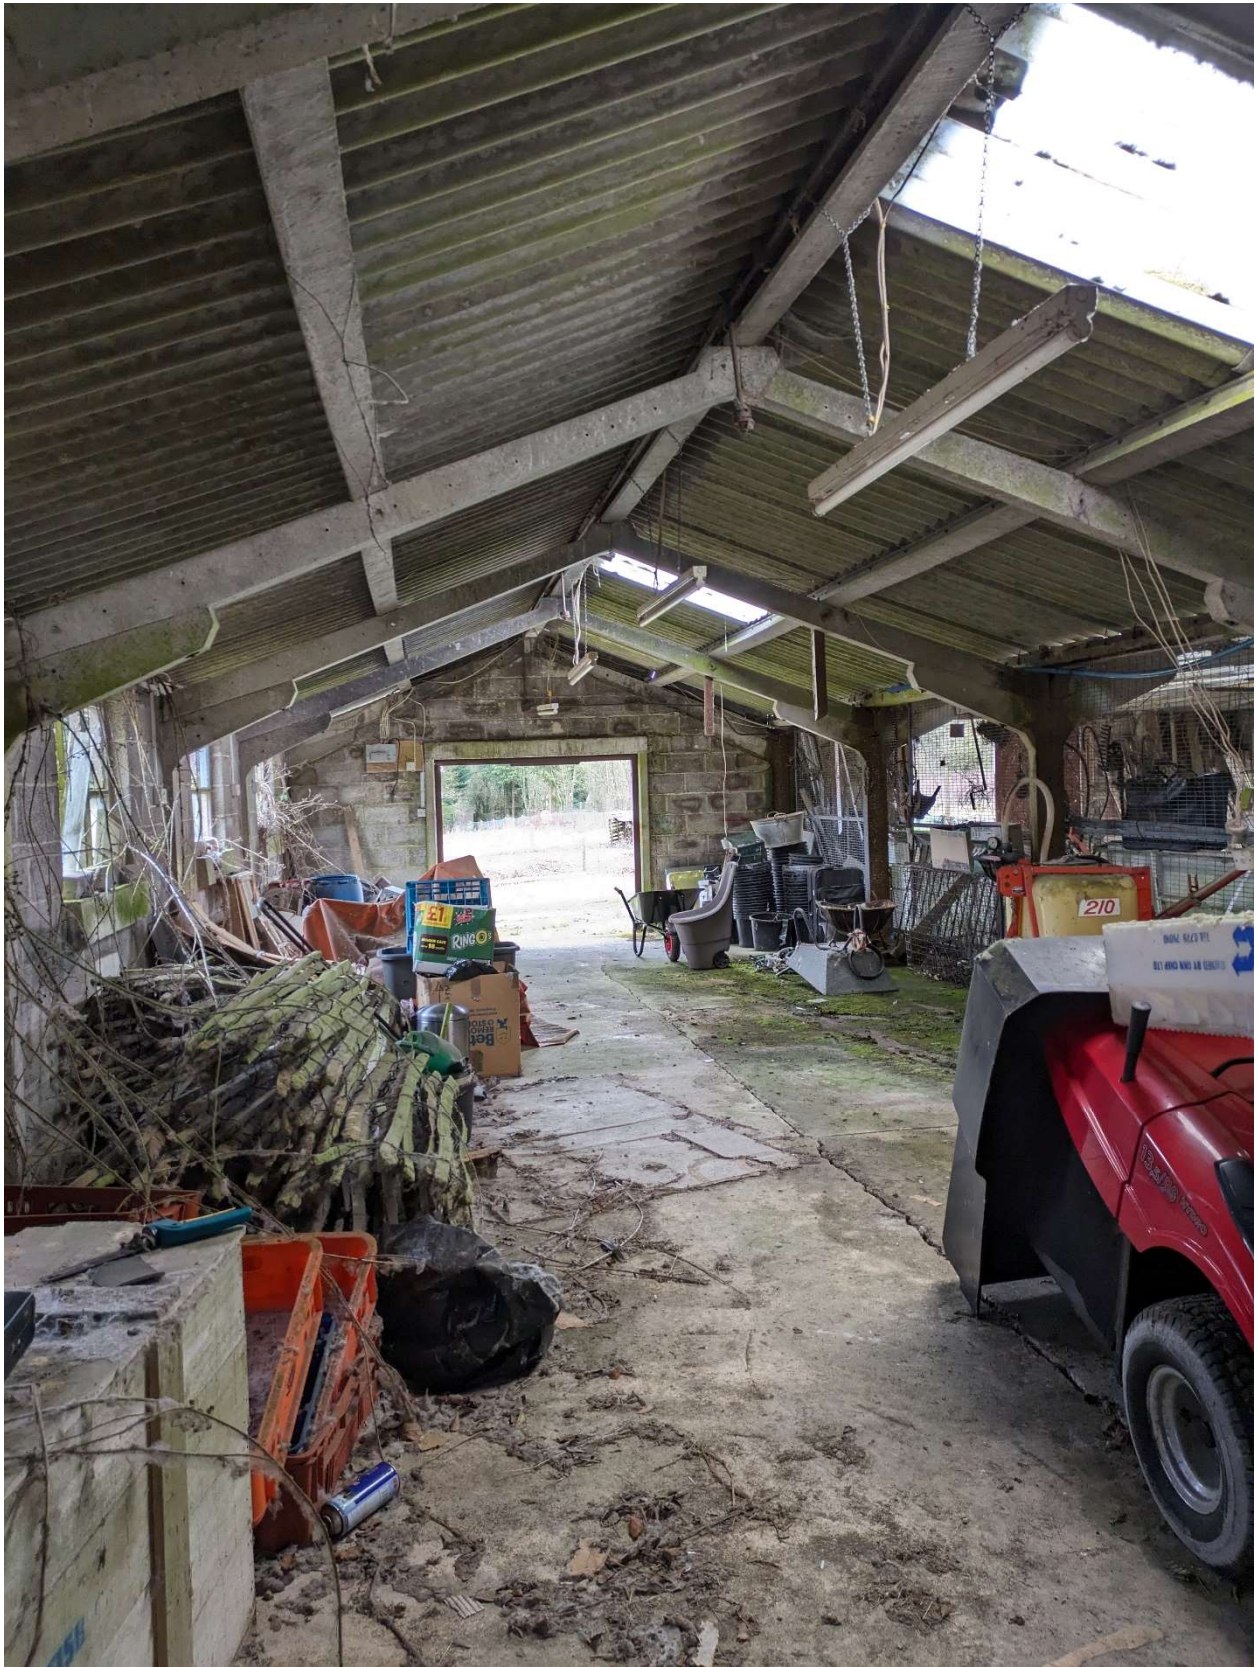
The structure is formed of seven pairs of precast concrete portal frames at approximately 3m centres forming a double pitched roof with central valley. Columns are located in the external walls and on the line of the central valley. Photograph 2 shows one half of the double portal frame.

As can be seen in Photograph 2 the floor is a ground bearing concrete slab, it has some cracks which are a combination of construction joints and thermal.

Photograph 2 View on one half of double portal frame.

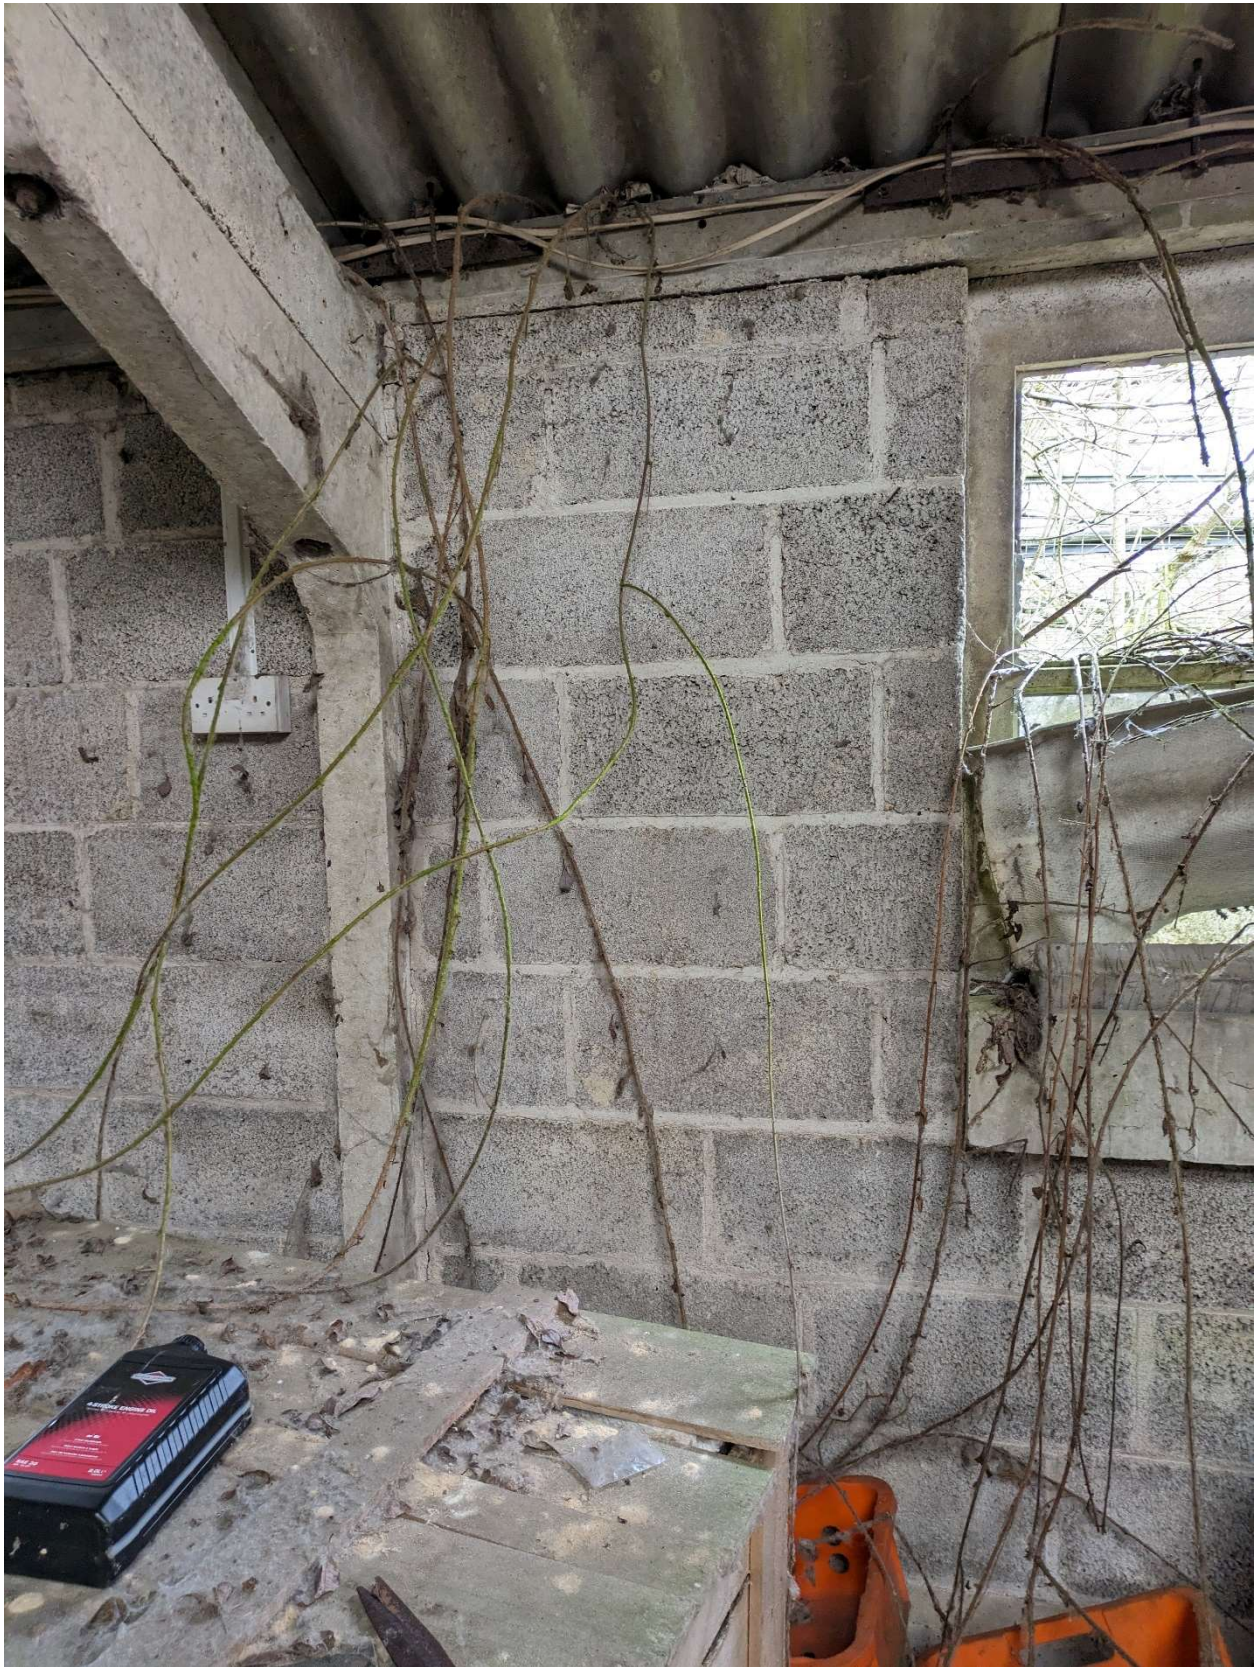
The external walls are formed in infill blockwork between the precast portal frames, refer to Photographs 3 and 4.

As seen in Photograph 3 the roof is formed in a profiled sheet, this spans from the precast eaves beam up to the ridge, refer to Photograph 6, and is supported at third points of the span by precast concrete purlins, refer to Photograph 7.

Photograph 3 Typical view on infill blockwork to external leaf.

The existing roof cladding is to be removed and replaced with a profiled metal sheet. Insulation to the roof is to be applied internally.

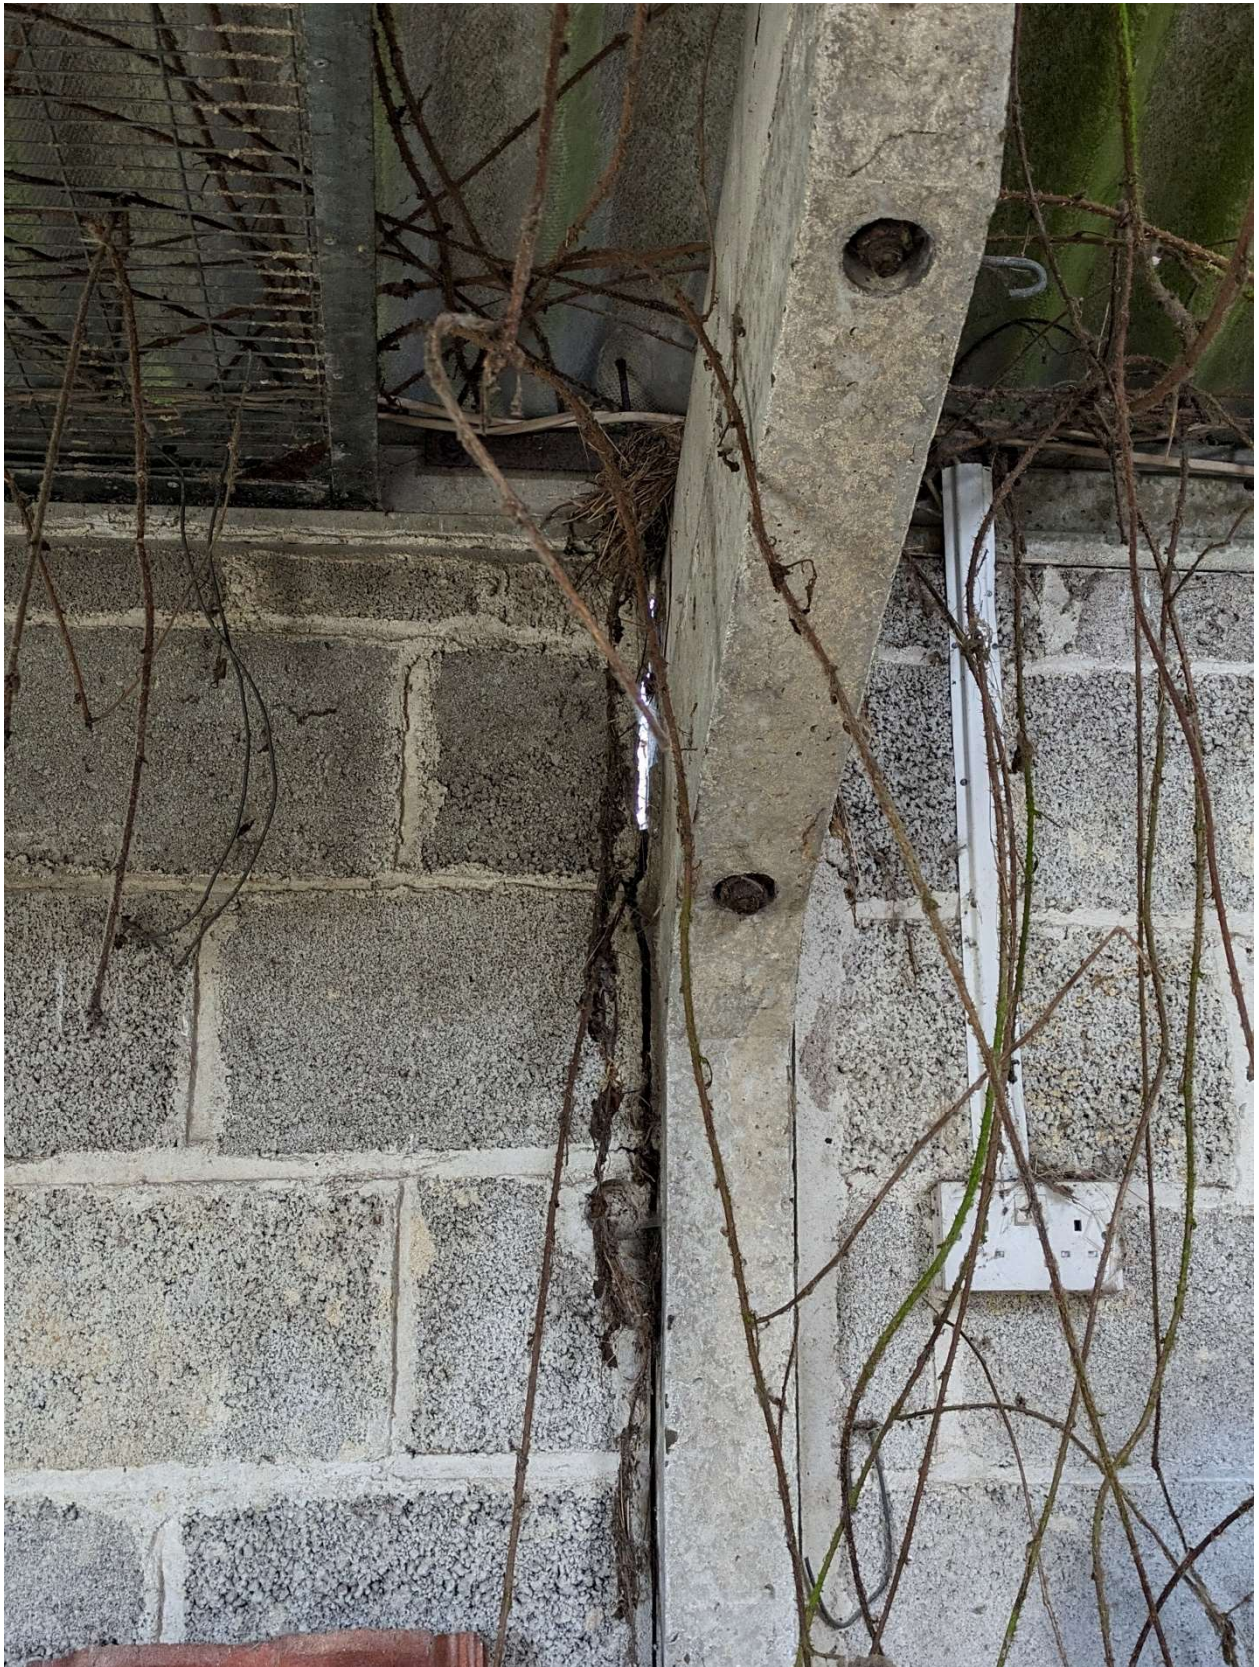
Photograph 4 Typical view on infill blockwork to external leaf.

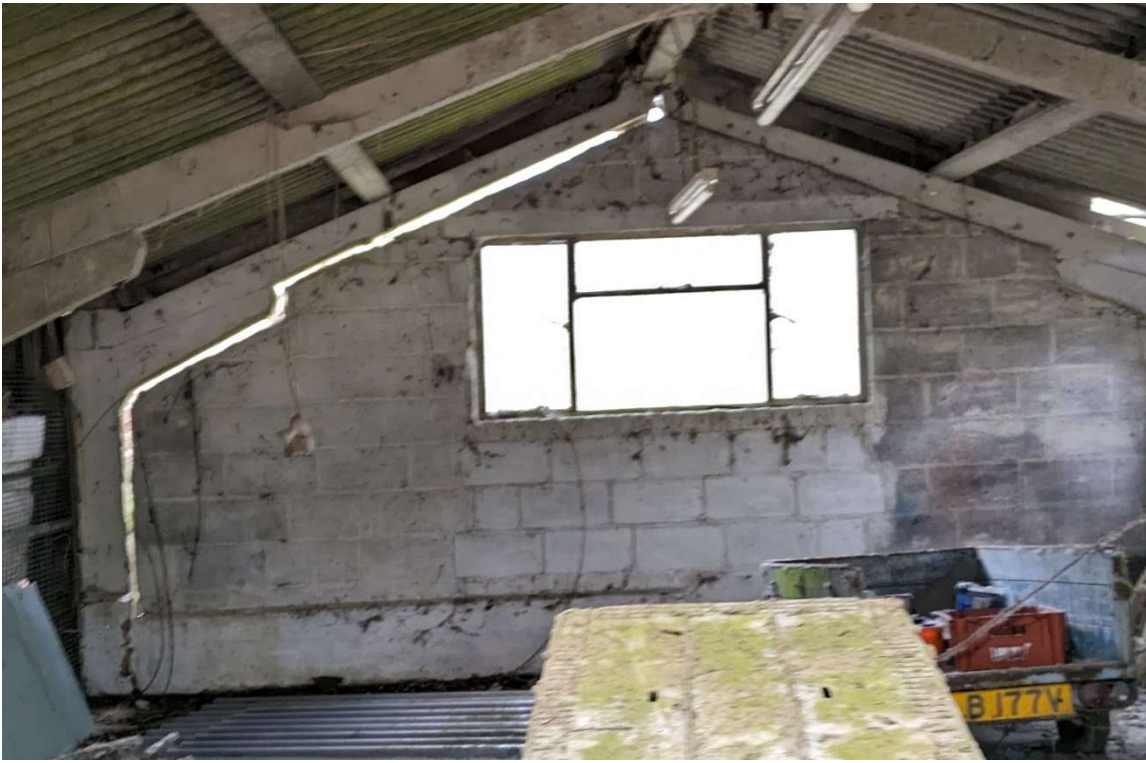
In many areas the blockwork has separated from the precast concrete, the worst affected area is the rear elevation, as shown in Photograph 5.

Photograph 5 View on rear elevation showing separation of infill blockwork and precast frame.

The rear elevation to the right hand side will require the blockwork wall replacing, where possible this will be built off the existing foundation, if not possible a new strip foundation will be constructed between the precast concrete columns.

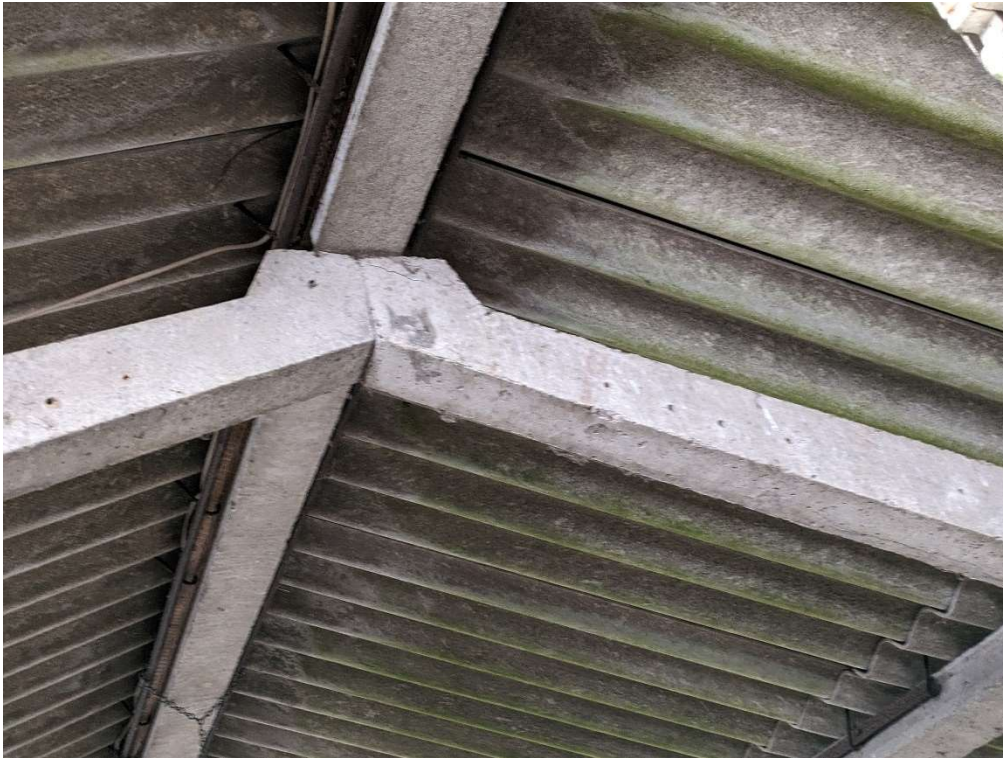
No distress or deflection was noted to the eaves beams or purlins.

Photograph 6 View on precast concrete ridge beam.

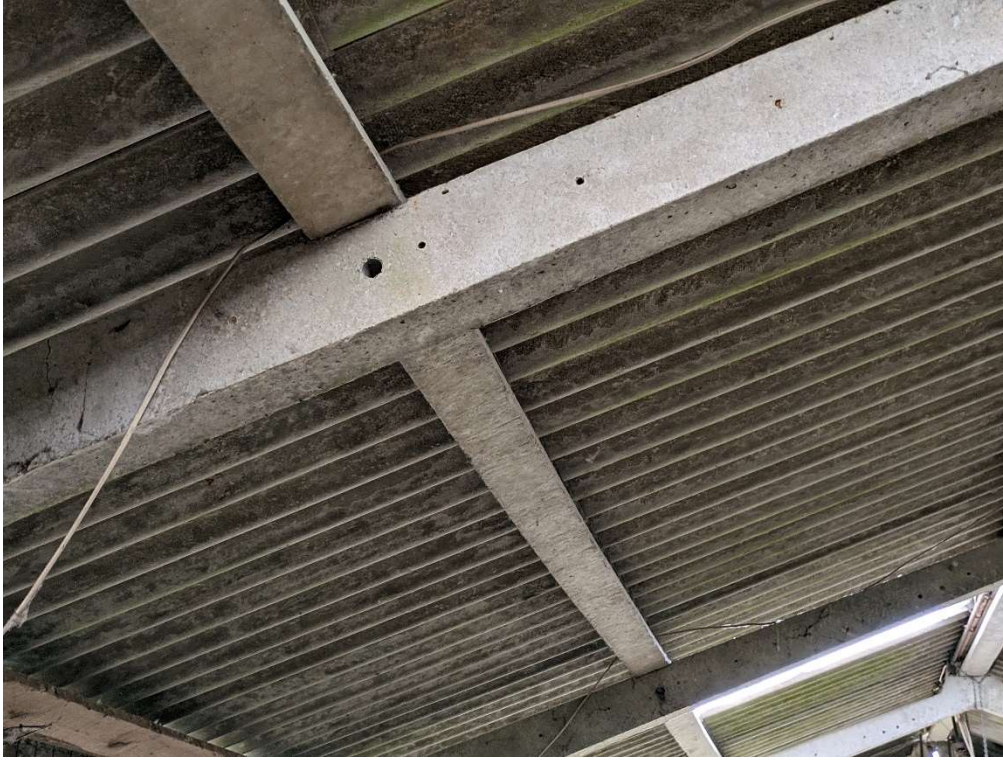
Photograph 7 View on precast concrete purlin.

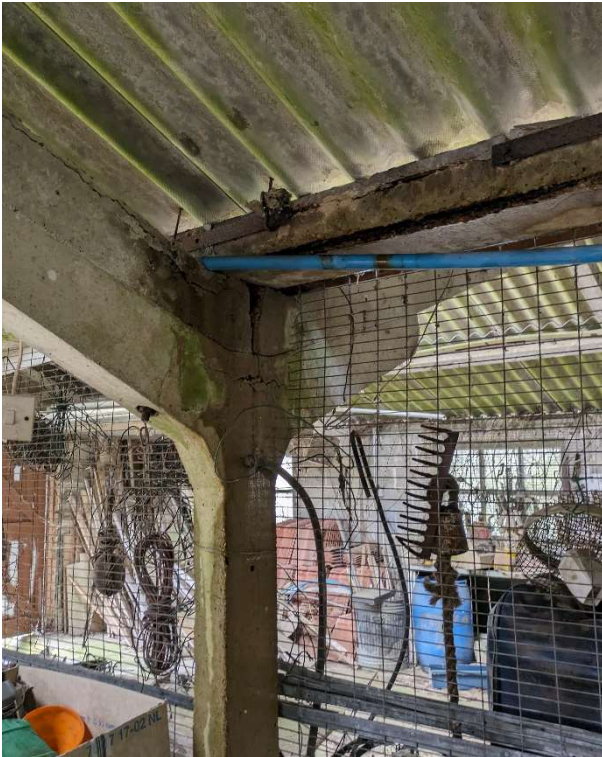
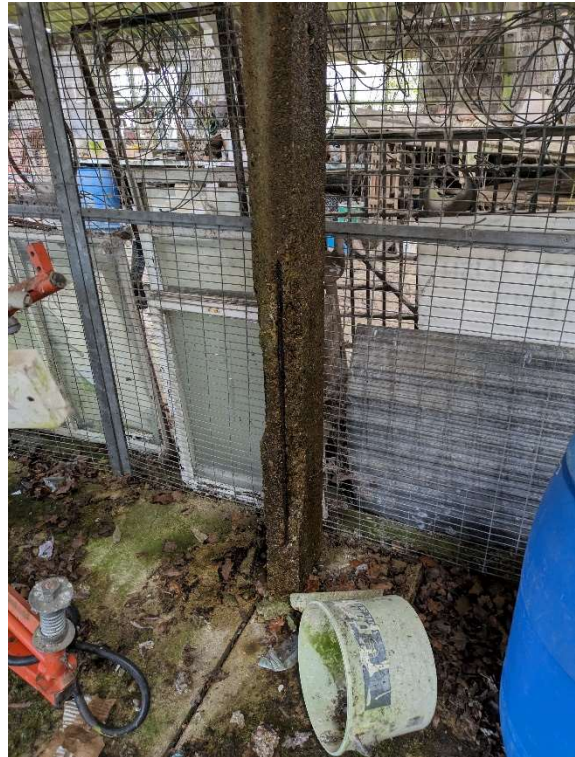
The central columns and associated valley beams are shown in Photograph 8. This shows damage to the column from water penetration and is typical to all central columns. Reinforcing bar is evident and will require concrete repair.

The precast concrete elements appear in a structurally sound condition, some concrete repair works are required, with no evidence of significant movement.

Photograph 8 View on central column/valley beam.

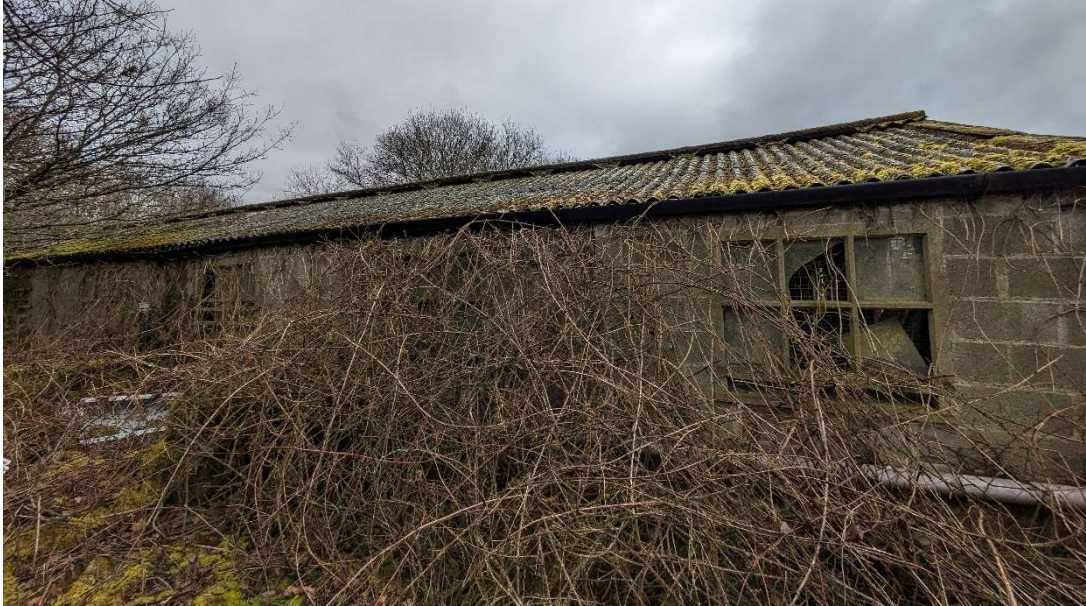
External elevations are blockwork, which apart from the separation from the frame in places appears sound. The

roof appears structurally sound with no significant deflections to the sheeting. Refer to Photographs 9 and 10.

Photograph 9 View on left hand side external elevation.

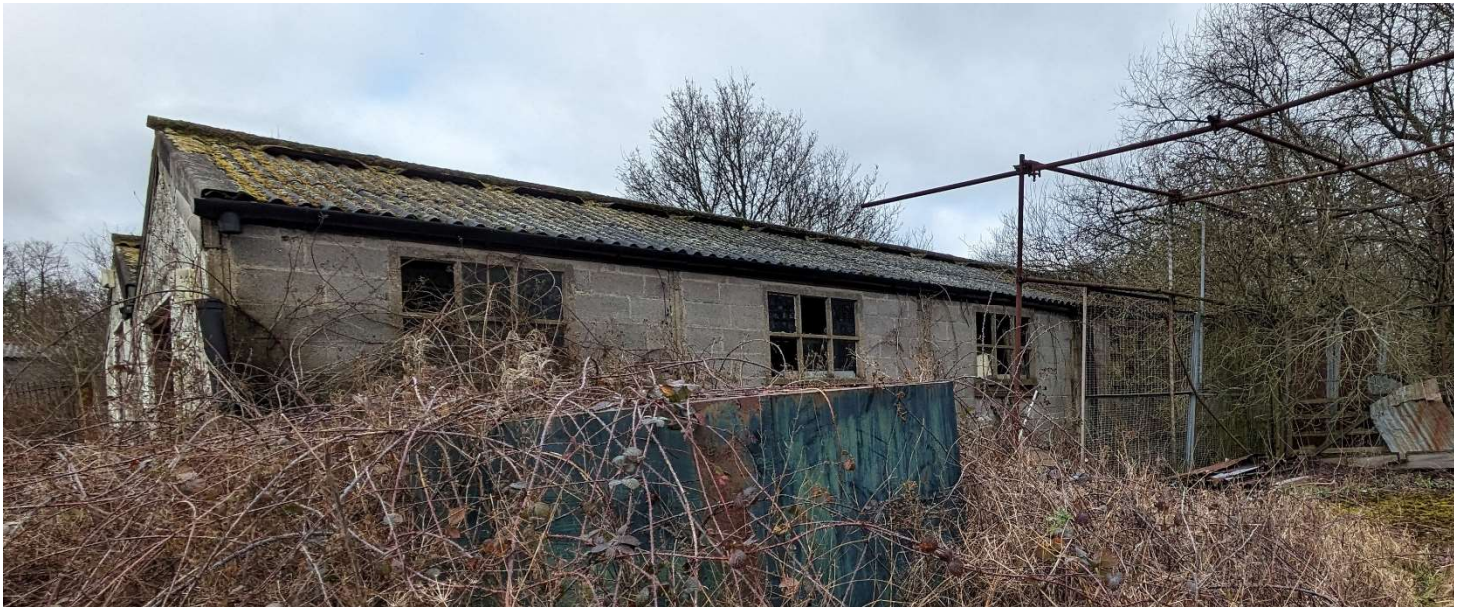
Photograph 10 View on right hand side external elevation.

Entrance doors and windows are to be formed in existing openings in the walls, frames are to be replaced. Only one opening to the right hand side elevation is to be widened.

No members of the portal frames will be amended/removed. Where the extended window opening is required in the wall the opening will require a new lintel.
