# Picus: Hatfield Police Station

Tree species:	Tree of Heaven	Tree height [m]:	16
Town:	Hatfield	North at measuring point:	1
Neighbourhood:	Police Station	Crown spread [m]:	10
Road:	Comet Way	Position of measuring point 1:	0
		Trunk circumference (130cm height)[cm]:	278
Number of tree:	1	Tomography level at height [cm]:	15
Measure date:	6/1/2018 9:01:00 AM

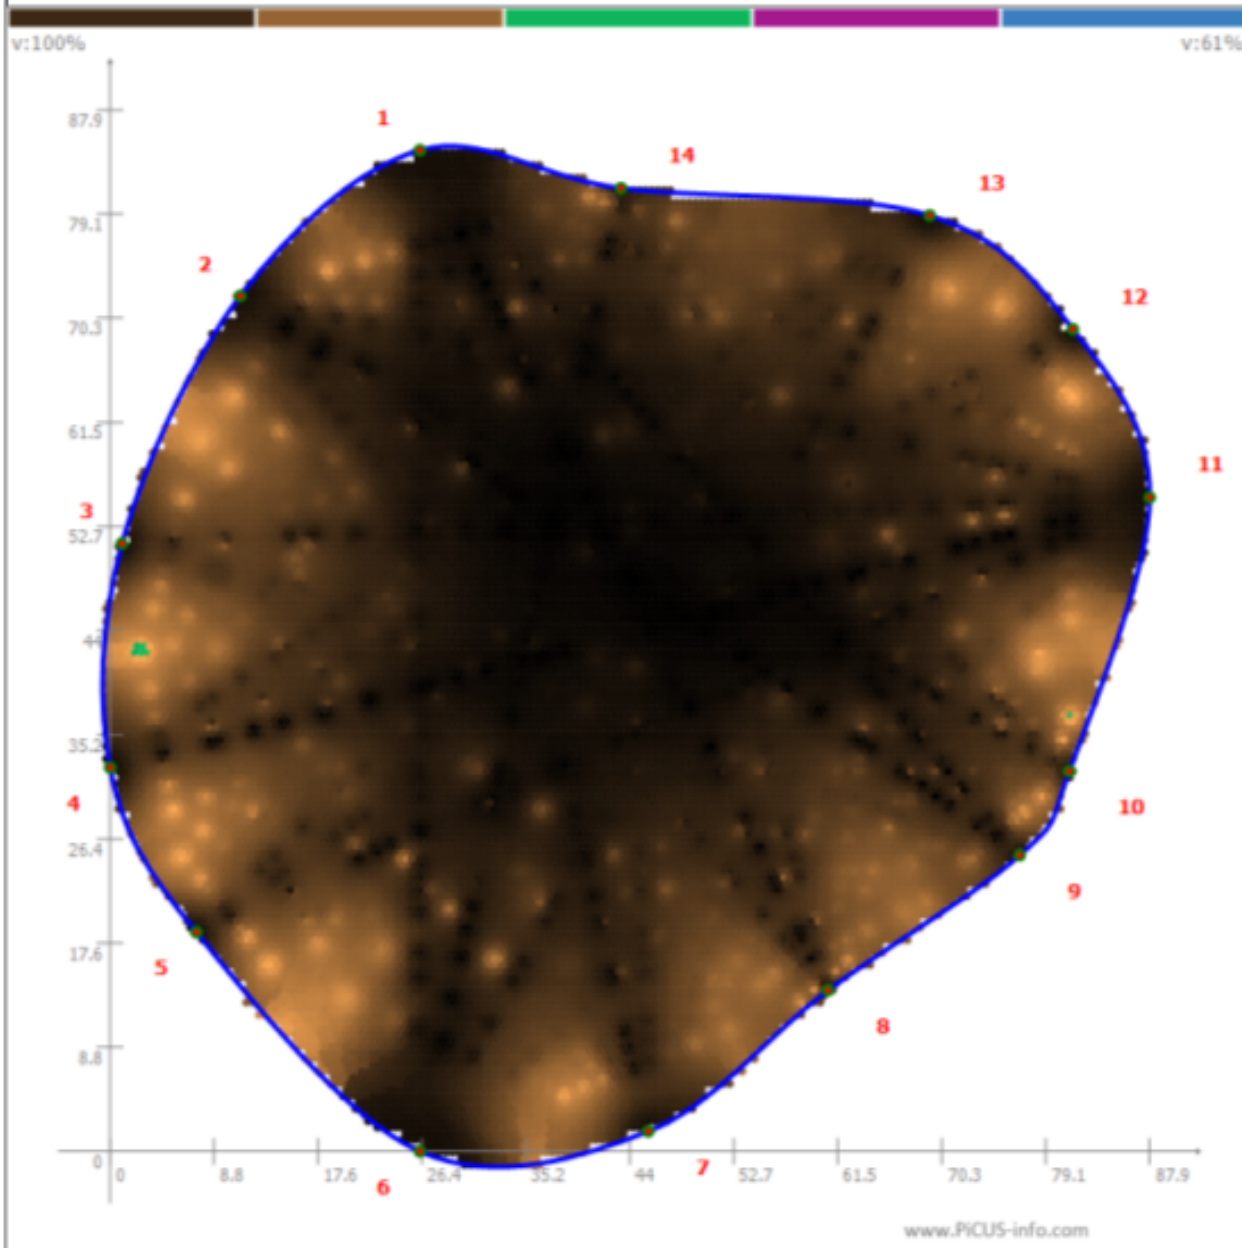
Initial inspection 04/05/18 at 17:30. Tree stands in wide grass area at front of Hatfield Police Station and to W of Comet Way; unsurfaced parking area 8m to S. Tree arises as a single stem with well-developed buttresses except on E side where a girdling root was observed at ground level. Marked helical stem creasing is visible from ground level to 3m with bark cracking on the ridges. Abnormal hammer sounds observed from ground level to 2m on E side; taps observed to produce ground vibration to the N side; lead shot damage at 1.5m N. Bole at 4m with four major ascending boughs and a pruning stub with open heartwood decay. Large canker visible on stem associated with abnormal hammer taps to E, extending from NE to SE quadrants, starting at ground level and extending upwards through bole and for 2m along bough projecting S/SE. Bark absent at 2-2.5m with some callus formation and linear bark cracks to either side. Seven old brackets of the primary decay fungus *Pleurotus ostreatus* associated with the canker between 4 and 6m; further bracket at 6m in branch union. Additional old, black *Inonotus*-like bracket at 4m S, above bole. Major limbs rubbing at 7m NW. Bark inclusion at 4m E directly above worst damage.

Second inspection 01/06/18 at 08:30. Significant distribution of toadstools of the saprophytic fungus *Marasmius oreades* associated with the buttresses and roots to the W and E of the stem. Crown fully flushed and healthy except for dieback on limb projecting S / SE. Bark delamination associated with canker appears to be superficial with hard wood behind. Sonic tomography at 15 and 220cms did not reveal the presence of decayed wood, however this was below the area primarily affected by the *Pleurotus* infection. Interpretation: Tree is suffering from at least three fungal infections creating two primary risks: 1. Primary decay of bough to S / SE by *Pleurotus ostreatus* and an unidentified *Inonotus*-like fungus at 4-6m which has compromised function of vascular wood, created a localised dieback condition and which is likely to have significantly compromised the structural integrity of this bough (sonic tomography was carried out below this level; further examination from rope and harness would be needed to explore this point). THREATS analysis: target = parking area;  $8 \times 25 \times 6 = 1200$ ; SIGNIFICANT; remediate within 4W; branches should be removed as indicated in the attached photo and the remaining crown reduced by up to 30% by volume to maintain shape and form. 2. A secondary infection of the roots by the saprophytic fungus *Marasmius oreades* and which indicates the presence of dead root material below the ground. Combined with the observation of hammer-induced ground vibrations to the N, this suggests the presence of a relatively wide-spread root pathology which has not yet affected crown vitality but which can be expected to produce symptoms in the foreseeable future. The health and prognosis of the tree could be improved by decompacting the soil using a Terravent or similar device.

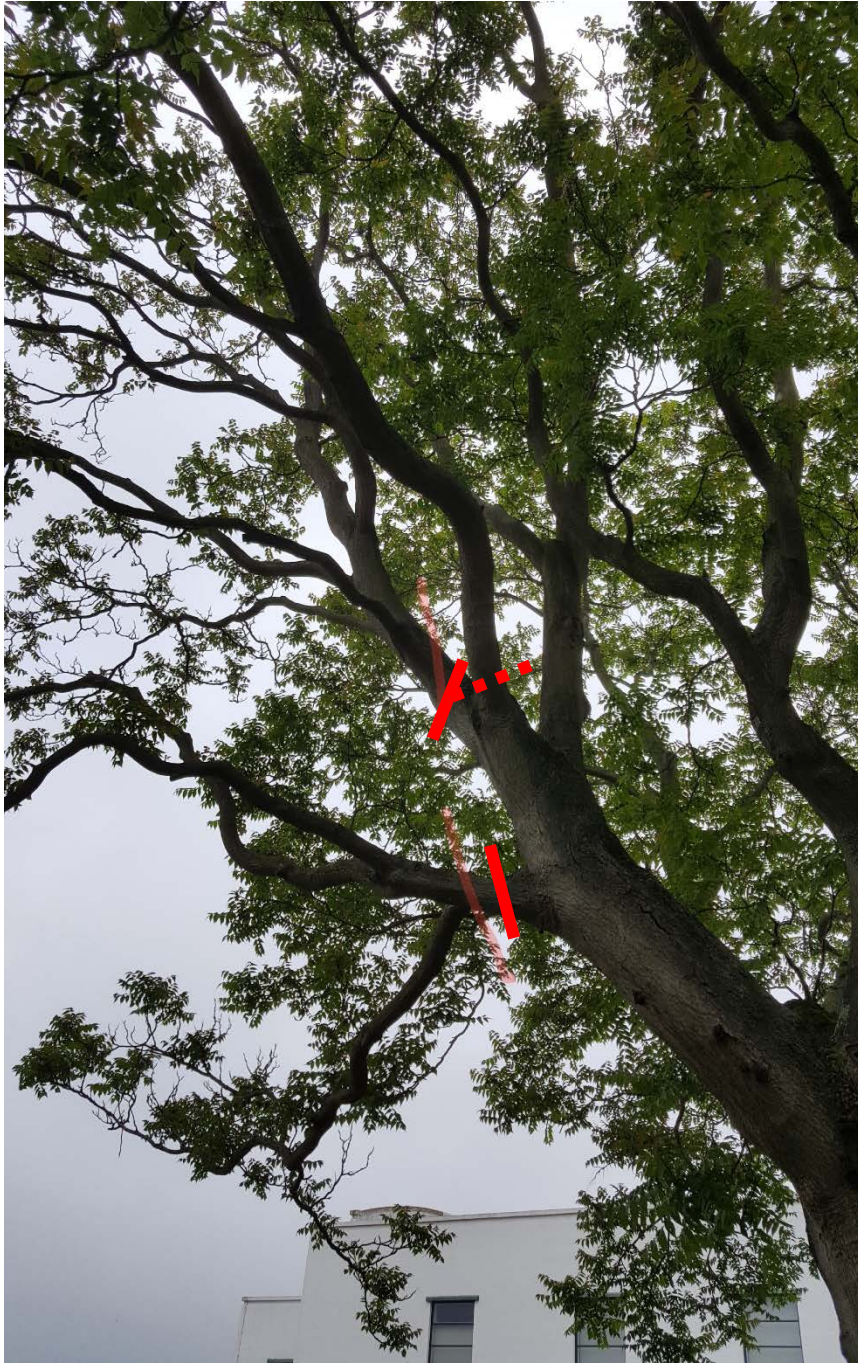
View of bough extending S / SE taken from E looking W.  
Solid red lines – cut points.  
Dashed red line – optional cut point – to be assessed by climber  
at time of pruning – retain if possible.
