# Report Document

**Project: 17874**

The Ramada Hatfield / Comet Hotel  
St Albans Road West  
Hatfield  
AL10 9RH

## Roof Survey Report & Recommendations

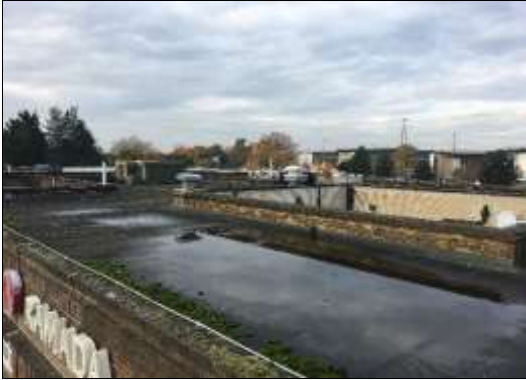
**Photograph No. 1**

Overview Roof 1 – Significant ponding water suggests issues within the deck and with drainage.

- Given the large areas of standing water and deflections in the deck we recommend a tapered insulations scheme to assist with drainage. Flatboard insulation is an option but the roof will have significant areas of standing water.

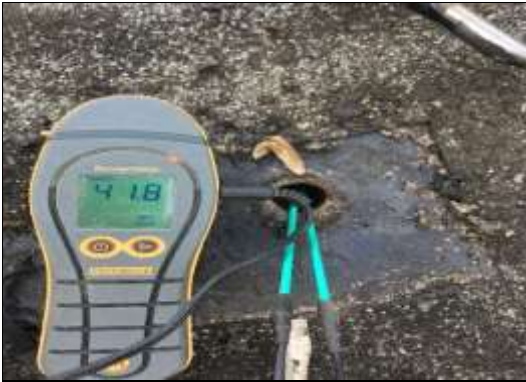
**Photograph No. 2**

Roof 1 – Moisture detected between the two asphalt coverings.

- We recommend stripping back the existing system to the 1<sup>st</sup> layer of asphalt and installing a bituminous membrane system.
- We recommend installing the Langley TA-20-W system including bituminous vapour barrier, tapered insulation (to achieve the required U-value 0.18 W/<sup>2</sup>K) with underlay and mineral cap sheet.

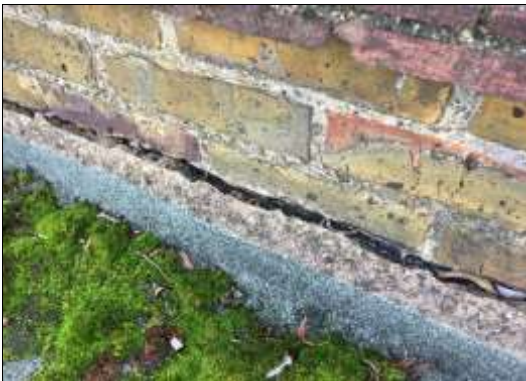
**Photograph No. 3**

Failed upstands have pulled away from the parapet allowing water to track inside.

- All outlets openings should be increased where necessary.
- Langley Paraflash flashing system should be installed to all perimeter upstands.
- All plant / wires / pipes should be temporarily removed to facilitate the works. All redundant plant should be removed.

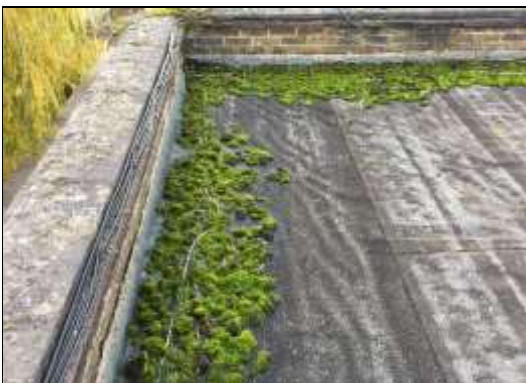
**Photograph No. 4**

Roof 1 – Moss growth and crazing effect within the roof covering.

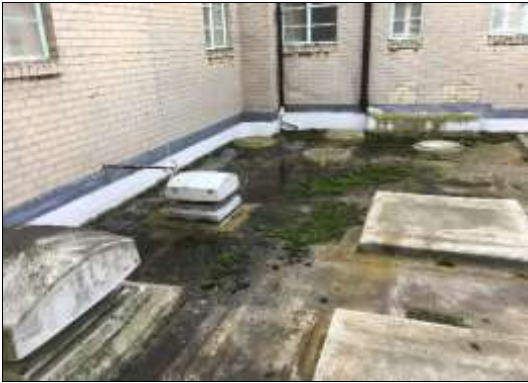
**Photograph No. 5**

Roof 2 – Standing water and significant moss growth indicate issues with drainage and falls.

Kerbs are visible to old plant/rooflight openings, these will make it hard to insulate the roof and consideration should be taken to removing / restoring them.

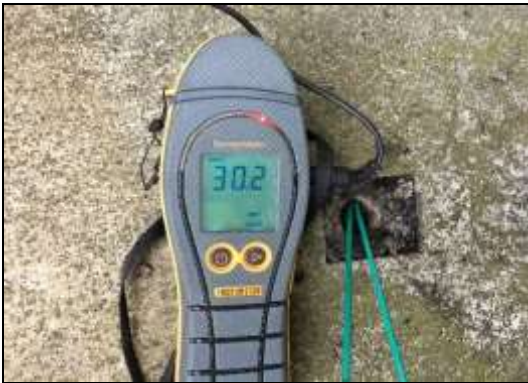
**Photograph No. 6**

Roof 2 Moisture detected between the two asphalt coverings.

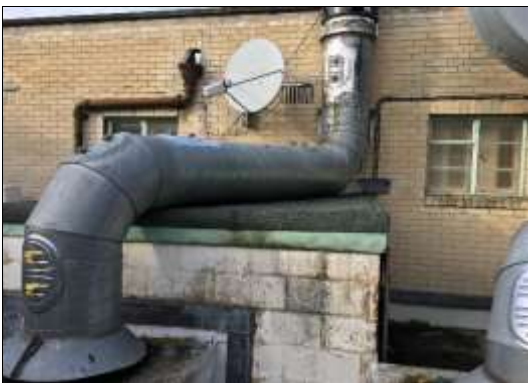
**Photograph No.7**

Plant rooms and ducting covering the roof.

All redundant plant should be removed and existing kerbs / housing encapsulated into the new roof system.

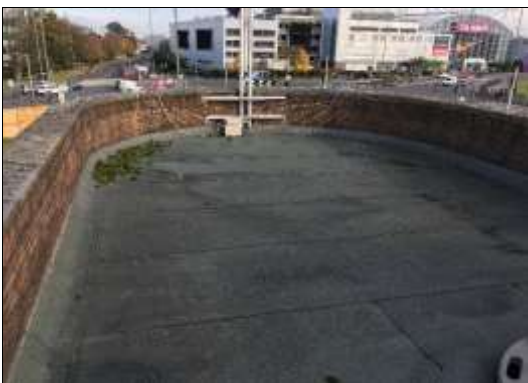
**Photograph No. 8**

Roof 3 Overview – Moisture detected between the asphalt layers.

Parapet walls and coping stones require attention.

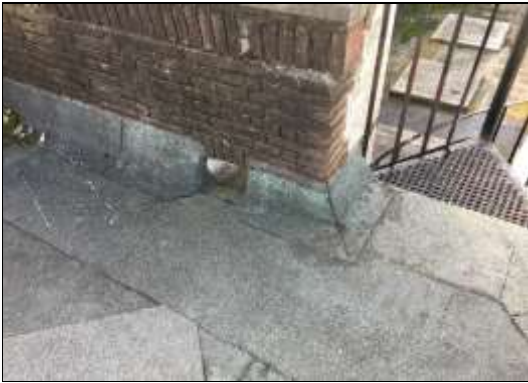
**Photograph No. 9**

Roof 3 - Drainage is towards a chute which discharges into external rainwater goods.

Like all of roofs 1-8 no cover flashing is present and the upstand has pulled away from the wall.

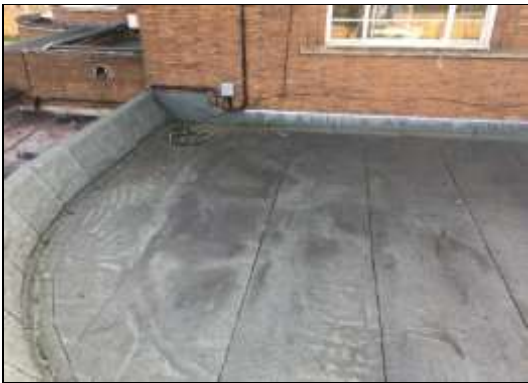
**Photograph No. 10**

Roof 4 - Internal parapet wall has been removed but still visible through the roof covering.

Significant crazing / blistering has formed in the covering indicating ongoing issues with ingress.

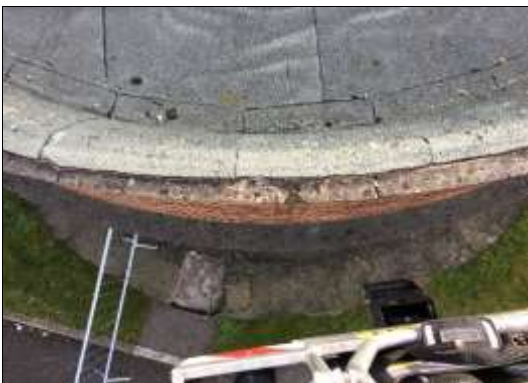
**Photograph No. 11**

The asphalt covering has receded exposing the parapet substrate beneath. This will be contributing to ingress.

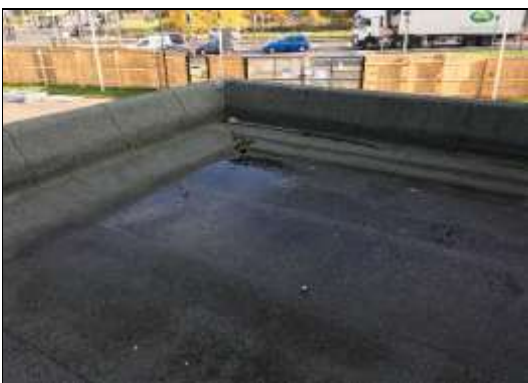
**Photograph No. 12**

Roof 6 – South section has had the inner parapet wall removed. Internal outlet discharges onto roof 7.

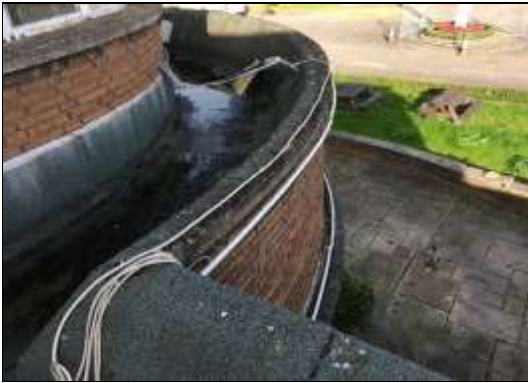
**Photograph No. 13**

Roof 6 - Curved section of roof joining the 2 main areas together. Wires have been fixed through the felt covering. The asphalt covering has receded on the drip edge with moss growing in the void.

- All penetrations should be extended to allow the minimum 150mm upstand from the finished roof surface.
- All drip details should be formed of a welted drip or with lead. **Please note:** The contractor / MC should seek guidance on which detail is most suitable as the building is listed.

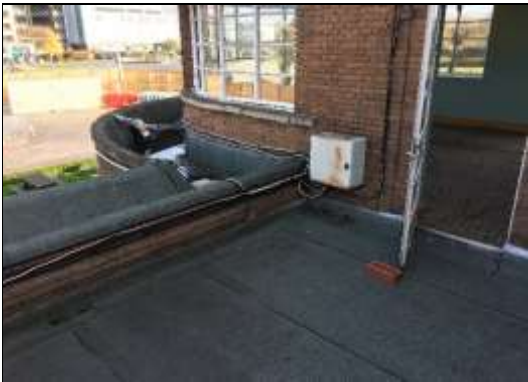
**Photograph No.14**

Roof 6 – curved section continued, north side has the parapet wall in place. Low door thresholds to both sides are only just above the roof level and display signs of ingress, consideration should be given to raising the door thresholds.

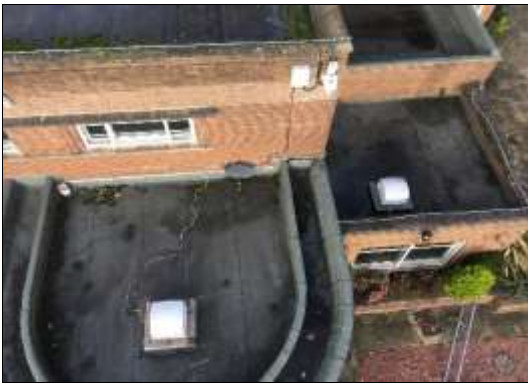
**Photograph No. 15**

Roof 8 – Internal parapet detail is still in place. Crazing and blisters have formed in the asphalt covering.

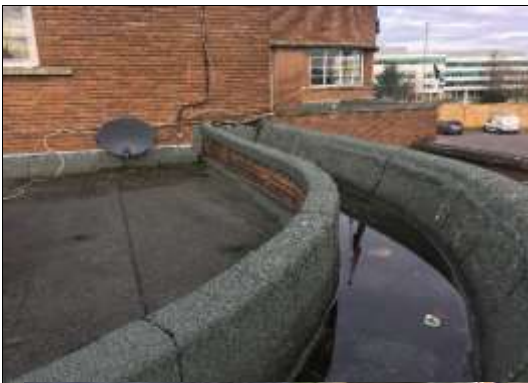
**Photograph No. 16**

Roof 8 - Large area of standing water to the perimeter section indicating issues with falls and drainage.

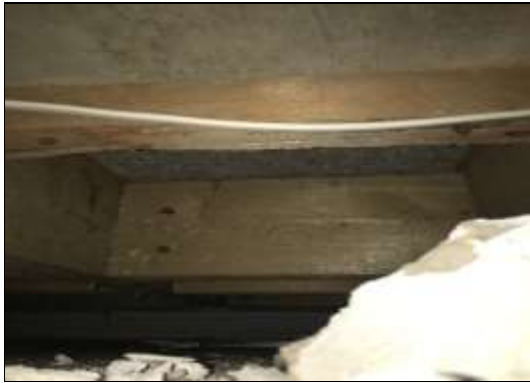
**Photograph No. 17**

Roof 9 – Felt covering visible from the ground and woodwool deck visible from beneath.

- We recommend overlaying the existing system and installing the Langley TA-20-W system including bituminous vapour barrier, flatboard insulation (to achieve the required U-value 0.18 W/<sup>2</sup>K) with underlay and mineral cap sheet.
- The roof does not have any thermal properties and it should be brought back up to current standards to comply with Building Regulations.
- Langley Paraflash flashing system should be installed to all perimeter upstands.
- All drip details should be formed of a welted drip or with lead.  
**Please note:** The contractor / MC should seek guidance on which detail is most suitable as the building is listed. The fascia will need to be adapted to account for the new raised roof level.

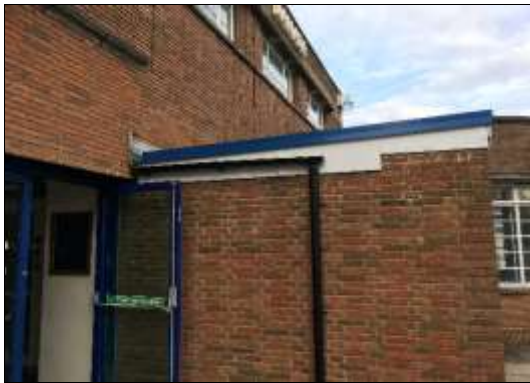
**Photograph No. 18**

Roof 9 – drains into an integral gutter which discharges into external rainwater goods.

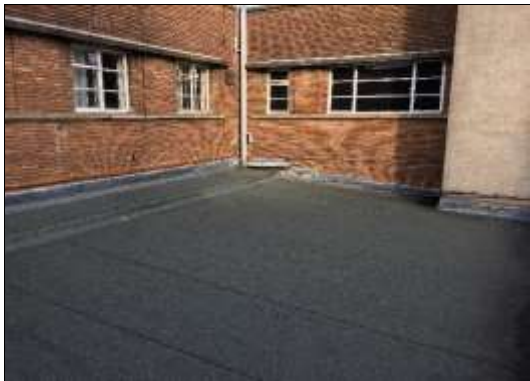
**Photograph No. 19**

Roof 10 – 3 layer insulated felt covering on a metal profile deck. Roofs appears to be in an adequate condition.

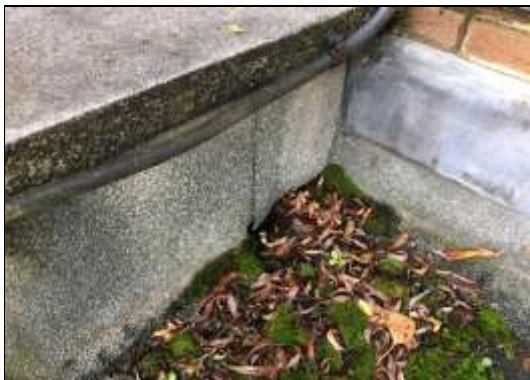
**Photograph No. 20**

Parapet wall to the edge with a chute which discharges onto roof 11. Detritus is blocking the outlet and preventing drainage.

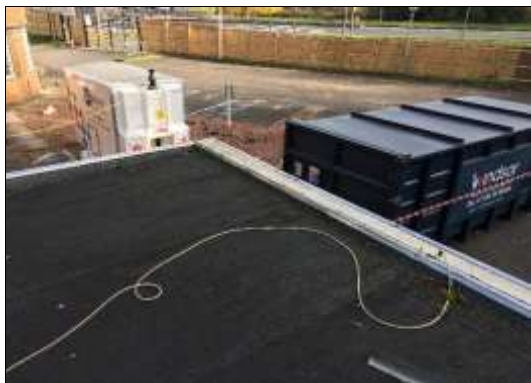
**Photograph No.21**

Roof 11 – Entrance canopy, 2 layer felt system on a plywood deck.

Covering appears to be adequate but the cladding is failing and requires attention.

- The existing roof covering is over and entrance canopy and appears to be in an adequate condition.
- The cladding to the perimeter has failed and requires attention.
- If the client wished to have all roofs under a Langley Guarantee then the roof should receive the Langley TA-20-C 2-layer system comprising of a bituminous underlay membrane and mineralised cap sheet.
