**Level and Crack Monitoring**

**Our Ref: 552624**

**Date of Issue: 10/10/2019**

Occupier:	<b>Removed for data protection purposes</b>
Address:	<b>10 Hook Lane</b>
Address:	
Town:	<b>Potters Bar</b>
County:	
Post Code:	<b>EN6 4DA</b>
Contact Name	<b>Removed for data protection purposes</b>

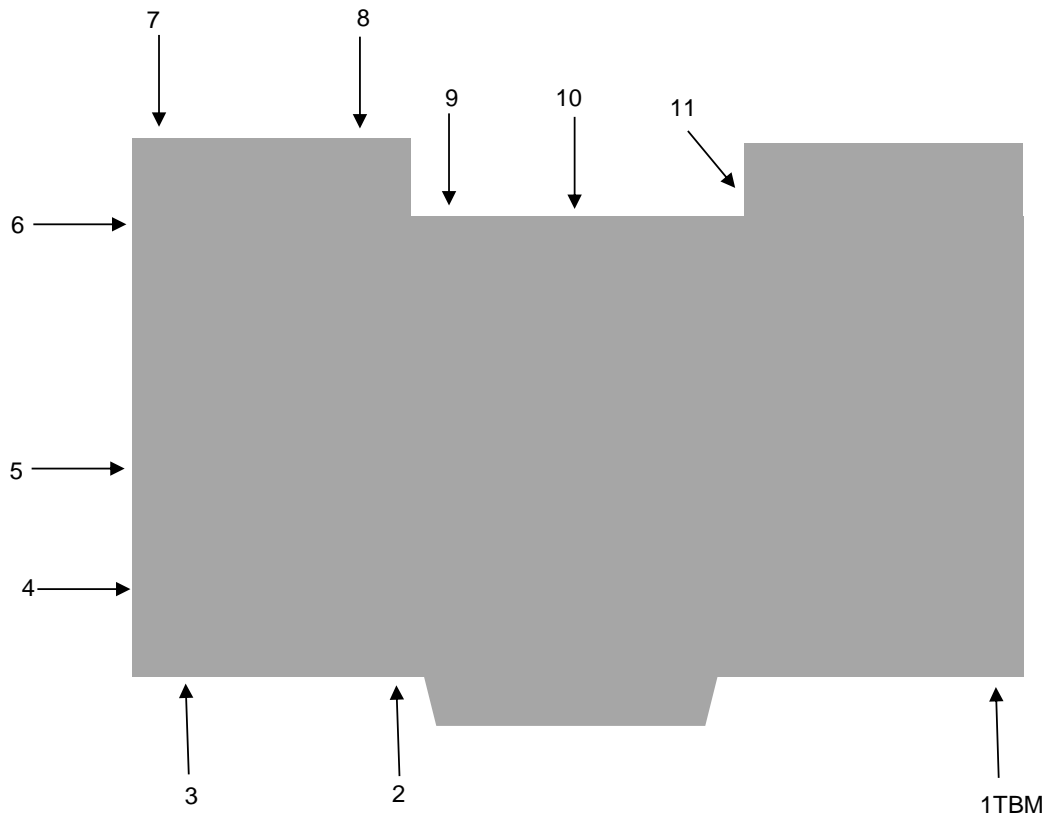
**Level and Crack Monitoring - Site Sketch**

1	INT office LHS of window
2	INT laundry room
3	EXT above front garage
4	EXT LHS where house meets extension
5	EXT LHS low level DPS level
6

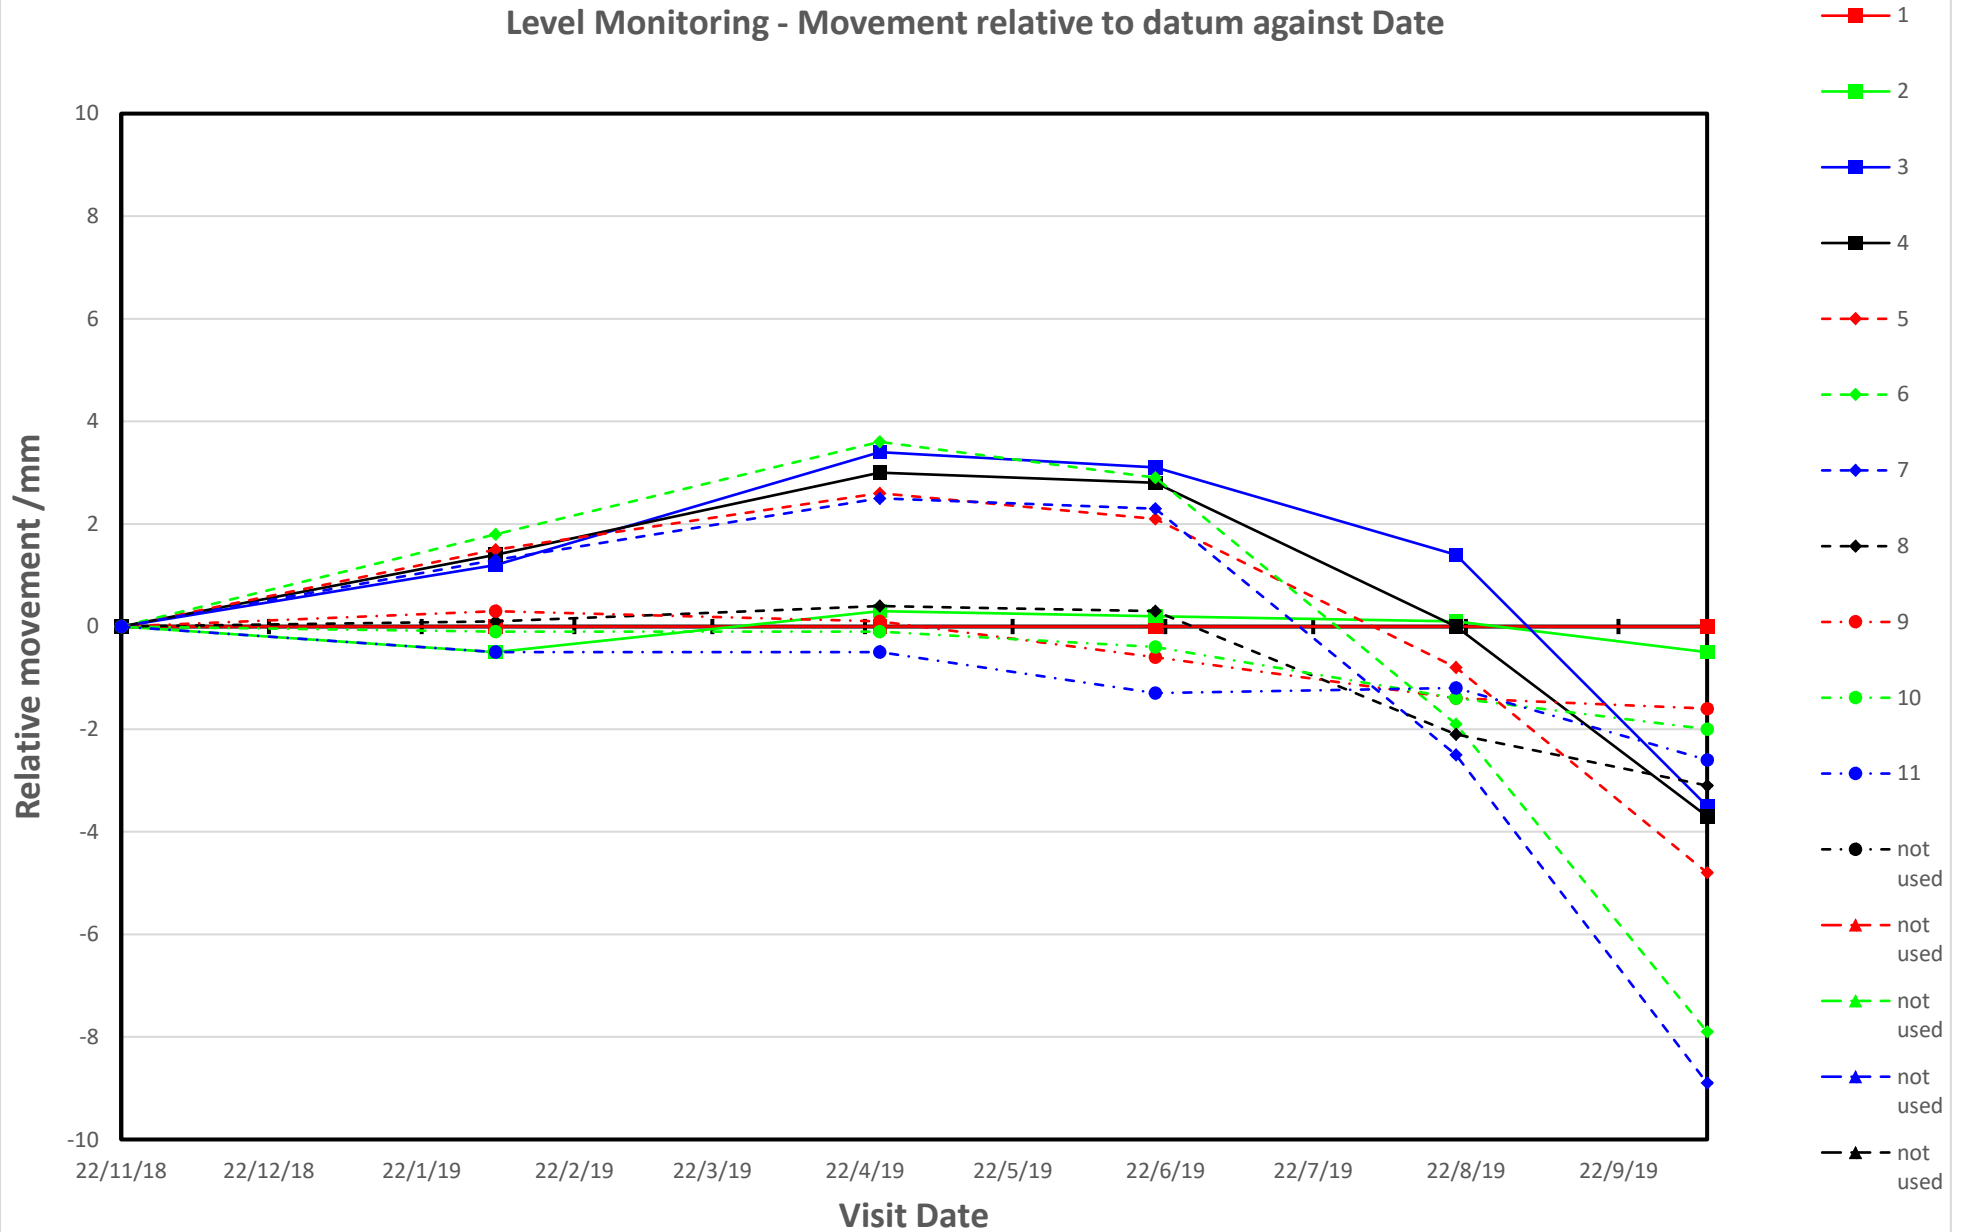
Level Monitoring - Movement relative to datum against Date

Reading Date	22/11/18	6/2/19	25/4/19	20/6/19	20/8/19	10/10/19						
Point / Reading	1	2	3	4	5	6	7	8	9	10	11	12
1	10.8355	10.8355	10.8355	10.8355	10.8355	10.8355						
2	10.9020	10.9015	10.9023	10.9022	10.9021	10.9015						
3	10.8805	10.8817	10.8839	10.8836	10.8819	10.8770						
4	10.9270	10.9284	10.9300	10.9298	10.9270	10.9233						
5	10.9993	11.0008	11.0019	11.0014	10.9985	10.9945						
6	10.9977	10.9995	11.0013	11.0006	10.9958	10.9898						
7	11.0159	11.0172	11.0184	11.0182	11.0134	11.0070						
8	11.0263	11.0264	11.0267	11.0266	11.0242	11.0232						
9	11.0608	11.0611	11.0609	11.0602	11.0594	11.0592						
10	11.1132	11.1131	11.1131	11.1128	11.1118	11.1112						
11	11.1268	11.1263	11.1263	11.1255	11.1256	11.1242						
not used												
not used												
not used												
not used												
not used												
Tech Initials	AH	AH	AH	JY/JH	JL	RB						
Level S/N.	520038	520038	520038	522936	522937	522939

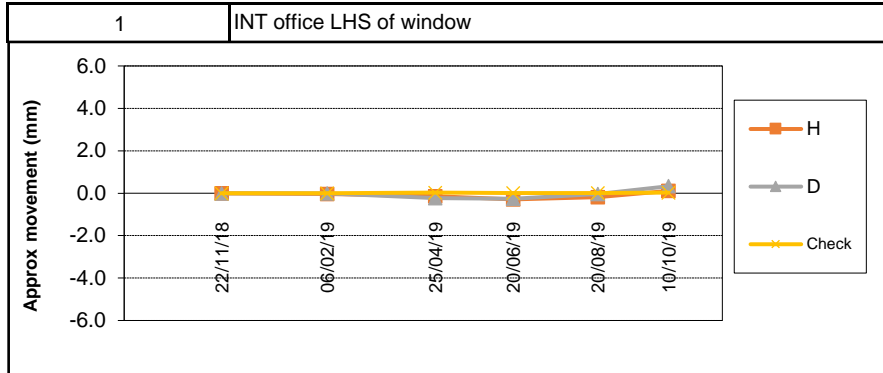
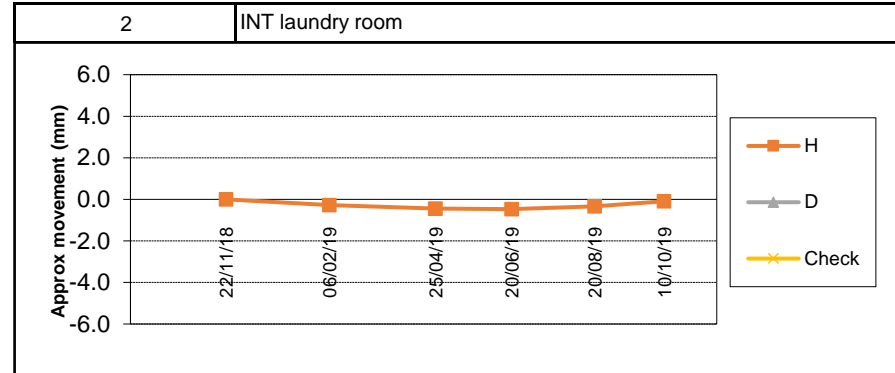
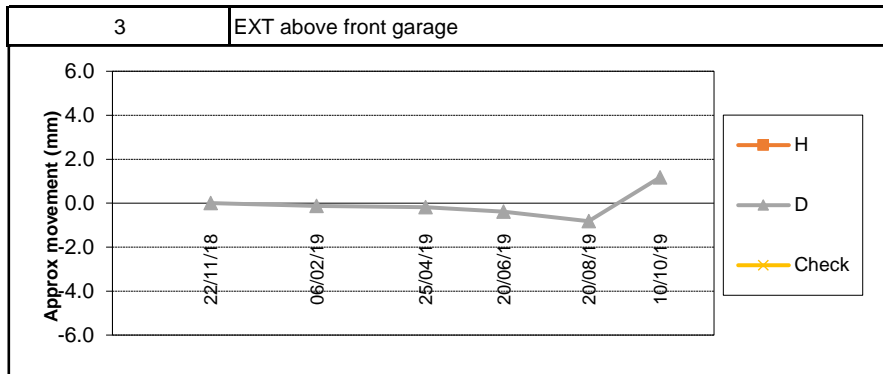
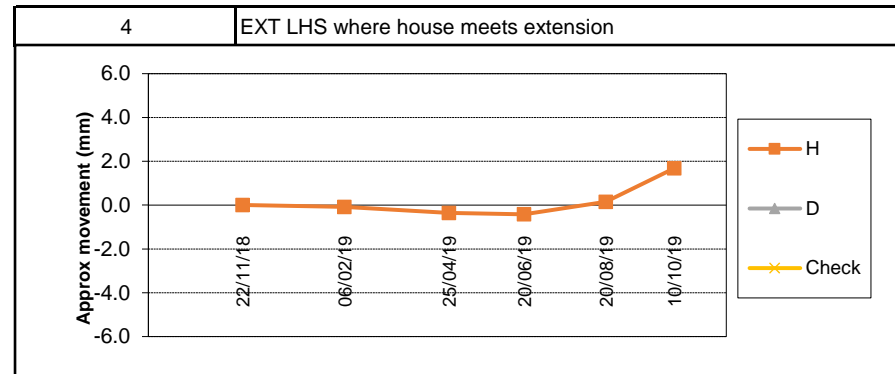
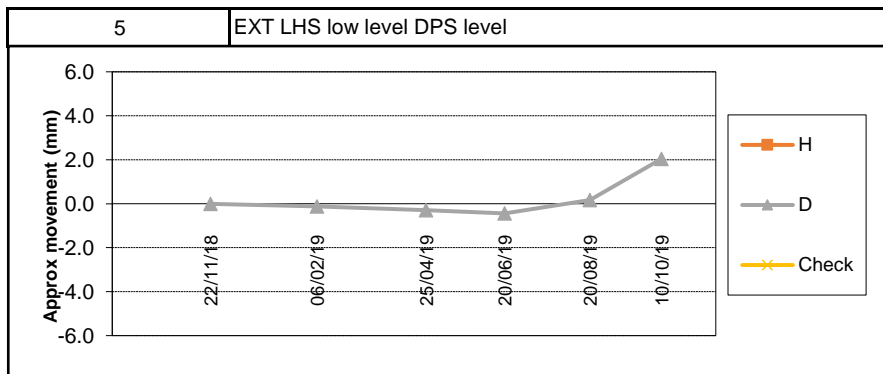
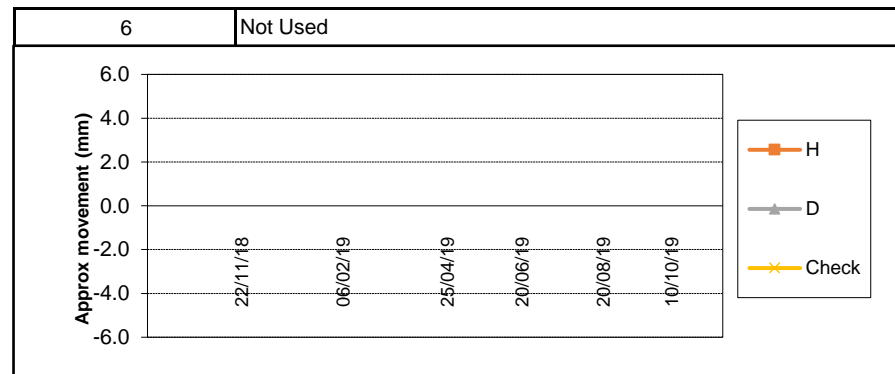
### Crack Monitoring - Movement Against Time

Studs nos.	Align-ment	Visit Date	22/11/18	Visit Date	06/02/19	Visit Date	25/04/19	Visit Date	20/06/19	Visit Date	20/08/19	Visit Date	10/10/19
		Reading	Current c/w	Reading	Current c/w	Reading	Current c/w	Reading	Current c/w	Reading	Current c/w	Reading	Current c/w
1	H	51.83	0.29	51.80	0.27	51.69	0.25	51.54	0.24	51.64	0.33	51.94	0.64
1	D	71.91	0.88	71.90	0.85	71.68	0.77	71.65	0.75	71.88	0.75	72.24	0.83
1	Check	84.50		84.50		84.53		84.51		84.51		84.53	
2	H	62.29	0.97	62.02	0.75	61.85	0.66	61.82	0.64	61.96	1.05	62.20	1.17
2	D												
2	Check												
3	H												
3	D	52.50	1.28	52.37	1.19	52.31	1.17	52.12	1.16	51.68	0.82	53.67	1.58
3	Check												
4	H	82.37	2.50	82.29	2.38	82.02	2.25	81.95	2.21	82.52	2.60	84.05	4.01
4	D												
4	Check												
5	H												
5	D	54.09	3.40	53.97	3.29	53.79	3.20	53.65	3.14	54.26	3.87	56.13	4.14
5	Check												
6	H												
6	D												
6	Check
