**NORTHAW PLACE, COOPERS LANE, NORTHAW,  
POTTERS BAR, EN6 4NQ**

**BS5837 TREE SURVEY, ARBORICULTURAL IMPACT ASSESSMENT  
AND METHOD STATEMENT**

**Elizabeth Greenwood CMLI FArborA**  
[ms.ejgreenwood@gmail.com](mailto:ms.ejgreenwood@gmail.com)  
November 2014

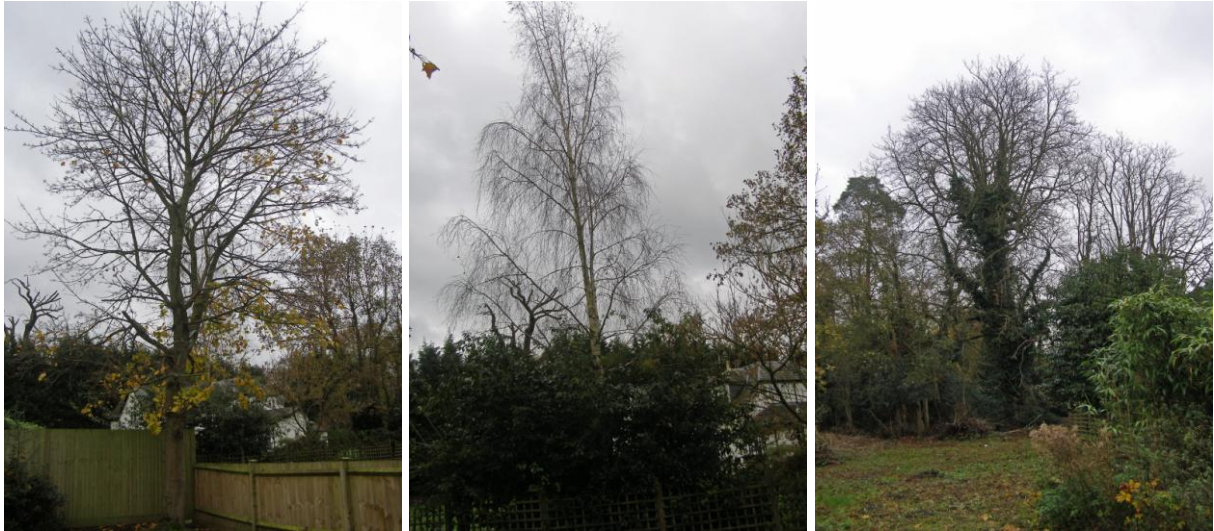
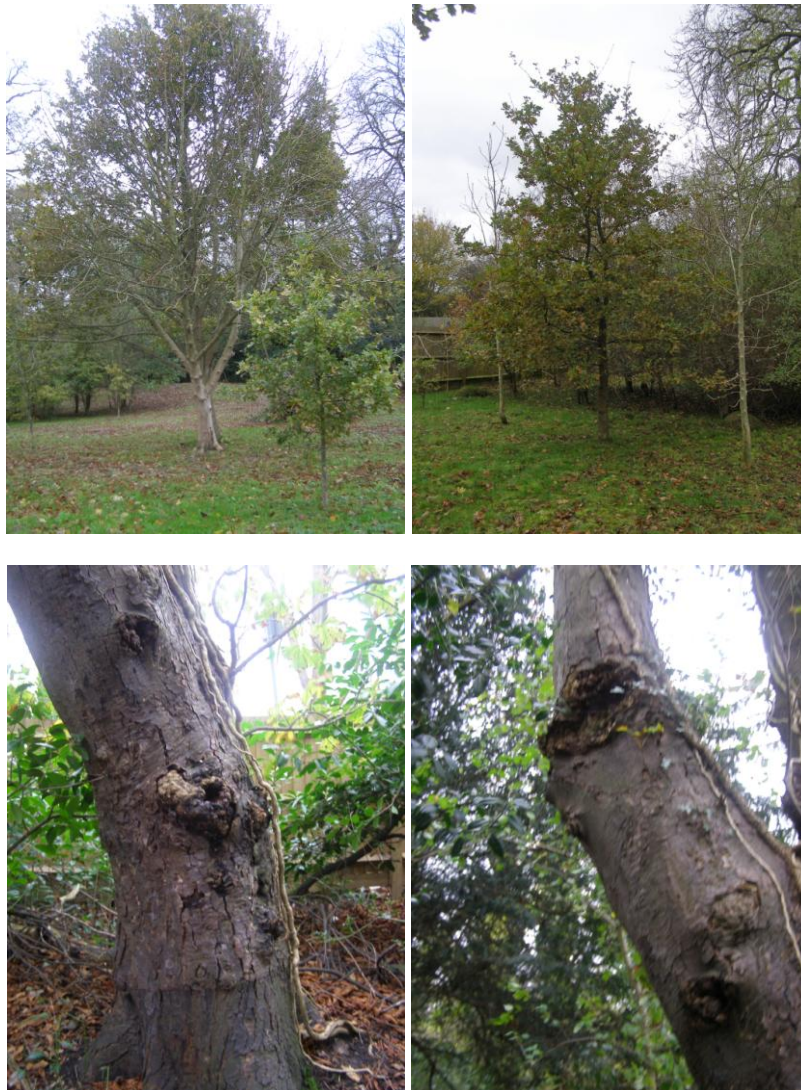
- 2.3.2 Of these trees, two are classified as potentially defective; the red horse chestnut (T16) has severe canker partially girdling the stem; and the tree within the Lodge (T18), has a fungal pathogen at the base rendering it potentially unstable. Both trees should be removed. The other horse chestnuts are classified as of C2 quality, with limited prognoses, some specified tree surgery to address health and safety.

**Above left-** the Norway maple (T1) within the corner of the garden. **Above centre-** the mature birch (T2) within the grounds of The Lodge. **Above-** the band of tree along Cooper Lane with the horse chestnut (T17) prominent in the foreground. **Below** - immature ash and oaks within the edge of the site.( T3, T4 & T5). **Bottom** - girdling canker on the horse Chestnut (T16)

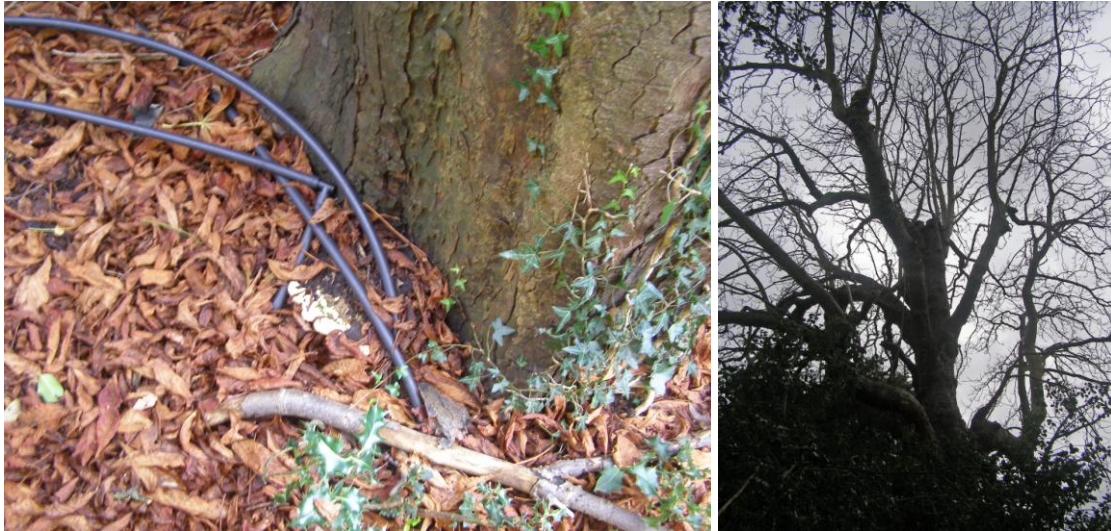
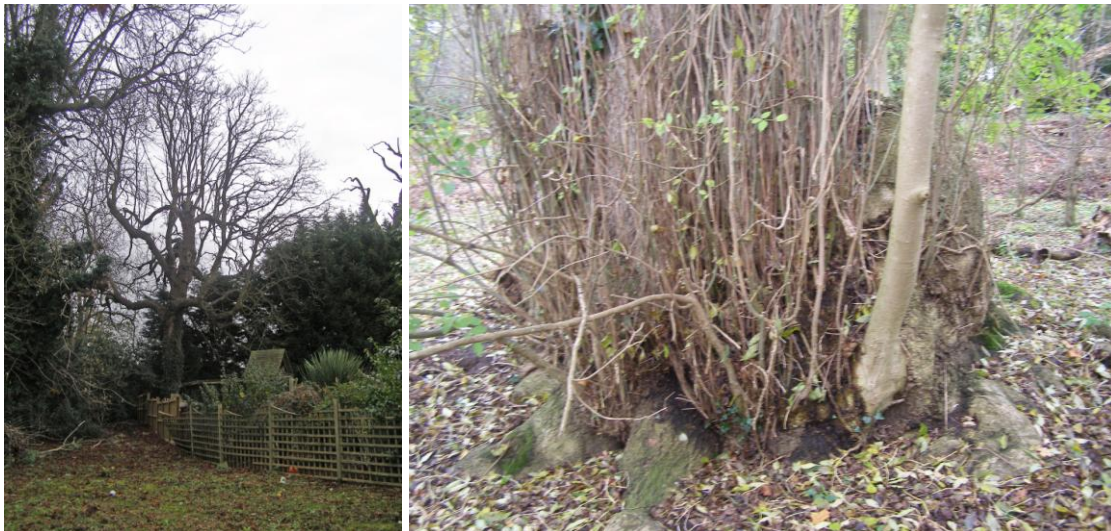
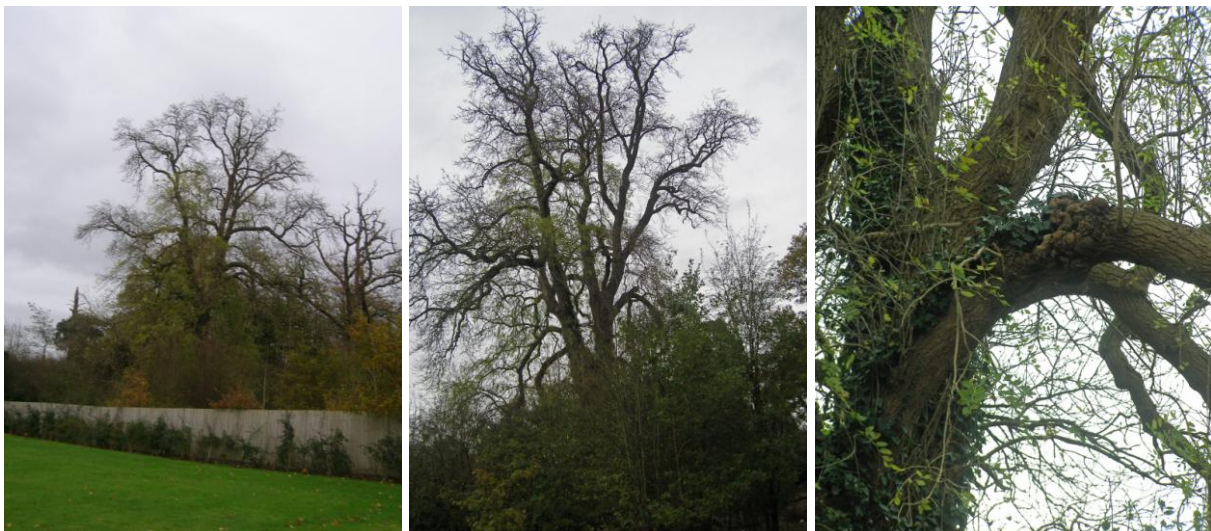
3.2.3 It is noted that the Horse chestnut T18 is of poor quality severely decayed and a potential hazard. It should be removed; however if may not be under the client's ownership: if retained tree protection measures are shown on the tree protection plan

Above and below left- a fungal pathogen and defective crown structure of the horse chestnut (T18). **Below right**- the basal growth and raised buttress of the ash (T42). **Bottom left & centre**- from afar the crown of the ash appears healthy. **Bottom right**- the cavity and the lowest lateral of the ash.

T48	Hornbeam	C2	Poor form- coppice
T18	Horse chestnut	U	Outside the clients ownership- potentially a hazardous tree- REMOVE with permission ( or tree surgery to make safe)

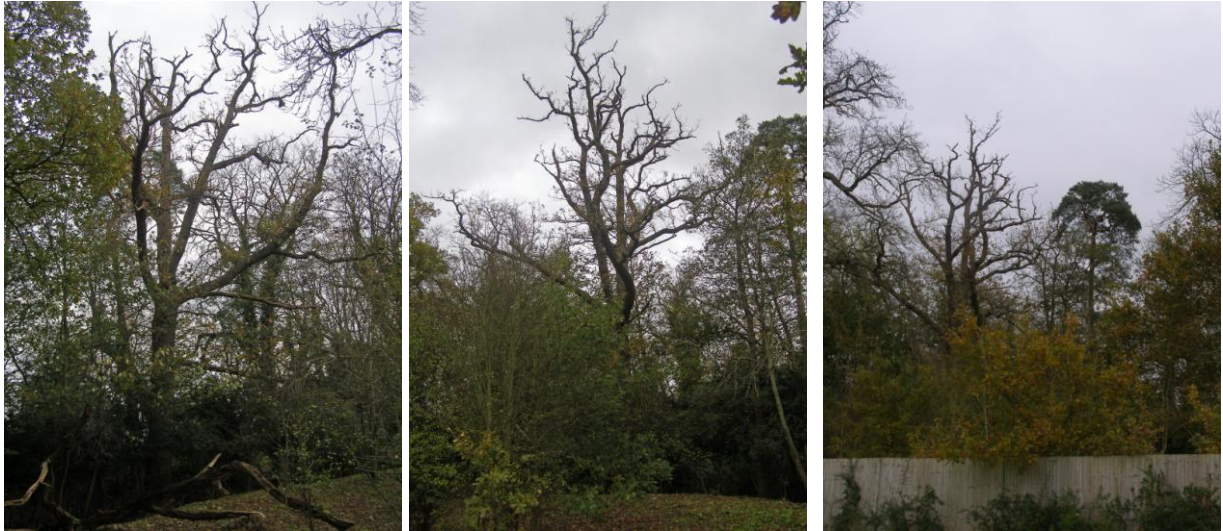
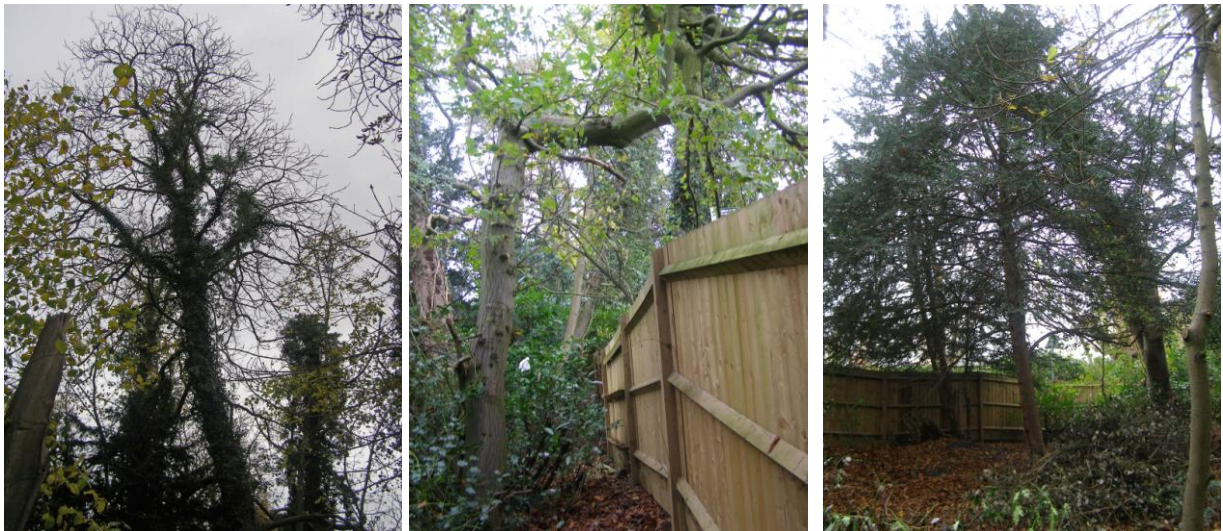
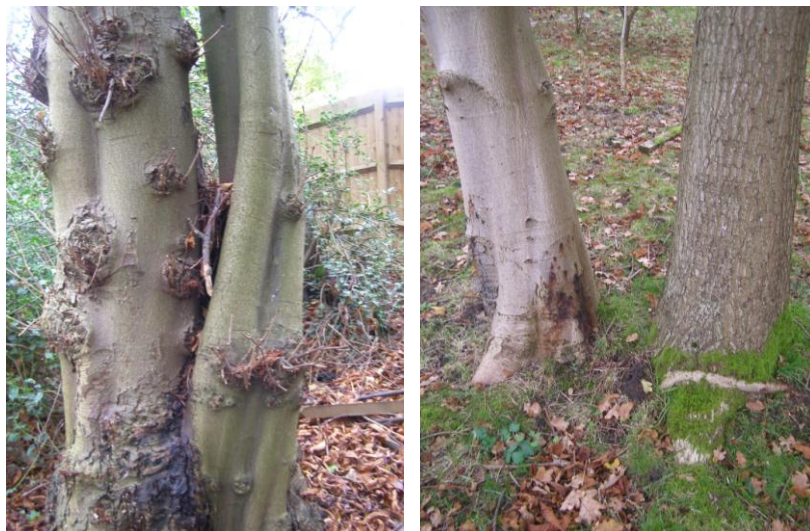
**Above** - the dead oak (T43) with good quality pine (T44) **Below left** - the leaning trunk of Horse chestnut (50). **Bellow centre-** the poorly formed hornbeam (T49). **Below right-** yews and hollies within the woodland. Bottom left -the tight fork of the twin stemmed horse chestnut (T46). **Bottom right-** the weeping buttress of the horse chestnut (T6 and oak (T7)

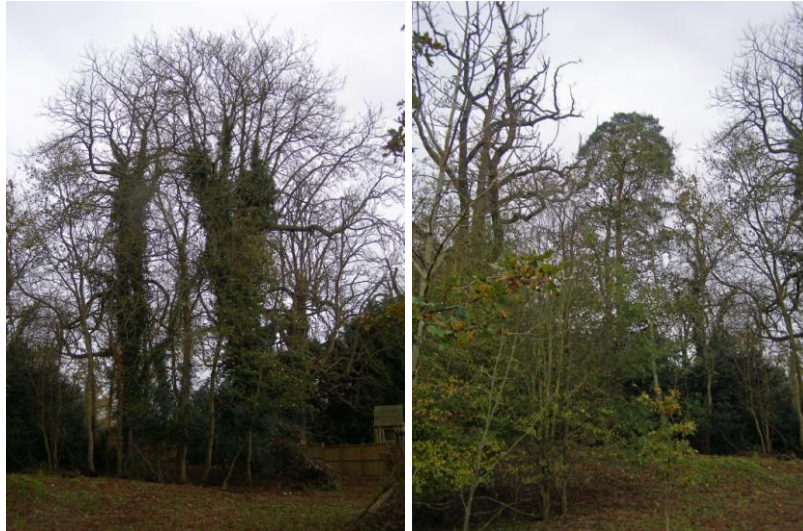
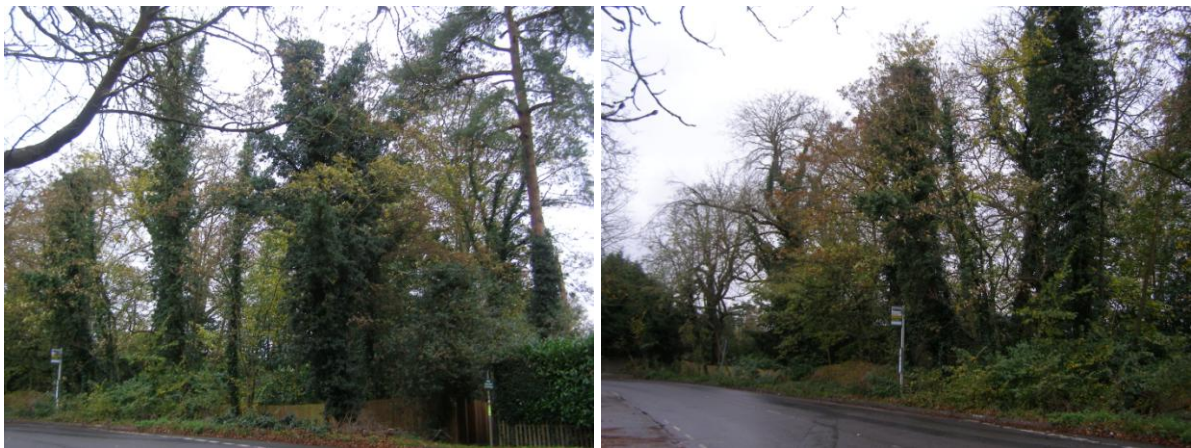
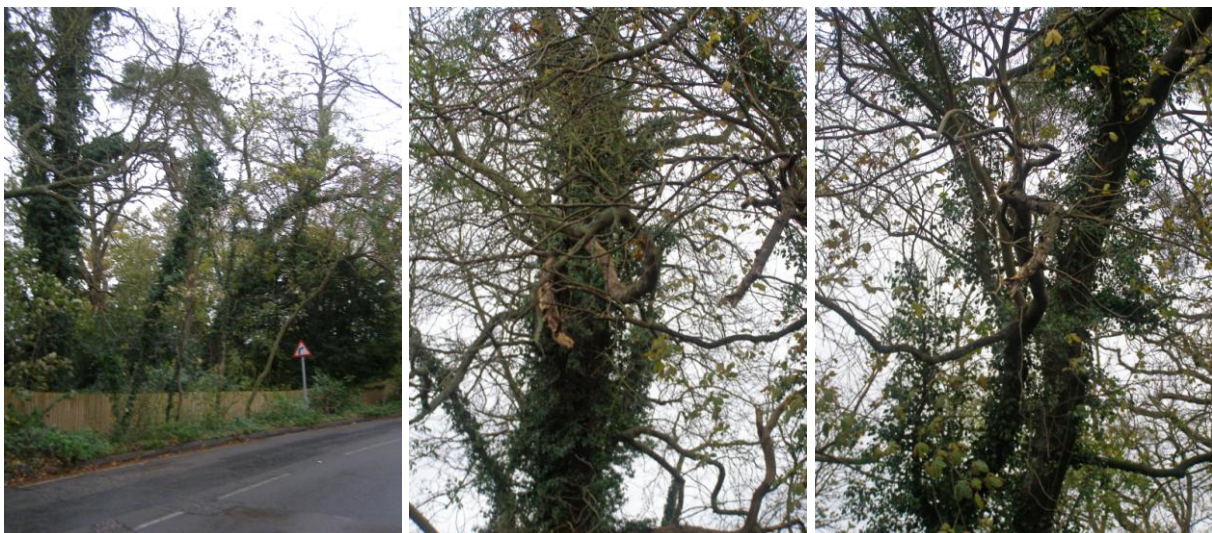
**Top left** - prolific ivy of the horse chestnut (T17 and T19) **Top right**- Immature trees, the dead oak (T43) and pine(T44). **Above and below left**- the two groups of trees (G1 and G2) both ivy covered sycamores growing along the road verge outside the site. Bottom centre and right- deadwood and storm damage limbs from horse chestnut tree (T17 and T18) overhanging Coopers Lane.- a potential hazard
