# ARBORICULTURAL ASSESSMENT REPORT

<b>For:</b>	<b>Client:</b>	Sedgwick International UK
	<b>Insurer:</b>	Axa Insurance
<b>Site:</b>	<b>Policyholder:</b>	Mr Wadmore
	<b>Risk Address:</b>	10 Hook Lane, Northaw, Potters Bar, Hertfordshire, EN6 4DA
<b>Refs:</b>	<b>PRI Ref:</b>	118020
	<b>Client Ref:</b>	6873723
	<b>Insurer Ref:</b>	12125047A

<b>Arborist Name:</b>	Sarah MacKinnon	<b>Date:</b>	07/12/2018
<b>QC</b>	Margaret MacQueen	<b>Date</b>	20/12/2018

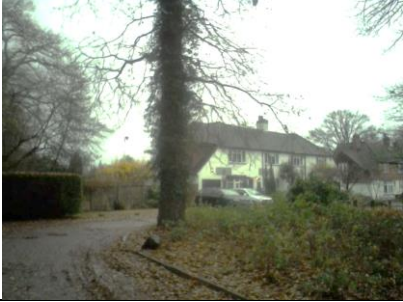
Tree No	Common Name	Age Class	Condition	Height (m)	Crown Spread (m)	Stem diam. (mm)	Dist to bidg. (m)	Roots Implicated	Pruning history	Recommendation	Tree work constraints	Notes	Owner address	Owner
T1	Oak (English)	Mature	Fair	19	14	910	16.9	N	No significant past tree works.	No work required.		Preliminary recommendation pending Site Investigation/Engineers Report/monitoring data. If level monitoring confirms movement down to front and Oak roots later found at front, then consider for removal.	Welwyn Hatfield District Council	LA
T2	Oak (English)	Mature	Fair	21	14	920	22.0	N	No significant past tree works.	No work required.		Ivy clad stem and crown. Situated on edge of ditch, near side to Policy holder's property but 6.5m beyond Policy holders' fence.	District land registry search required	UKN

<p>T1 - Oak (English)</p>	<p>Location of trees to LHS PH property, between PH fence and roadside ditch</p>

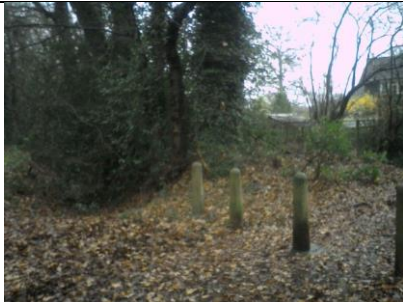
<p>Location of trees to LHS PH property, between PH fence and mainly within boundary of roadside ditch</p>	<p>T2 - Oak (English)</p>

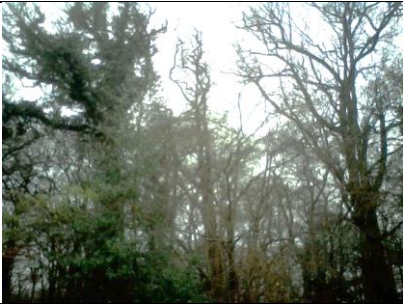
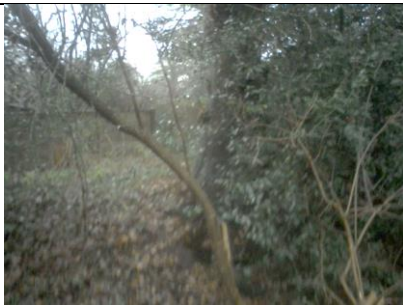
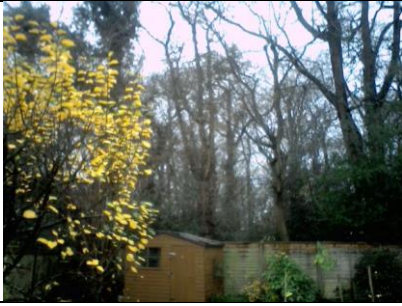
Tree No	Common Name	Age Class	Condition	Height (m)	Crown Spread (m)	Stem diam. (mm)	Dist to bldg. (m)	Roots Implicated	Pruning history	Recommendation	Tree work constraints	Notes	Owner address	Owner
T3	Oak (English)	Mature	Fair	20	14	580	24	N	No significant past tree works.	No work required.		Situated on edge of ditch, near side to Policy holder's property but 7m beyond Policy holders' fence.	Welwyn Hatfield District Council	LA
T4	Oak (English)	Mature	Fair	28	22	1100*	17	N	No significant past tree works.	Fell and treat stump.		Situated on edge of ditch, near side to Policy holder's property but est. 6m beyond Policy holders' fence.	District land registry search required	UKN
T5	Oak (English)	Mature	Fair	25.5	20	1000*	18	N	No significant past tree works.	Fell and treat stump.		Situated on edge of ditch, near side to Policy holder's property but 1.7m beyond Policy holders fence.	District land registry search required	UKN

<p>T3 - Oak (English)</p>	<p>T4 - Oak (English)</p>

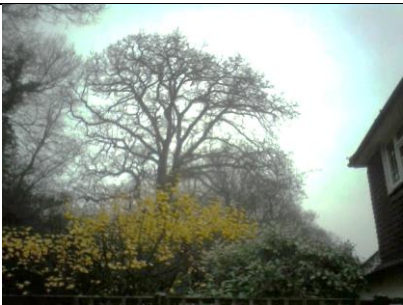
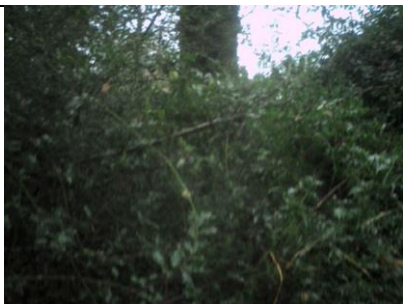
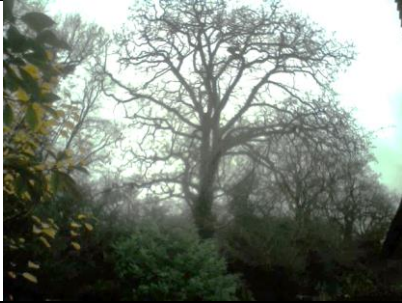
<p>T5 - Oak (English)</p>	<p>T3 - Oak (English)</p>

Tree No:	Species	Works Required
T4	Oak (English)	Fell and treat stump.
T5	Oak (English)	Fell and treat stump.

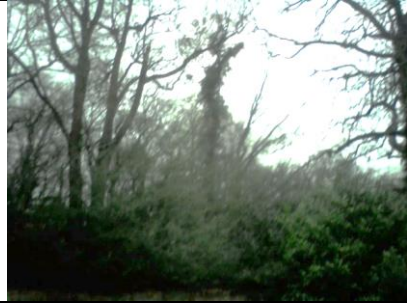
T6	Oak (English)	Mature	Fair	21	14	590	22.0	N	No significant past tree works.	No work required.		Ivy clad stem. Situated on far edge of ditch.	District land registry search required	UKN
T7	Oak (English)	Mature	Fair	17	18*	700*	17	N	No significant past tree works.	No work required.			9 Hook Lane, Northaw, Potters Bar, EN6 4DA	P3P

T6 - Oak (English)

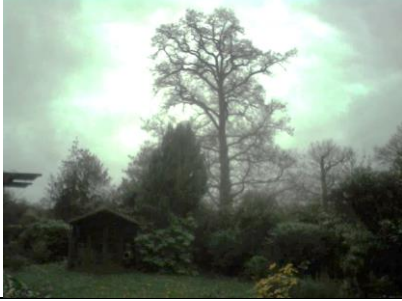
T7 - Oak (English)
