# BS5837:2012

## Tree Survey

London Lodge  
Bedwell Park, Essendon  
Herts, AL9 6HY

Report reference: TGA.2552.TreeSurvey

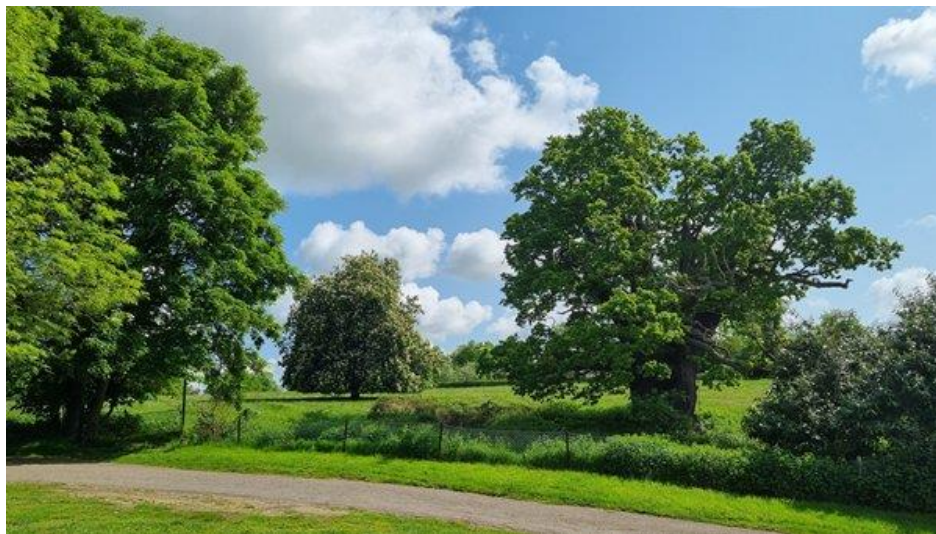
**T2 Sycamore (left) T1 oak (right)**

No.	Species	Ht (crown)	Dia (stems)	Crown spread (NESW)	Life stage	ERC	Comments & preliminary recommendations	BS Cat
T1	Quercus robur (Common Oak)	12(1)	2490(1)	6, 6, 6, 6	V	40+	High individual quality and landscape value. Veteran tree. Hollow trunk. Cracks splits and hollows. Great age and size. Attached major deadwood present.	A2
T2	Acer pseudoplatanus (Sycamore)	13(1)	350 340 330 100(4)	5, 5, 5, 5	M	40+	Multi stem from ground level. Landscape value as part of boundary screening. Ivy on main stem.	B2
T3	Ilex aquifolium (Holly)	10(0)	240 260 230(3)	3, 3, 3, 3	M	40+	Landscape value as part of boundary screening. Ivy on main stem. Triple stem.	C2
T4	Ilex aquifolium (Holly)	10(0)	180(1)	3, 3, 3, 3	EM	20+	Low individual quality but landscape value as part of boundary screening.	C2
T5	Acer campestre (Field Maple)	10(0)	250 260 200 150(4)	7, 7, 2, 2	M	40+	Multi stem from ground level. Unbalanced crown shape.	B2

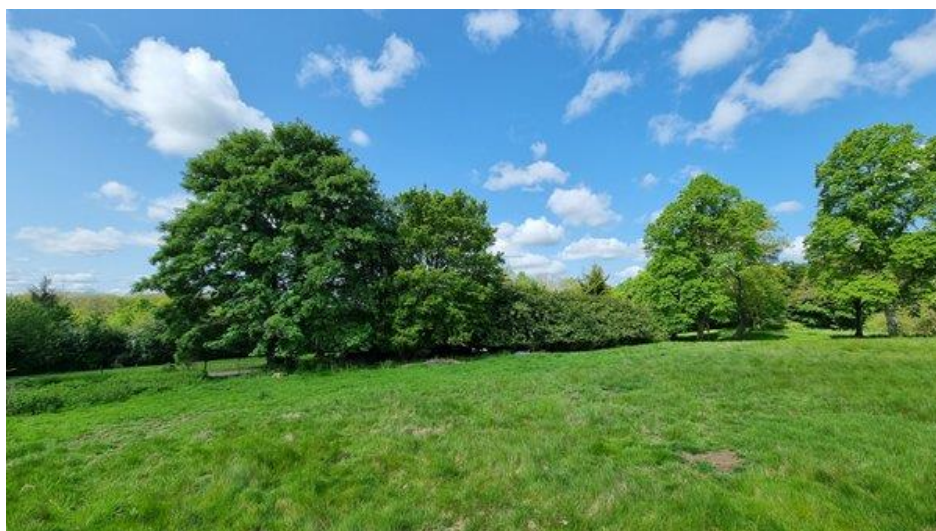
**View of site from north T2, T5, G7, T19 & T20 (left-right)**

T19	Tilia X europaea (Common Lime)	20(3)	640(1)	6, 6, 6, 6	M	40+	No visible significant defects. High individual quality and landscape value.	A2
T20	Tilia cordata (Small-leaved Lime)	18(3)	520(1)	6, 6, 6, 6	M	40+	No visible significant defects. High individual quality and landscape value.	A2

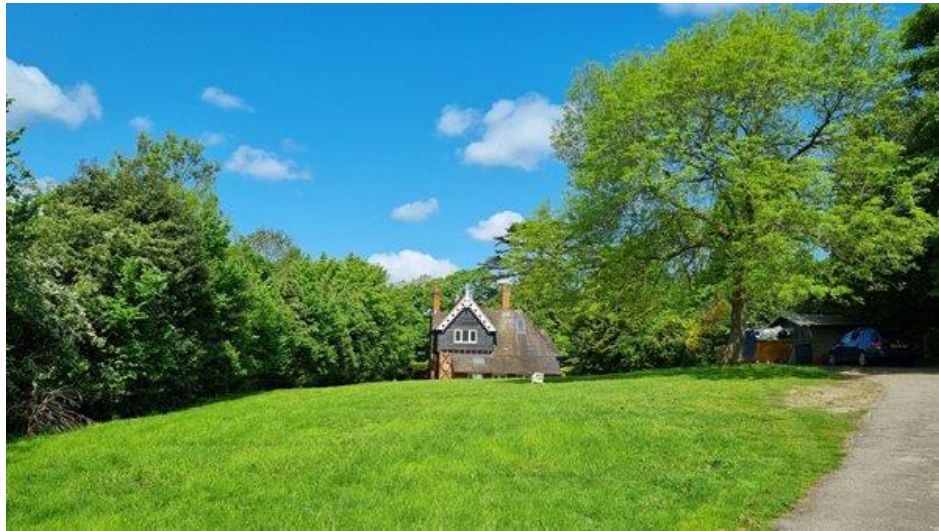
- 3.4. T6 is a common ash tree located on the site interior. This tree has little landscape value as it is not notably visible from the outside of the site, and therefore of low category in terms of constraint. Ash dieback disease is visibly present within trees on site within the G15 group, and therefore T6 will also have a limited life expectancy due to the impact of the disease.

**Rear garden area at south of site G15 left, T6 right**

T6	Fraxinus excelsior (Ash)	13(5)	490(1)	5, 7, 7.5, 7.5	M	10+	Limited life expectancy due to Ash dieback disease. Sparse crown. Major deadwood in crown. Low landscape significance on interior of site.	C1

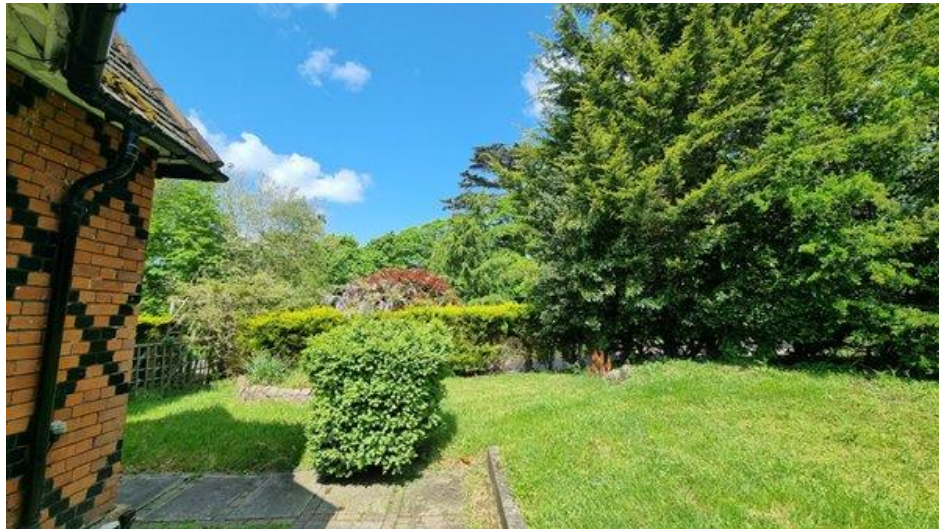
- 3.3. The site is bounded by post and chain link fence, though this is incomplete in places. There are dense hedges on the boundaries, comprising mainly laurel on the boundary with Cucumber Lane, and to the northeast. There are formal hedges at the front (north) of the house. These are mainly C category as individual trees but have landscape value as screening.

**Front garden area G12, T8 – 11 right**

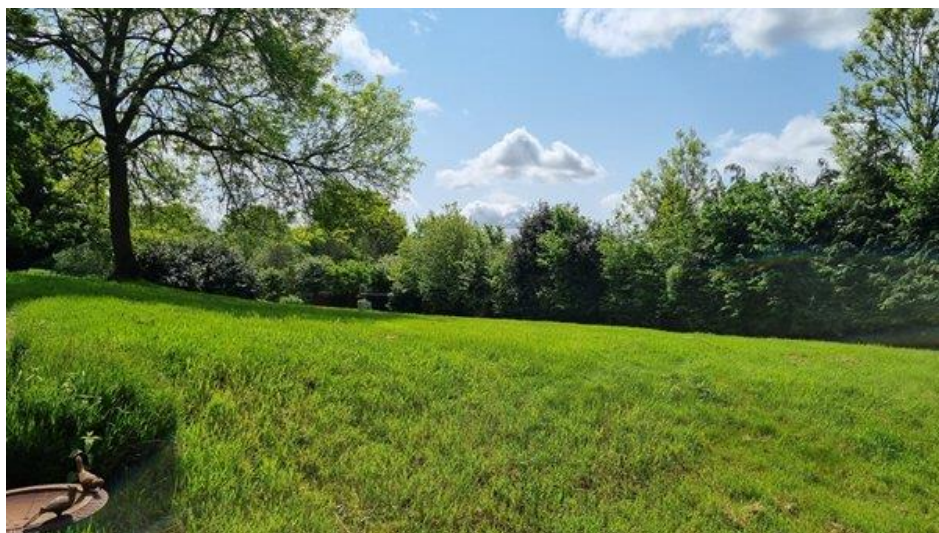
**Rear garden area T6 left, G16 right**
