Phase I DESK TOP STUDY REPORT

**Northaw House,
Cuffley
Potters Bar
EN6 4PS**

**May 2018
Report No. 14736**

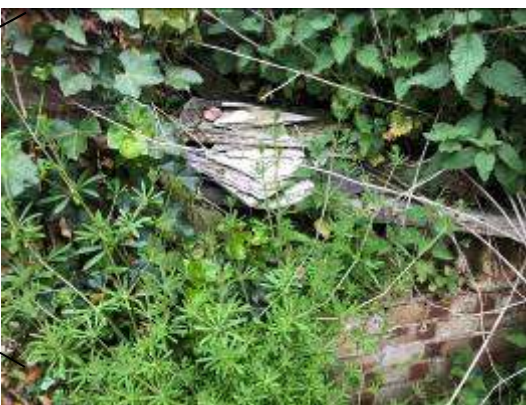
Asbestos containing materials were reviewed on site from our walk over inspection. These were recorded within the complex of buildings and from our visual observations at the time of the walk over formed corrugated sheeting on the animal pens to the west, which has broken in place and fragments were seen in place on the surface around these buildings; also within the area of the dilapidated stables to the east, building debris is in place, with potential asbestos containing fiber board present. We recommend that an asbestos survey of the buildings be carried out, if not done so already, prior to any demolished or works on site; A full Asbestos survey will be required in order to fully consider Asbestos within the developed area of the site, and along any driveways.

Print 7	View of the former stables to the east of the main building	Print 8	Potential Asbestos fibreboard to the south of the out building within the north east of the developed complex

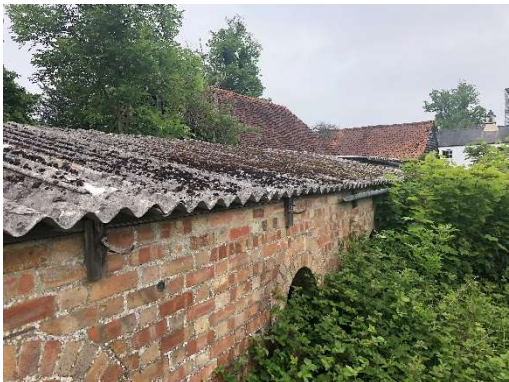
Print 23	Asbestos roof on Animal Pens	Print 24	View of outbuilding
