## Findings of the Arboricultural Assessment - Arboricultural Development Statement

## Northaw House, Cuffley

On behalf of LW Developments Ltd

January 2018

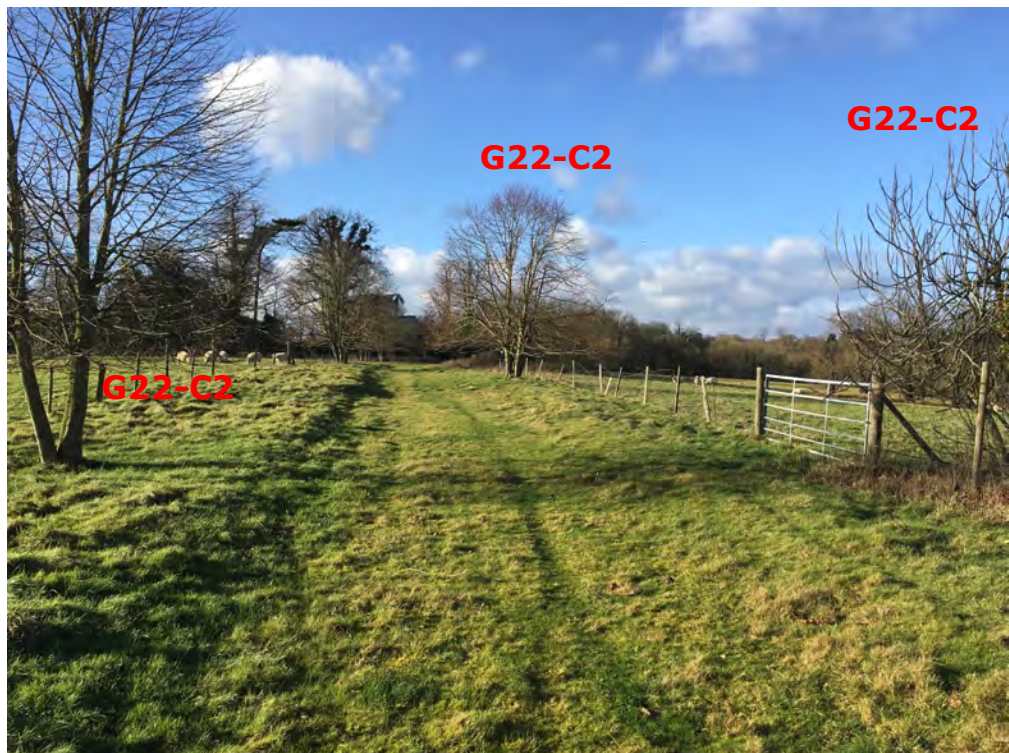
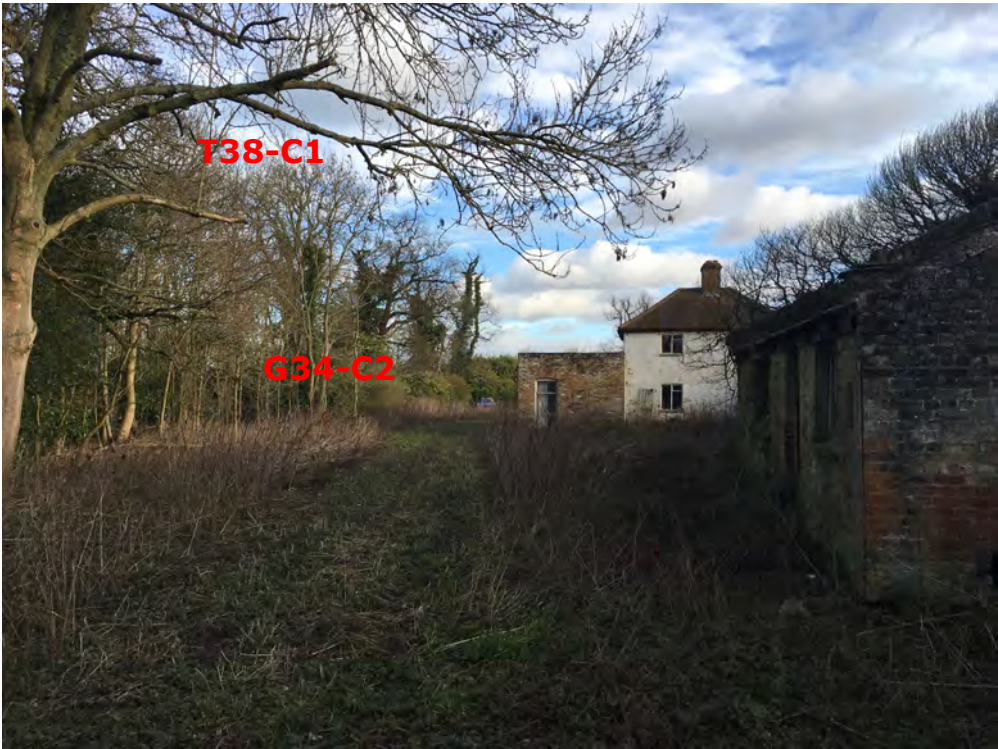
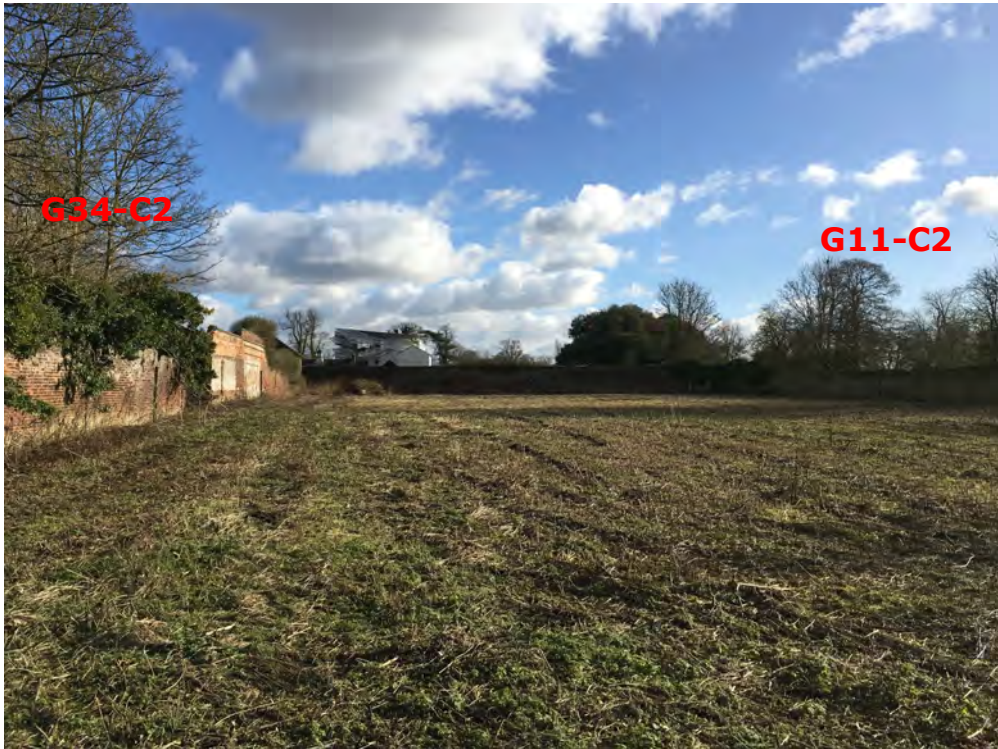
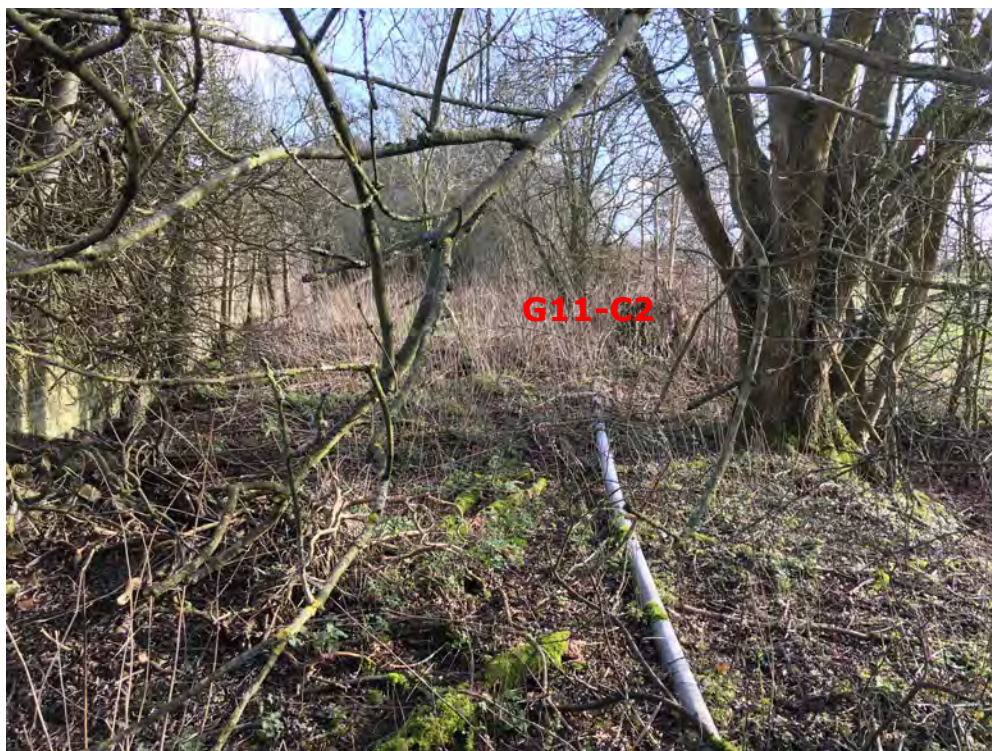
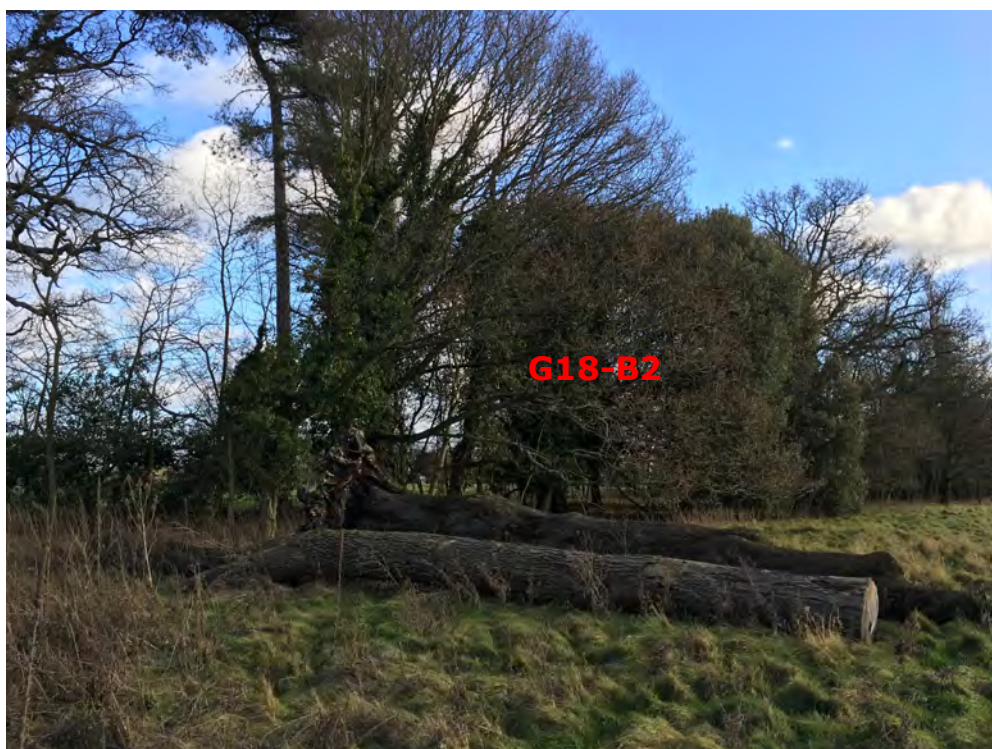
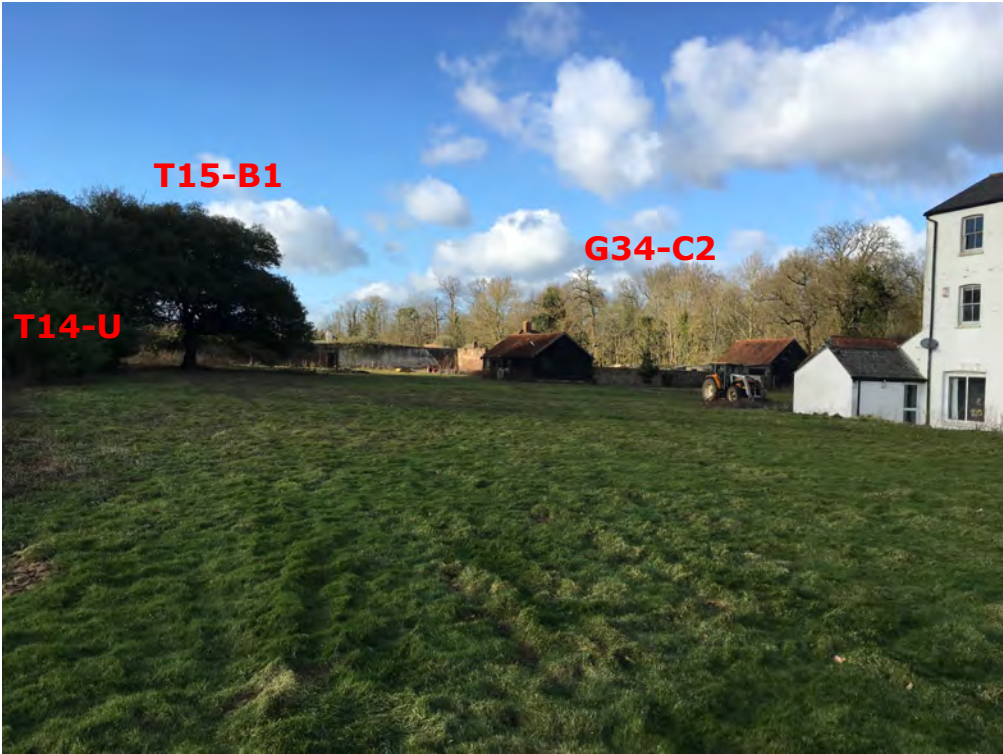
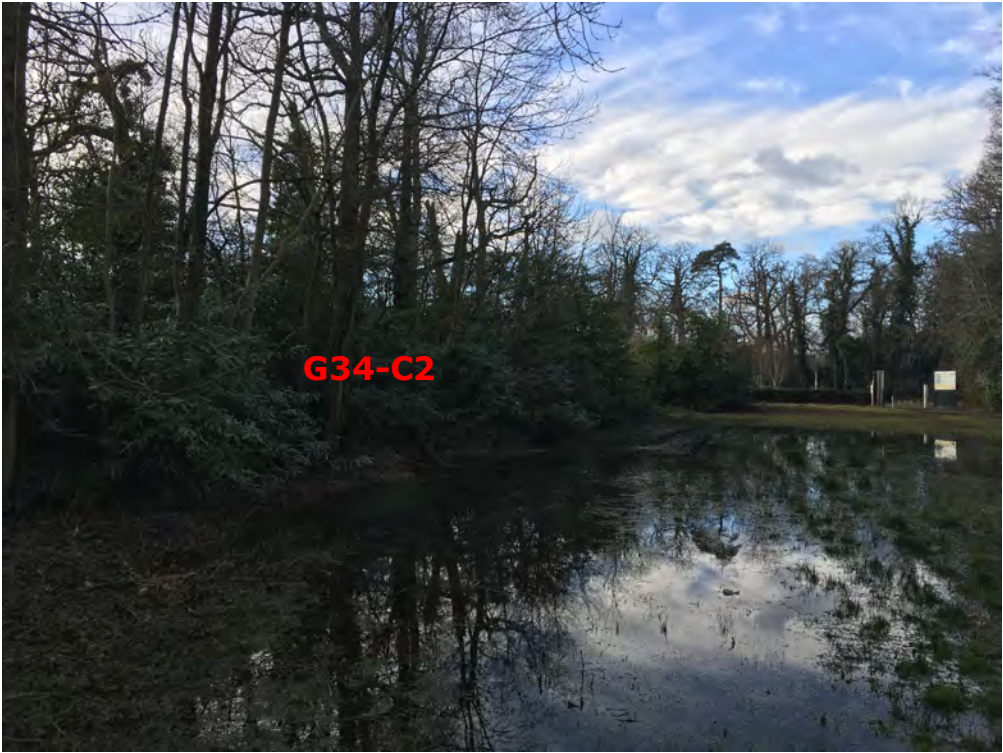
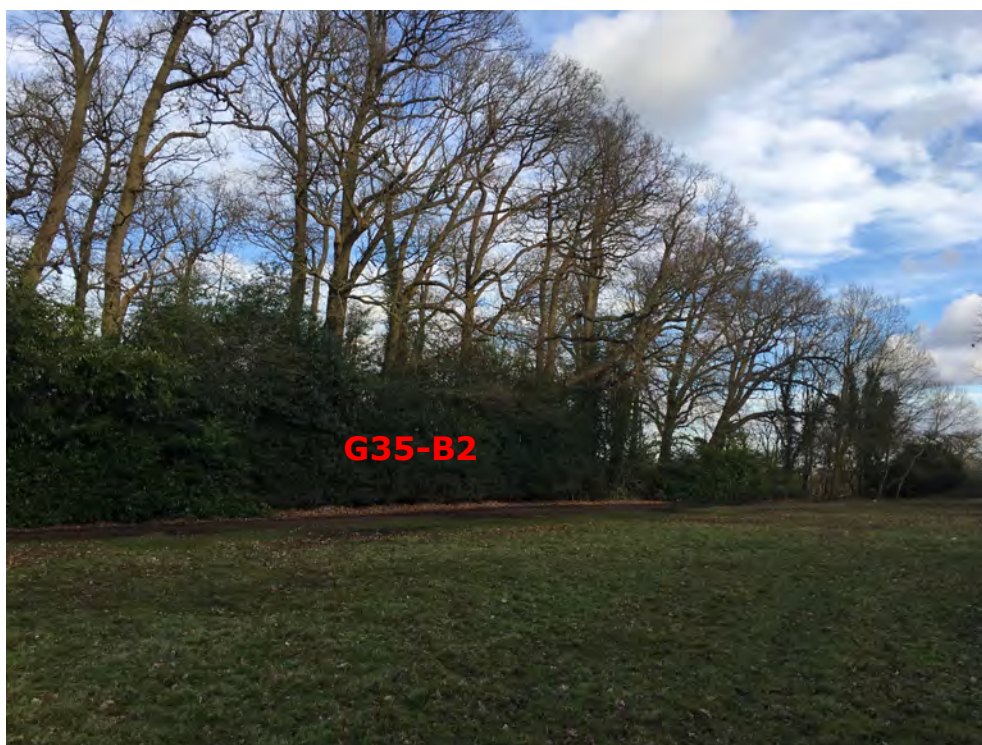
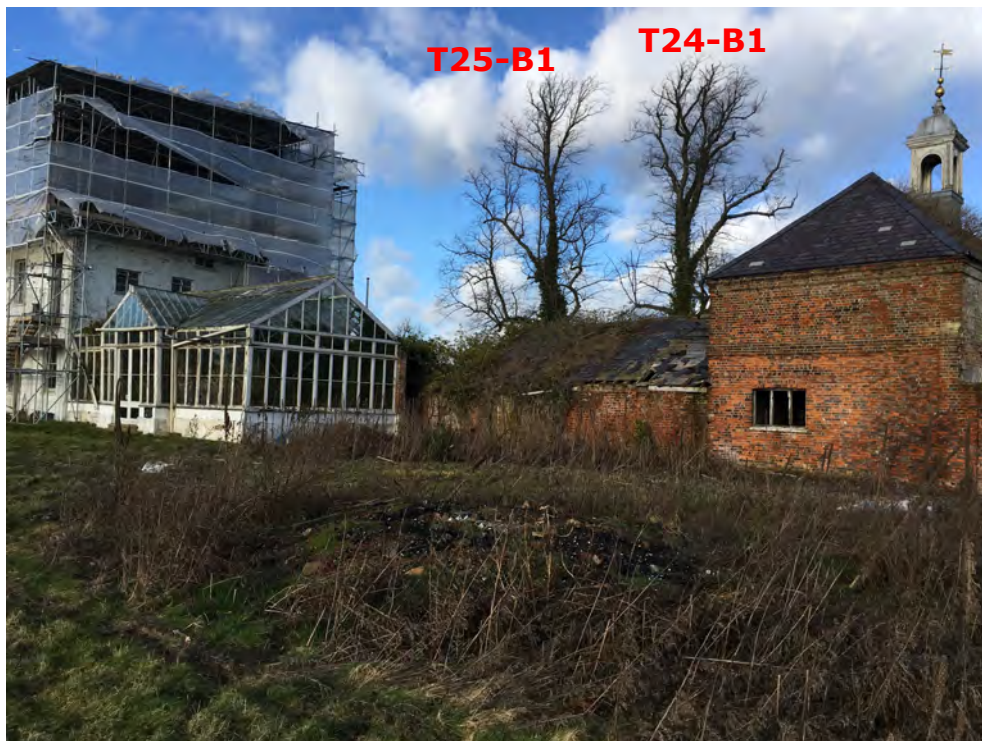
2.8 Selected photographs of the site are shown below:
