MSCP Welwyn Garden City

**Proposed Surface Water Drainage Technical Note
and Maintenance Regime**

Document №: BWG-AKSW-XX-XX-RP-C-0001

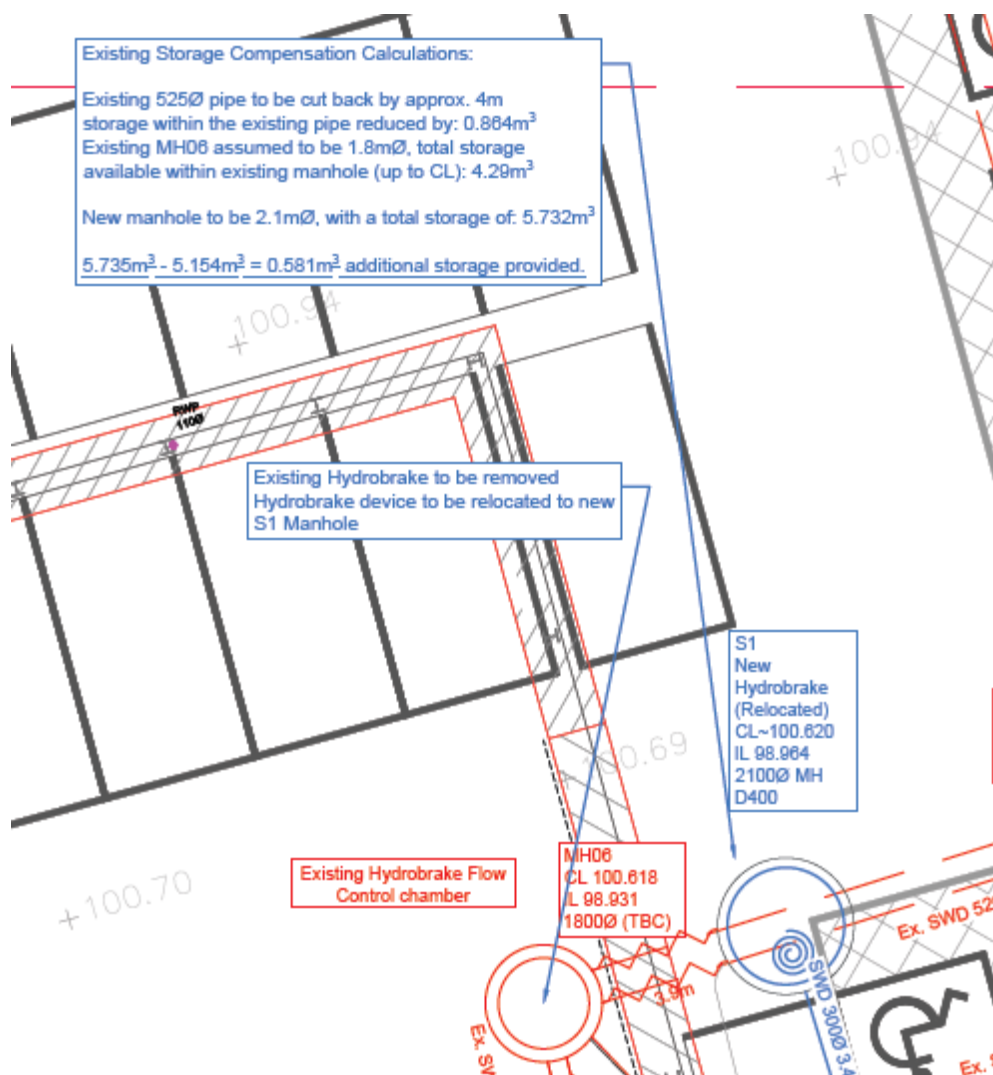
Figure 2: Proposed Drainage (drg. 9101) extract – Area 1

An extract of the proposed diversion works is attached below. An existing attenuation storage tank has been calculated and an oversized manhole provided to contribute to the attenuation storage loss.

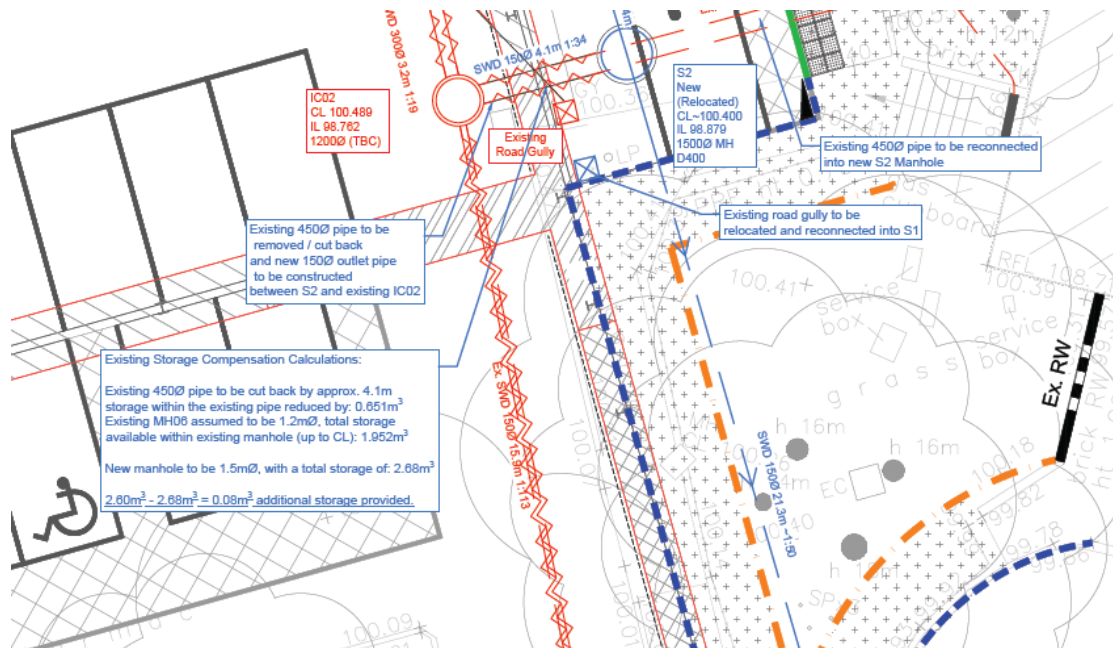
Figure 3: Proposed Drainage (drg. 9101) extract – Area 2

It is proposed that the existing 1.2m diameter PCC ring is replaced with 1.5m diameter PCC ring which will compensate the loss of attenuation storage.

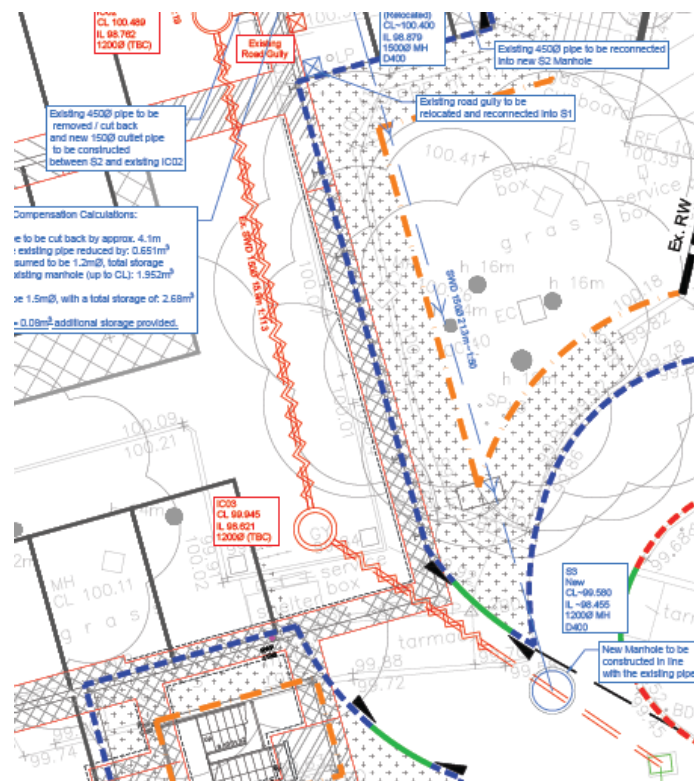
Figure 4: Proposed Drainage (drg. 9101) extract – Remaining Diversion Part

The remaining part of the proposed drainage diversion does not require any storage compensation to be provided as it is located downstream from the existing hydrobrake manhole. This part of existing surface water drainage pipe will be relocated beyond the proposed car parking area as shown below.

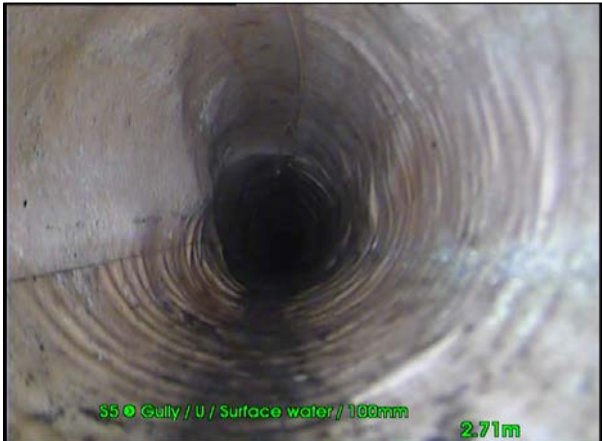
Section 1: Manhole S5 upstream to Gully1 located in car park at rear (found to be full of silt and requires emptying) - deformed pipe under liner & open joint.

Photo: 2_2_4_A.jpg, 00:00:31
2.79m, Deformed sewer/drain, 10%

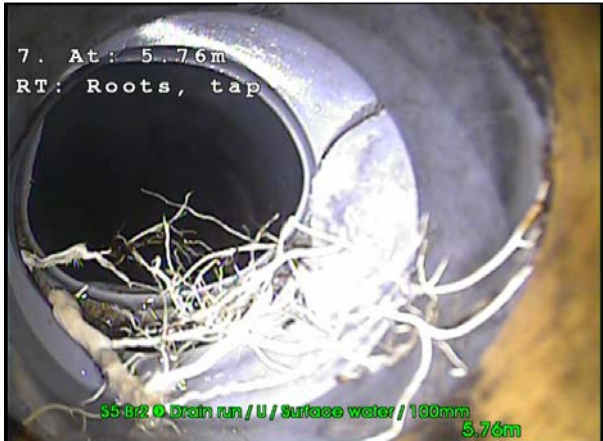
Section 6: Manhole S5 along Branch Br2 upstream to Rwdp L following further high pressure jetting works - fracture & tap root still present in pipe. Rwdp L tested to confirm running clear into S5.

Photo: 7_7_37_A.jpg, 00:00:53
5.76m, Roots, tap

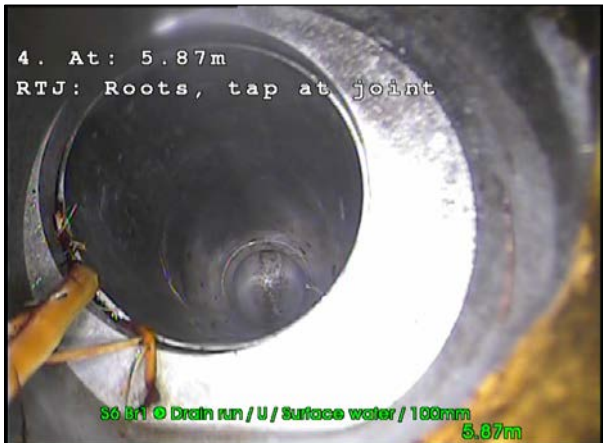
Photo: 11_11_67_A.jpg, 00:00:56
5.87m, Roots, tap at joint

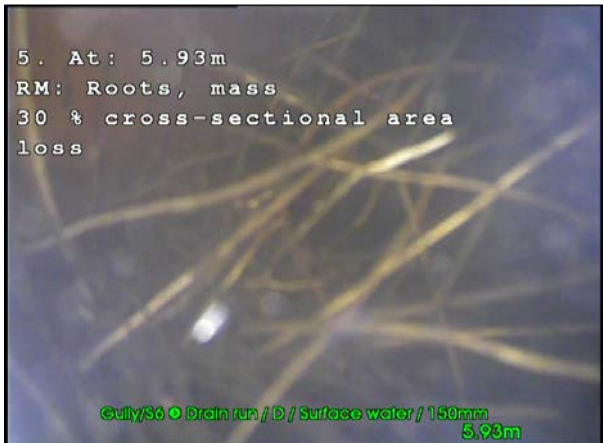
Photo: 17_17_113_A.jpg, 00:01:19
5.93m, Roots, mass 30 % cross-sectional area loss

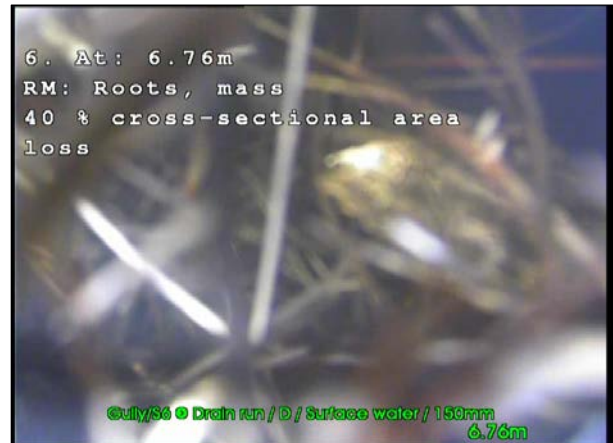
Photo: 17_17_114_A.jpg, 00:01:36
6.76m, Roots, mass 40 % cross-sectional area loss

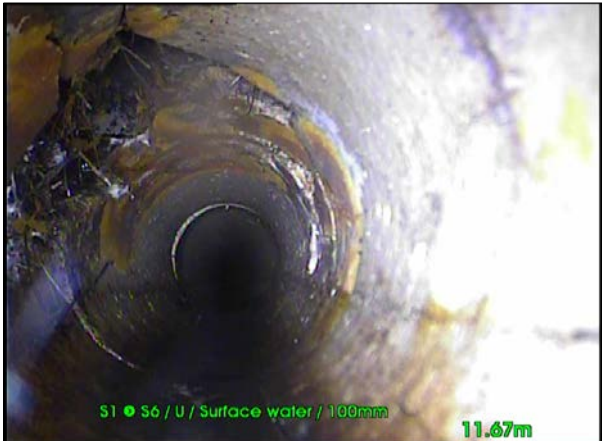
Photo: 22_22_488_A.jpg, 00:01:13
11.67m, Broken pipe, from 12 to 12 o'clock

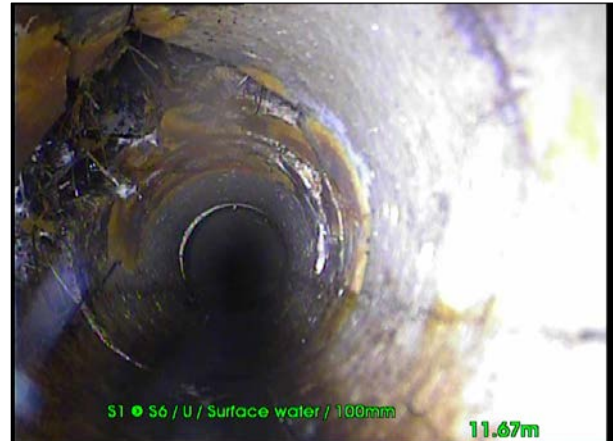
Photo: 22_22_489_A.jpg, 00:01:13
11.67m, Hole in drain/sewer, from 9 to 12 o'clock

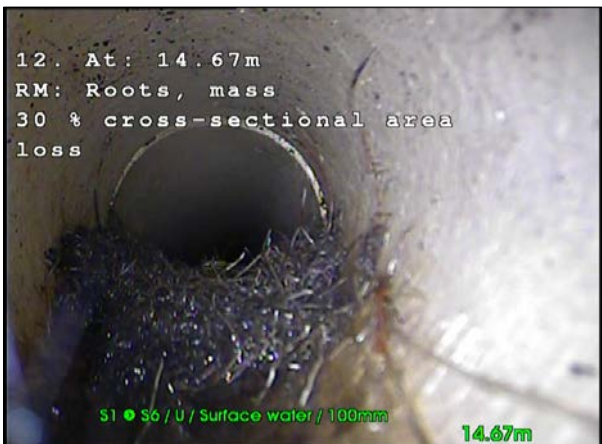
Photo: 22_22_176_A.jpg, 00:01:52
14.67m, Roots, mass 30 % cross-sectional area loss

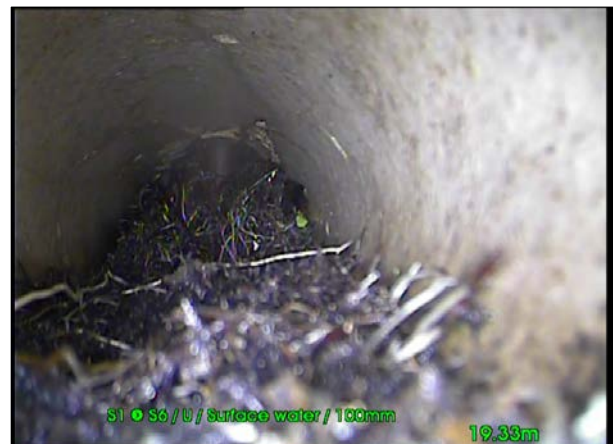
Photo: 22_22_179_A.jpg, 00:02:43
19.61m, Roots, mass 70 % cross-sectional area loss

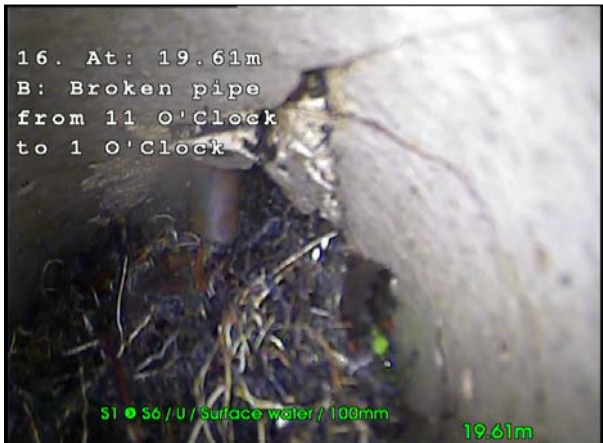
Photo: 22_22_180_A.jpg, 00:02:45

19.61m, Broken pipe from 11 O'Clock to 1 O'Clock

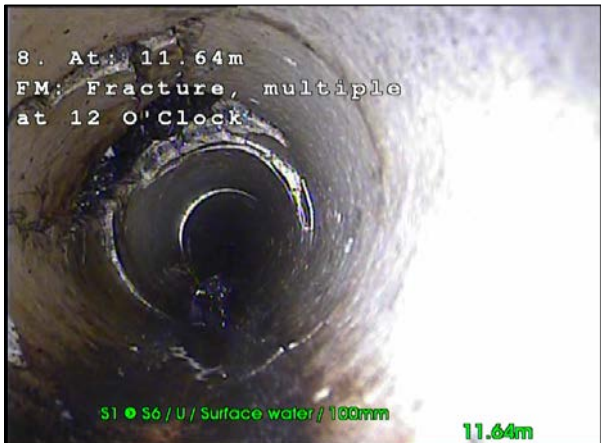
Photo: 23_23_190_A.jpg, 00:01:04
11.64m, Fracture, multiple, from 12 to 12 o'clock

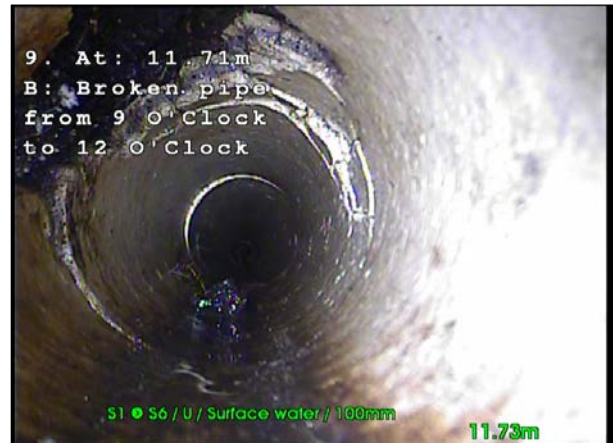
Photo: 23_23_191_A.jpg, 00:01:08
11.71m, Broken pipe, from 12 to 12 o'clock

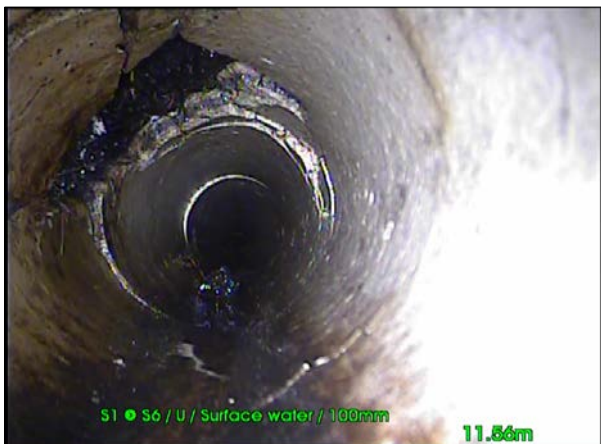
Photo: 23_23_486_A.jpg, 00:01:09
11.75m, Hole in drain/sewer, from 9 to 12 o'clock

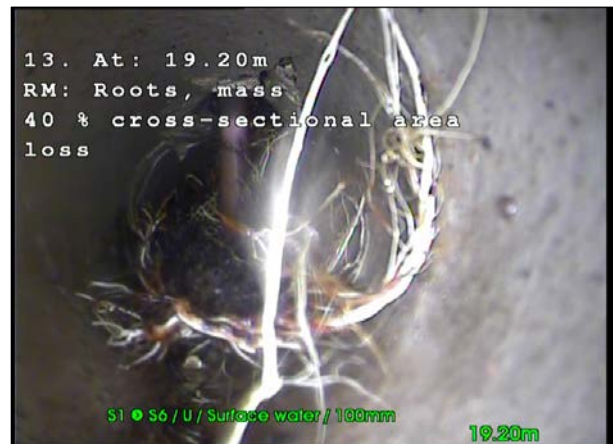
Photo: 23_23_195_A.jpg, 00:02:06
19.2m, Roots, mass 40 % cross-sectional area loss

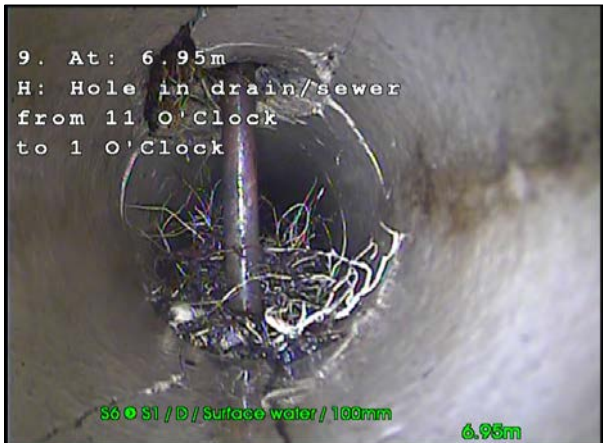
Photo: 25_25_212_A.jpg, 00:01:12
 6.95m, Hole in drain/sewer from 11 O'Clock to 1 O'Clock

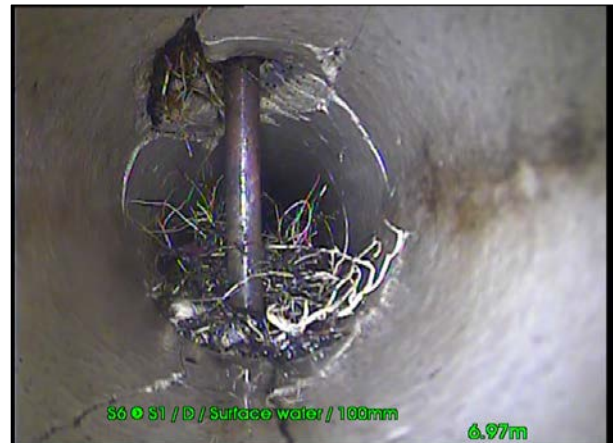
Photo: 25_25_585_A.jpg, 00:01:13
 6.95m, Broken pipe, from 12 to 12 o'clock

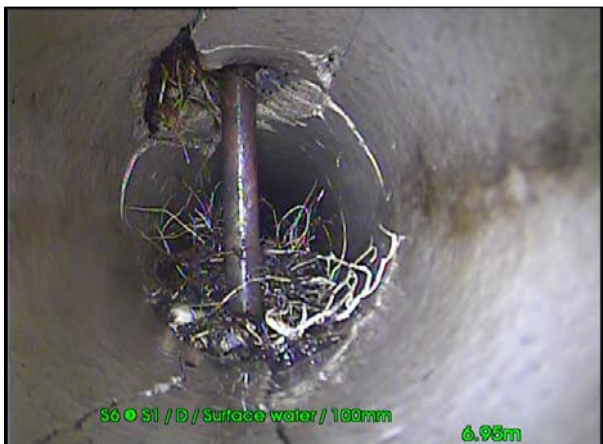
Photo: 25_25_213_A.jpg, 00:01:18
 6.97m, Fracture, multiple at 12 O'Clock

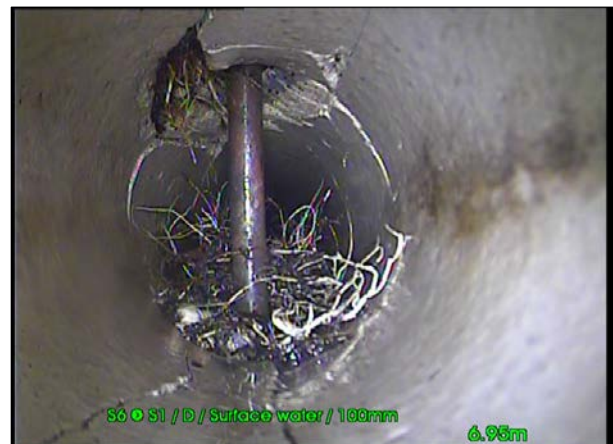
Photo: 25_25_214_A.jpg, 00:01:19
 6.97m, Other obstacles protruding through wall, from 12 to 6 o'clock, 95% cross-sectional area loss (rod / spike)

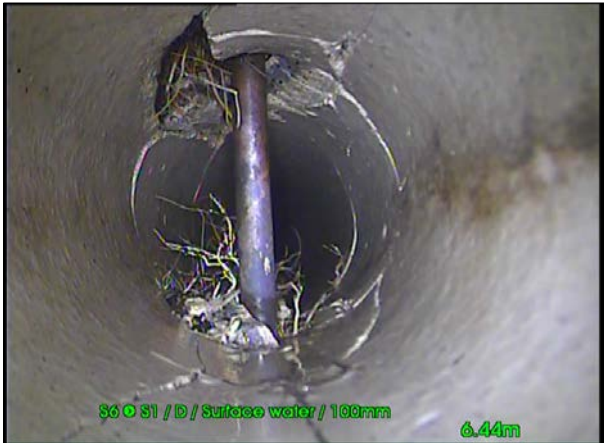
Photo: 27_27_232_A.jpg, 00:00:56
6.46m, Broken pipe, from 12 to 12 o'clock

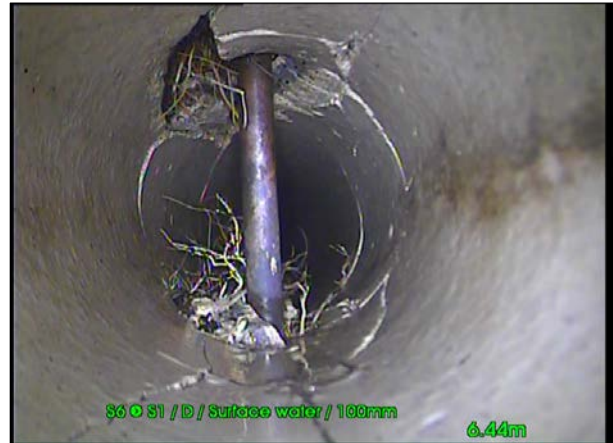
Photo: 27_27_236_A.jpg, 00:01:03
6.46m, Other obstacles protruding through wall, from 12 to 6 o'clock, 95% cross-sectional area loss

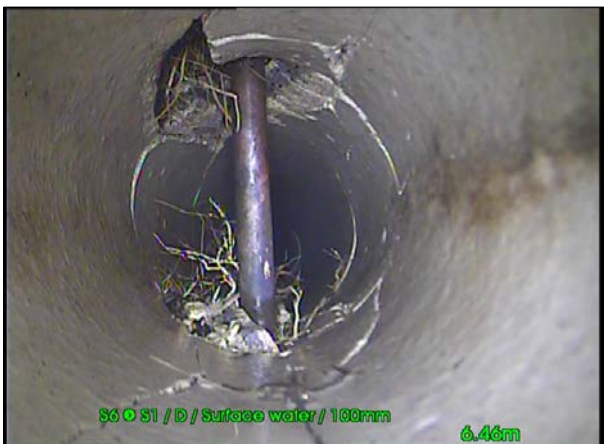
Photo: 27_27_586_A.jpg, 00:00:59
6.46m, Hole in drain/sewer, from 11 to 1 o'clock

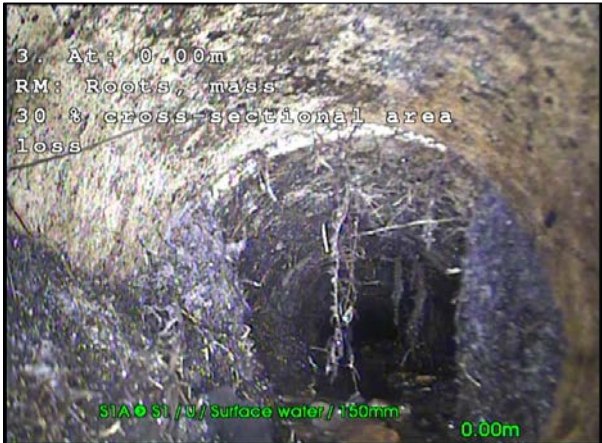
Photo: 28_28_240_A.jpg, 00:00:03
0m, Roots, mass 30 % cross-sectional area loss

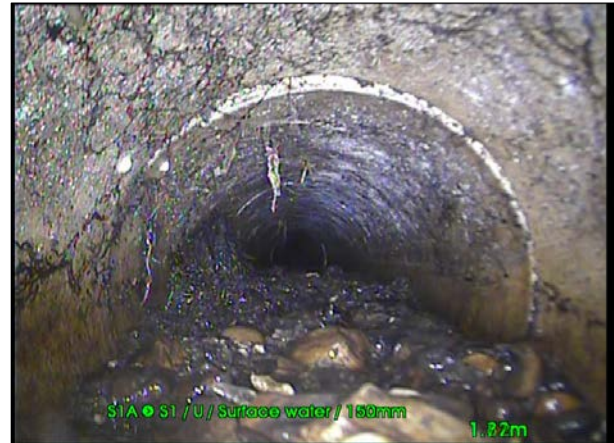
Photo: 28_28_241_A.jpg, 00:00:16
1.82m, Settled deposits, fine, 30% cross-sectional area loss,
Start

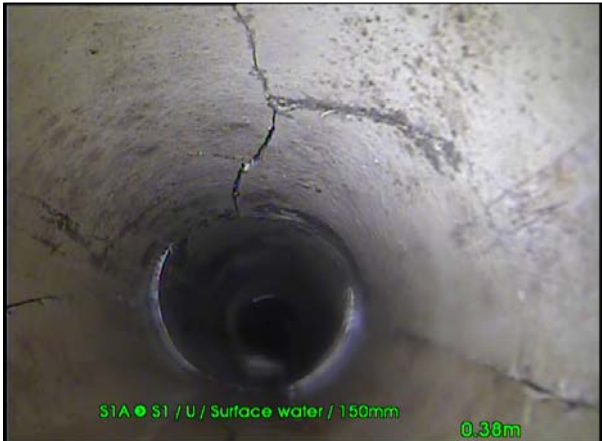
Photo: 30_30_498_A.jpg, 00:00:30
0.3m, Fracture, multiple, from 12 to 12 o'clock

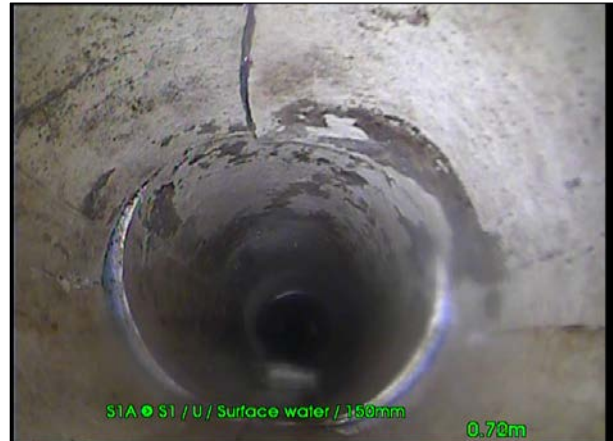
Photo: 30_30_499_A.jpg, 00:00:36
0.6m, Deformed sewer/drain, 5%

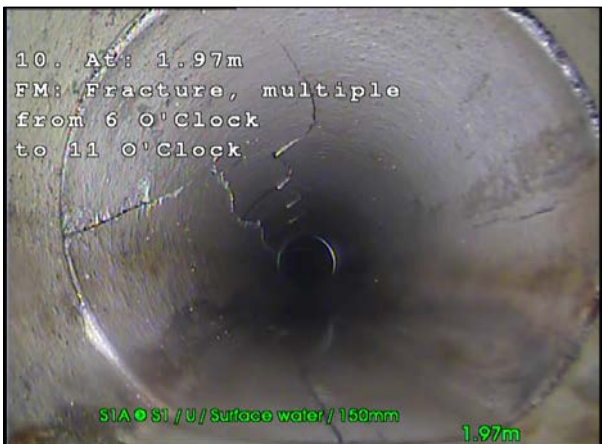
Photo: 30_30_257_A.jpg, 00:00:47
1.9m, Fracture, multiple, from 6 to 11 o'clock, Start

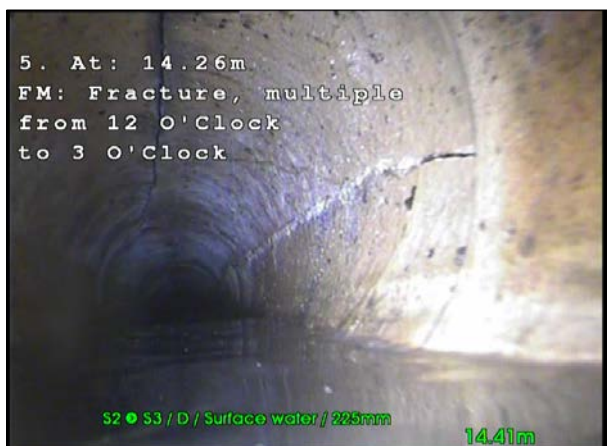
Photo: 31_31_264_A.jpg, 00:01:02
14.26m, Fracture, multiple from 12 O'Clock to 3 O'Clock

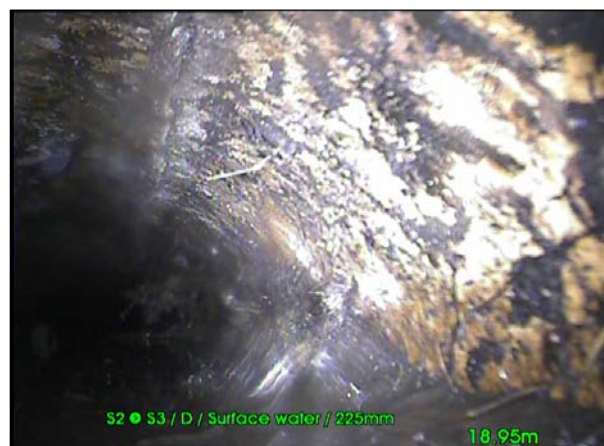
Photo: 31_31_506_A.jpg, 00:02:11
18.82m, Roots, mass, 50% cross-sectional area loss

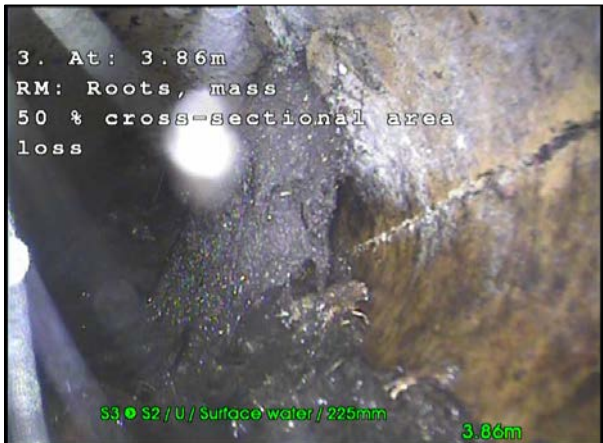
Photo: 32_32_272_A.jpg, 00:00:20
3.86m, Roots, mass 50 % cross-sectional area loss

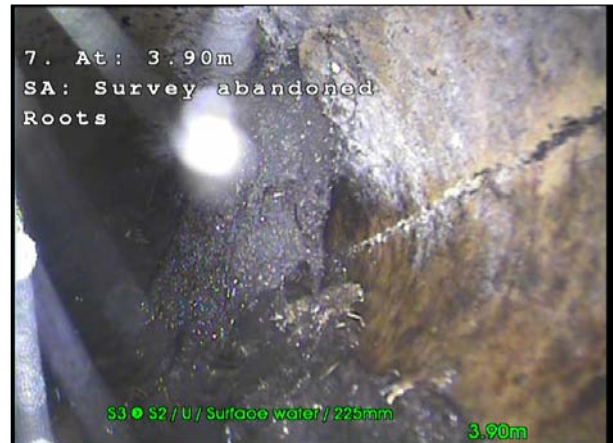
Photo: 32_32_274_A.jpg, 00:00:36
3.9m, Hole in drain/sewer, at 2 o'clock
