# Draincare

## Inspection pictures

| Place :<br><b>Welwyn Garden city</b> | Road :<br><b>Campus West Car park</b> | Date :<br><b>21/06/2019</b> | Section number :<br><b>36</b> | PLR Suffix :<br><b>X</b> |

| Use:<br>Year laid :<br>Purpose :<br>Total length : | <b>Surface water</b><br><br><b>Routine inspection of condition</b><br><b>19.06 m</b> | Pipe shape :<br>Pipe size :<br>Pipe material :<br>Lining : | <b>Circular</b><br><b>225 mm</b><br><b>Vitrified clay</b><br><br> | |

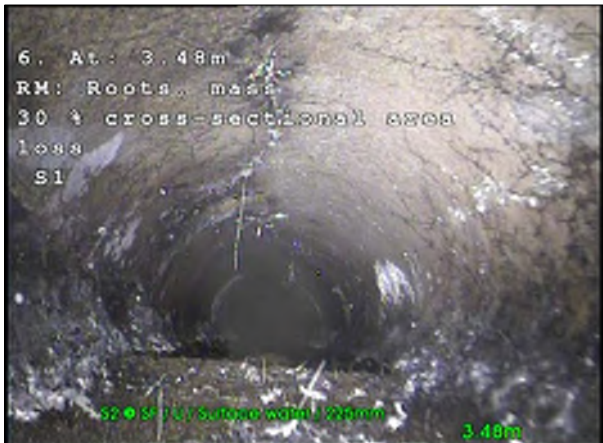
Photo: 37\_37\_297\_A.jpg, 00:00:34  
3.48m, Roots, mass 30 % cross-sectional area loss S1

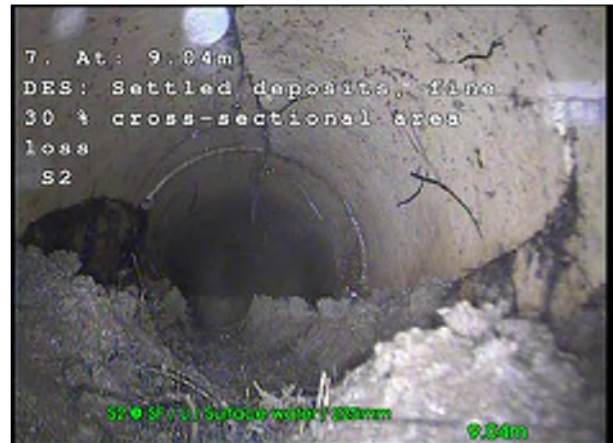
Photo: 37\_37\_298\_A.jpg, 00:00:56  
9.04m, Settled deposits, fine 30 % cross-sectional area loss S2

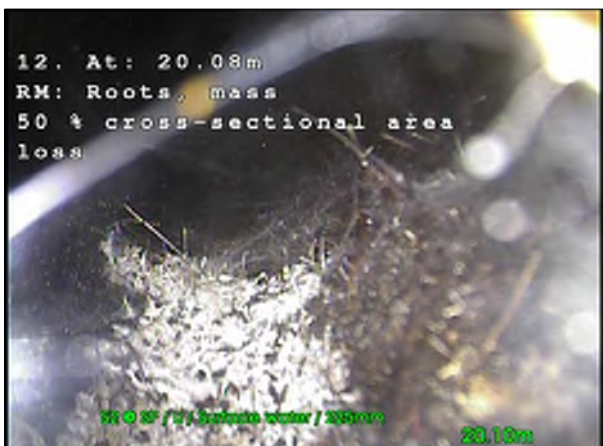
Photo: 37\_37\_303\_A.jpg, 00:01:59  
20.08m, Roots, mass 50 % cross-sectional area loss

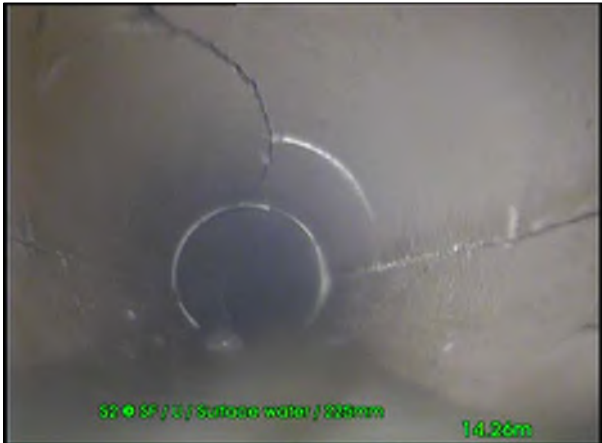
| 1:165<br>Depth: 1.22 | Position | Code | Observation | Photo | Grade | | | | |
|---|---|---|---|---|---|---|---|---|---|
| | 3.11 | <b>S1</b> FM | Fracture, multiple, from 12 to 12 o'clock, Start | 38_38_310_A.jpg | (Struct) 4 | | | | |

Photo: 38\_38\_310\_A.jpg, 00:00:14  
3.11m, Fracture, multiple, from 12 to 12 o'clock, Start

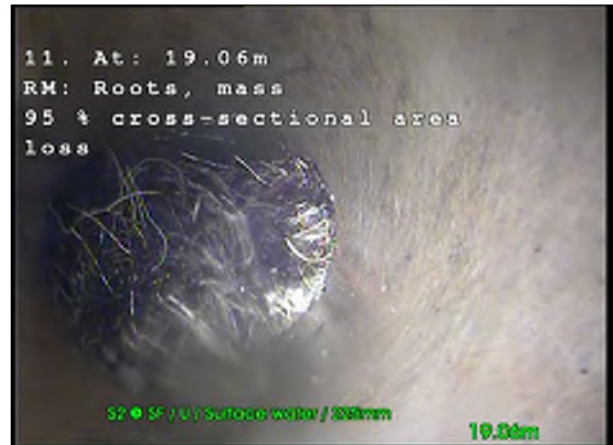
| 1:165<br>Depth: 1.22 | Position | Code | Observation | Photo | Grade | | | | |
|---|---|---|---|---|---|---|---|---|---|
| | 19.06 | RM | Roots, mass 95 % cross-sectional area loss | 38_38_317_A.jpg | (Serv) 5 | | | | |

Photo: 38\_38\_317\_A.jpg, 00:02:23  
19.06m, Roots, mass 95 % cross-sectional area loss

| 1:165<br>Depth: 1.22 | Position | Code | Observation | Photo | Grade | | | | |
|---|---|---|---|---|---|---|---|---|---|
| 19.06 | SA | Survey abandoned - unable to continue due to roots (to be further HP Jetted & re-surveyed) | | (Misc) 0 | | | | | |

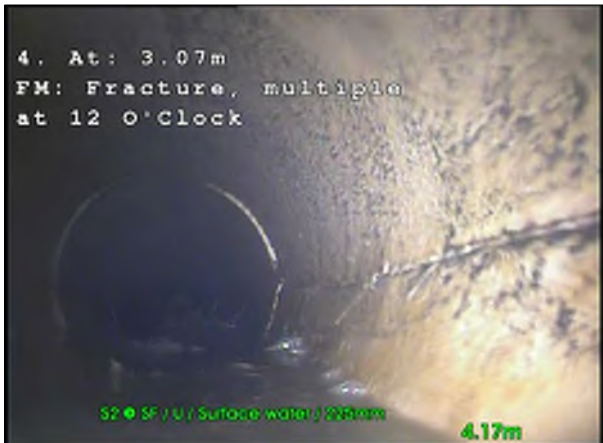
| 1:165<br>Depth: 1.22 | Position | Code | Observation | Photo | Grade | | | | |
|---|---|---|---|---|---|---|---|---|---|
| | 3.07 | S1 FM | Fracture, multiple, from 12 to 12 o'clock, Start | 39_39_322_A.jpg | (Struct) 4 | | | | |

Photo: 39\_39\_322\_A.jpg, 00:00:16  
3.07m, Fracture, multiple, from 12 to 12 o'clock, Start

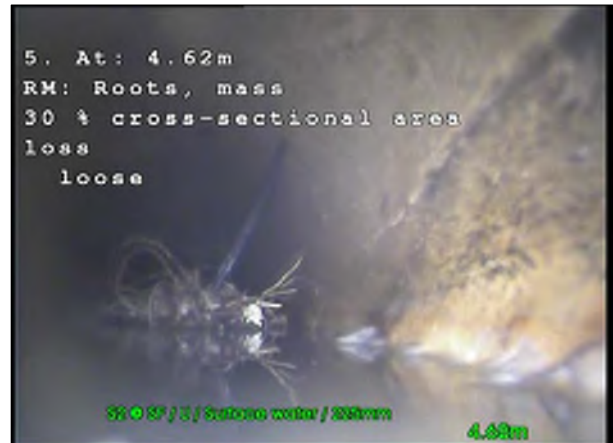
| 1:165<br>Depth: 1.22 | Position | Code | Observation | Photo | Grade | | | | |
|---|---|---|---|---|---|---|---|---|---|
| | 4.62 | RM | Roots, mass 30 % cross-sectional area loss loose | 39_39_323_A.jpg | (Serv) 5 | | | | |

Photo: 39\_39\_323\_A.jpg, 00:00:24  
4.62m, Roots, mass 30 % cross-sectional area loss loose

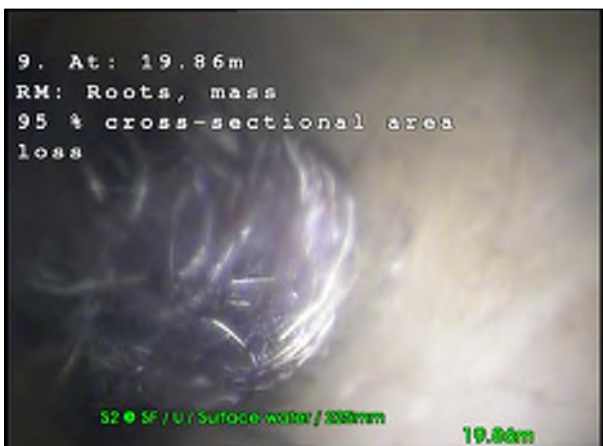
Photo: 39\_39\_327\_A.jpg, 00:01:34  
19.86m, Roots, mass 95 % cross-sectional area loss

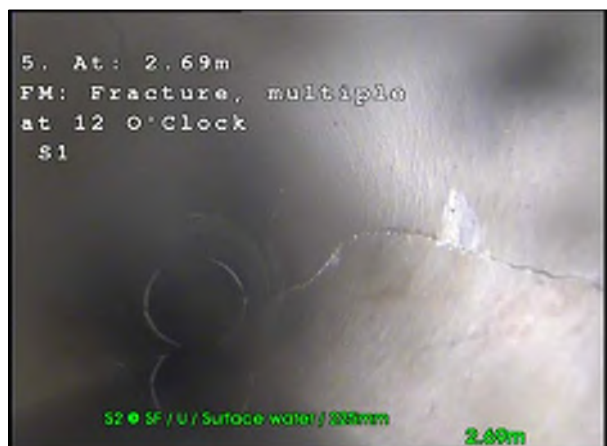
| 1:162<br>Depth: 1.2 | Position | Code | Observation | Photo | Grade |
|---|---|---|---|---|---|
| | <u>2.69</u> | <b>S1</b> FM | Fracture, multiple, from 12 to 12 o'clock, Start | 41_41_334_A.jpg | (Struct) 4 |

Photo: 41\_41\_334\_A.jpg, 00:00:28  
 2.69m, Fracture, multiple, from 12 to 12 o'clock, Start

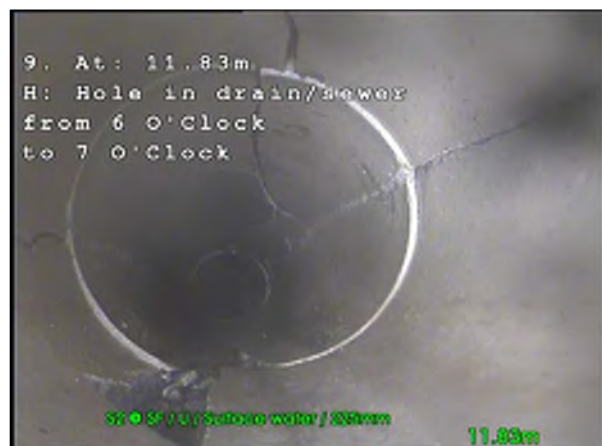
Photo: 41\_41\_338\_A.jpg, 00:01:36  
 11.83m, Hole in drain/sewer from 6 O'Clock to 7 O'Clock

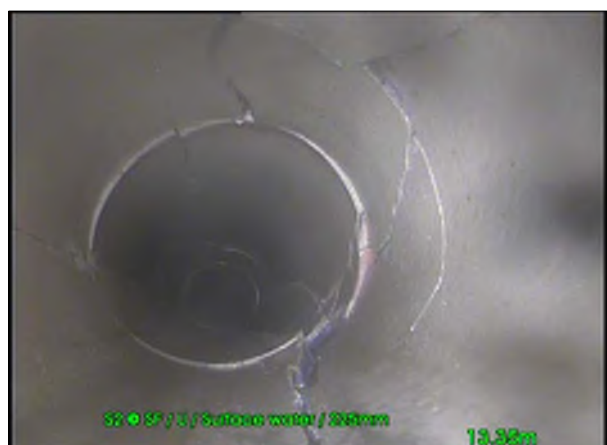
Photo: 41\_41\_526\_A.jpg, 00:01:59  
 13.35m, Deformed sewer/drain, 5%

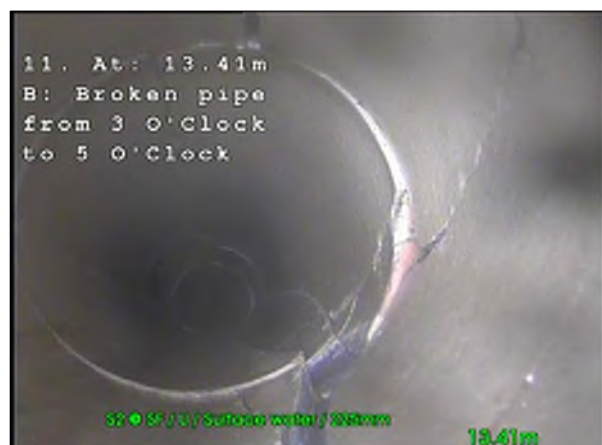
| 1:162<br>Depth: 1.2 | Position | Code | Observation | Photo | Grade |
|---|---|---|---|---|---|
| | <u>13.41</u> | B | Broken pipe from 3 O'Clock to 5 O'Clock | 41_41_340_A.jpg | (Struct) 4 |

Photo: 41\_41\_340\_A.jpg, 00:02:14  
 13.41m, Broken pipe from 3 O'Clock to 5 O'Clock

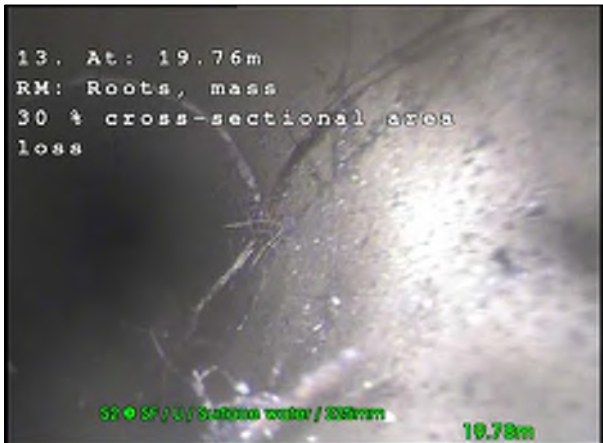
Photo: 41\_41\_342\_A.jpg, 00:02:59  
19.76m, Roots, mass 30 % cross-sectional area loss

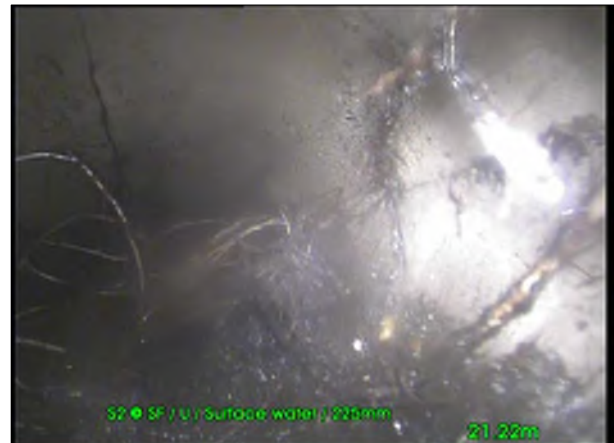
Photo: 41\_41\_528\_A.jpg, 00:03:35  
21.22m, Roots, mass, 35% cross-sectional area loss

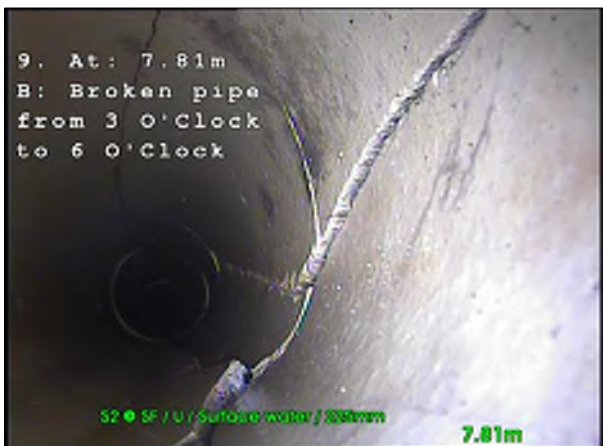
| 1:162<br>Depth: 1.2 | Position | Code | Observation | Photo | Grade |
|---|---|---|---|---|---|
| 7.81 | | <b>B</b> | Broken pipe from 3 O'Clock to 6 O'Clock | 42_42_354_A.jpg | (Struct) 4 |

Photo: 42\_42\_354\_A.jpg, 00:01:12  
 7.81m, Broken pipe from 3 O'Clock to 6 O'Clock

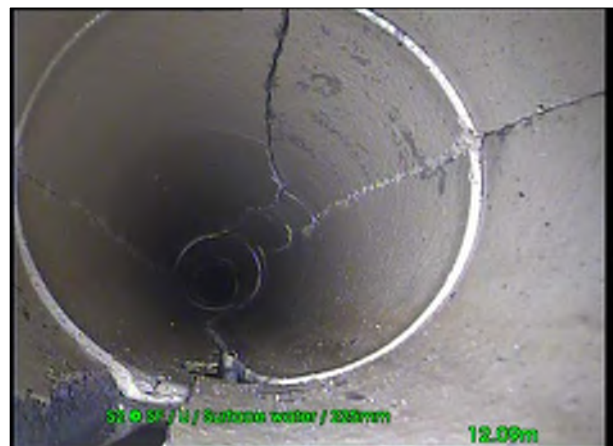
Photo: 42\_42\_534\_A.jpg, 00:01:44  
 12.09m, Hole in drain/sewer, at 7 o'clock

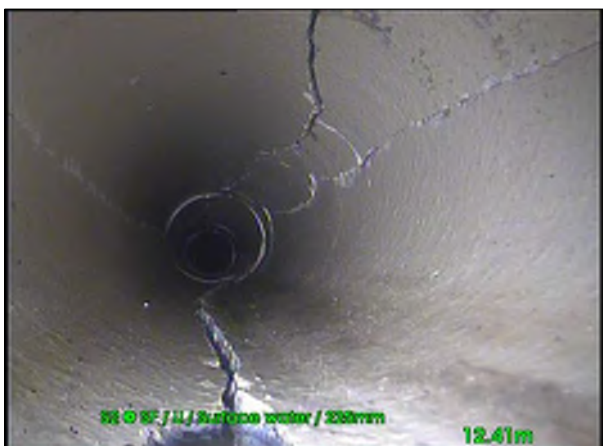
Photo: 42\_42\_535\_A.jpg, 00:01:46  
 12.41m, Hole in drain/sewer, at 6 o'clock

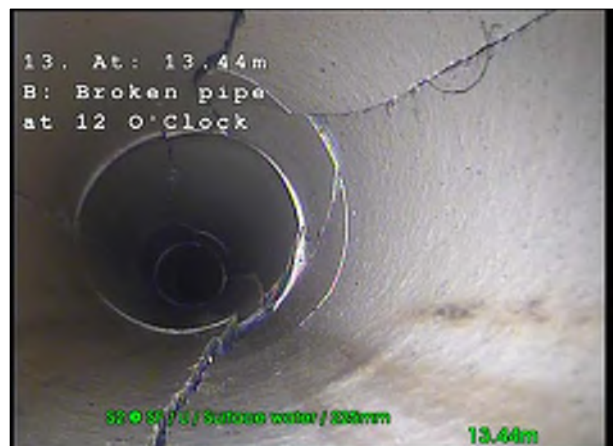
| 1:162<br>Depth: 1.2 | Position | Code | Observation | Photo | Grade |
|---|---|---|---|---|---|
| 13.44 | | <b>B</b> | Broken pipe, from 12 to 2 o'clock | 42_42_358_A.jpg | (Struct) 4 |

Photo: 42\_42\_358\_A.jpg, 00:02:07  
 13.44m, Broken pipe, from 12 to 2 o'clock

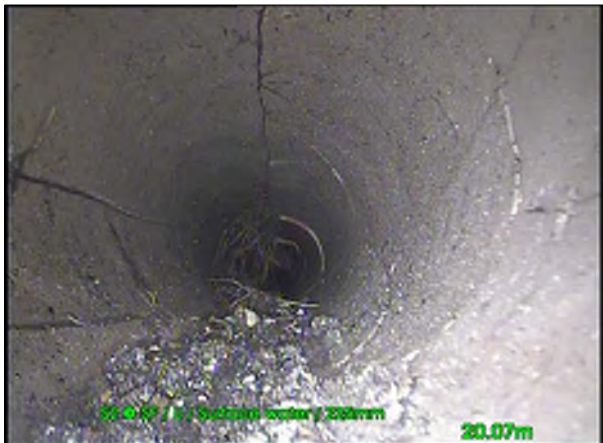
| 1:162<br>Depth: 1.2 | Position | Code | Observation | Photo | Grade |
|---|---|---|---|---|---|
| 20.09 | <b>S2</b> | <b>FM</b> | Fracture, multiple, from 12 to 12 o'clock, Start | 42_42_363_A.jpg | (Struct) 4 |

Photo: 42\_42\_363\_A.jpg, 00:03:12  
20.09m, Fracture, multiple, from 12 to 12 o'clock, Start

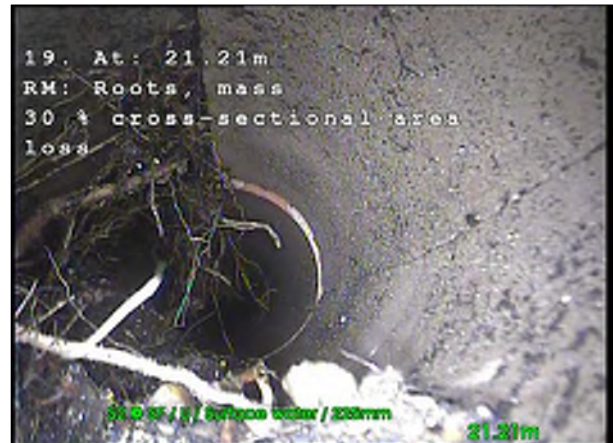
Photo: 42\_42\_364\_A.jpg, 00:03:28  
21.21m, Roots, mass 30 % cross-sectional area loss

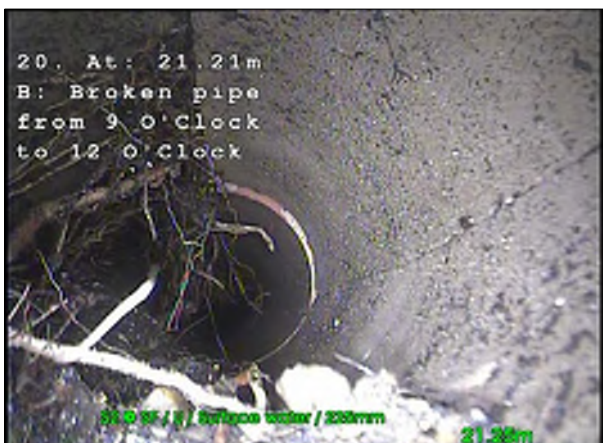
| 1:162 | Position | Code | Observation | Photo | Grade |
|---|---|---|---|---|---|
| | <a href="#">21.21</a> | B | Broken pipe from 9 O'Clock to 12 O'Clock | <a href="#">42_42_365_A.jpg</a> | (Struct) 4 |

Photo: 42\_42\_365\_A.jpg, 00:03:31  
21.21m, Broken pipe from 9 O'Clock to 12 O'Clock

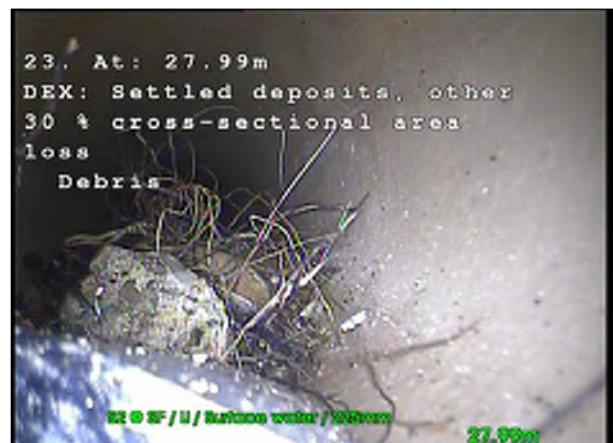
Photo: 42\_42\_368\_A.jpg, 00:04:27  
27.99m, Settled deposits, other 30 % cross-sectional area loss Debris

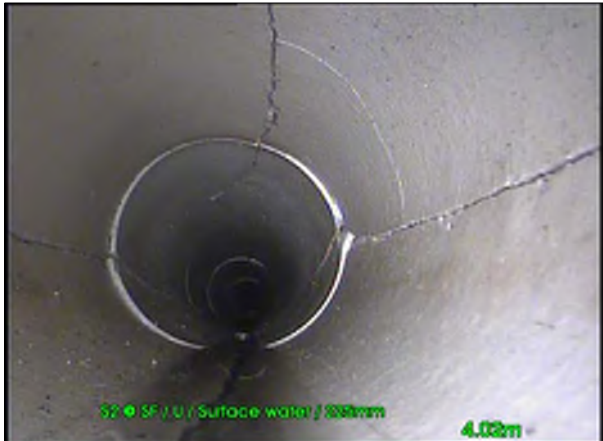
| 1:234<br>Depth: 1.2 | Position | Code | Observation | Photo | Grade |
|---|---|---|---|---|---|
| | <u>2.44</u> | <b>S1</b> FM | Fracture, multiple, from 12 to 12 o'clock, Start | 43_43_540_A.jpg | (Struct) 4 |

Photo: 43\_43\_540\_A.jpg, 00:00:20  
 2.44m, Fracture, multiple, from 12 to 12 o'clock, Start

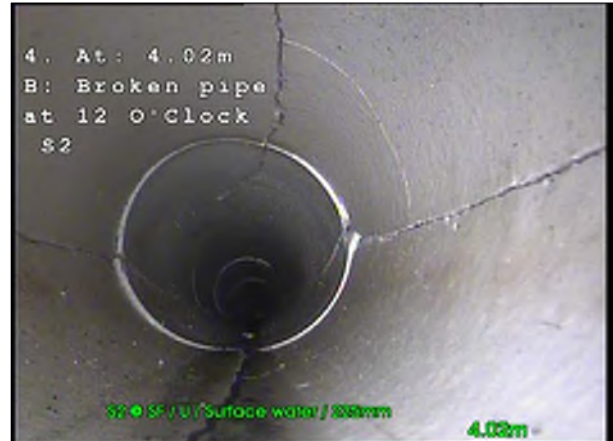
| 1:234<br>Depth: 1.2 | Position | Code | Observation | Photo | Grade |
|---|---|---|---|---|---|
| | <u>4.02</u> | <b>S2</b> B | Broken pipe, from 12 to 12 o'clock, Start | 43_43_542_A.jpg | (Struct) 4 |

Photo: 43\_43\_542\_A.jpg, 00:00:30  
 4.02m, Broken pipe, from 12 to 12 o'clock, Start

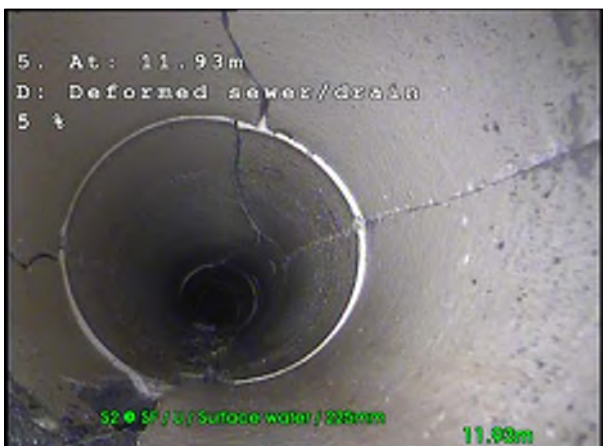
Photo: 43\_43\_375\_A.jpg, 00:01:15  
 11.93m, Deformed sewer/drain 5 %

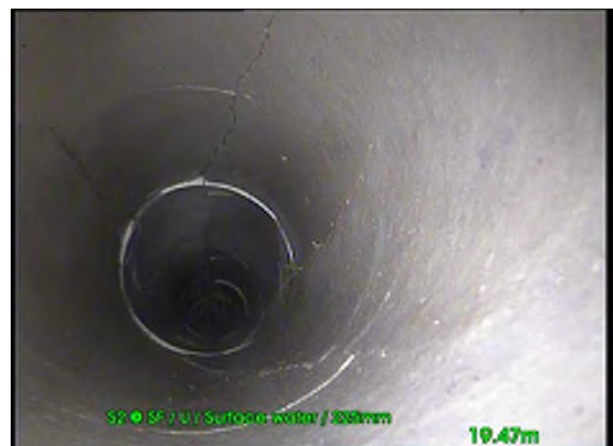
| 1:234<br>Depth: 1.2 | Position | Code | Observation | Photo | Grade |
|---|---|---|---|---|---|
| | <u>19.47</u> | <b>S3</b> FM | Fracture, multiple, from 12 to 12 o'clock, Start | 43_43_545_A.jpg | (Struct) 4 |

Photo: 43\_43\_545\_A.jpg, 00:01:53  
 19.47m, Fracture, multiple, from 12 to 12 o'clock, Start

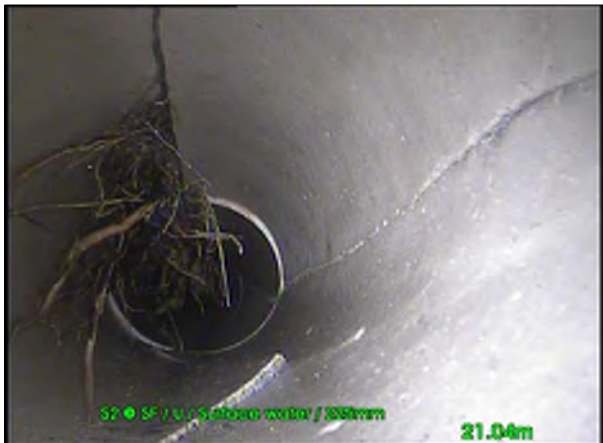
| 1:234<br>Depth: 1.2 | Position | Code | Observation | Photo | Grade |
|---|---|---|---|---|---|
| | <u>20.10</u> | <b>S4</b> B | Broken pipe, from 12 to 12 o'clock, Start | 43_43_546_A.jpg | (Struct) 4 |

Photo: 43\_43\_546\_A.jpg, 00:01:59  
20.1m, Broken pipe, from 12 to 12 o'clock, Start

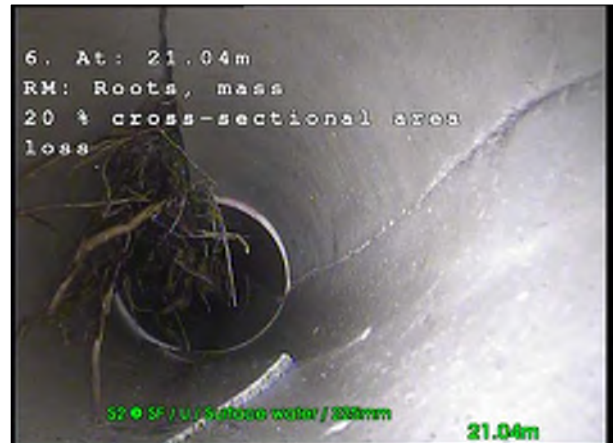
Photo: 43\_43\_376\_A.jpg, 00:02:07  
21.04m, Roots, mass, 20% cross-sectional area loss, Start

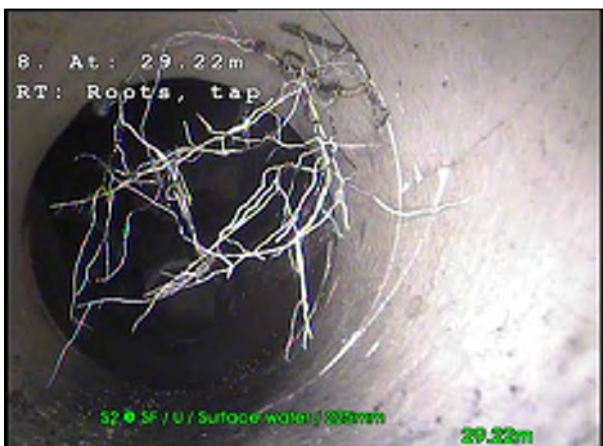
Photo: 43\_43\_378\_A.jpg, 00:02:58  
29.22m, Roots, tap

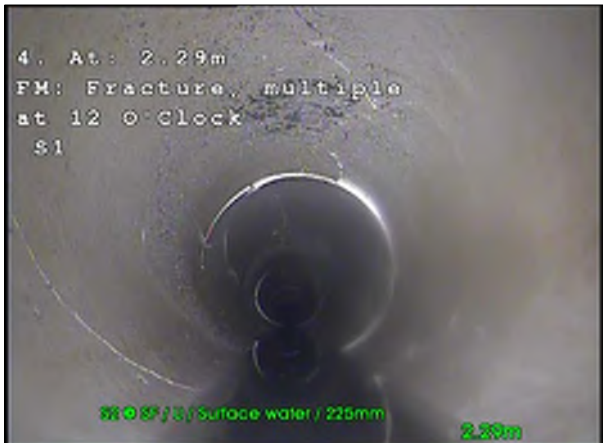
| 1:198<br>Depth: 1.2 | Position | Code | Observation | Photo | Grade |
|---|---|---|---|---|---|
| | | <b>S1</b> | FM Fracture, multiple, from 12 to 12 o'clock | 44_44_553_A.jpg | (Struct) 4 |

Photo: 44\_44\_553\_A.jpg, 00:00:32  
2.29m, Fracture, multiple, from 12 to 12 o'clock

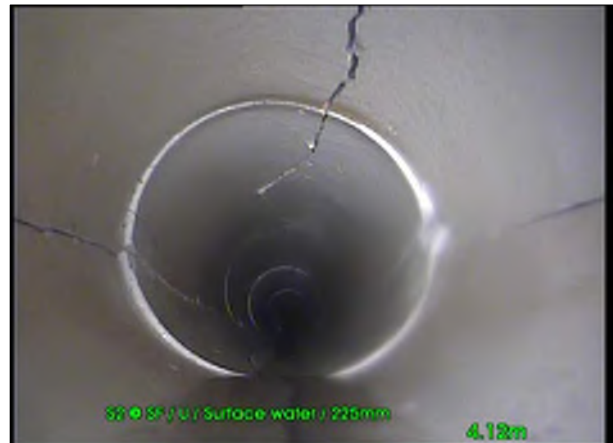
| 1:198<br>Depth: 1.2 | Position | Code | Observation | Photo | Grade |
|---|---|---|---|---|---|
| | | <b>S2</b> | B Broken pipe, from 12 to 12 o'clock, Start | 44_44_555_A.jpg | (Struct) 4 |

Photo: 44\_44\_555\_A.jpg, 00:00:41  
4.12m, Broken pipe, from 12 to 12 o'clock, Start

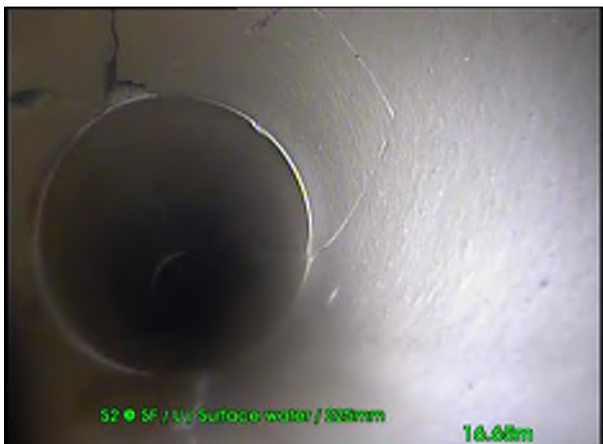
Photo: 44\_44\_556\_A.jpg, 00:02:06  
16.65m, Hole in drain/sewer, at 11 o'clock

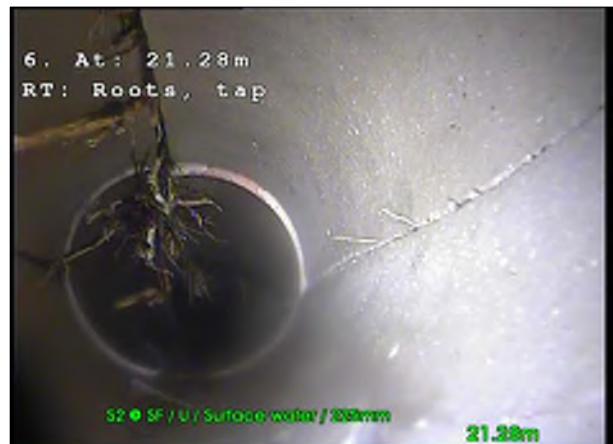
Photo: 44\_44\_564\_A.jpg, 00:02:38  
21.28m, Roots, tap

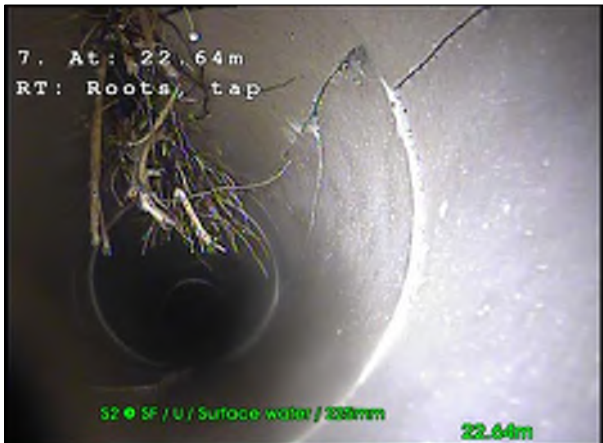
Photo: 44\_44\_386\_A.jpg, 00:03:04  
22.64m, Roots, tap

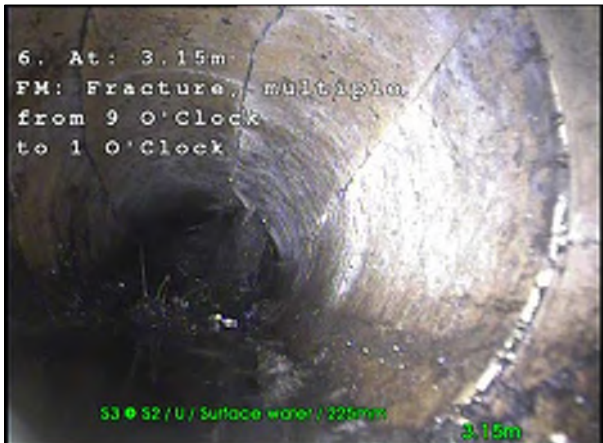
| 1:50<br>Depth: 1.4 | Position | Code | Observation | Photo | Grade | | | | |
|---|---|---|---|---|---|---|---|---|---|
| 3.15 | FM | | Fracture, multiple, from 9 to 3 o'clock | 45_45_397_A.jpg | (Struct) 4 | | | | |

Photo: 45\_45\_397\_A.jpg, 00:00:29  
3.15m, Fracture, multiple, from 9 to 3 o'clock

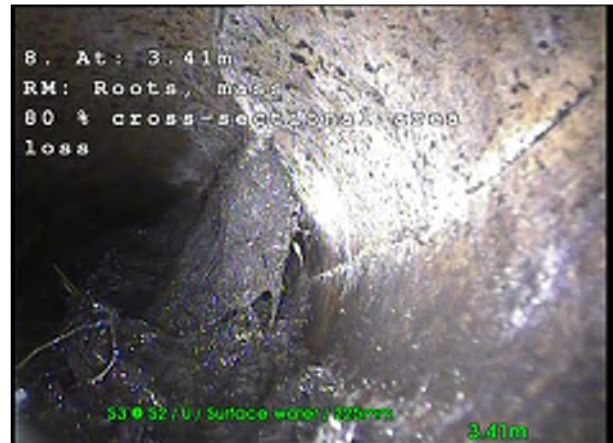
Photo: 45\_45\_399\_A.jpg, 00:00:34  
3.41m, Roots, mass 80 % cross-sectional area loss

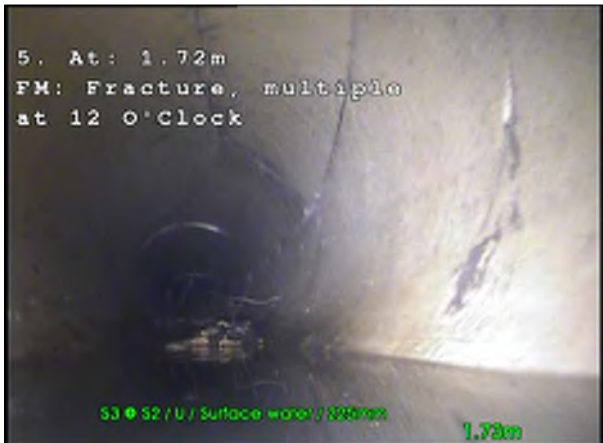
| 1:75<br>Depth: 1.4 | Position | Code | Observation | Photo | Grade | | | | |
|---|---|---|---|---|---|---|---|---|---|
| | 1.72 | S1 FM | Fracture, multiple, from 12 to 12 o'clock, Start | 46_46_405_A.jpg | (Struct) 4 | | | | |

Photo: 46\_46\_405\_A.jpg, 00:00:17  
1.72m, Fracture, multiple, from 12 to 12 o'clock, Start

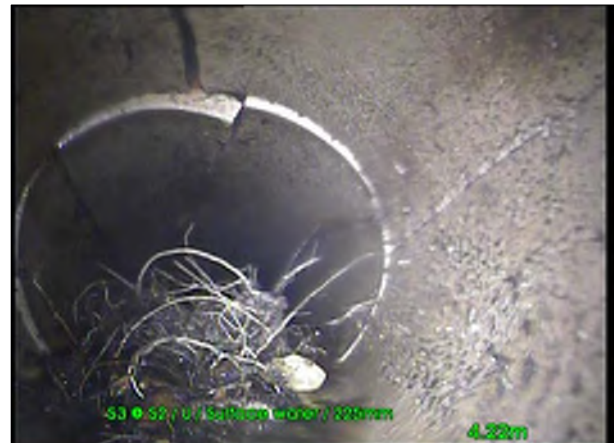
| 1:75<br>Depth: 1.4 | Position | Code | Observation | Photo | Grade | | | | |
|---|---|---|---|---|---|---|---|---|---|
| | 4.24 | B | Broken pipe from 9 O'Clock to 12 O'Clock | 46_46_407_A.jpg | (Struct) 4 | | | | |

Photo: 46\_46\_407\_A.jpg, 00:00:30  
4.24m, Broken pipe from 9 O'Clock to 12 O'Clock

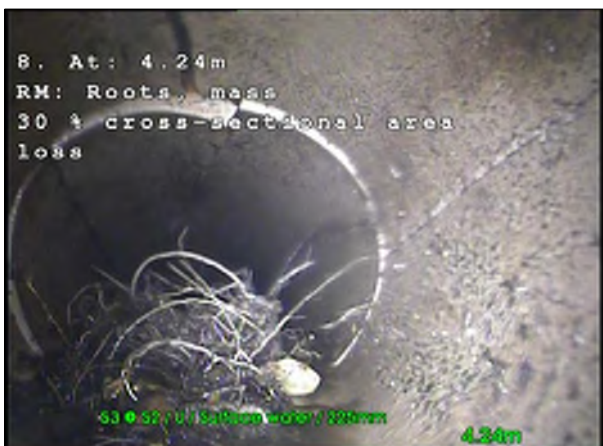
Photo: 46\_46\_408\_A.jpg, 00:00:32  
4.24m, Roots, mass 30 % cross-sectional area loss

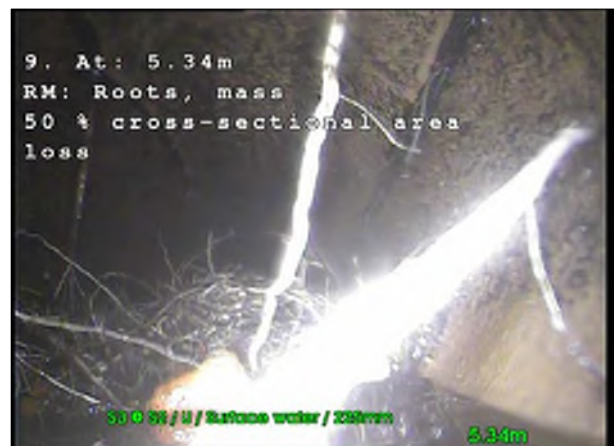
Photo: 46\_46\_409\_A.jpg, 00:00:38  
5.34m, Roots, mass 50 % cross-sectional area loss

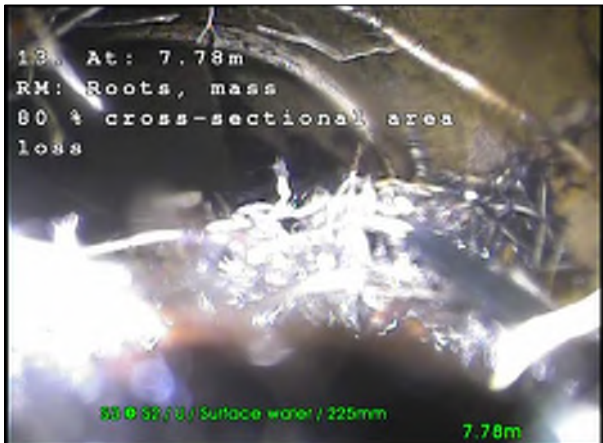
Photo: 46\_46\_413\_A.jpg, 00:01:03

7.78m, Roots, mass 80 % cross-sectional area loss

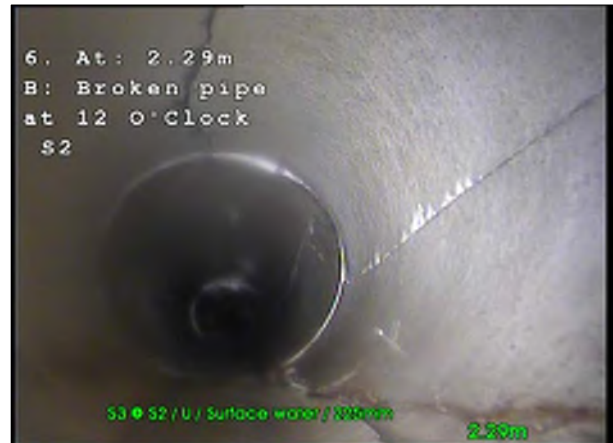
| 1:210<br>Depth: 1.4 | Position | Code | Observation | Photo | Grade |
|---|---|---|---|---|---|
| 2.29 | <b>S02</b> | B | Broken pipe, from 12 to 12 o'clock, Start | 47_47_579_A.jpg | (Struct) 4 |

Photo: 47\_47\_579\_A.jpg, 00:00:30  
2.29m, Broken pipe, from 12 to 12 o'clock, Start

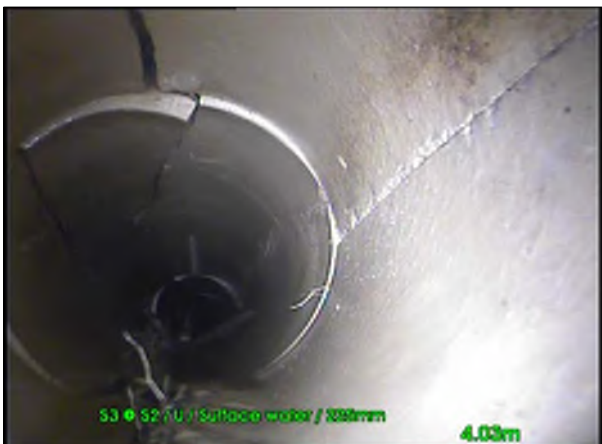
Photo: 47\_47\_580\_A.jpg, 00:00:39  
4.03m, Deformed sewer/drain, 10%

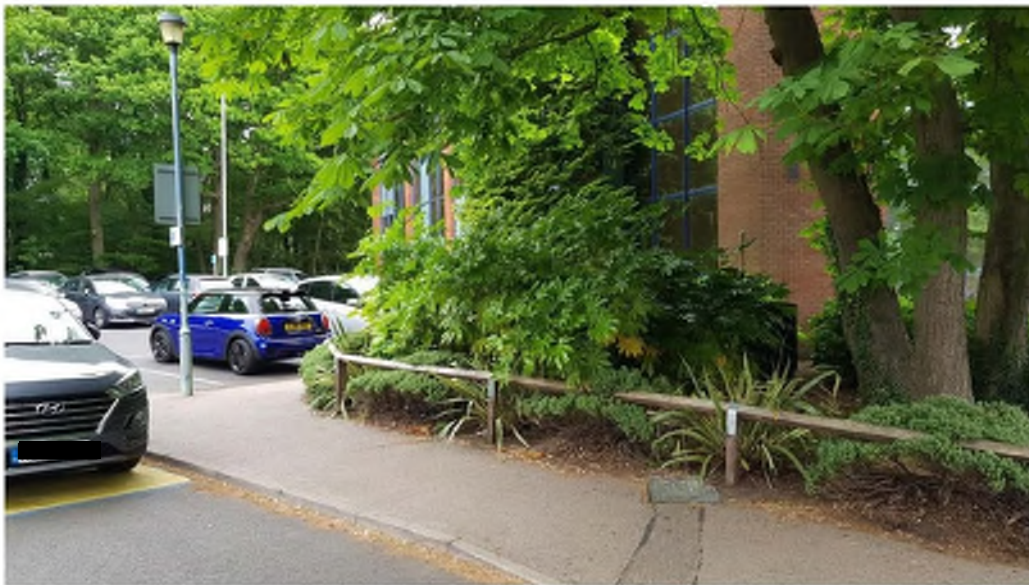
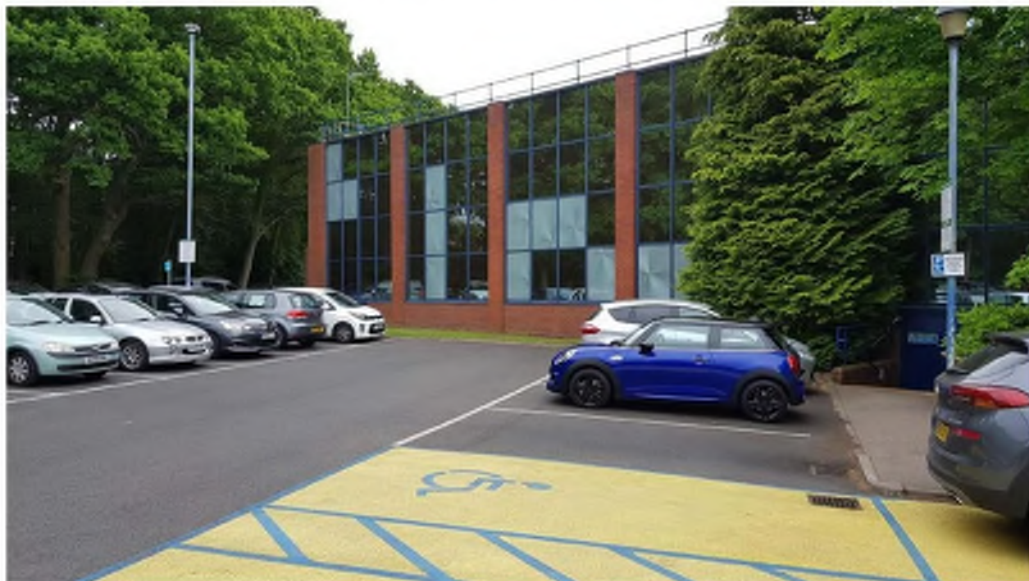
View of bushed area containing green kiosk and believed to be where rod / spike has been found intruding through pipework between Manholes S6 & S1

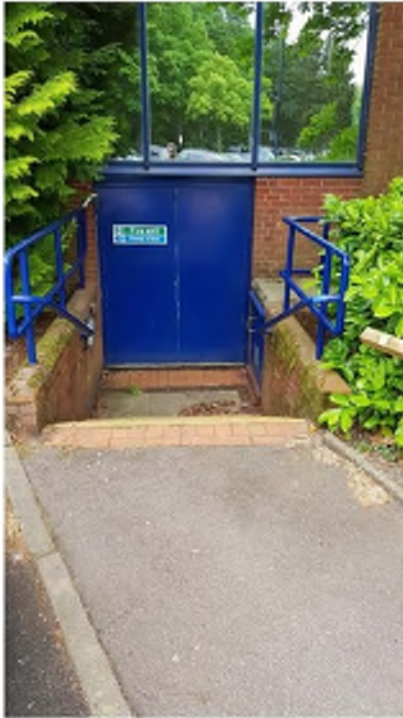
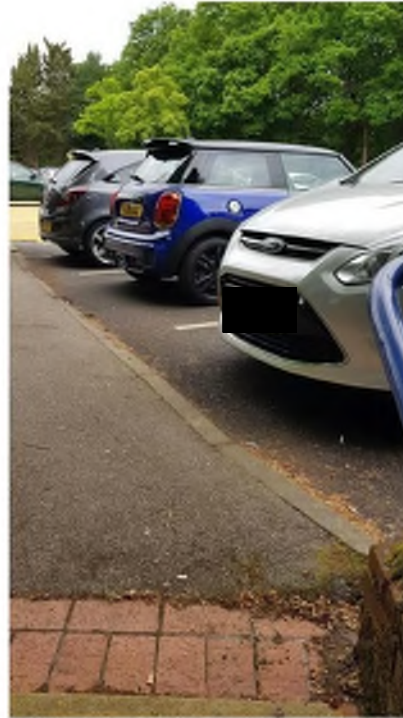
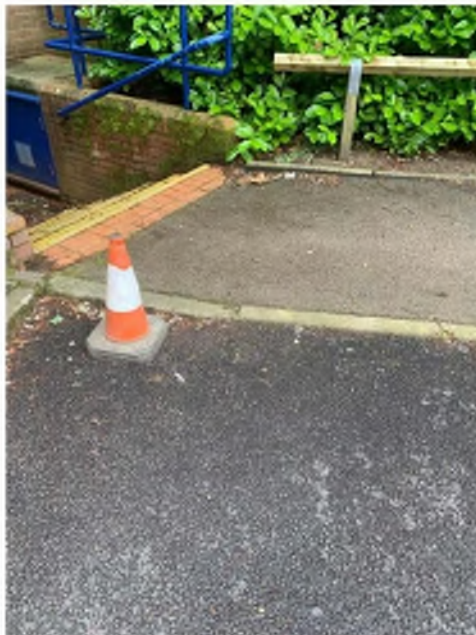
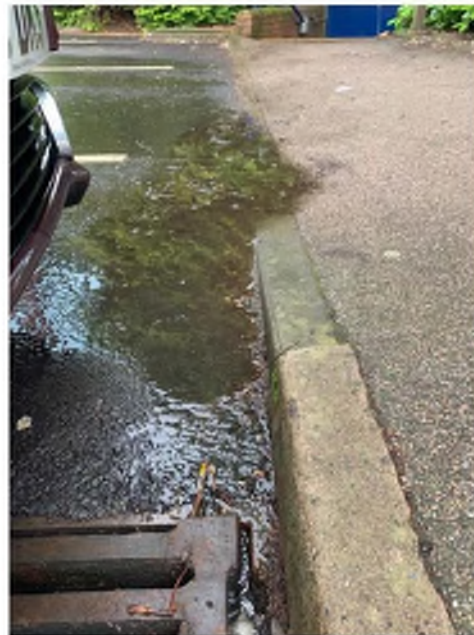
View of dropped kerb in front of steps down to low level Fire Exit with Low Level Aco, which has allowed water to flood inside Roller City during very heavy rain. Car park noted to slope towards dropped kerb, possibly allowing water to run off car park & down steps

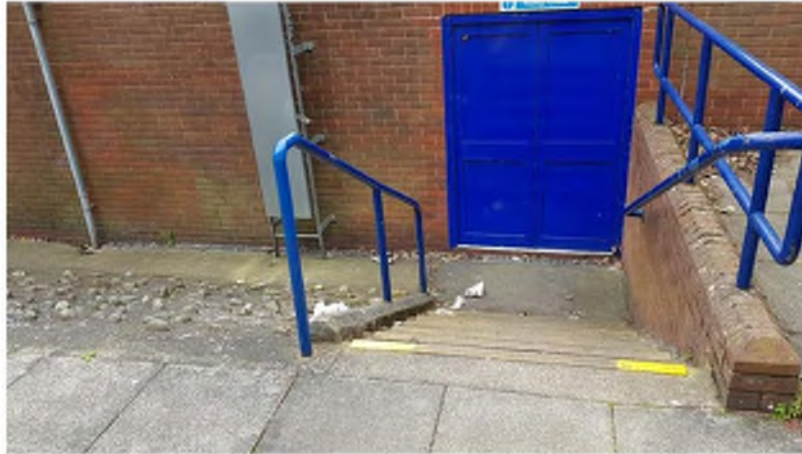
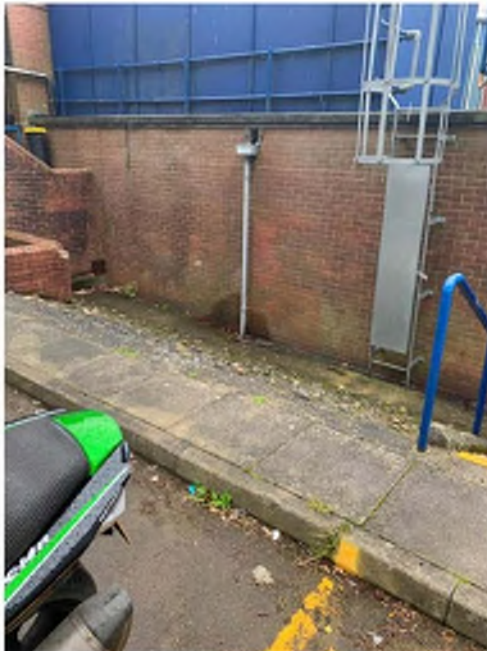
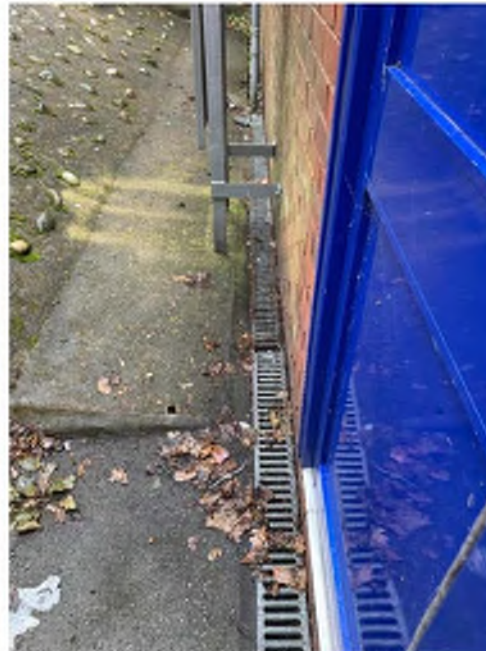
View of rear low level Fire Exit with Rear Lower Level Aco connecting into Gully2, which has allowed water to flood inside Roller City during very heavy rain

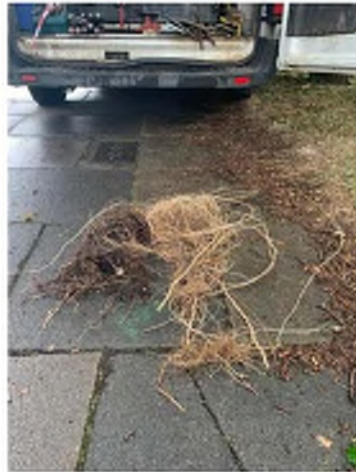
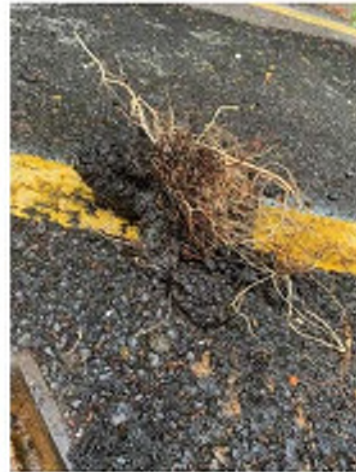
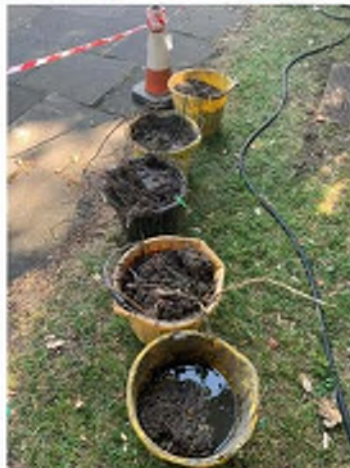
View of examples of debris / roots removed from SW drainage system
