29 Broadwater Road, Welwyn. Herts AL7 3BQ

# PART 1 BS5837 TREE SURVEY, PART 2 INDICATIVE ARBORICULTURAL IMPACT ASSESSMENT AND METHOD STATEMENT.

**Demolition of the existing unit and proposed new  
residential development - updated March 2024**

Elizabeth Greenwood CMLI, F Arbor A.  
[ms.ejgreenwood@gmail.com](mailto:ms.ejgreenwood@gmail.com)

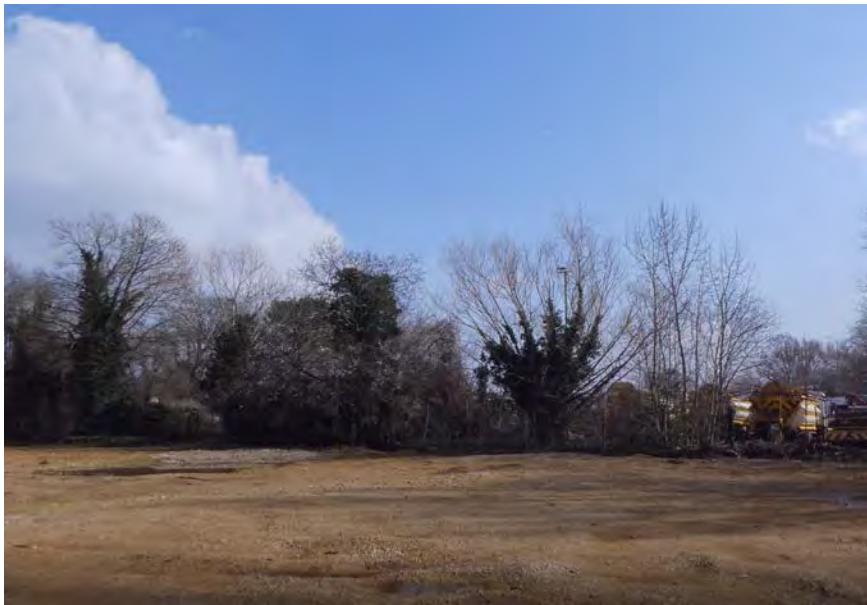
**Above-** the Norway maple, and crack willows along the eastern boundary.

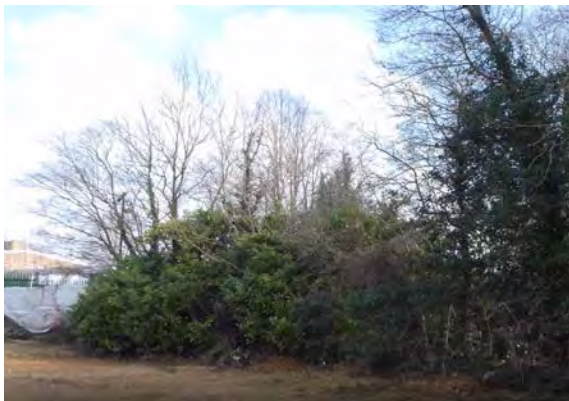
**Below left-** the group of field maples (G1). **Below centre** - ground stripping within the RPA of protected trees. **Bottom** pollarded willow (T7)

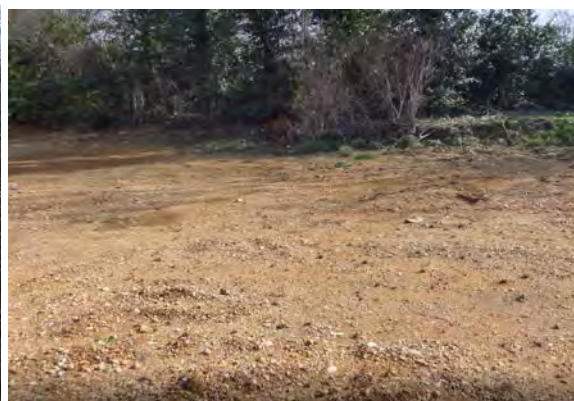
- 1.5.2. The topographical survey shows the ground levels are between 84 to 85 metres on a relatively flat site.
- 1.5.3. A wide grass verge borders the road. Soil has been stripped along this eastern boundary extending into the root protection area of some of the trees.

- 4.2.1. Mitigation will be in form of protection of the crown and the roots of the trees.
- 4.2.2. Owing to the soil stripping which has extended close to the protected trees, some additional soft landscape treatment is recommended, with gravel material removed and replacement soil inserted within the root protection areas of the trees. This is outlined in section 5.5.2.
- 4.2.3 Some crown management of the trees will also be required to safeguard the branches from damage by construction traffic.

Soil stripping has resulted in removal of surface soils within the root protection areas of the protected tree. The recommendations are as following within the root protection area of the protected tree.

- a) use of a soil auger, puncturing the soil throughout the root system to improve soil aeration.
  - b) localized cultivation, e.g. by hand tools or air lances, involving backfilling with loose material.

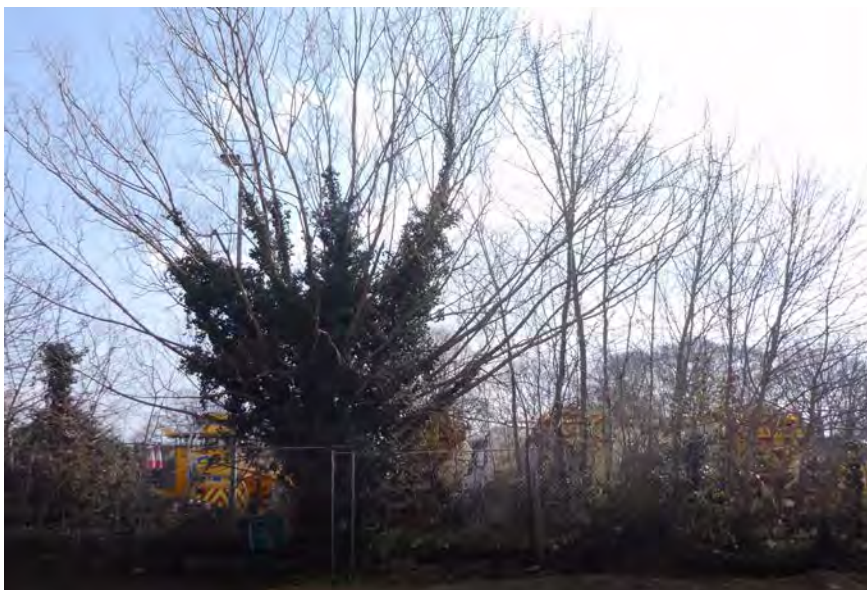
- 3.1.5 A crack willow (T5) is of 'C2' quality and is leaning against the Norway maple (T4). It has storm damage and defective branches within the crown. A further crack willow (T7) which is growing within the edge of the site boundary has been managed as a pollard.

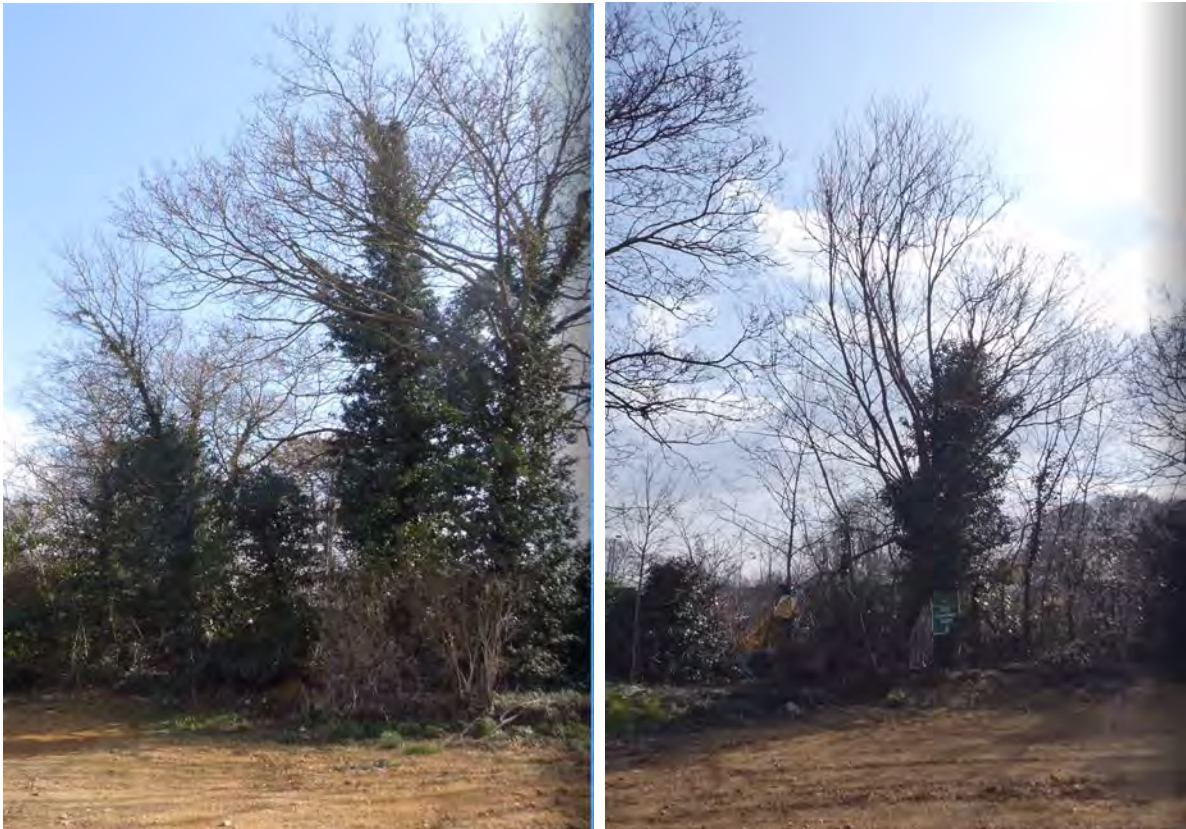
- 3.1.4 Four of the Norway maples along this section (T1, T3, T4, and T6) are also classified as 'B2' quality with prolific ivy within their crowns competing with the crown foliage. Growing as a line of trees, several of the trees have unbalanced crowns. The majority of trees have prolific ivy growth; severing ivy would reduce ivy competition with the crown of the tree and reduce the incidences if storm damage.

**Above left-** a group of field maples (G2) and two Norway maples (T1 and T3). **Above right-** the willow (T5) leaning on the Norway maple (T4) **Below left-** the Norway maple (T13) and sycamore (T14)  
**Below centre and right** - the fastigate oaks (T8-T12)
