Stage 1 Road Safety Audit and Designers Response

Northaw Road, Cuffley Proposed Site Access - Option 2

Stage 1 Road Safety Audit

November 2014

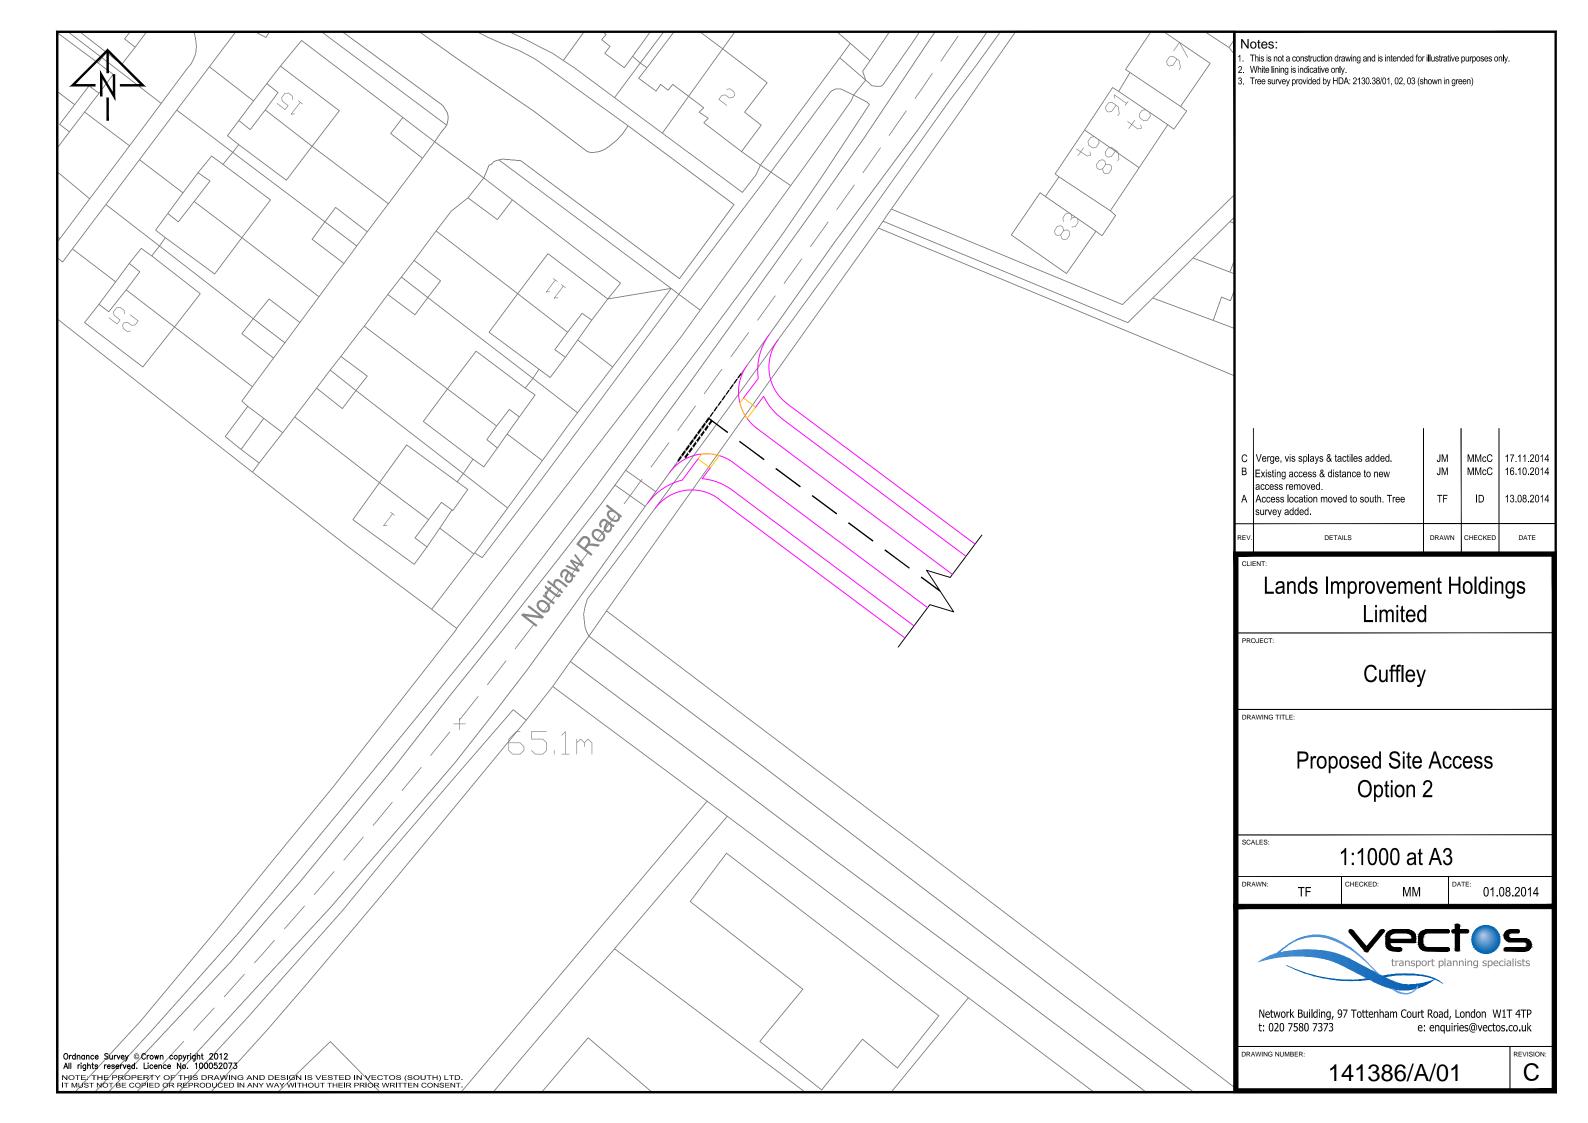
General Arrangement Plan

Summary: Swept path tracking has been provided for a refuse vehicle and fire tender. The swept path manoeuvre for the refuse vehicle is very tight and appears to cross over the footway on the western side of Northaw Road, resulting in potential conflict with pedestrians.

Ensure swept path manoeuvres can be accommodated within the carriageway.

3.4	Location: General Summary: Swept path tracking has been provided for a refuse vehicle and fire tender. The swept path manoeuvre for the refuse vehicle is very tight and appears to cross over the footways on the western side of Northaw Road, resulting in potential conflict with pedestrians.	Ensure swept path manoeuvres can be accommodated within the carriageway.	Noted. The swept path analysis of the refuse truck has been checked and this confirms that the manoeuvres can be undertaken within the carriageway. The updated drawing is included at Appendix A .
