TECHNICAL REPORT ON A SUBSIDENCE CLAIM

Crawford Reference: SU1900914

Mr K & Mrs A Sum
4 Densley Close
Welwyn Garden City
Herts
AL8 7JX

20 March 2019

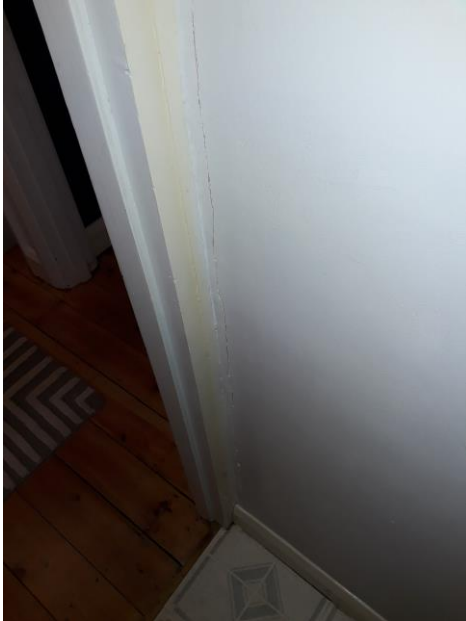
Vertical 1 mm crack on kitchen side adjacent to hall

Kitchen - Vertical crack 1mm wide floor to ceiling to left of door just inside from hallway. Minor 0.5mm crack above kitchen door to hallway- same location as crack in hall. Minor cracks on wall internally below stairways above. Door to hall sticking.

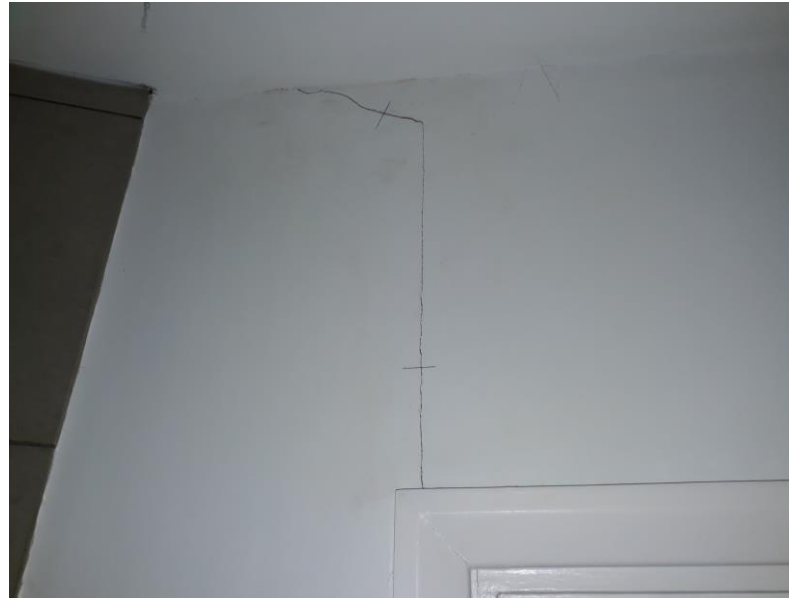
Max 1 mm wide crack - above bathroom door first floor rear

Landing - Less than 1mm wide crack above door to rear bathroom on 1st floor

Bathroom - Less than 1mm wide crack above door into landing - same location as crack in landing. Door to landing sticking

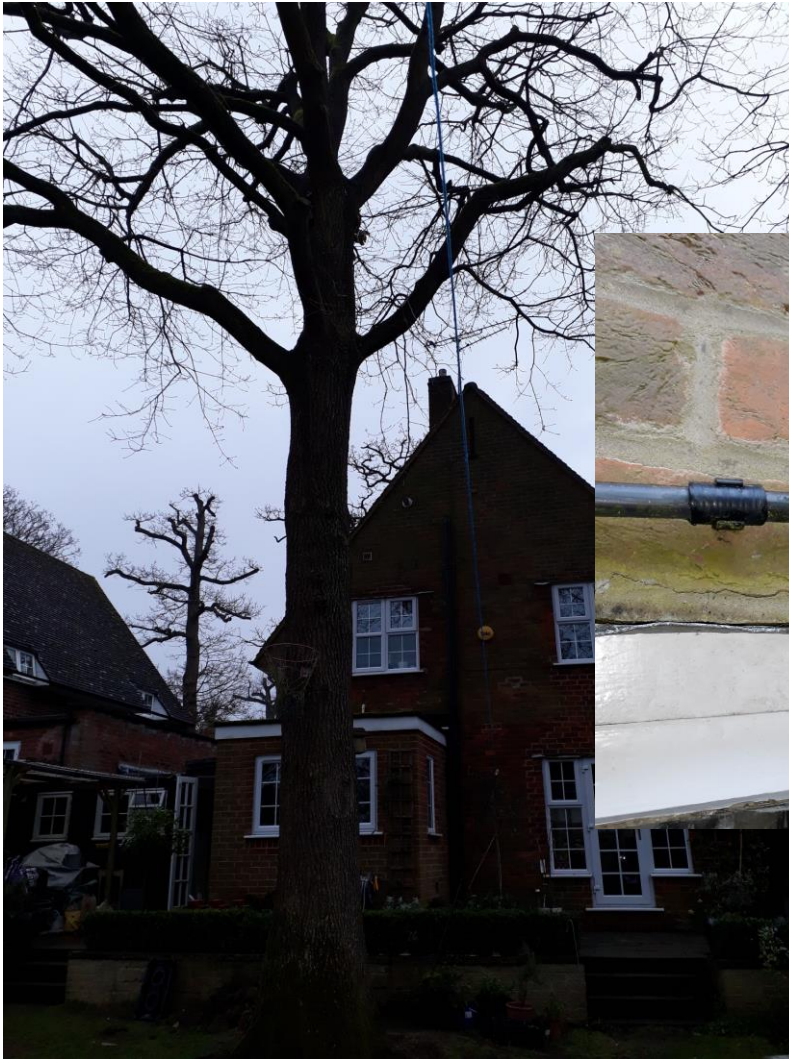
Rear elevation - Minor stepped cracks along mortar line below first floor window - less than 1mm wide.

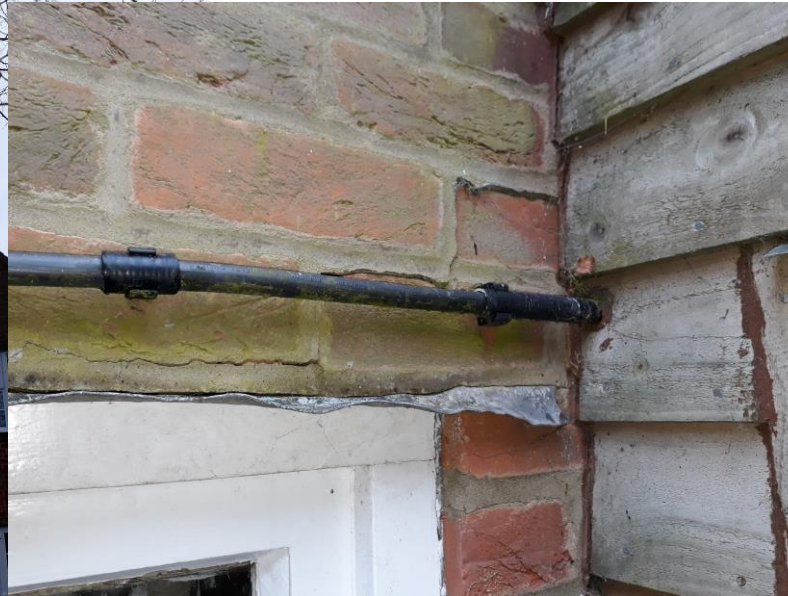
Stepped crack and brick distortion - side flank wall opposite garage

Flank wall - right -- when viewed from front. Minor stepped cracks along mortar line mid way along wall above and below side window. Bricks slightly distorted.

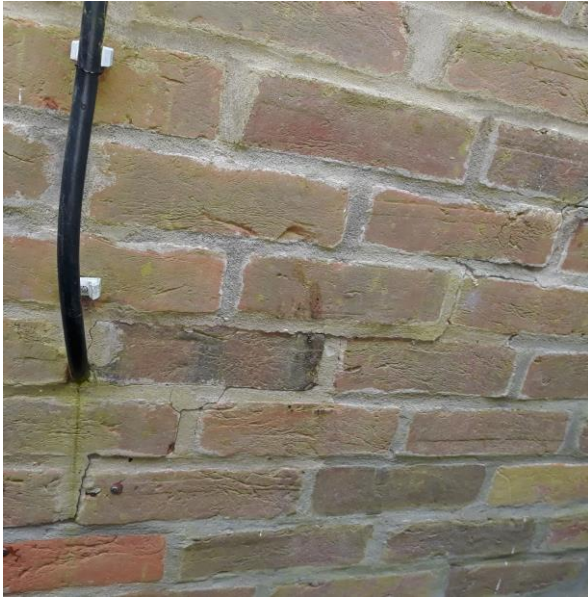
Stepped cracks - opposite garage on side flank wall

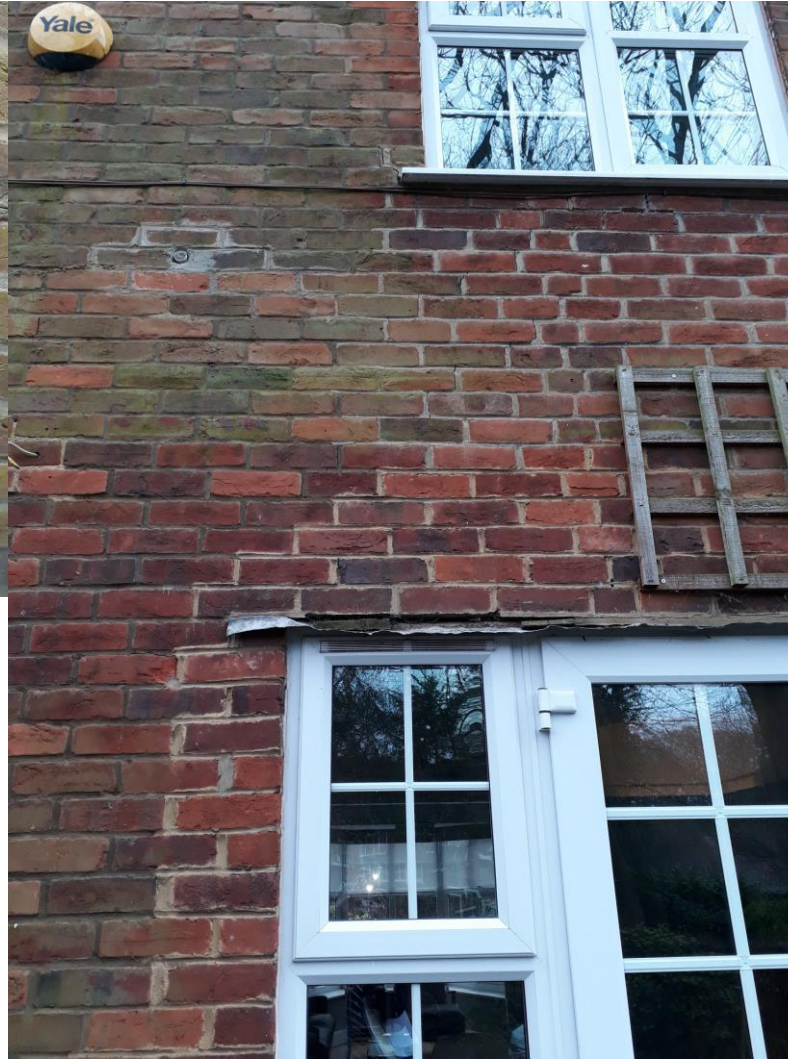
Minor stepped cracks rear elevation - evidence of previous works pre dates Insured's occupation

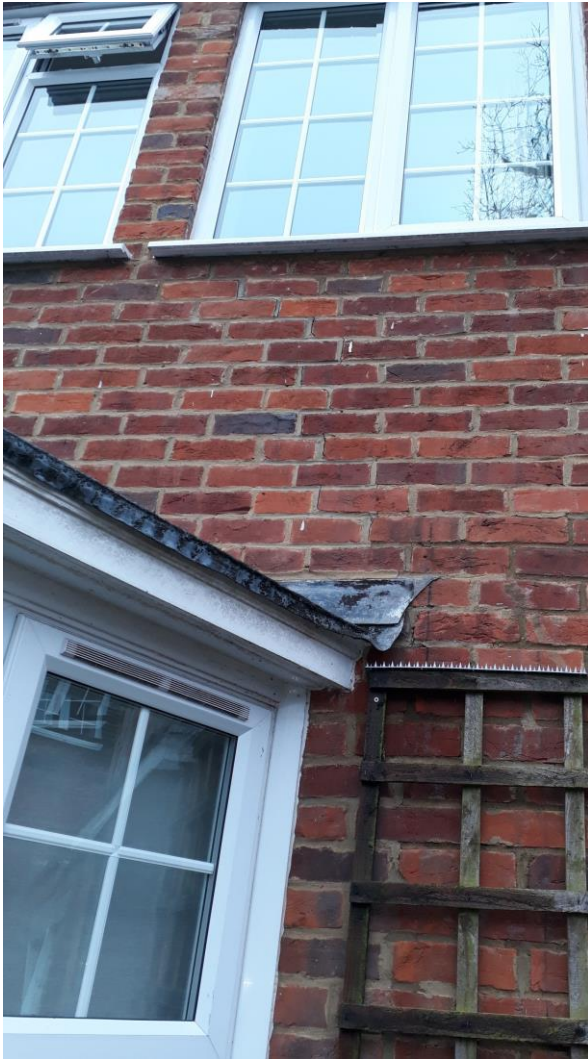
Front elevation -- Minor stepped cracks along mortar line below first floor window - less than 1mm wide.

Minor stepped cracks on front elevation
below first floor window

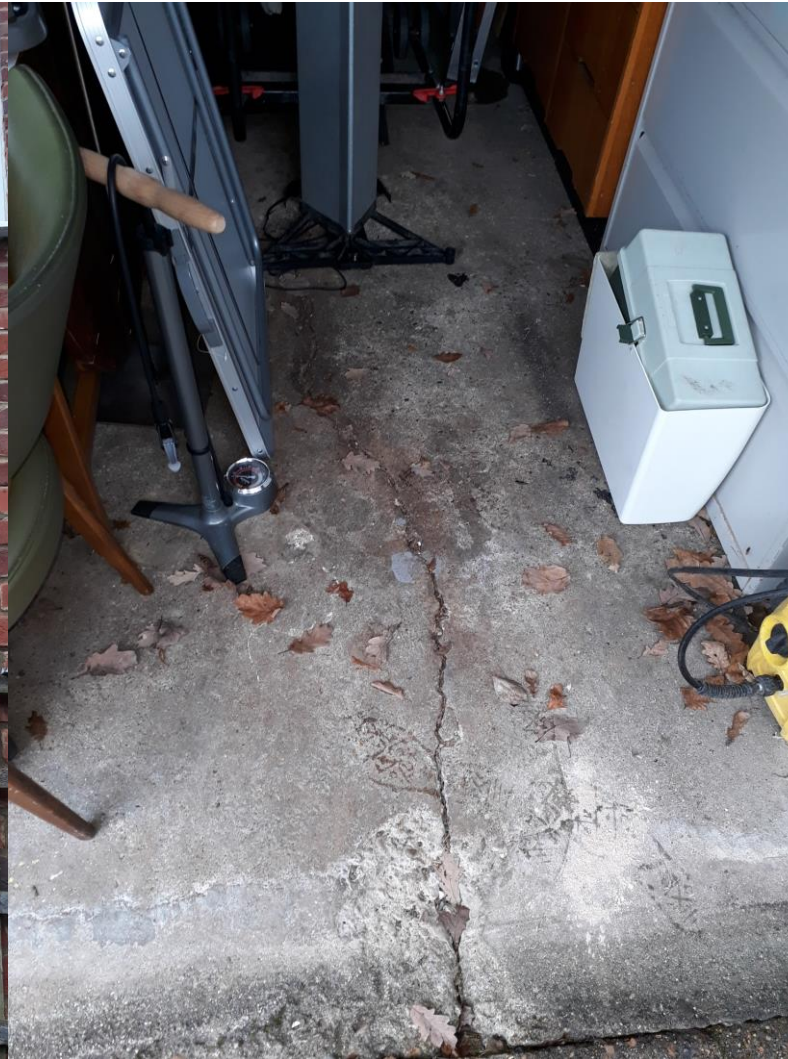
Garage -- Wall facing flank wall of house. Leaning 25mm from vertical towards main house at top. Gap between garage up and over door and wall making door hard to open and close. Cracking in concrete floor of garage.

Crack in garage floor

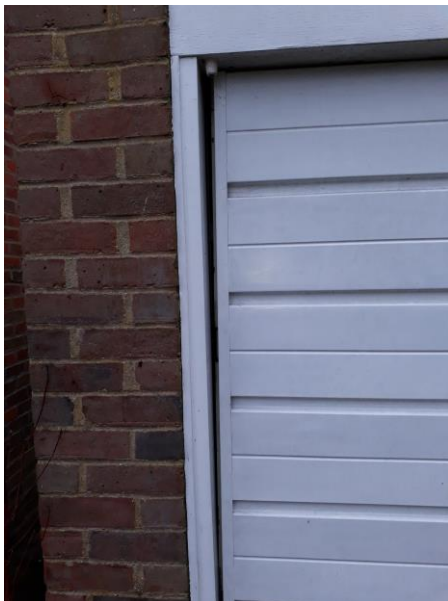
Close up of gap to garage up and over
door

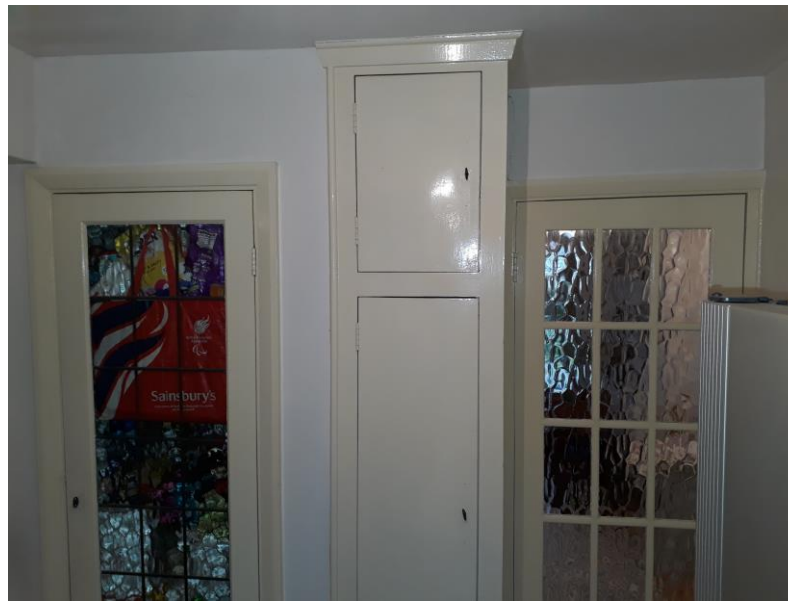
Areas of minor cracking in kitchen on wall
adjacent to hall

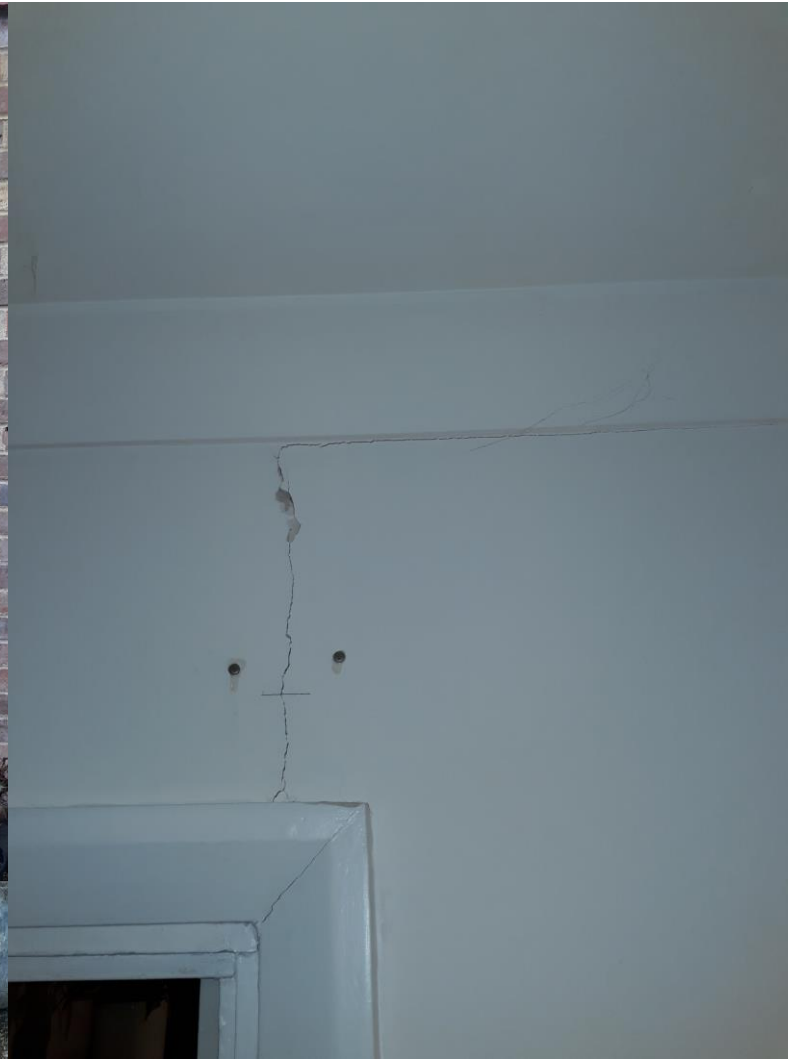
Hallway - Vertical crack less than 1mm wide above door to rear kitchen.

1 mm wide crack above door from hall into kitchen beyond
