Arboricultural Appraisal Report

Subsidence Damage Investigation at:

4 Densley Close
 Welwyn Garden City
 Herts
 AL8 7JX

CLIENT: Crawford & Company
 CLIENT REF: SU1900914
 MWA REF: SUB190724-5156
 MWA CONSULTANT: George Peters BSc. (Hons), M.Arbor.A
 REPORT DATE: 22/08/2019

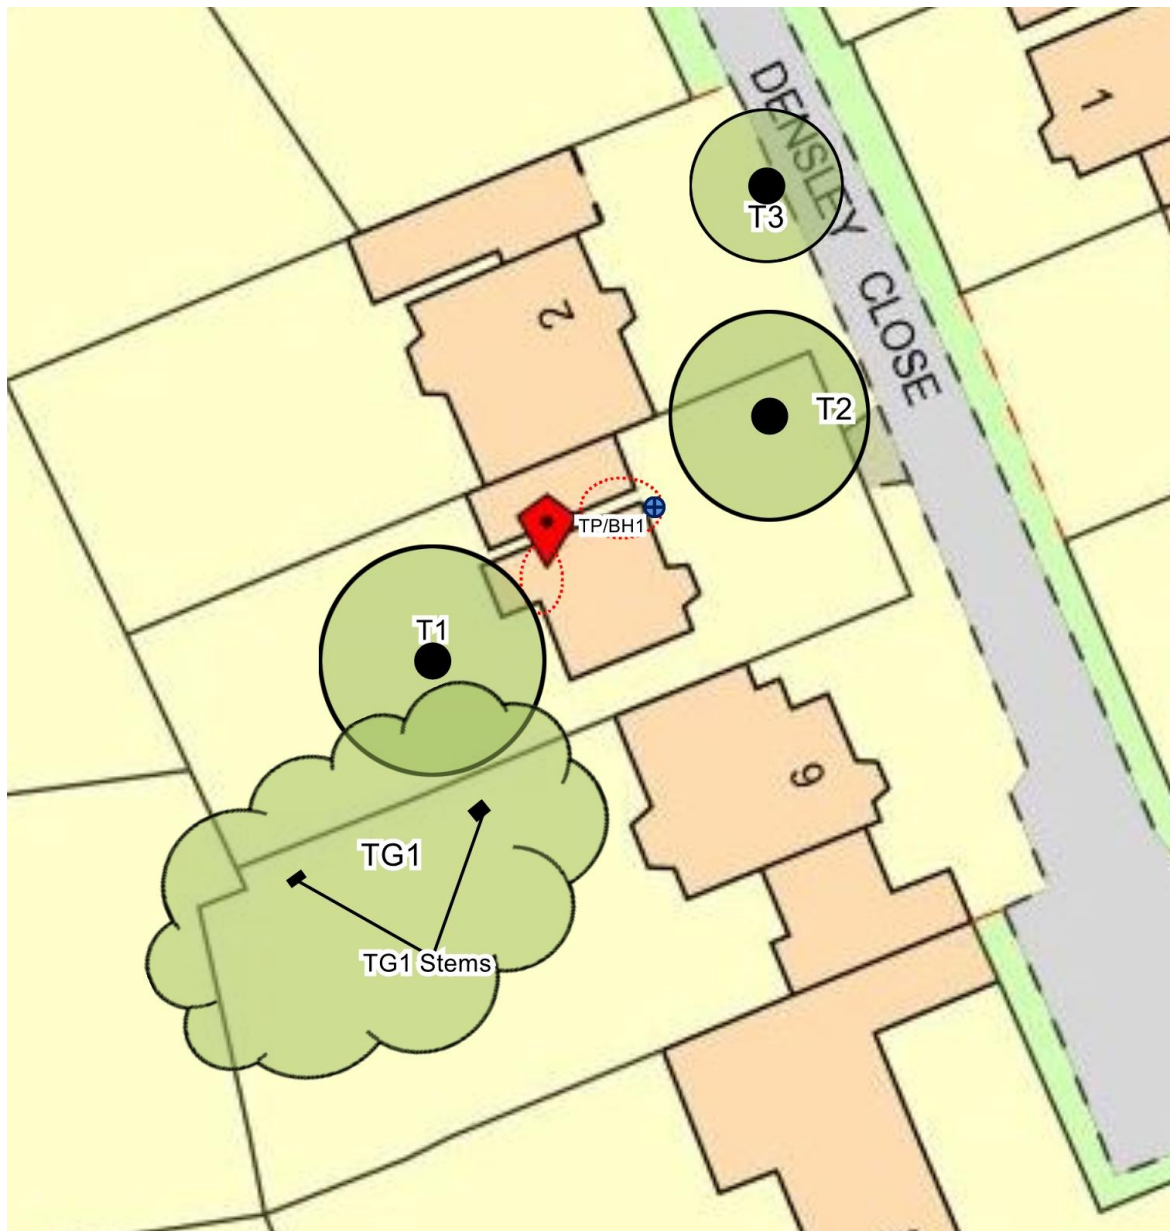
Site Plan

Approximate areas of damage

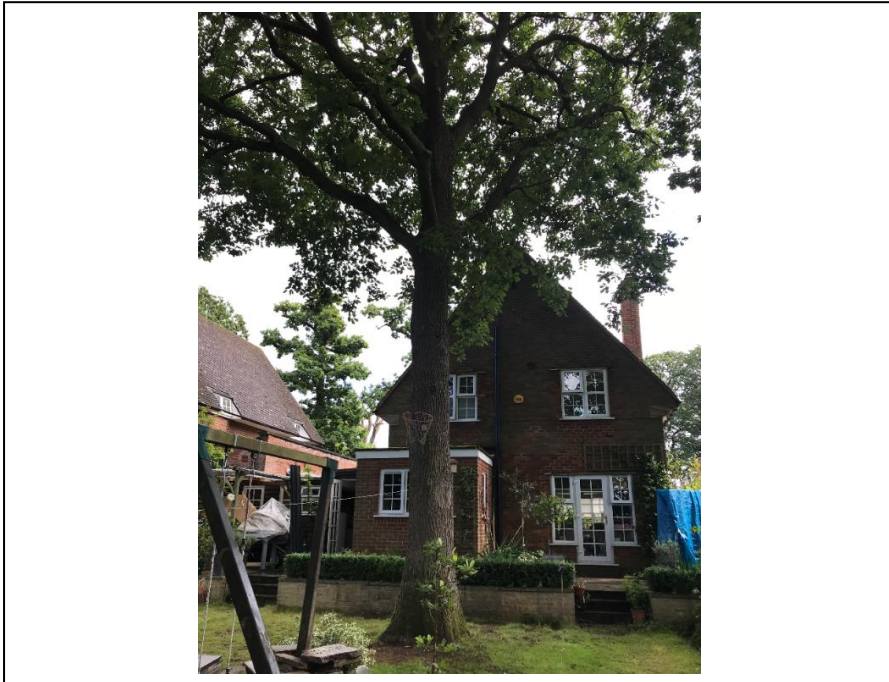
Irrespective of the identification of recovered root samples and relative to the damage at the rear of the property, the roots of T1 (Oak) are likely to be present below foundation level in proximity to the area of movement/damage and influencing soil moisture and volumes.

Based on the technical reports currently available, engineering opinion and our own site assessment we conclude the damage is consistent with shrinkage of the clay subsoil related to moisture abstraction by vegetation. Having considered the information currently available, it is our opinion that T1 and T2 are the principal cause of the current subsidence damage.

View of T1 Oak, current claim

If an arboricultural solution is to be implemented to mitigate the influence of the implicated trees/vegetation we recommend that T1 and T2 are removed. Other vegetation recorded presents a potential future risk to building stability and management is therefore recommended.

Tree No.	Species	Ht (m)	Dia (mm)	Crown Spread (m)	Dist. to building (m)	Age Classification	Ownership
T1	Oak	15 *	800	12	3.5	Younger than Property	Policy Holder
Management history		No recent management noted.					
Recommendation		Remove (fell) to near ground level. Owner to physically remove any regrowth (no chemical treatment due to translocation risk).					
T2	Oak	12	700 *	12	7	Younger than Property	Policy Holder
Management history		No recent management noted. Spindle Shank at base. Tree is in decline. From a tree hazard perspective this tree represents an unacceptable level of risk.					
Recommendation		Remove (fell) to near ground level. Owner to physically remove any regrowth (no chemical treatment due to translocation risk).

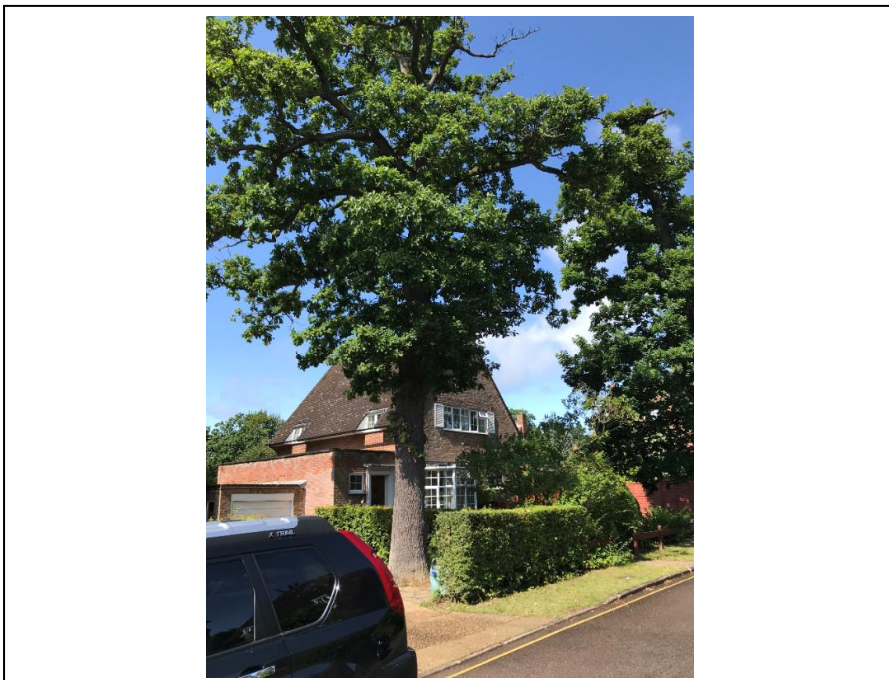
Roots were observed to a depth of 100mm bgl in TP/BH1 and recovered samples have been positively identified (using anatomical analysis) as *Quercus* spp., the origin of which will be T2 (Oak) confirming its influence on the soils below the foundations.

View of T2 Oak, current claim.

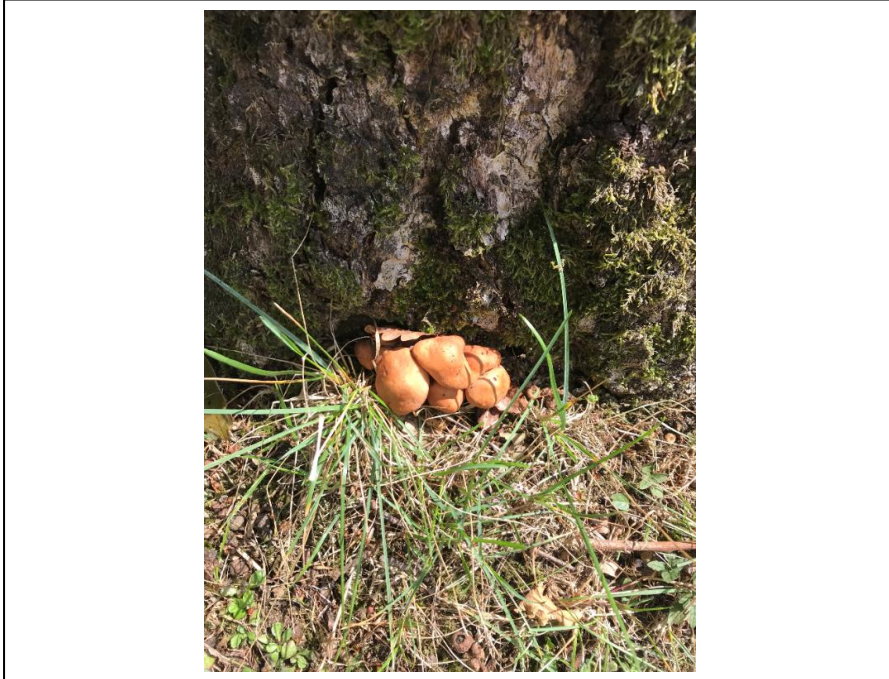
View of Spindle Shank at base of T2.

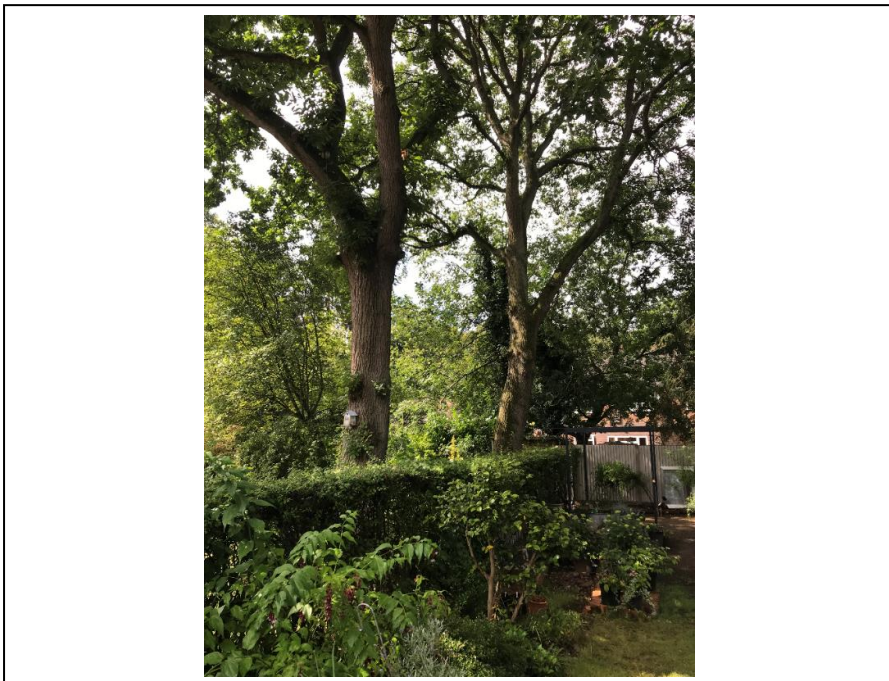
View of TG2 Oak, future risk.

Tree No.	Species	Ht (m)	Dia (mm)	Crown Spread (m)	Dist. to building (m)	Age Classification	Ownership
T3	Oak	15	700	8	14	Younger than Property	Third Party: 2 Densley Close, AL8 7JX
Management history		No recent management noted.					
Recommendation		Maintain broadly at no more than current dimensions by periodic pruning.					
TG1	Oak	15	900 *	20	10	Younger than Property	Third Party: 6 Densley Close, AL8 7JX
Management history		No recent management noted.					
Recommendation		Maintain broadly at no more than current dimensions by periodic pruning.
