Details to 15 Park Street, pertaining to S6/2014/1564/FP - S6/2014/1566/LB

Andrew Starr 16 November 2014

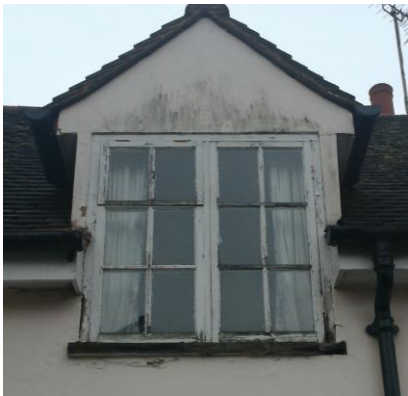
Figure 1 – front upstairs left

The existing windows are in softwood and single glazed. The upstairs windows (3 off) are flush casements, each with two opening lights and narrow plain chamfered glazing bars (figures 1 and 2). The state of repair is very poor, with a quantity of putty and paintwork missing. Several sills are badly rotted. Variation in the existing design shows signs of replacement, with differing casement sections and glazing bars.

The pattern of the windows is proposed to be the same light arrangements as the existing ones. All new windows are proposed with:

- pine frames
- flush casement
- full sill
- weather bar above
- double glazing
- plain chamfered glazing bars
- finished in white paint.

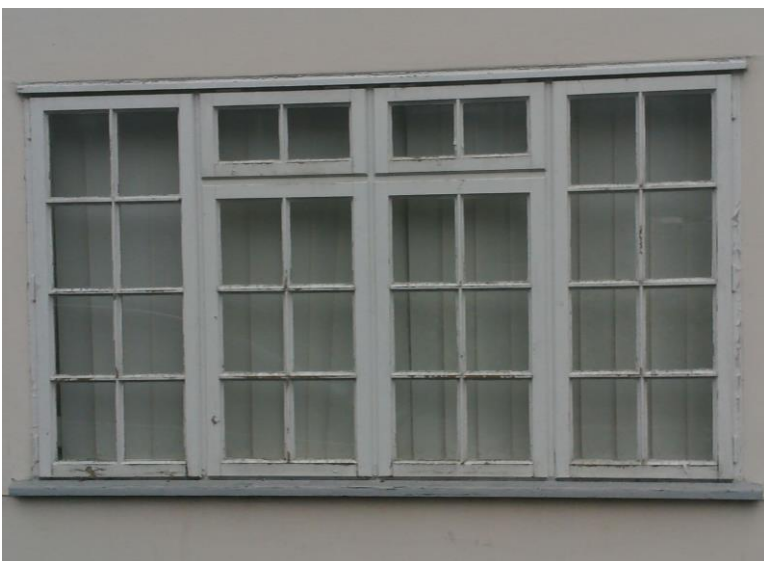
Figure 3 – front downstairs

The downstairs window is a “stormproof” casement with four opening lights and narrow plain chamfered section glazing bars (figures 3 and 4).

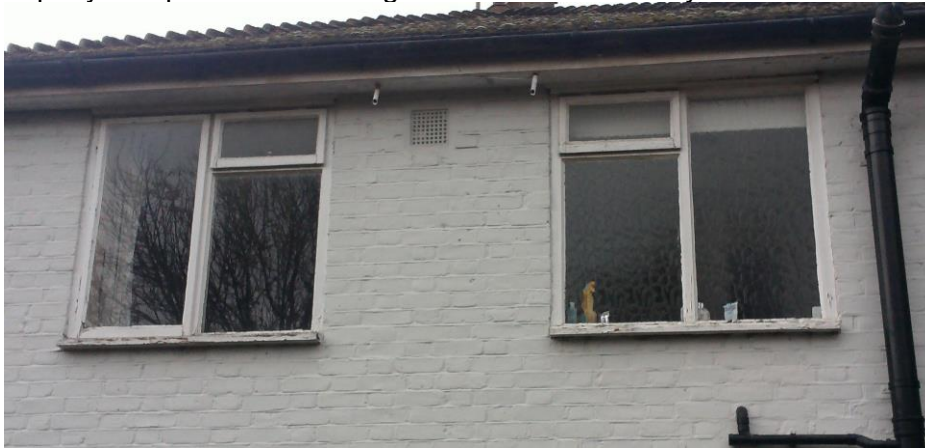
Figure 5 – rear upstairs

The existing windows are in softwood and single glazed. The upstairs windows (2 off) are “stormproof” casements with no glazing bars. The bedroom window has two opening lights and the bathroom window has one (figure 5). The state of repair is very poor, with a quantity of putty and paintwork missing. Several sills are badly rotted.

The pattern of the windows is proposed to be the same light arrangements as the existing ones. All new windows are proposed with:

- pine frames
- stormproof casement
- full sill
- weather bar above
- double glazing (bathroom windows obscured)
- no glazing bars
- finished in white paint.

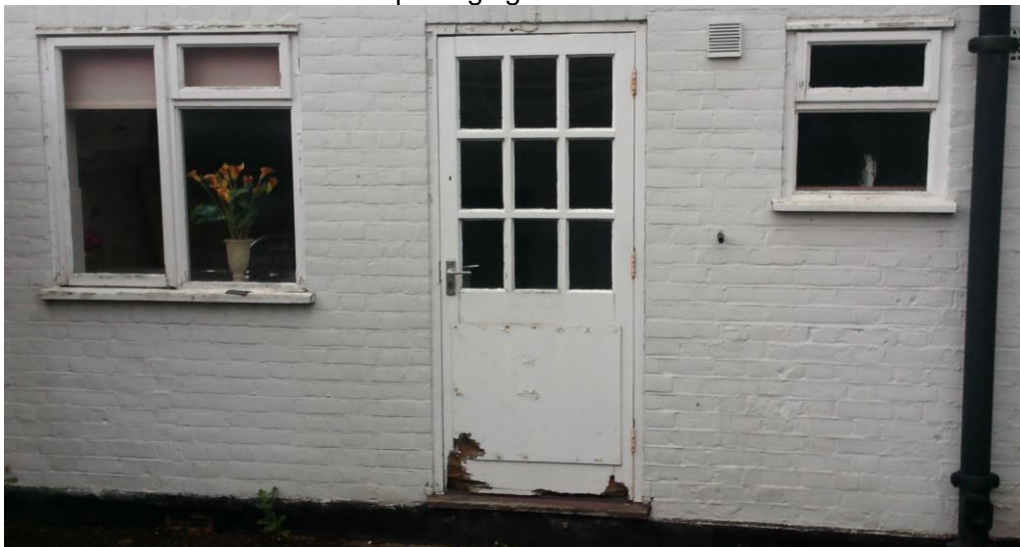
Figure 6 – rear downstairs

Downstairs the existing windows (2 off) are “stormproof” casements with no glazing bars. The kitchen window has two opening lights and the bathroom window has one (figure 6).

The existing door is a pine 9-light door in very poor repair (see figure 6 above).

It is proposed to change the door for a six-light wood door similar to figure 9, glazed in clear glass. To be finished in white paint.

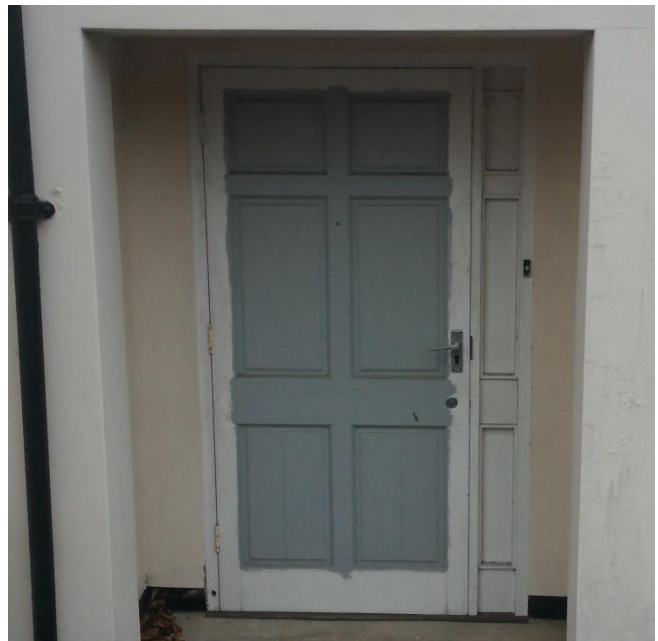
Figure 7 above

The existing door is a pine 6-panelled door which permits no light into the hallway (figure 7).

It is proposed to change the door for a two-light wood door similar to figure 8 (for illustration - it is possible that this will have to be custom made, because the existing doorway is unusually wide). To be finished in white paint.

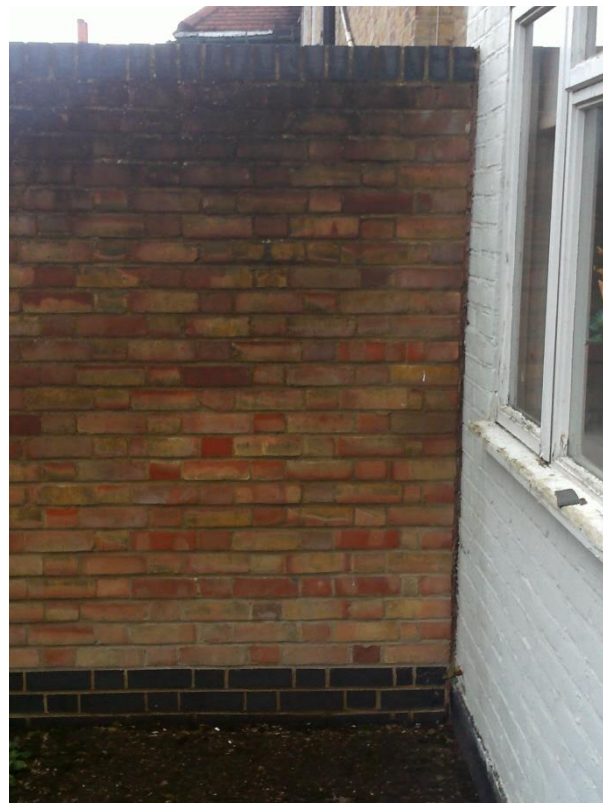
Figure 10 – wall to be altered

The garden wall is constructed of local stock brick in Flemish bond with blue engineering brick footings and a single blue brick capping (figure 10). The materials and construction are late C20th.

It is proposed to cut the wall to create access of width 1m to the adjoining alley. A gate will be constructed from reclaimed materials (figure 11), ledged & braced, hung with galvanised hardware, and fitted to secure the access.

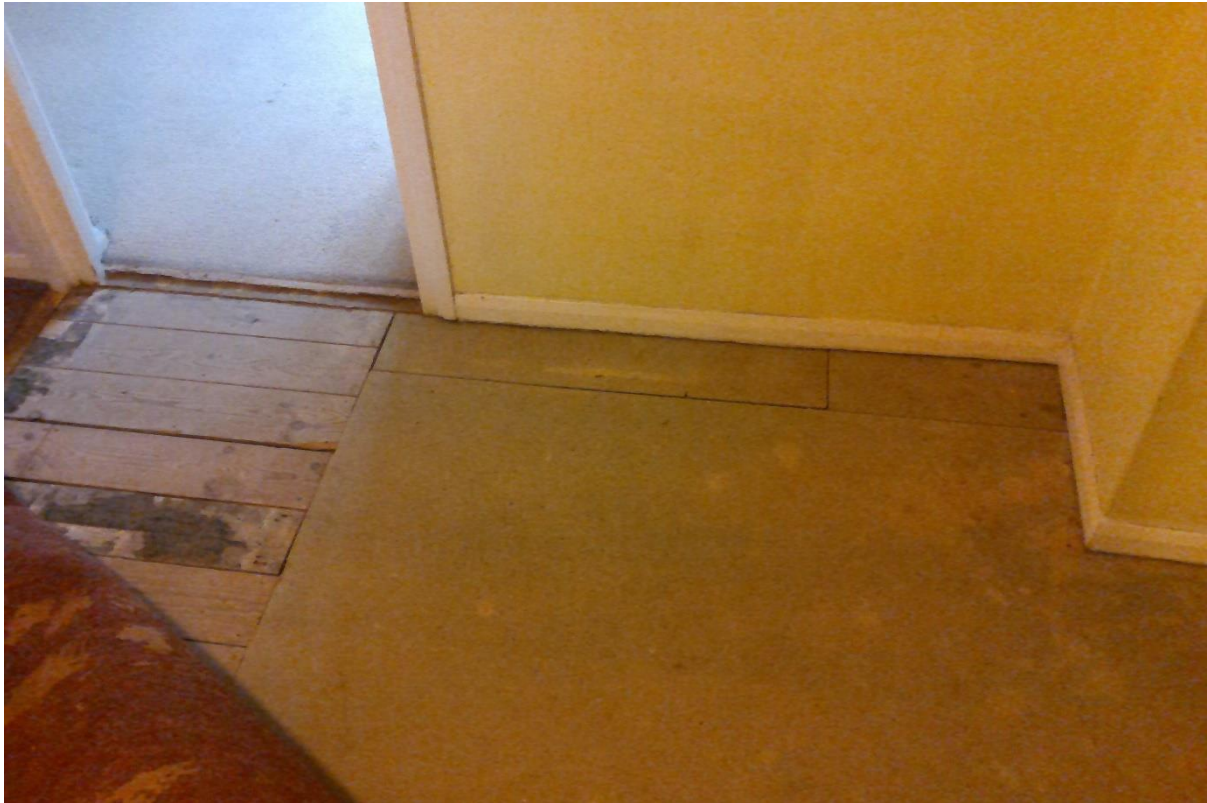
Figure 12

The stairs were removed at an unknown date between 1960 (new built) and 2011. The former stairwell void is clearly shown under the carpet of the landing, in green flooring-grade chipboard, set into the 1960 pine floorboards (figure 12).

It is proposed to reinstate the stairs to the same pattern as the neighbouring terrace, number 17 Park Street, which was built at the same time, in mirror image. The aim is to use modern materials to reinstate a construction similar in style to the 1960s neighbours.
