Arboricultural Appraisal Note

Project: Wells Farm, Cuffley, Potters Bar **Ref:** BMD.19.004.12.TN.002_A
Subject: Arboricultural Desk Review of Access Points **Date:** 12/11/2020
Status: FOR INFORMATION **Rev:** A

Review of existing Access Point off Northaw Road East (B156)

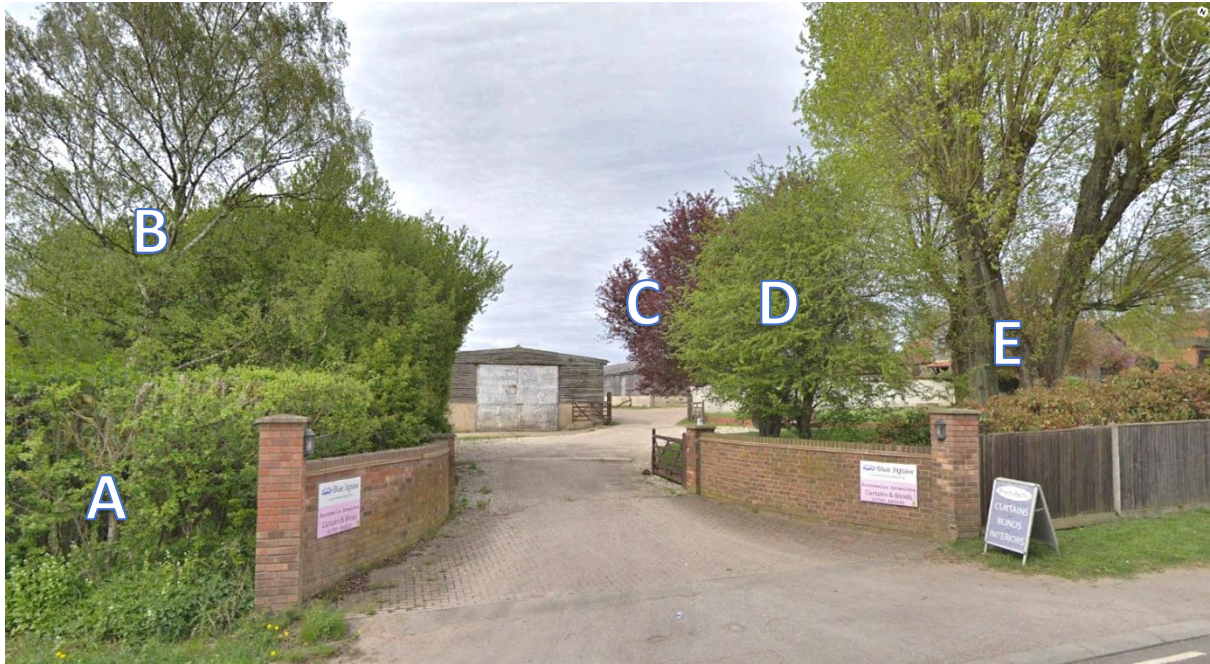
- 1.10 There is a valuable hedge along the south-east boundary which should be retained if possible (marked as A on Fig. 1).
- 1.11 Tree B is a Silver Birch. It is too far from the existing access to be a constraint.

- 1.12 There is an ornamental Purple Leaf Plum and a Crab Apple tree where the access opens out into the site (marked as C and D). These look to be in reasonable condition and would make an attractive feature.

- 1.13 There is a large tree (Tree E) to the right of the entrance which is in poor condition due to historic pruning. If retained, it may need to be pollarded.

Fig. 1 Image taken from Google Earth dated 4/2018. Hedge A and Trees B-E are labelled © 2019 Google Maps

- 1.14 Forming a suitable access for residential development will not have any significant arboricultural implications.
