Heritage Statement

Application ref: **6/2024/0268/LB**

Relating to Flat 11, Astwick Manor, Coopers Gren Lane, Hatfield, AL10 9BP.

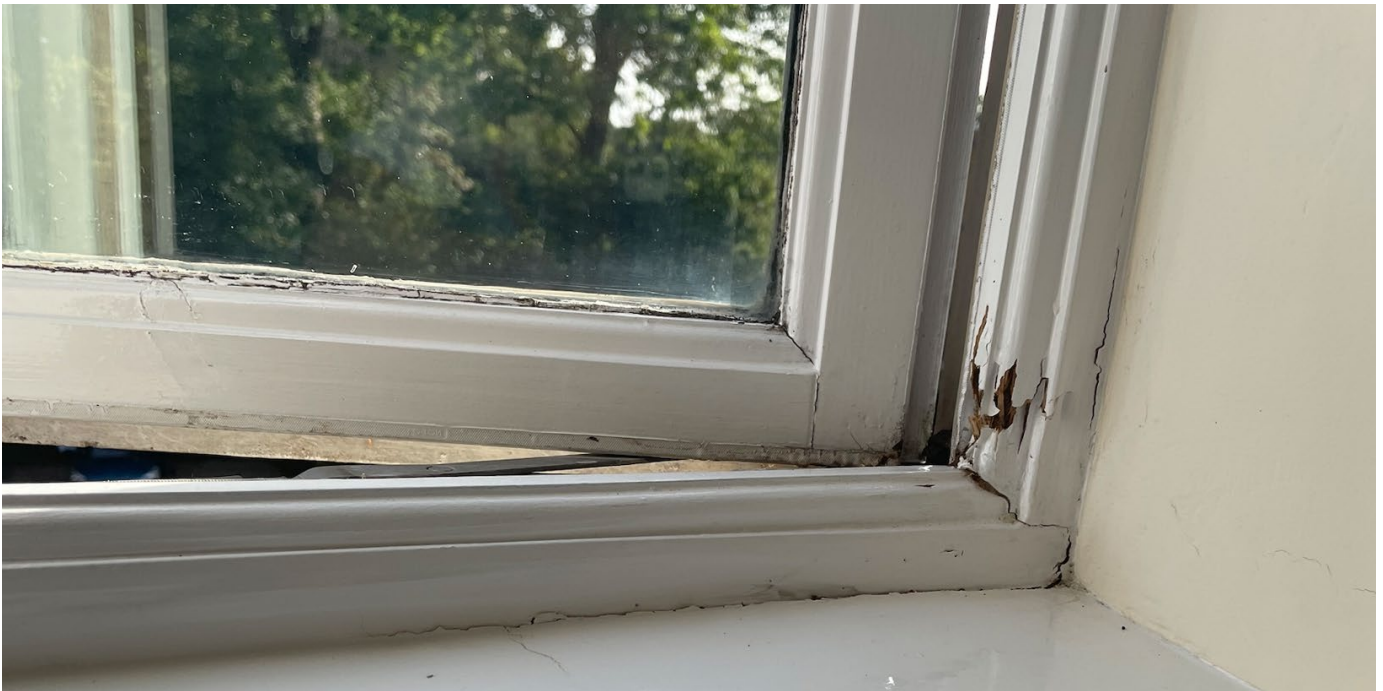
Image1

My main bedroom window (see image 1 below) is the worst affected. The rotten wood extends upwards on the right by about 10inches, and all the way across the bottom of the frame making the window hinges unstable. Image 2 shows how the water is seeping in and swelling the wood of the window-sill.

These images were taken in Sept 23 and have since got much worse. After the recent bad weather and high winds, the window was shaking in the frame, and I am now concerned it poses a danger if it falls out or blows inwards.

I have sought, and found, a window provider and installer (Anglian) who are able to match the existing windows like for like in design, style and measurement with a wood grain look. Therefore (appreciating it's my opinion), I see no negative impact to the overall look of the building – indeed only a positive. From an external point of view, the windows would like identical to the existing windows should they be only redecorated, it will improve the look of the property and in turn the building, whilst keeping in line with the current style. It will also ensure safety to others outside the building, considering the state of the current windows today. Internally, the proposed windows will be both safer and more energy efficient. There will be no structural changes or impact on any other property or surrounding land. This I hope demonstrates the avoidance of or minimal adverse impact on the the significance of the building.

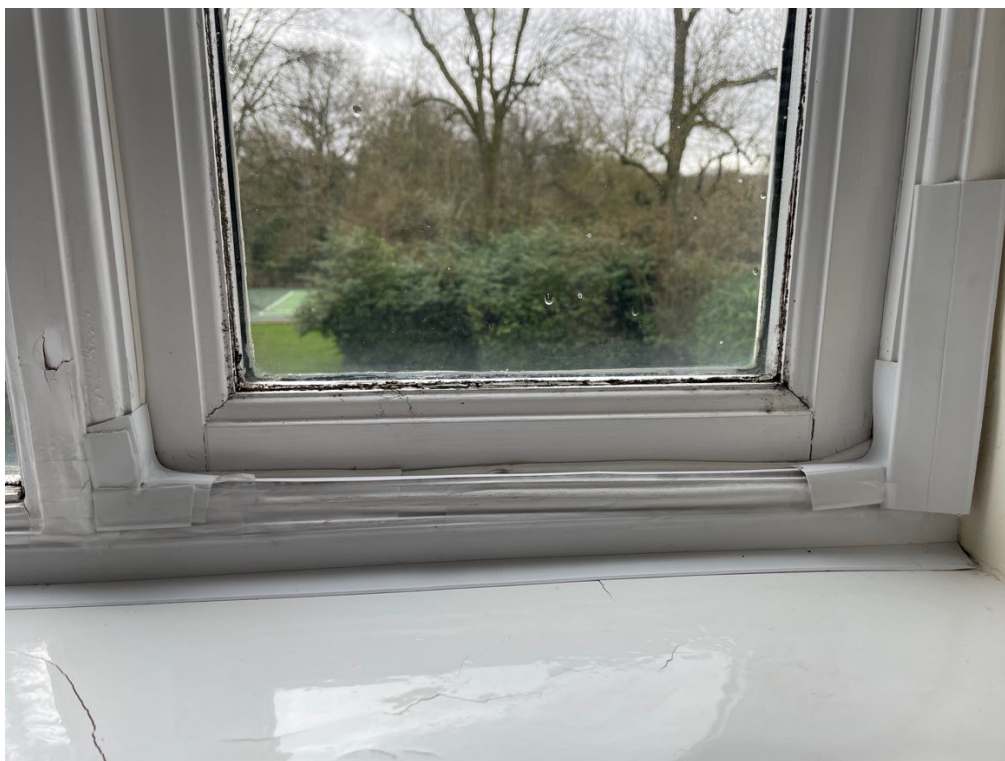
As a result, I have added plastic waterproof sealing strips to the open areas inside and out to both protect further damage to the paint to stop it from exposing more rotten wood and to stop water coming in through the window frame. Please see image below.

I am unable to provide an image of the same protection on the outside as I am not confident in opening the window since I've added it.
