BS 5837:2012 Arboricultural Survey, Impact Assessment and Method Statement

Premier Inn Welwyn Garden City
for:

Whitbread Plc

SHF.1483.003.Ar.R.001.B

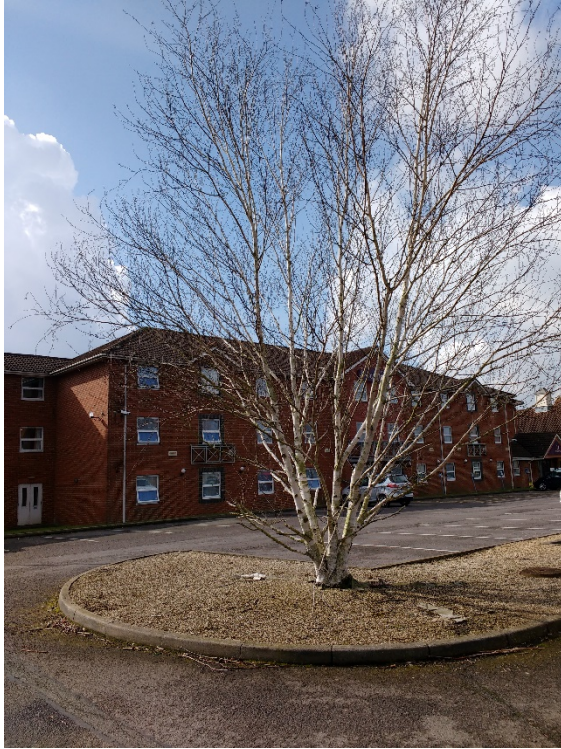
Ref	Species	Ht (m)	Stem dia (cm)	Canopy spread (m)				Clear crown	Life stage	RULE	Cond.	Notes (Including preliminary management recommendations)	BS Cat.	RPA (m)	RPA (m ²)
				N	E	S	W								
G10	Himalayan birch (<i>Betula utilis jaquemontii</i> 'Doorenbos')	10	25 (average combined stem diameter)	4	4	4	4	0.5	EM	20+	Good	Three trees forming part of ornamental car park planting, multi-stemmed cultivars	C2	3.00	28.2
G11	Mixed hedgerow	Up to 14m	20	See plan				5	M	40+	Good	Mixed mature screen planting within adjacent housing estate, including eucalyptus, laurel and maple species	B2	2.40	18.1
T12	Ash (<i>Fraxinus excelsior</i>)	16	55	4	3	4	4.5	5	M	40+	Good	Mature tree, past crown reduction measures including pollarding at 7-8m and crown lift over adjacent car park and highway	B2	6.60	136.8
T13	Ash species (<i>Fraxinus sp.</i>)	5	12	2	2	2	2	2	YNG	20+	Fair	Some recent bark damage at 1m, possibly caused by chaffing of tree tie (recently removed but remaining attached to tree stake to north of stem)	C1	1.44	6.5

Plate 1: Himalayan birch in hotel car park

4.2.1 All three trees within group G10 (Himalayan birch) will need to be removed to facilitate the construction of the hotel extension and the construction of additional car parking spaces. Although in good condition, these are located in the centre of the site and their removal is not expected to have any impact on the local landscape. They are also relatively young, therefore replacement tree planting is expected to quickly mitigate the loss of these trees.

5.1.1 Prior to the site being set-up, a qualified arborist will remove the three trees within G10 (Himalayan birch). No other trees should be removed. To find a suitably qualified tree surgeon, please refer to the Arboricultural Association's list of Registered Contractors.

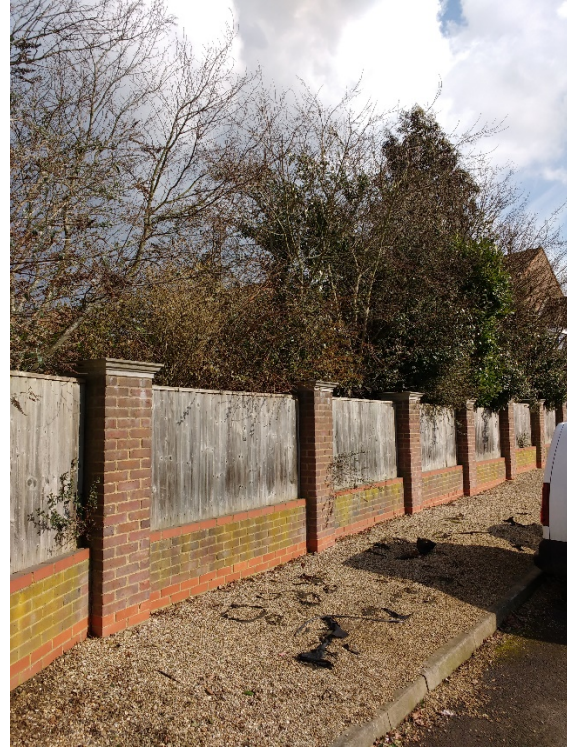
Plate 2: Ornamental screen planting along north boundary

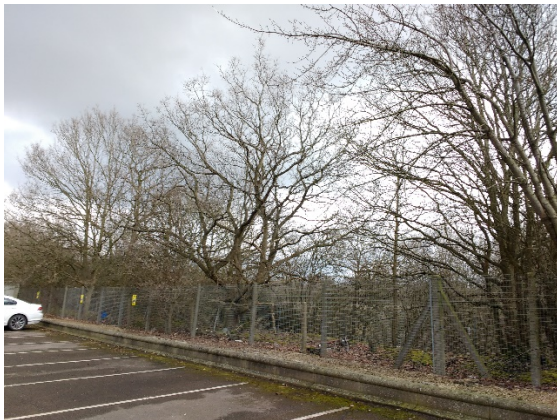
T5	Pedunculate oak (<i>Quercus robur</i>)	20+	35+ 30+ 25+ 18+ 15+ 11 (estimated)	5.5	6	5	8	1.6	M	40+	Good	Mature multi-stemmed tree located outside site boundary, on top of steep railway embankment to east, canopy slightly overhanging site boundary	B2	6.60	136.8
T6	Pedunculate oak (<i>Quercus robur</i>)	20	40+ 38+ 30+ 28 (estimated)	5.5	7	6	5.5	0.5	M	40+	Good	Multi-stemmed tree located off site, oak marble galls visible on tip of some branches	B2	8.28	215.3
T7	Pedunculate oak (<i>Quercus robur</i>)	20+	35+ 30 (estimated)	5.5	2	6	7	2.5	M	40+	Good	Twin-stemmed tree outside site boundary	B2	5.52	95.7
T8	Pedunculate oak (<i>Quercus robur</i>)	20+	50 (estimated)	7.5	7	7	7.5	2.5	M	40+	Good	Located outside site boundary	B2	6.00	113.1
T9	Wild cherry (<i>Prunus avium</i>)	10	10	3	2	2.5	4	0.5	YNG	10+	Fair	Located close to boundary fence	C1	1.20	4.5

Plate 3: Mature oak and hawthorn along eastern boundary

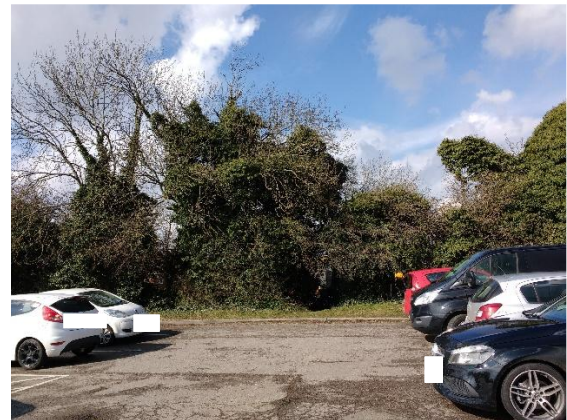
G14	Mixed hedgerow	Up to 15m	30 (average)	See plan				0	M	40+	Good	Mixed screen hedgerow between car park and footpath, includes ash and hawthorn, heavily ivy covered with moderate bat roost potential	B2	3.60	40.7
T15	Ash (<i>Fraxinus excelsior</i>)	20	45	6	5	4	6	2	M	40+	Good	Ivy covering stem up to 8m, moderate bat roost potential)	B2	5.40	91.6
T16	Maple species (<i>Acer sp.</i>)	9	25	3	3	3	3	0.5	M	20+	Good	Stake remaining adjacent to stem, low fork at 0.4m	C2	3.00	28.2
T17	Maple species (<i>Acer sp.</i>)	8	21	3	3	3	3	0.5	M	20+	Good	Stake remaining adjacent to stem, low fork at 0.5m	C2	2.52	19.9

Plate 4: Mature ash and dense ivy growth in the south-western corner of the site

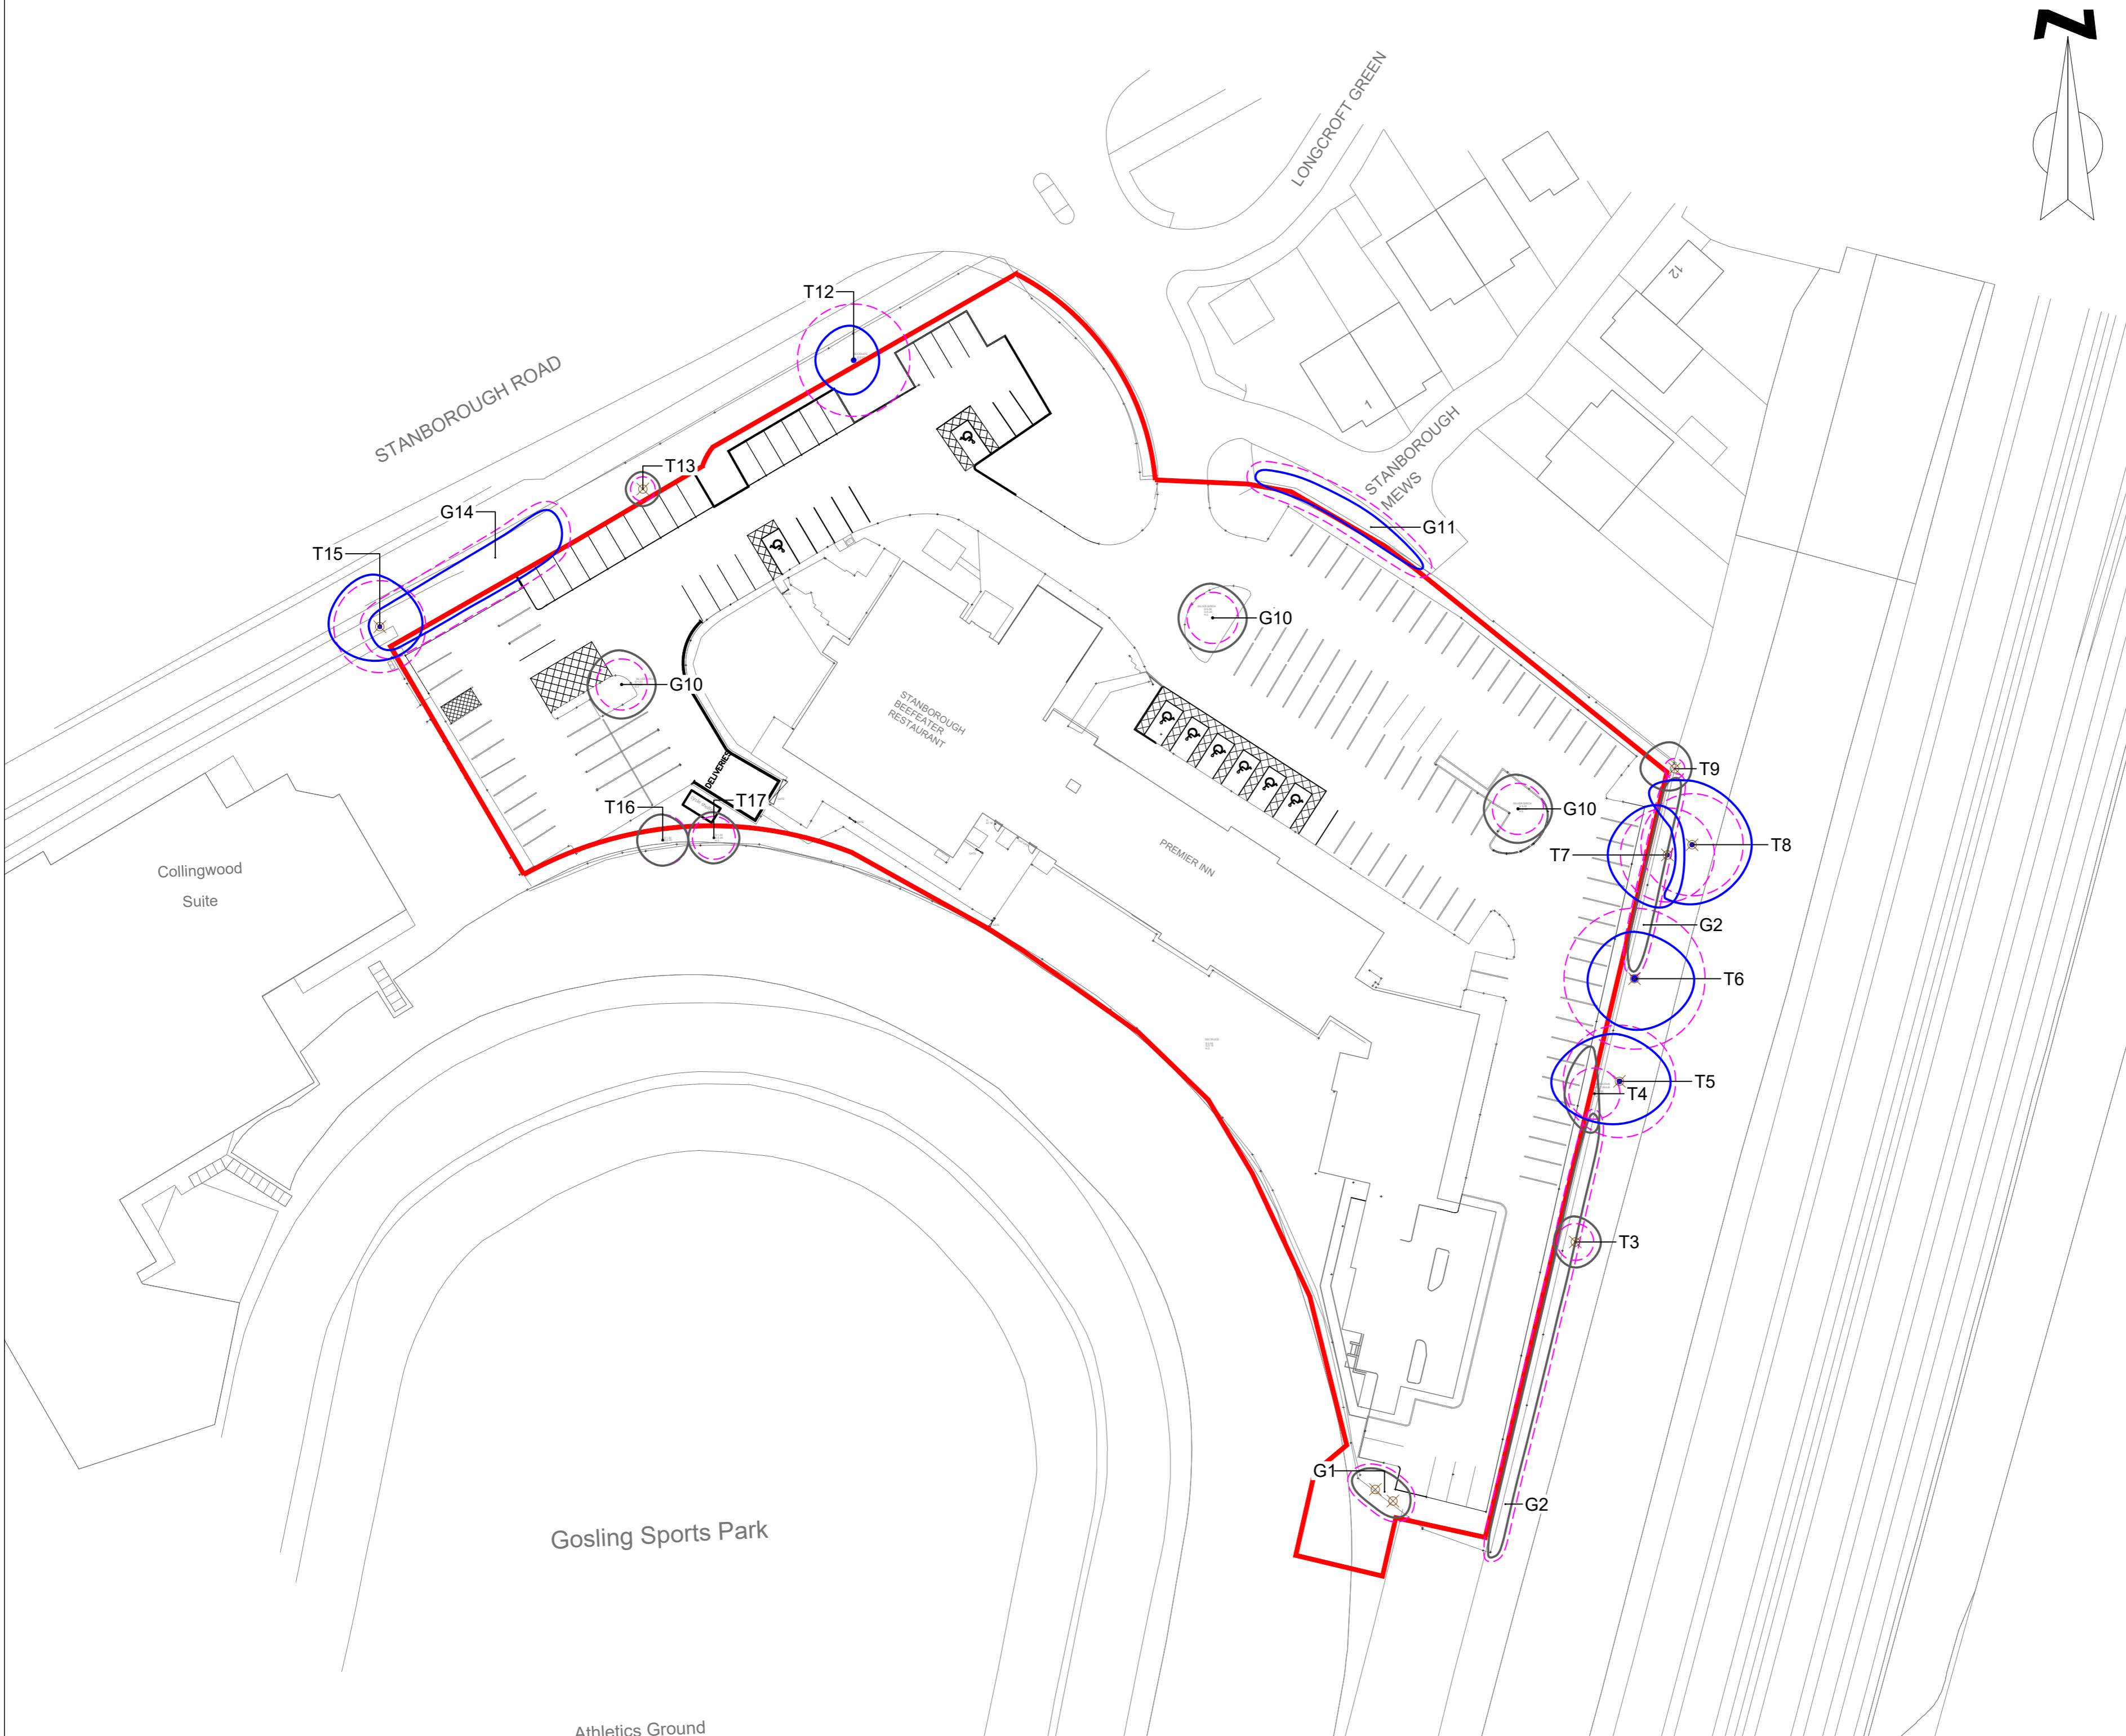
FIGURE NO: SHF.1483.003.Ar.D.001

3.4.1 The Root Protection Areas for each Category A to C tree and tree group has been calculated based on measured stem diameters. Both the radius and the area of each RPA are listed in [Appendix 1 - Arboricultural Survey Schedule](#) and shown on the plan included in [Appendix 3 – Tree Survey and Tree Constraints Plan](#).

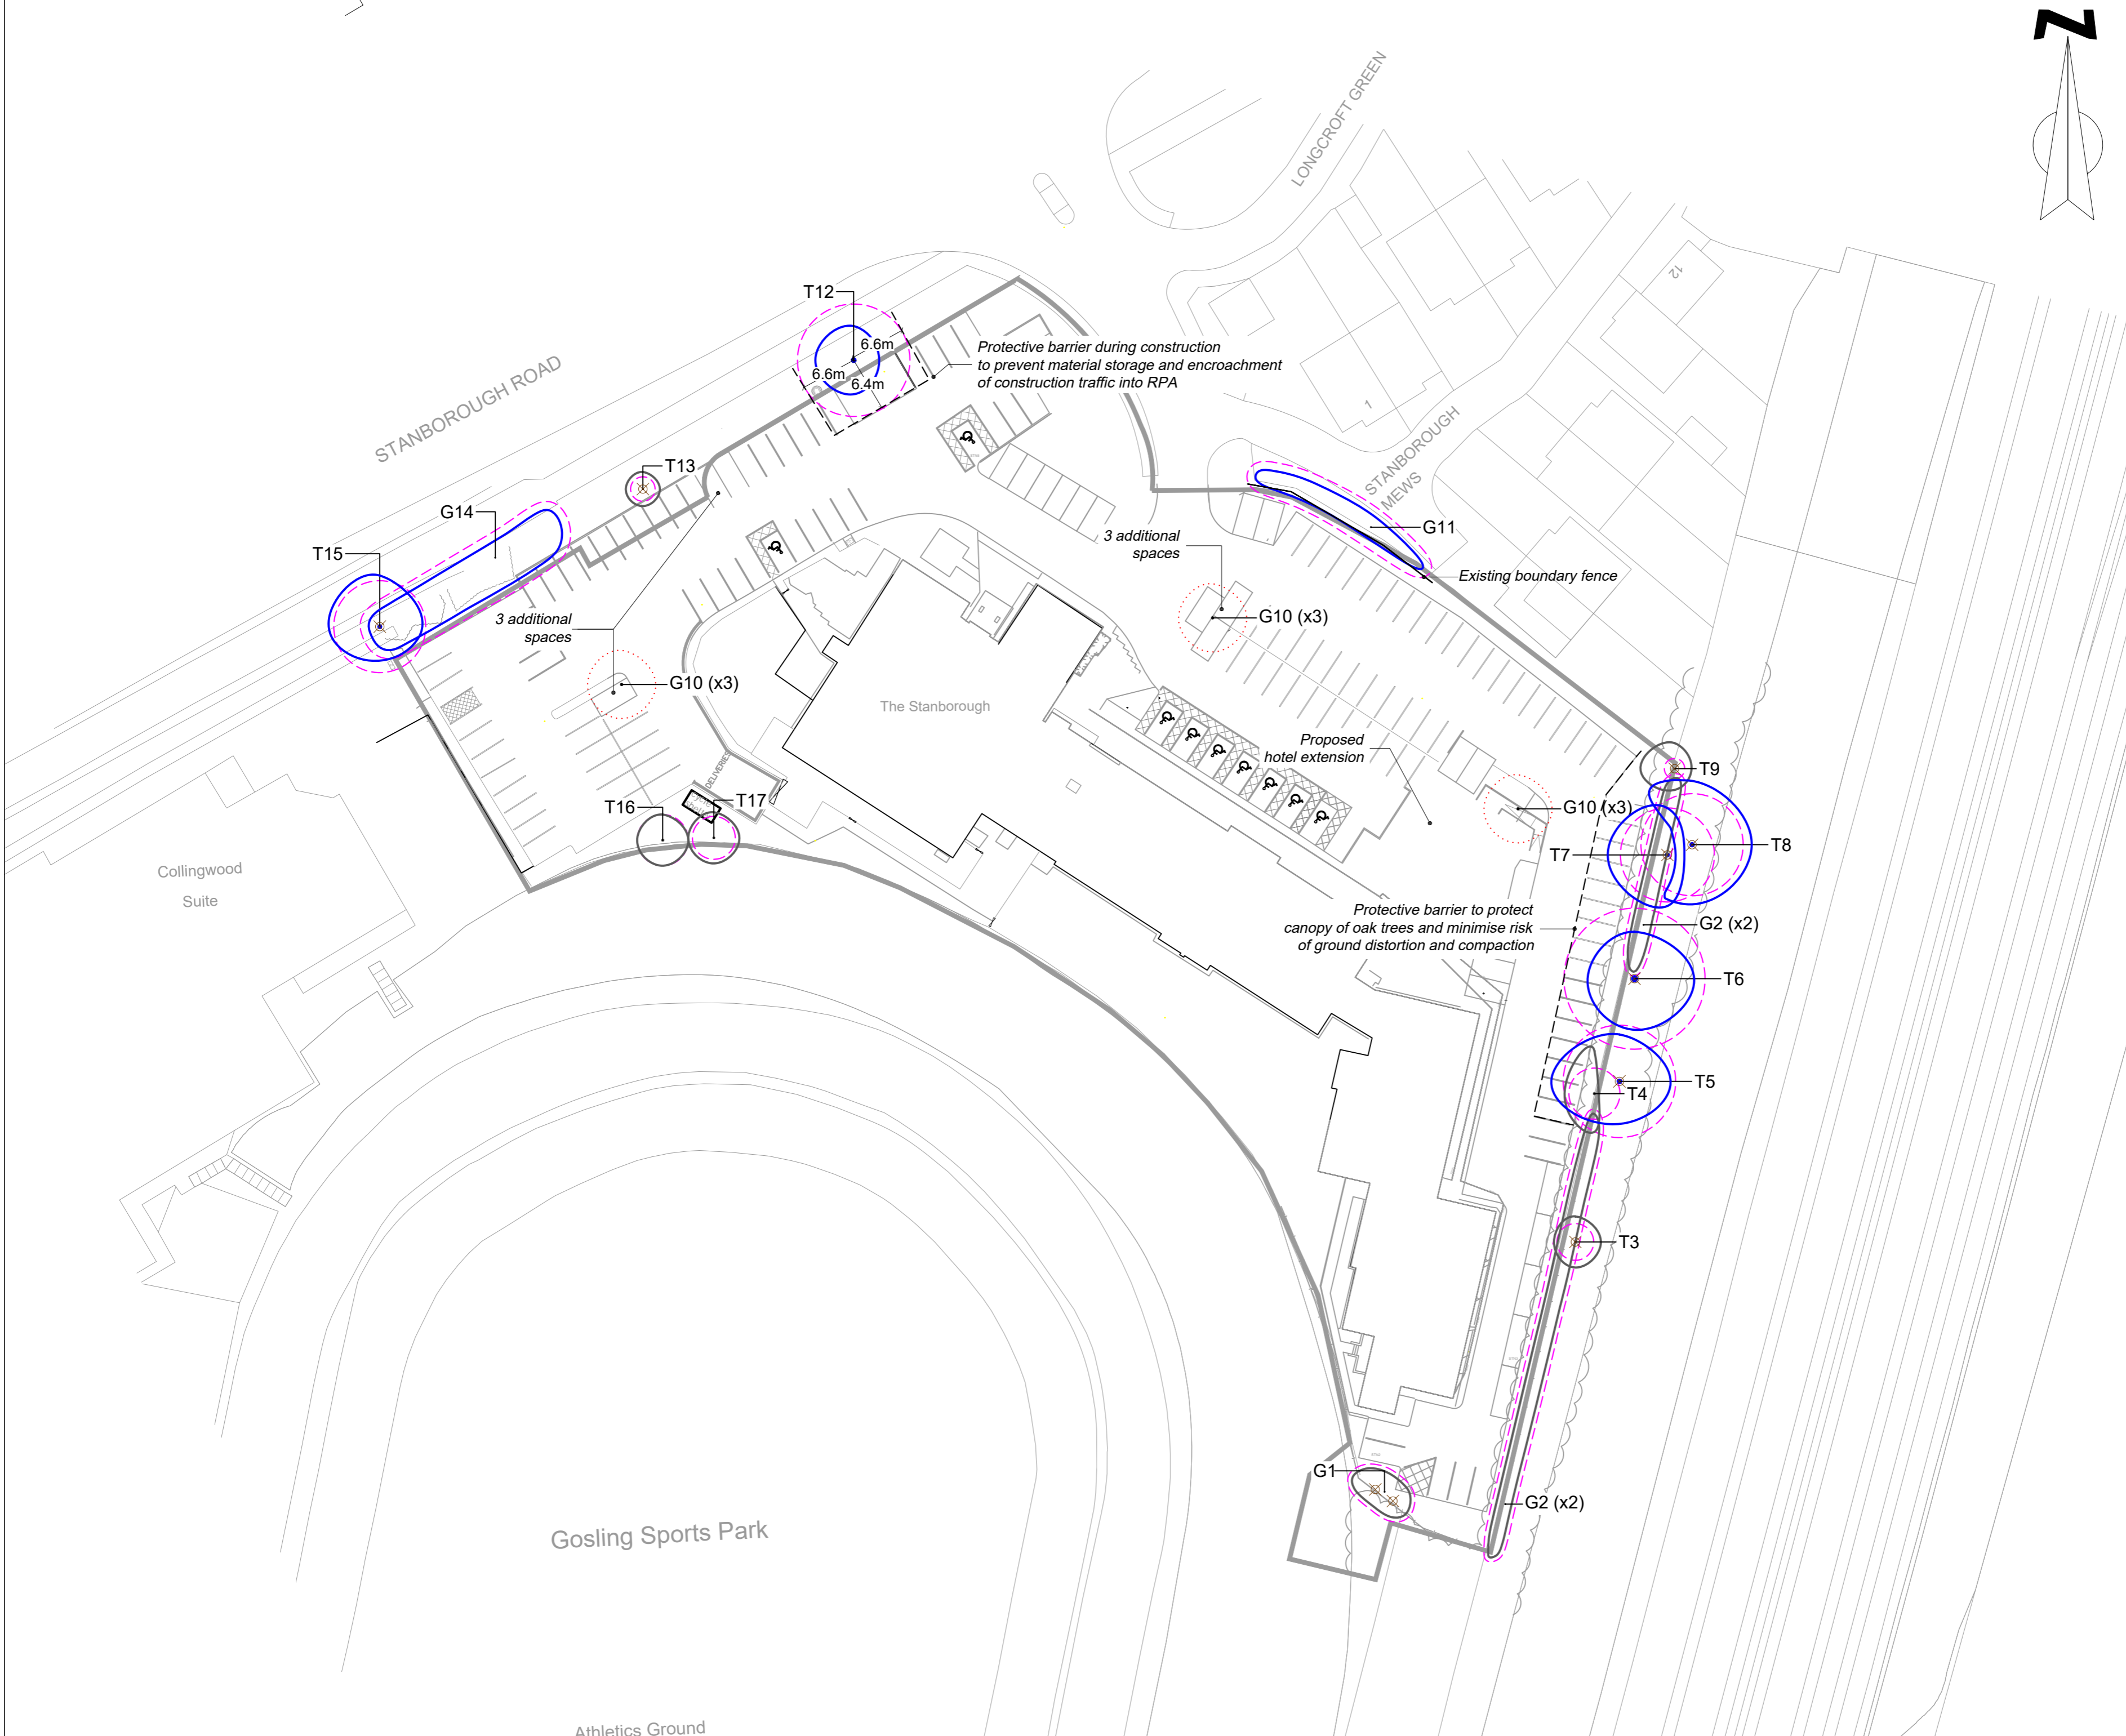
FIGURE NO:
SHF.1483.003.Ar.D.002.C

4.3.1 Unless adequate protection is provided, construction operations near retained trees are likely to cause accidental damage of tree trunks and low hanging branches in particular of trees along the eastern boundary and ash T12 in the west.

5.2.1 Where construction operations are likely to cause damage to above ground parts of retained trees or compaction of the Root Protection Areas (RPA), a protective barrier should be erected prior to commencement of any works on site to create a sacrosanct Construction Exclusion Zone (CEZ). The alignment of the fence should follow the canopy line of the trees or the edges of the RPA, whichever is greater.

5.2.2 The alignment of the barrier, including indicative setting-out information, is shown on the drawing included in [Appendix 4 – Tree Protection Plan](#).

5.2.5 Where temporary access of the CEZ is required for the installation of hard landscape or any other permitted work which is required prior to the main construction works being completed, the barrier may be realigned as shown in [Appendix 4 – Tree Protection Plan](#).
