April 2021

A BS 5837 Tree Survey Report and Tree Constraints Plan

Cuffley

In April 2021, trees on and around a proposed development site were subject to a survey in line with BS 5837, 2012: Trees in Relation to Design, Demolition and Construction: Recommendations.

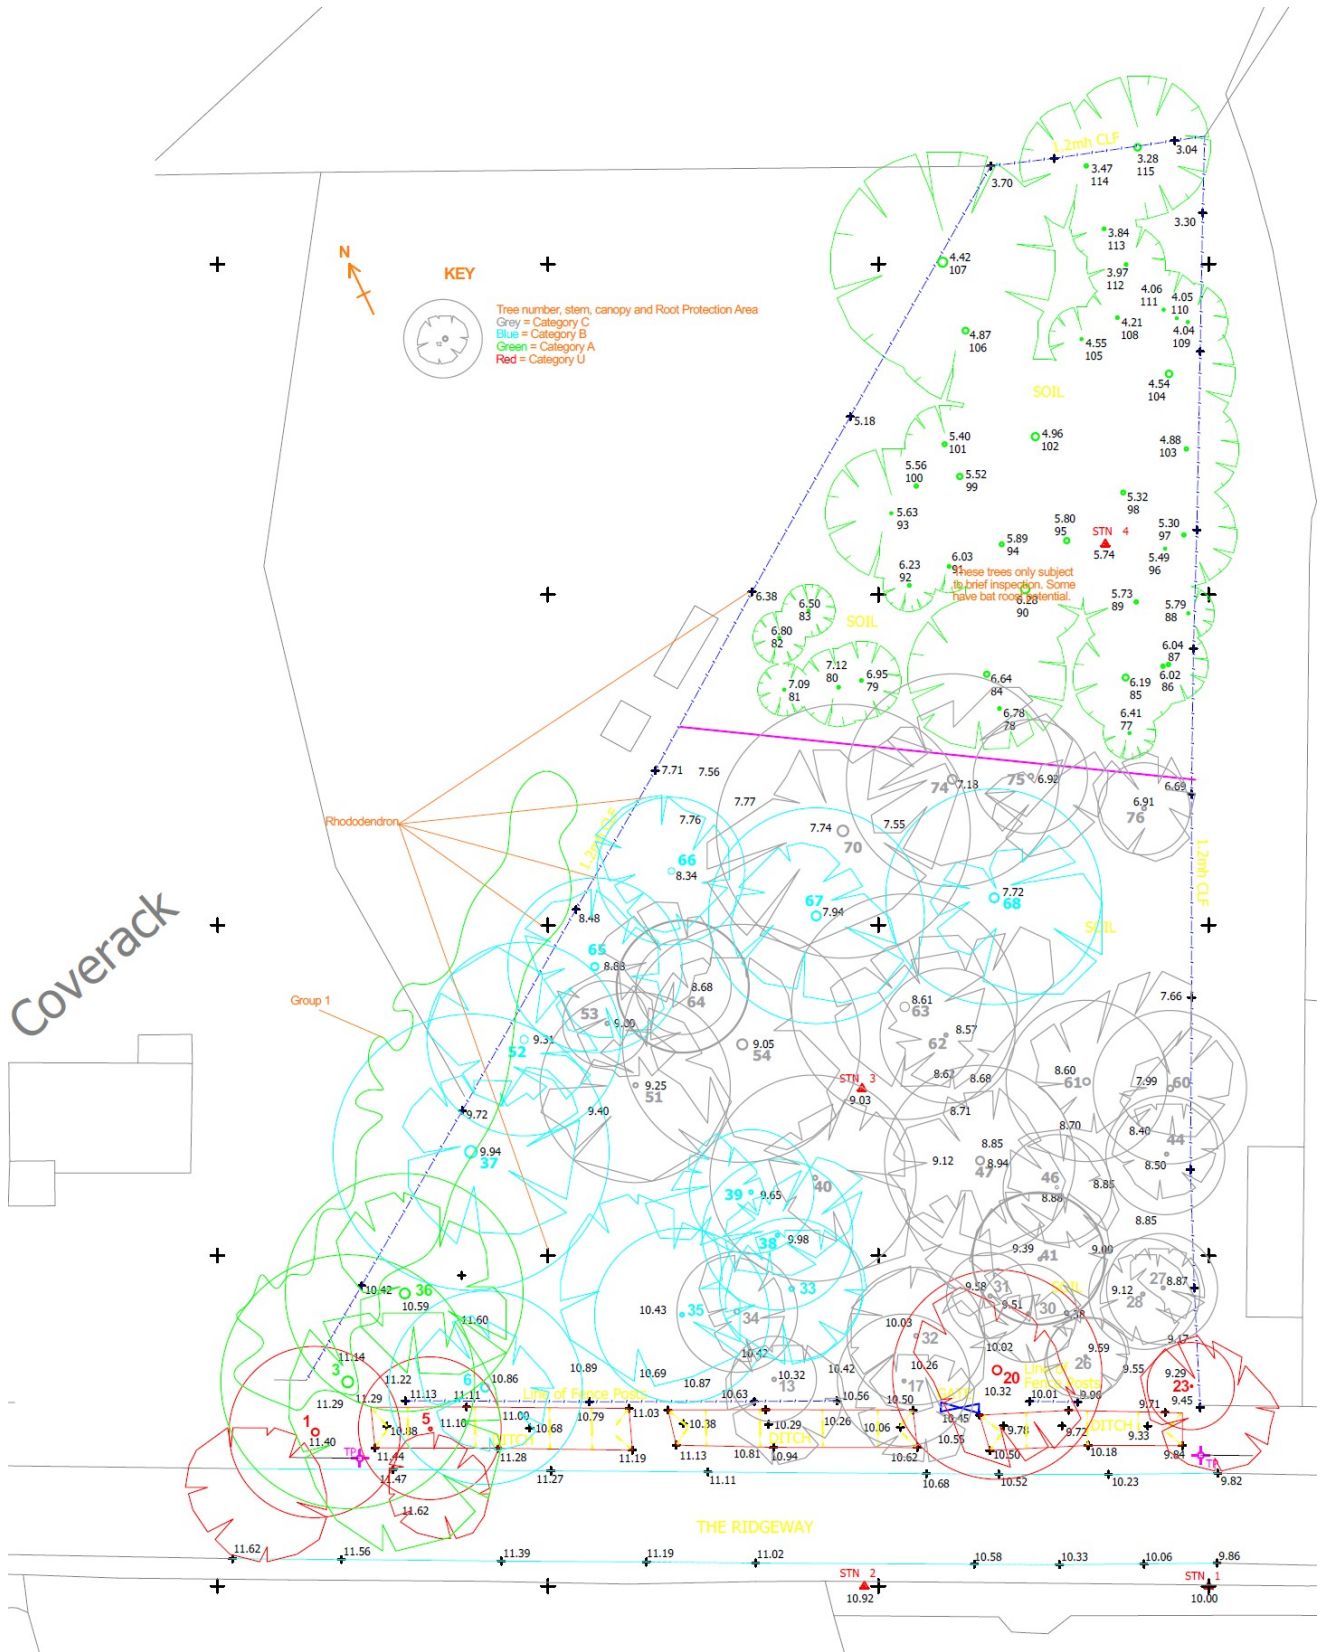
6.2 Appendix 2. Tree Constraints Plan

The location, BS5837 category, RPA and canopy extents of the trees recorded are shown in the TCP figure, Appendix 2.

The TCP in Appendix 3 shows the locations of trees on/near the site, their BS5837 category, their canopy extents and RPA. RPA have not been offset/adjusted.
