Findings of the Arboricultural Assessment - Arboricultural Development Statement

Northaw House, Cuffley

On behalf of LW Developments Ltd

January 2018

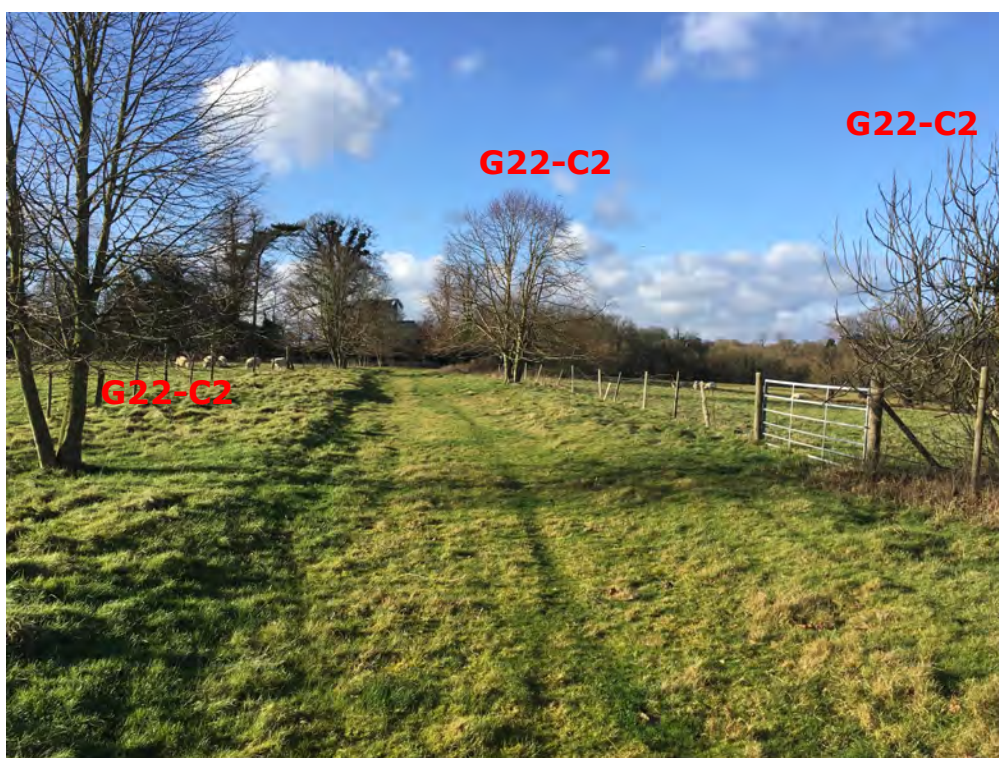
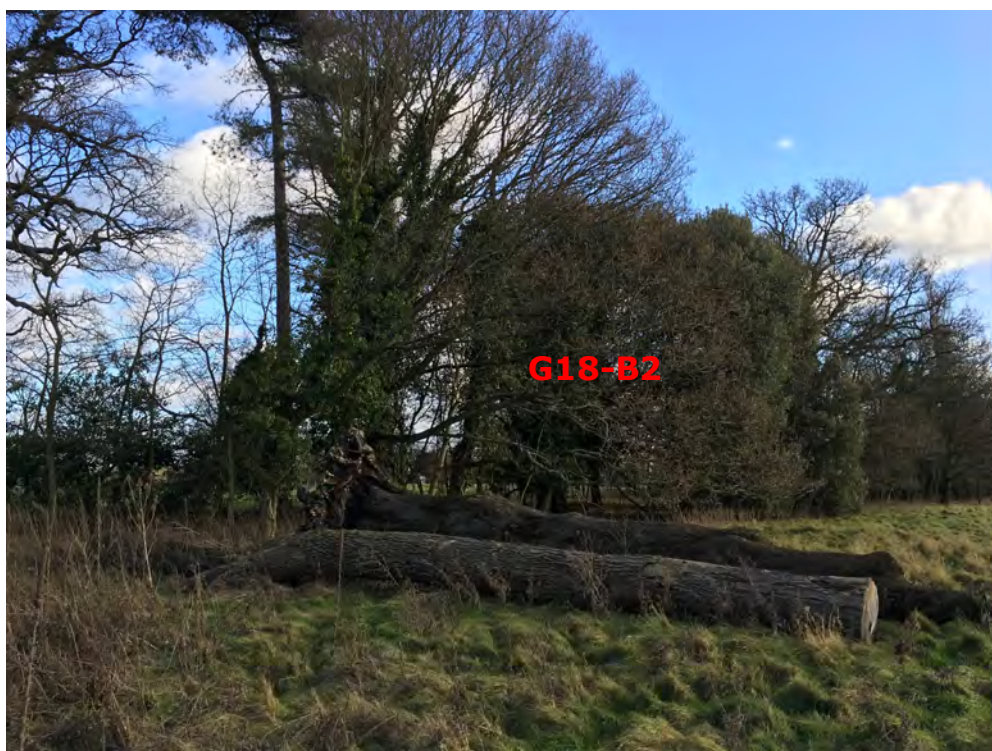
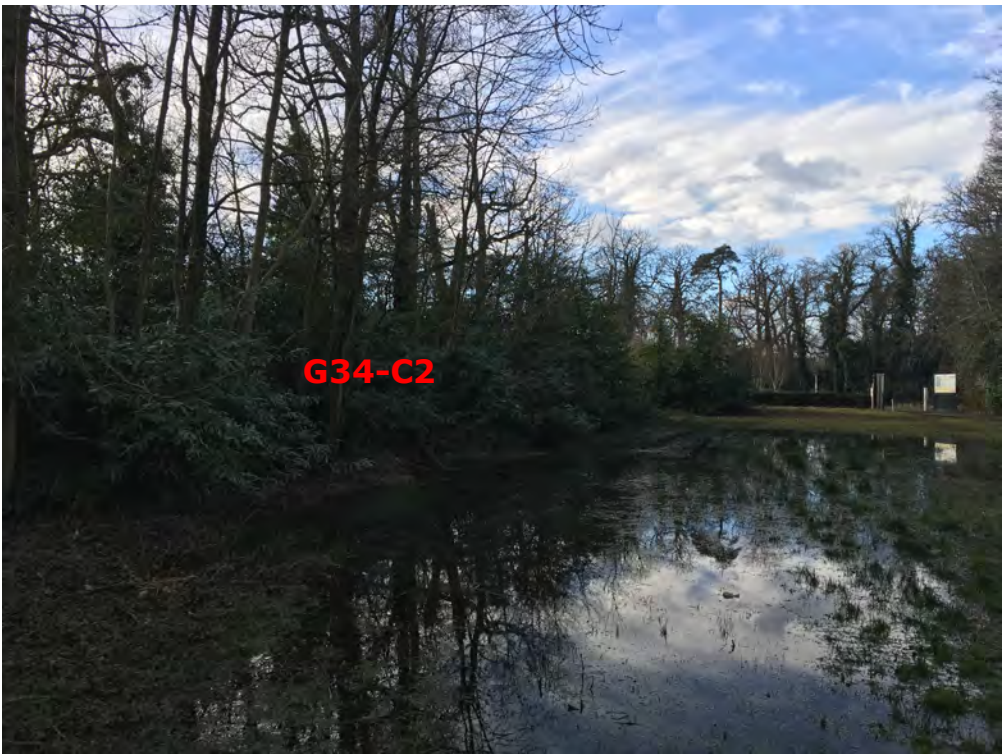
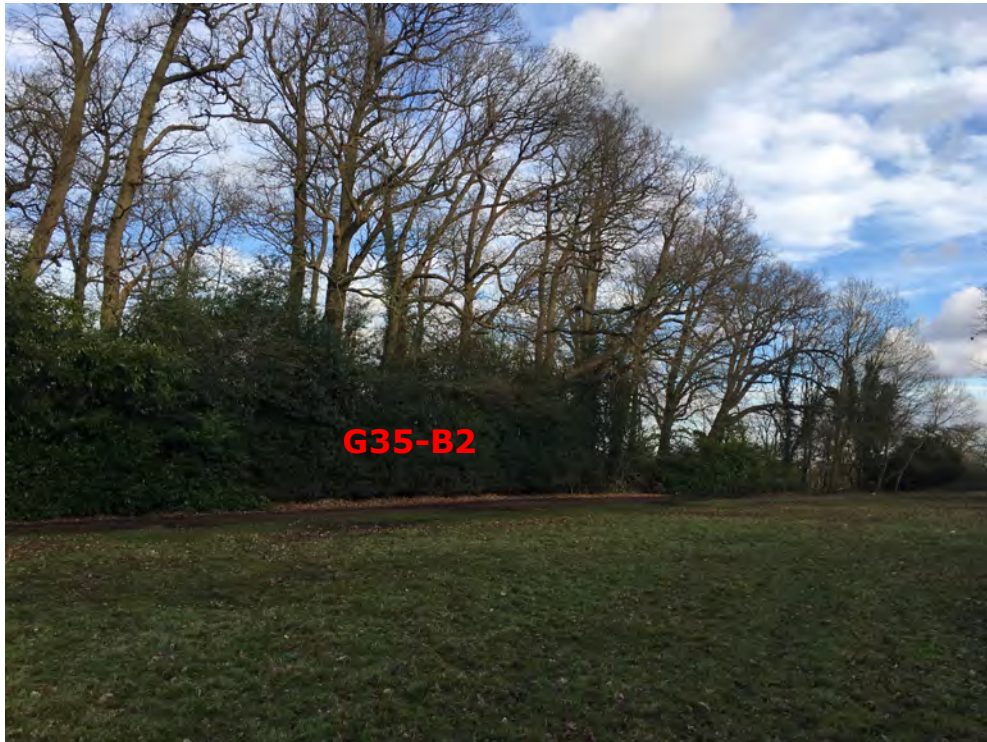
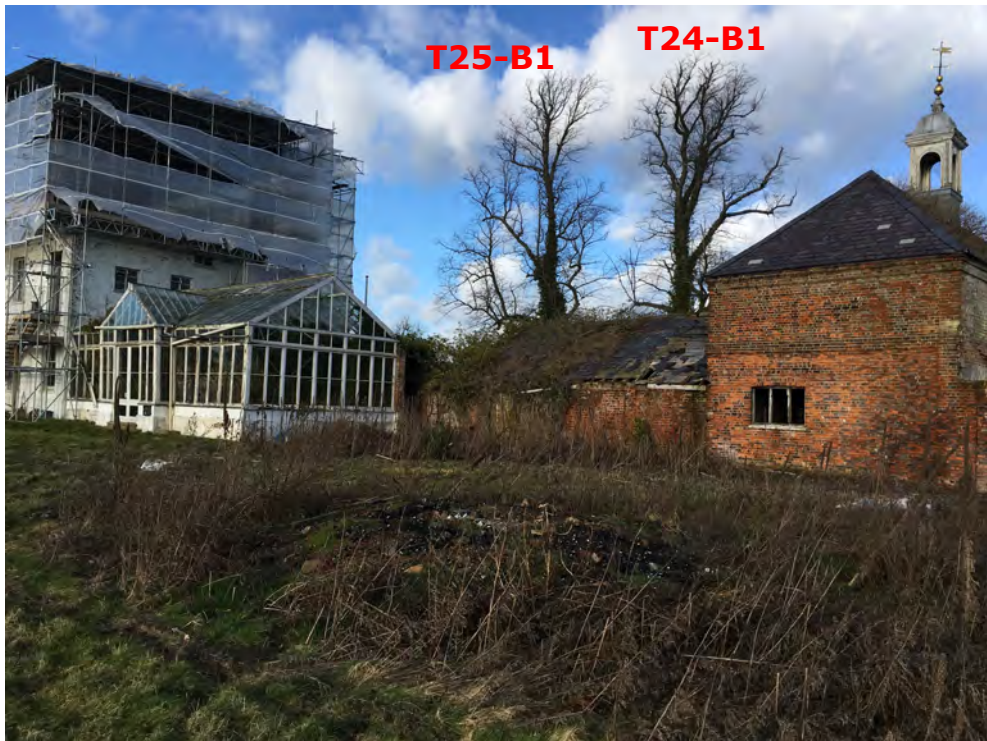
2.8 Selected photographs of the site are shown below:

- 2.4 The site has been absent of managed for many years, in which time vegetation has colonised and areas have become overgrown, been recently cleared, or become inaccessible. The area to the south of the walled garden has become largely inaccessible and comprises regenerating hawthorn, ash and sycamore, none of which are large or remarkable examples of their species. The area needs active management.

- 2.5 There is an area (G34-C2) of trees and vegetation between the walled garden and the access road, which again requires management. The ground is littered with glass bottles, is generally absent in places of understorey, with laurel scattered throughout. Many of the trees are poor quality individually, with areas of garden refuse, and dead or in decline trees.

- 2.6 To the north, and aligning the access road, is another area (G35-B2) of trees which comprises larger better quality trees with holly and laurel

throughout. Parts are inaccessible, and there are multiple poor quality trees. Again, the area requires active management.
