## COLLAPSED GARDENERS STORE | NORTHAW HOUSE PLANNING & HERITAGE STATEMENT

July 2022

Issue 1

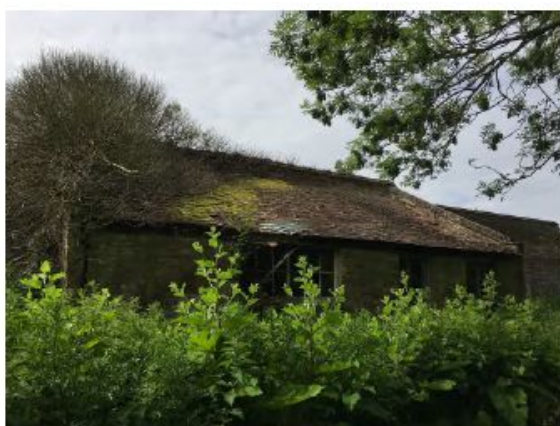
**Plate 31:** Building 2: Brick Gardener's Store as seen from the north

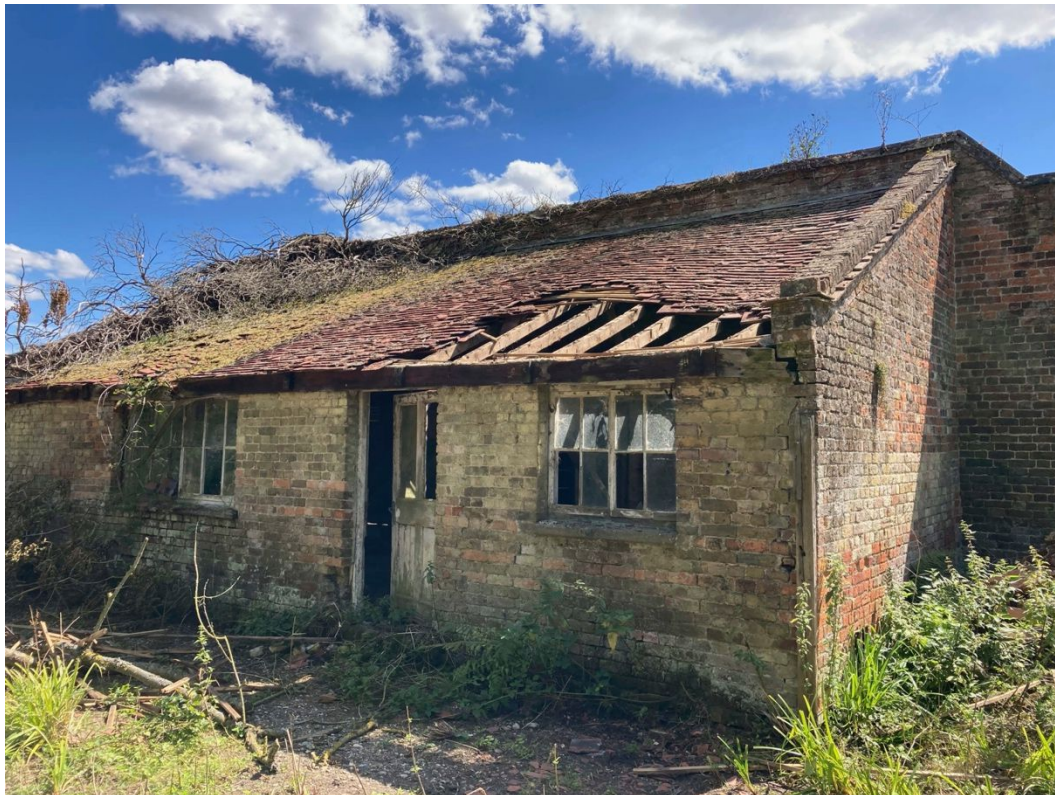
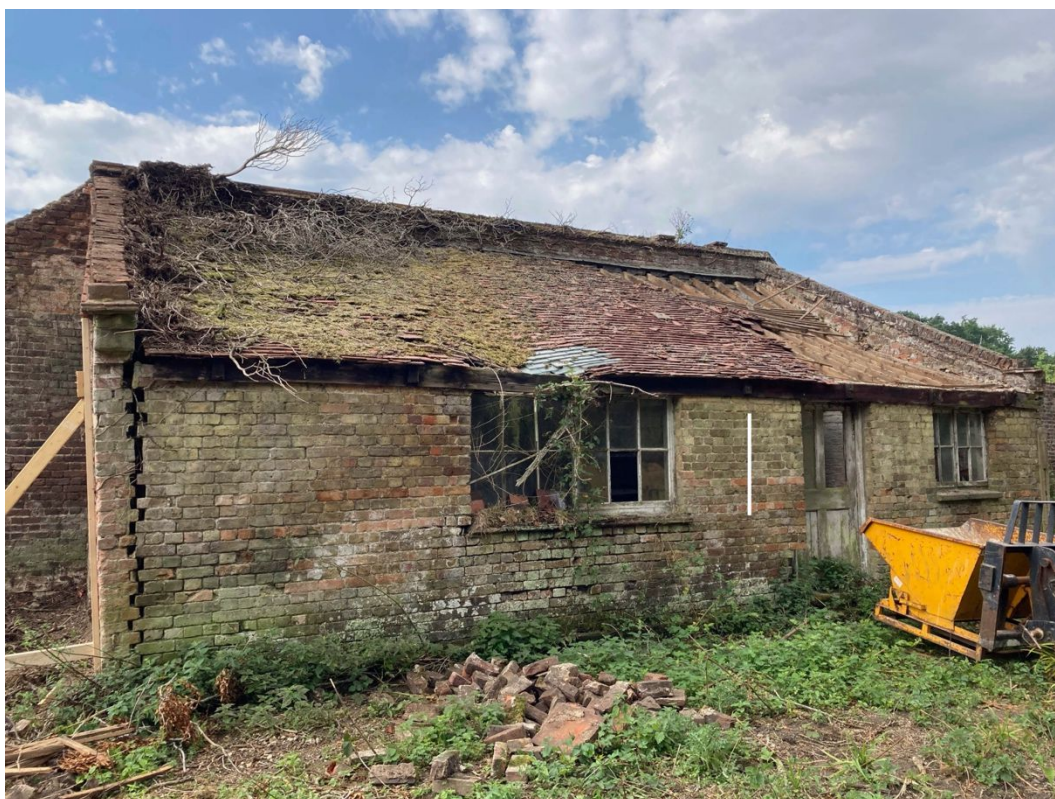
Viewed from Northwest

Viewed from Northeast

The structure had been left neglected for many decades without any serious intervention to ensure its longevity, as a result all doors and windows had rotted, the roof covering was significantly failed and in places missing, resulting in failure to the roof structure. There was significant plant growth in and on the structure that has impacted the fabric. Most significantly the two end walls (east and west) had both detached from the northern wall with significant cracking evident, in particular to the eastern junction.

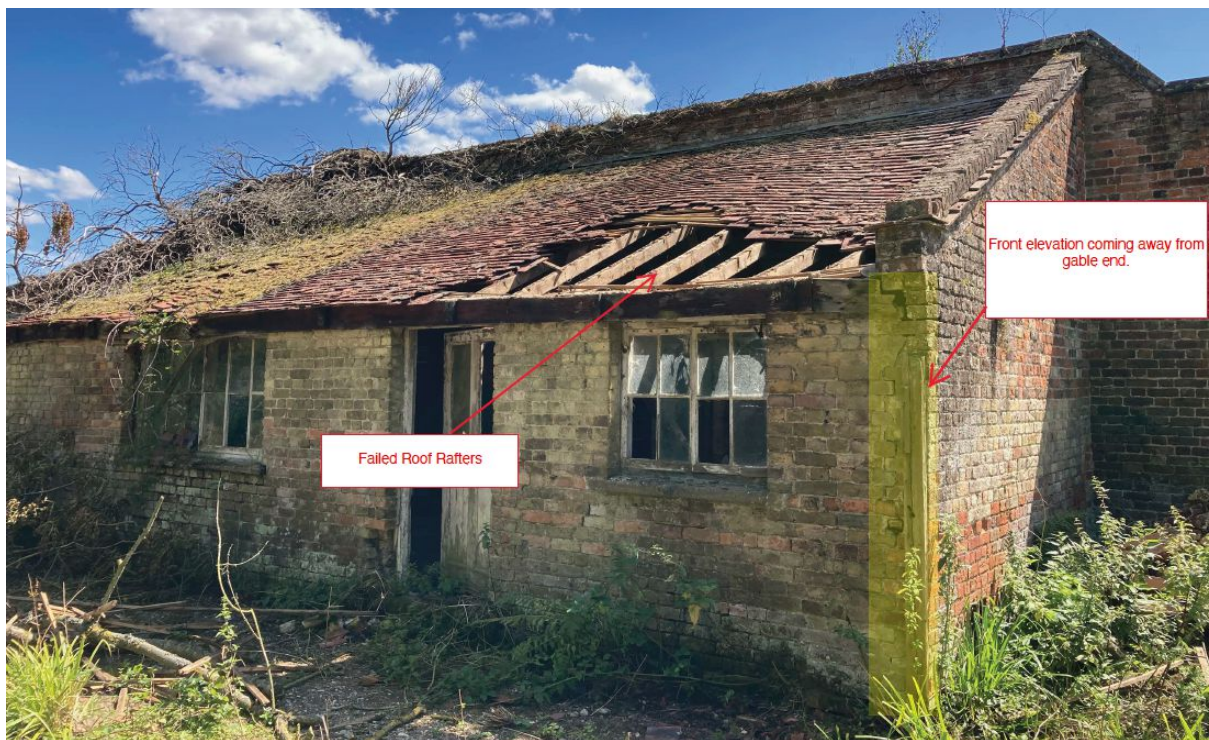
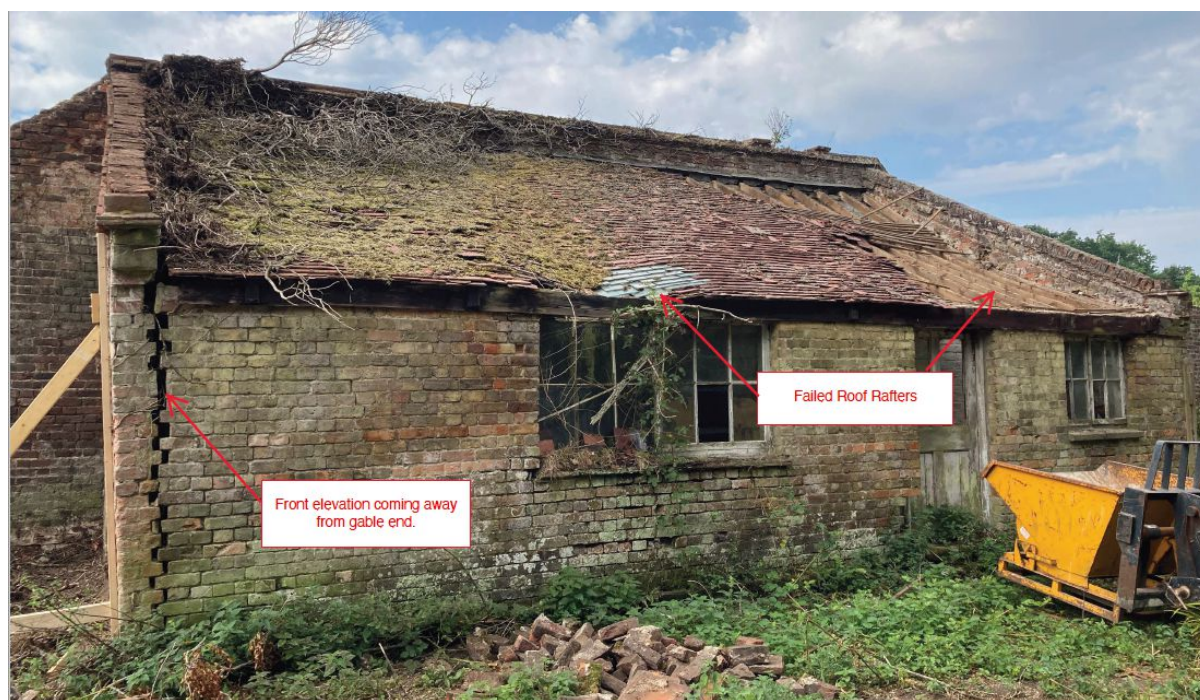
The store itself had been propped for some time before it became necessary to take it down and was an unsafe structure that could not be repaired.

During the storms of February 2022 the eastern gable and the roof structure collapsed. The remainder of the building was dismantled before it had the opportunity to collapse, before further weather took control, or the remaining structure came down of its own volition. The timing of this also ensured that it could be carefully dismantled and all materials that could be were salvaged and set aside for re-use.

By carefully controlling the dismantling of the remaining structure the high level walled garden wall could be protected and monitored to ensure no damage to this heritage asset, which has already been part of a series of brickwork and re-pointing repairs.

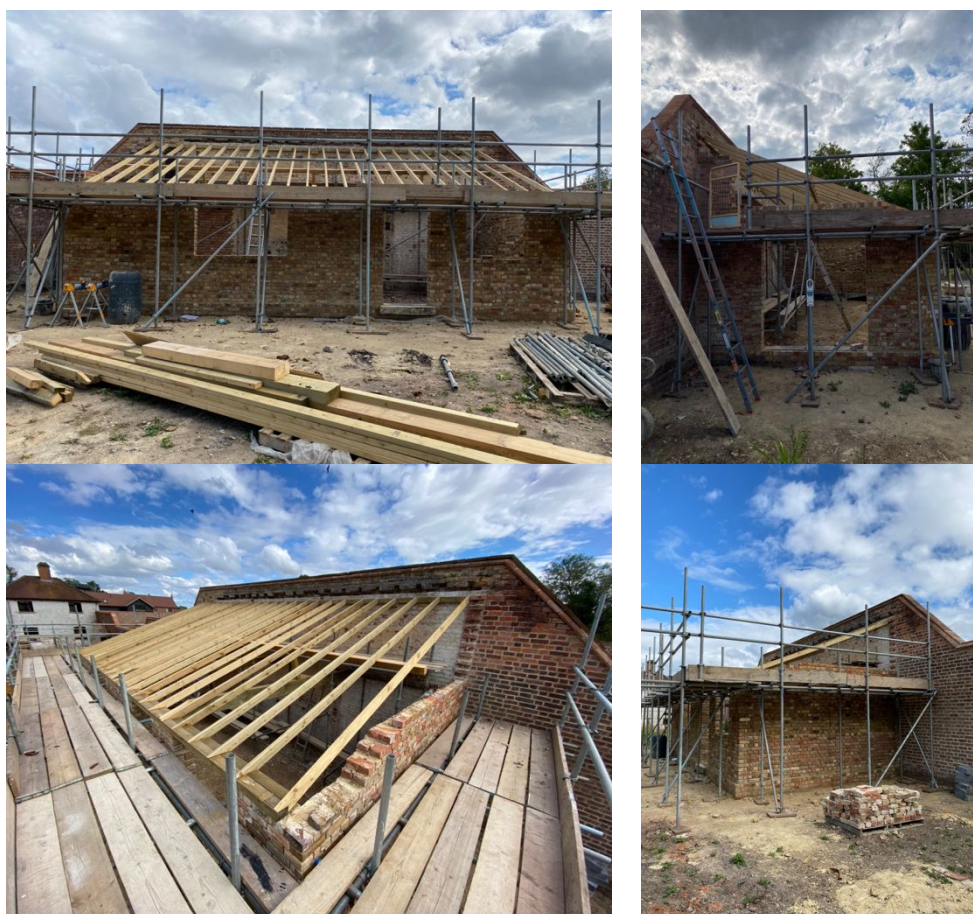
Photos showing the works to date.

The building has been re-built like for like in terms of its construction, proportions and dimension. These walls have been reconstructed on the same footing using the reclaimed brick and laid in a in 1:3 NHL 3.5 lime to sharp sand. Laid in English bond.

The roof structure has been reformed using softwood timbe joists and purlins with oak collars at eaves level. The roof is to be covered in a breather membrane and softwood treated battens and clad in reclaimed second hand plain tiles to match those removed. Some of those removed have been retained and whilst not fit for re-use can be used to ensure an accurate match.

The verge cornice detailing and abutment to the garden wall and eaves detail will all match the existing details.
