**BS 5837:2012 Tree Survey & Arboricultural Impact**

**Address: 8 Densley Close,  
Welwyn Garden City**

**Date 7<sup>th</sup> January 2015**

Drawing Title: Tree Constraints Plan

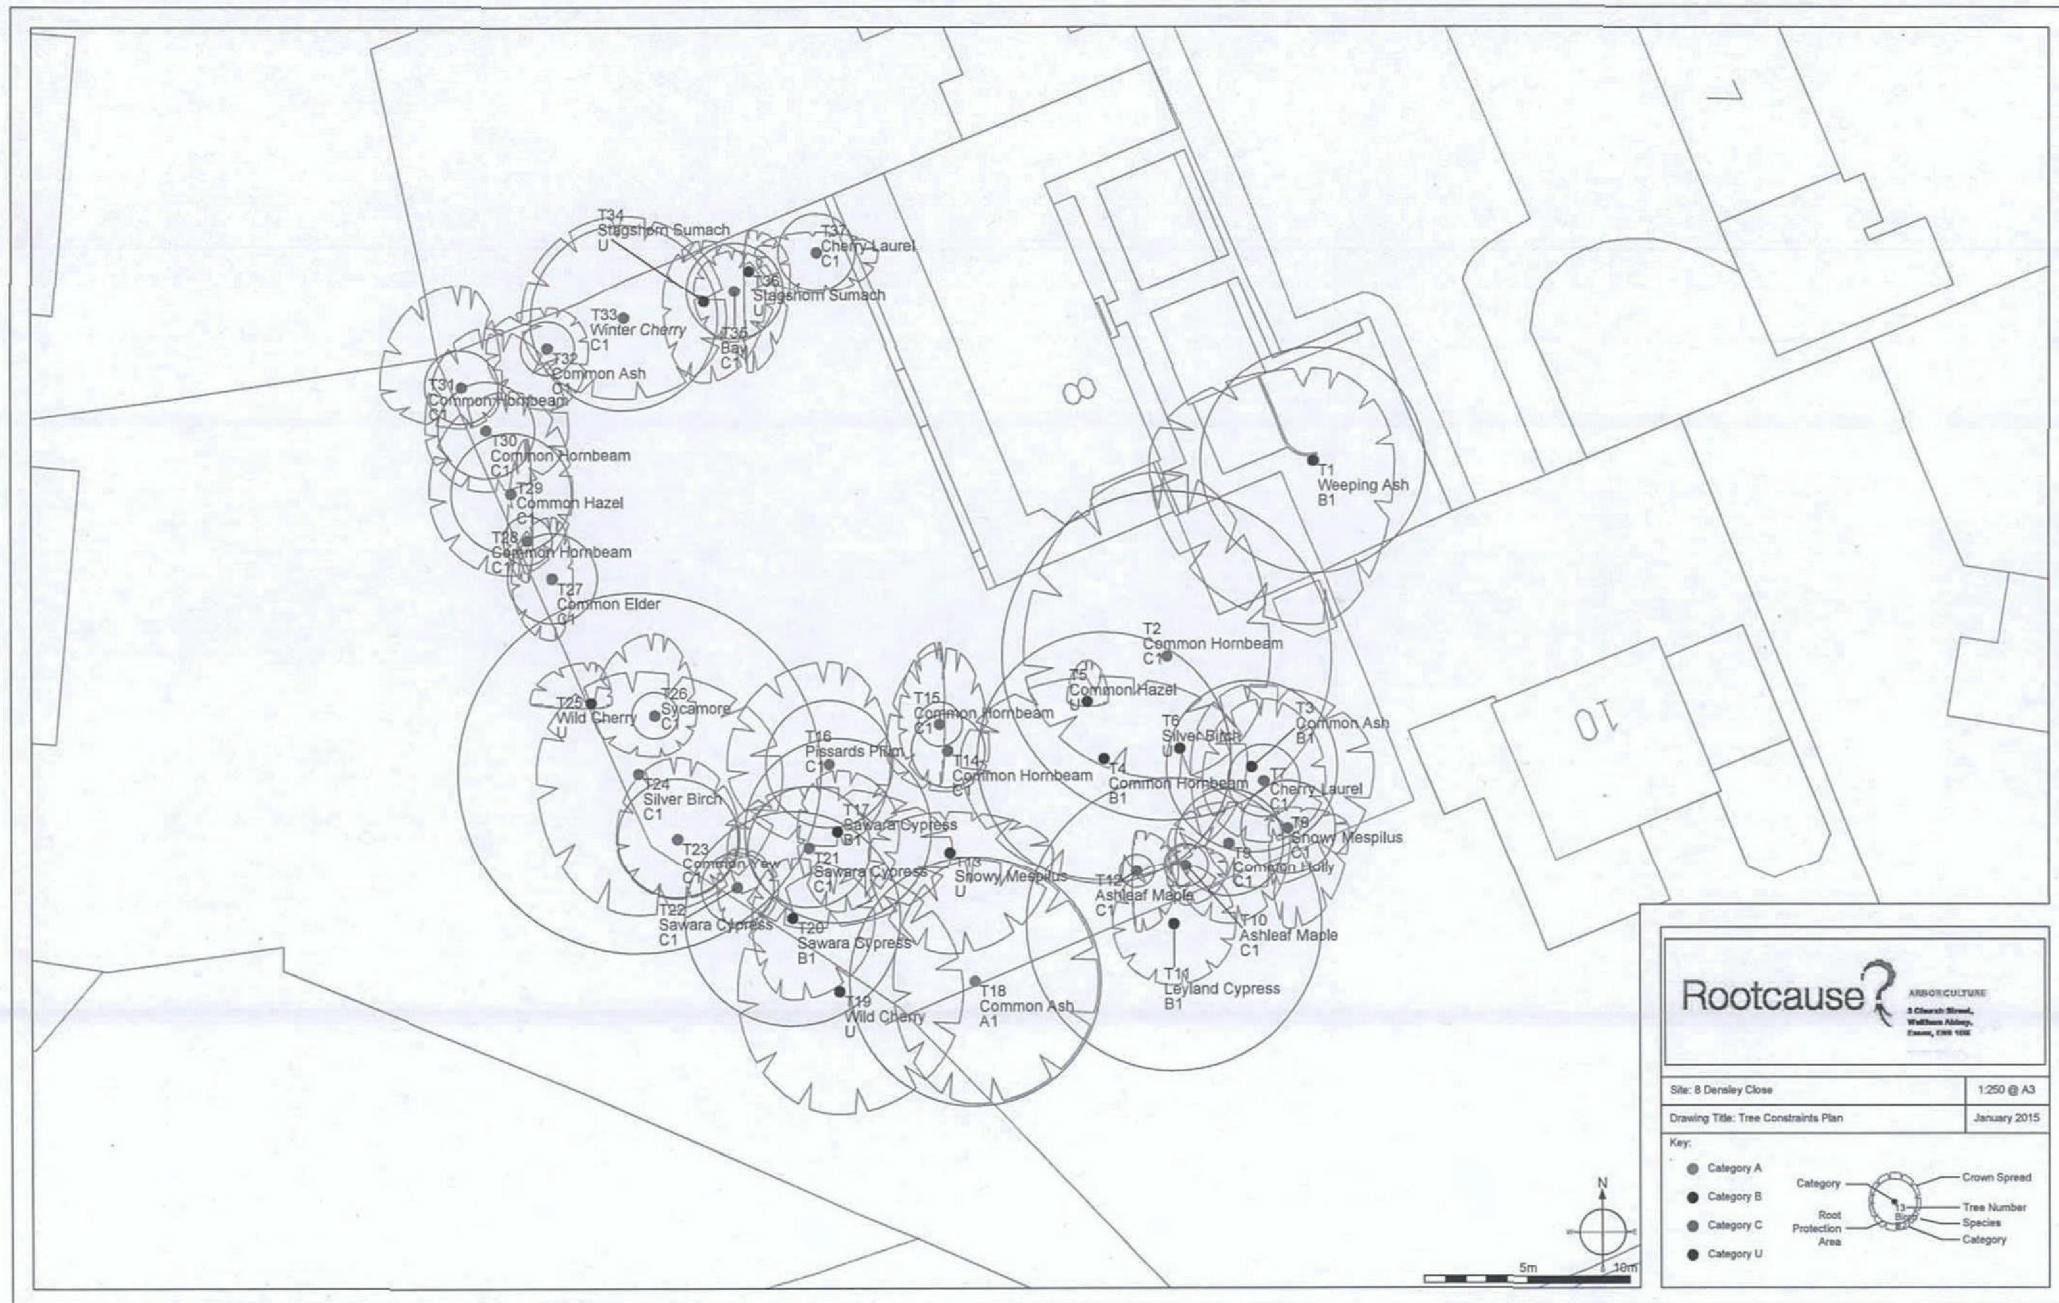
5.2.1 I recorded thirty seven trees within the site, or near to the site boundaries, which might be affected by the proposal. The tree details are included in Appendix 2 and plotted on the attached site plans in Appendix 3 and Appendix 4. Appendix 3 shows the existing ground floor layout with the tree constraints. Appendix 4 shows the proposed ground floor layout to indicate where the proposal could affect the retained trees.
