29 Broadwater Road, Welwyn. Herts AL7 3BQ

# PART 1 BS5837 TREE SURVEY, PART 2 INDICATIVE ARBORICULTURAL IMPACT ASSESSMENT AND METHOD STATEMENT.

**Demolition of the existing unit and proposed new  
residential development**

Elizabeth Greenwood CMLI, F Arbor A.  
[ms.ejgreenwood@gmail.com](mailto:ms.ejgreenwood@gmail.com)

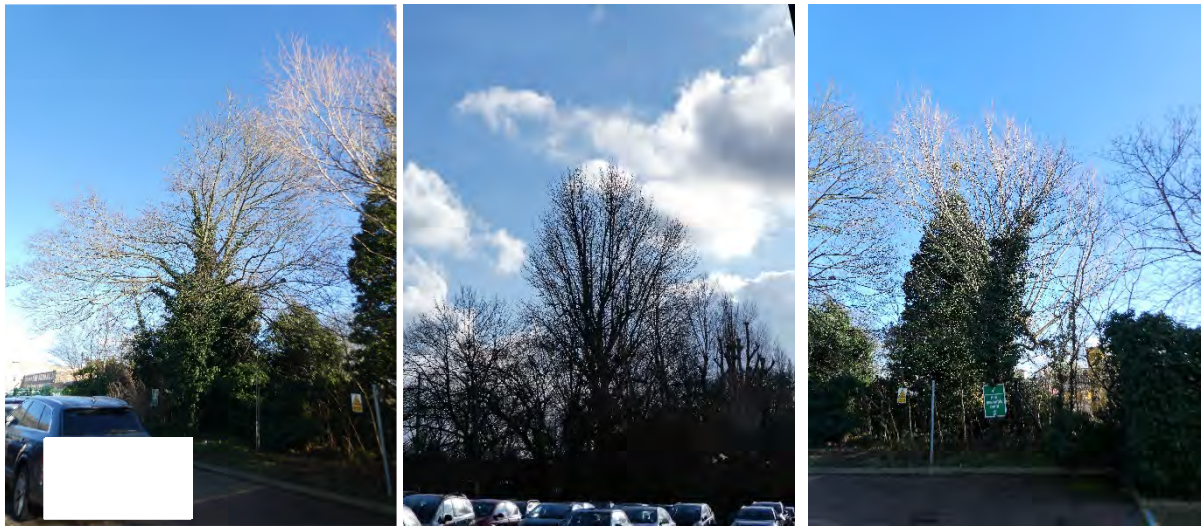
**Above and below-** protected trees along the eastern boundary part of TPO G2. **Left-**The Norway maple with prolific ivy growth. **Right** the Norway maple and willow (T4 and T5)

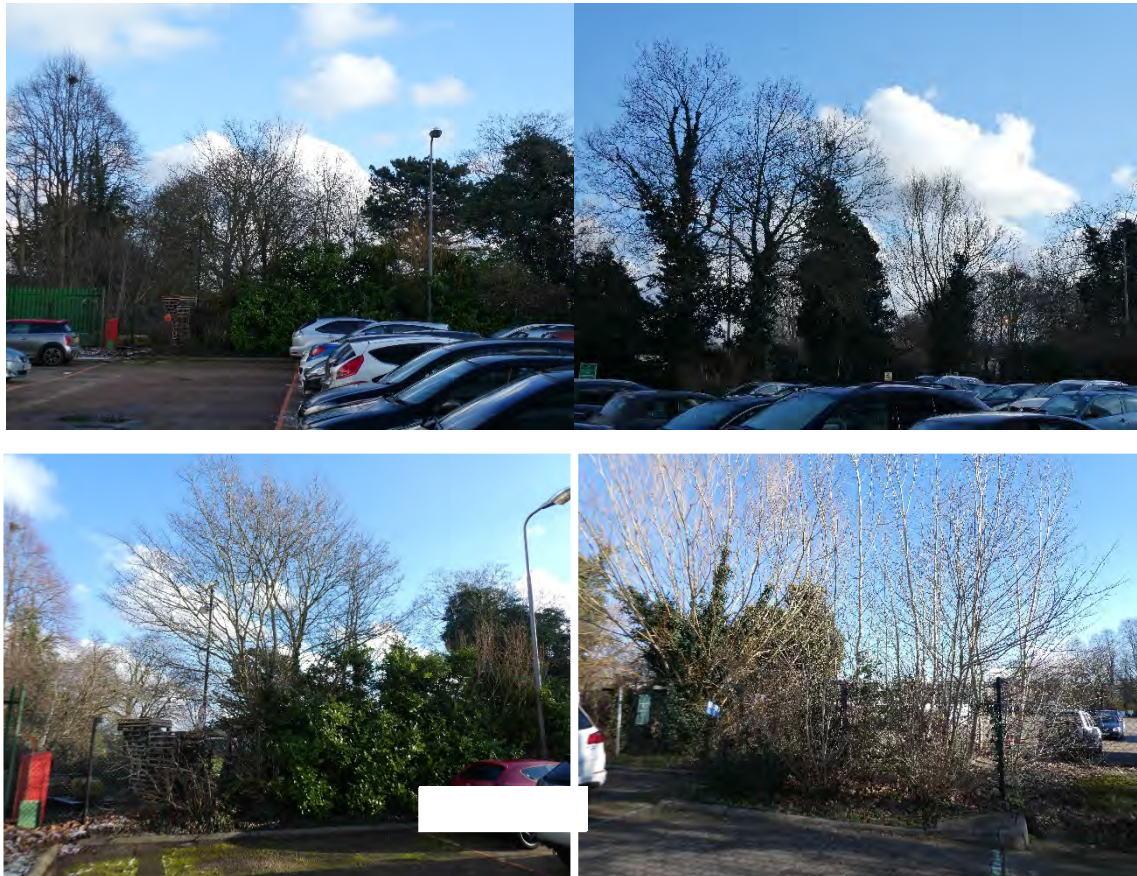
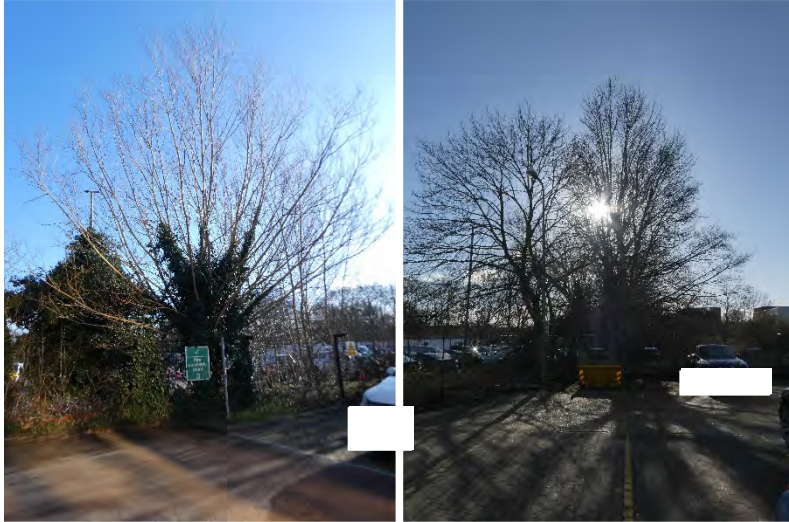
**Above left-** the pollarded willow (T6). **Above right** - the group of sycamores and Norway maples (G2). **Below** – the two purple leaved plums (T13 and T14) planted on the northern side of the building. **Bottom-** the row of 5 fastigate oaks (T8, T9, T10, T11 and T12) planted along Broadwater Road

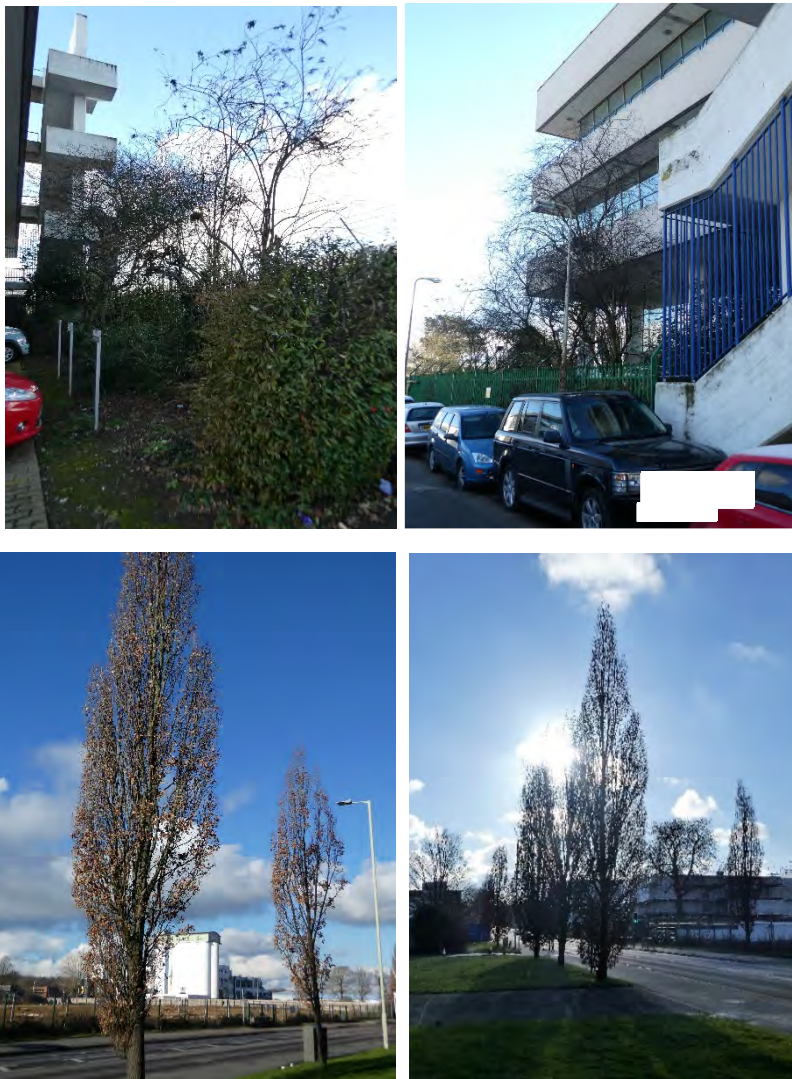
**Above left** - the plums (T13 and T14) and mixed shrub planting (S1 and S2).

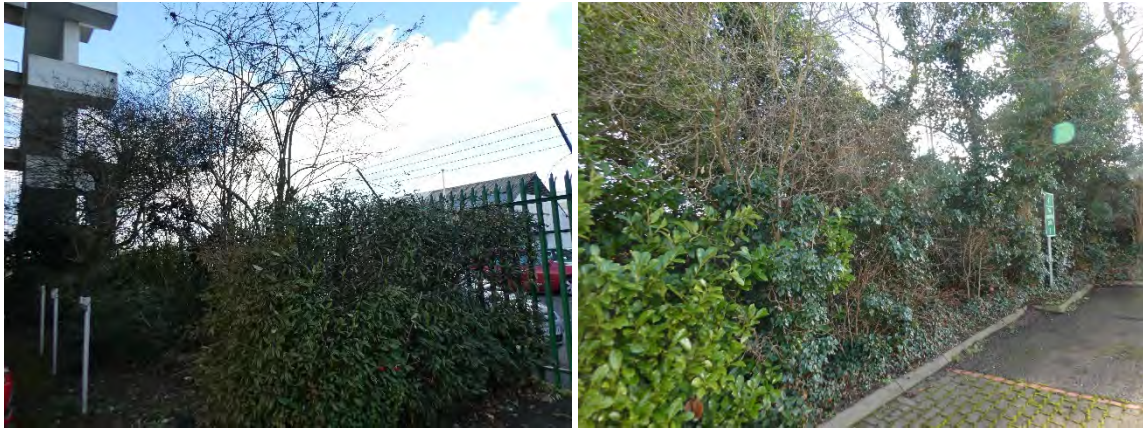
**Above right** - the boundary planting mostly native along the edge of the car park which lies within the TPO G2.
