EXISTING WEST ELEVATION - SCALE 1:50

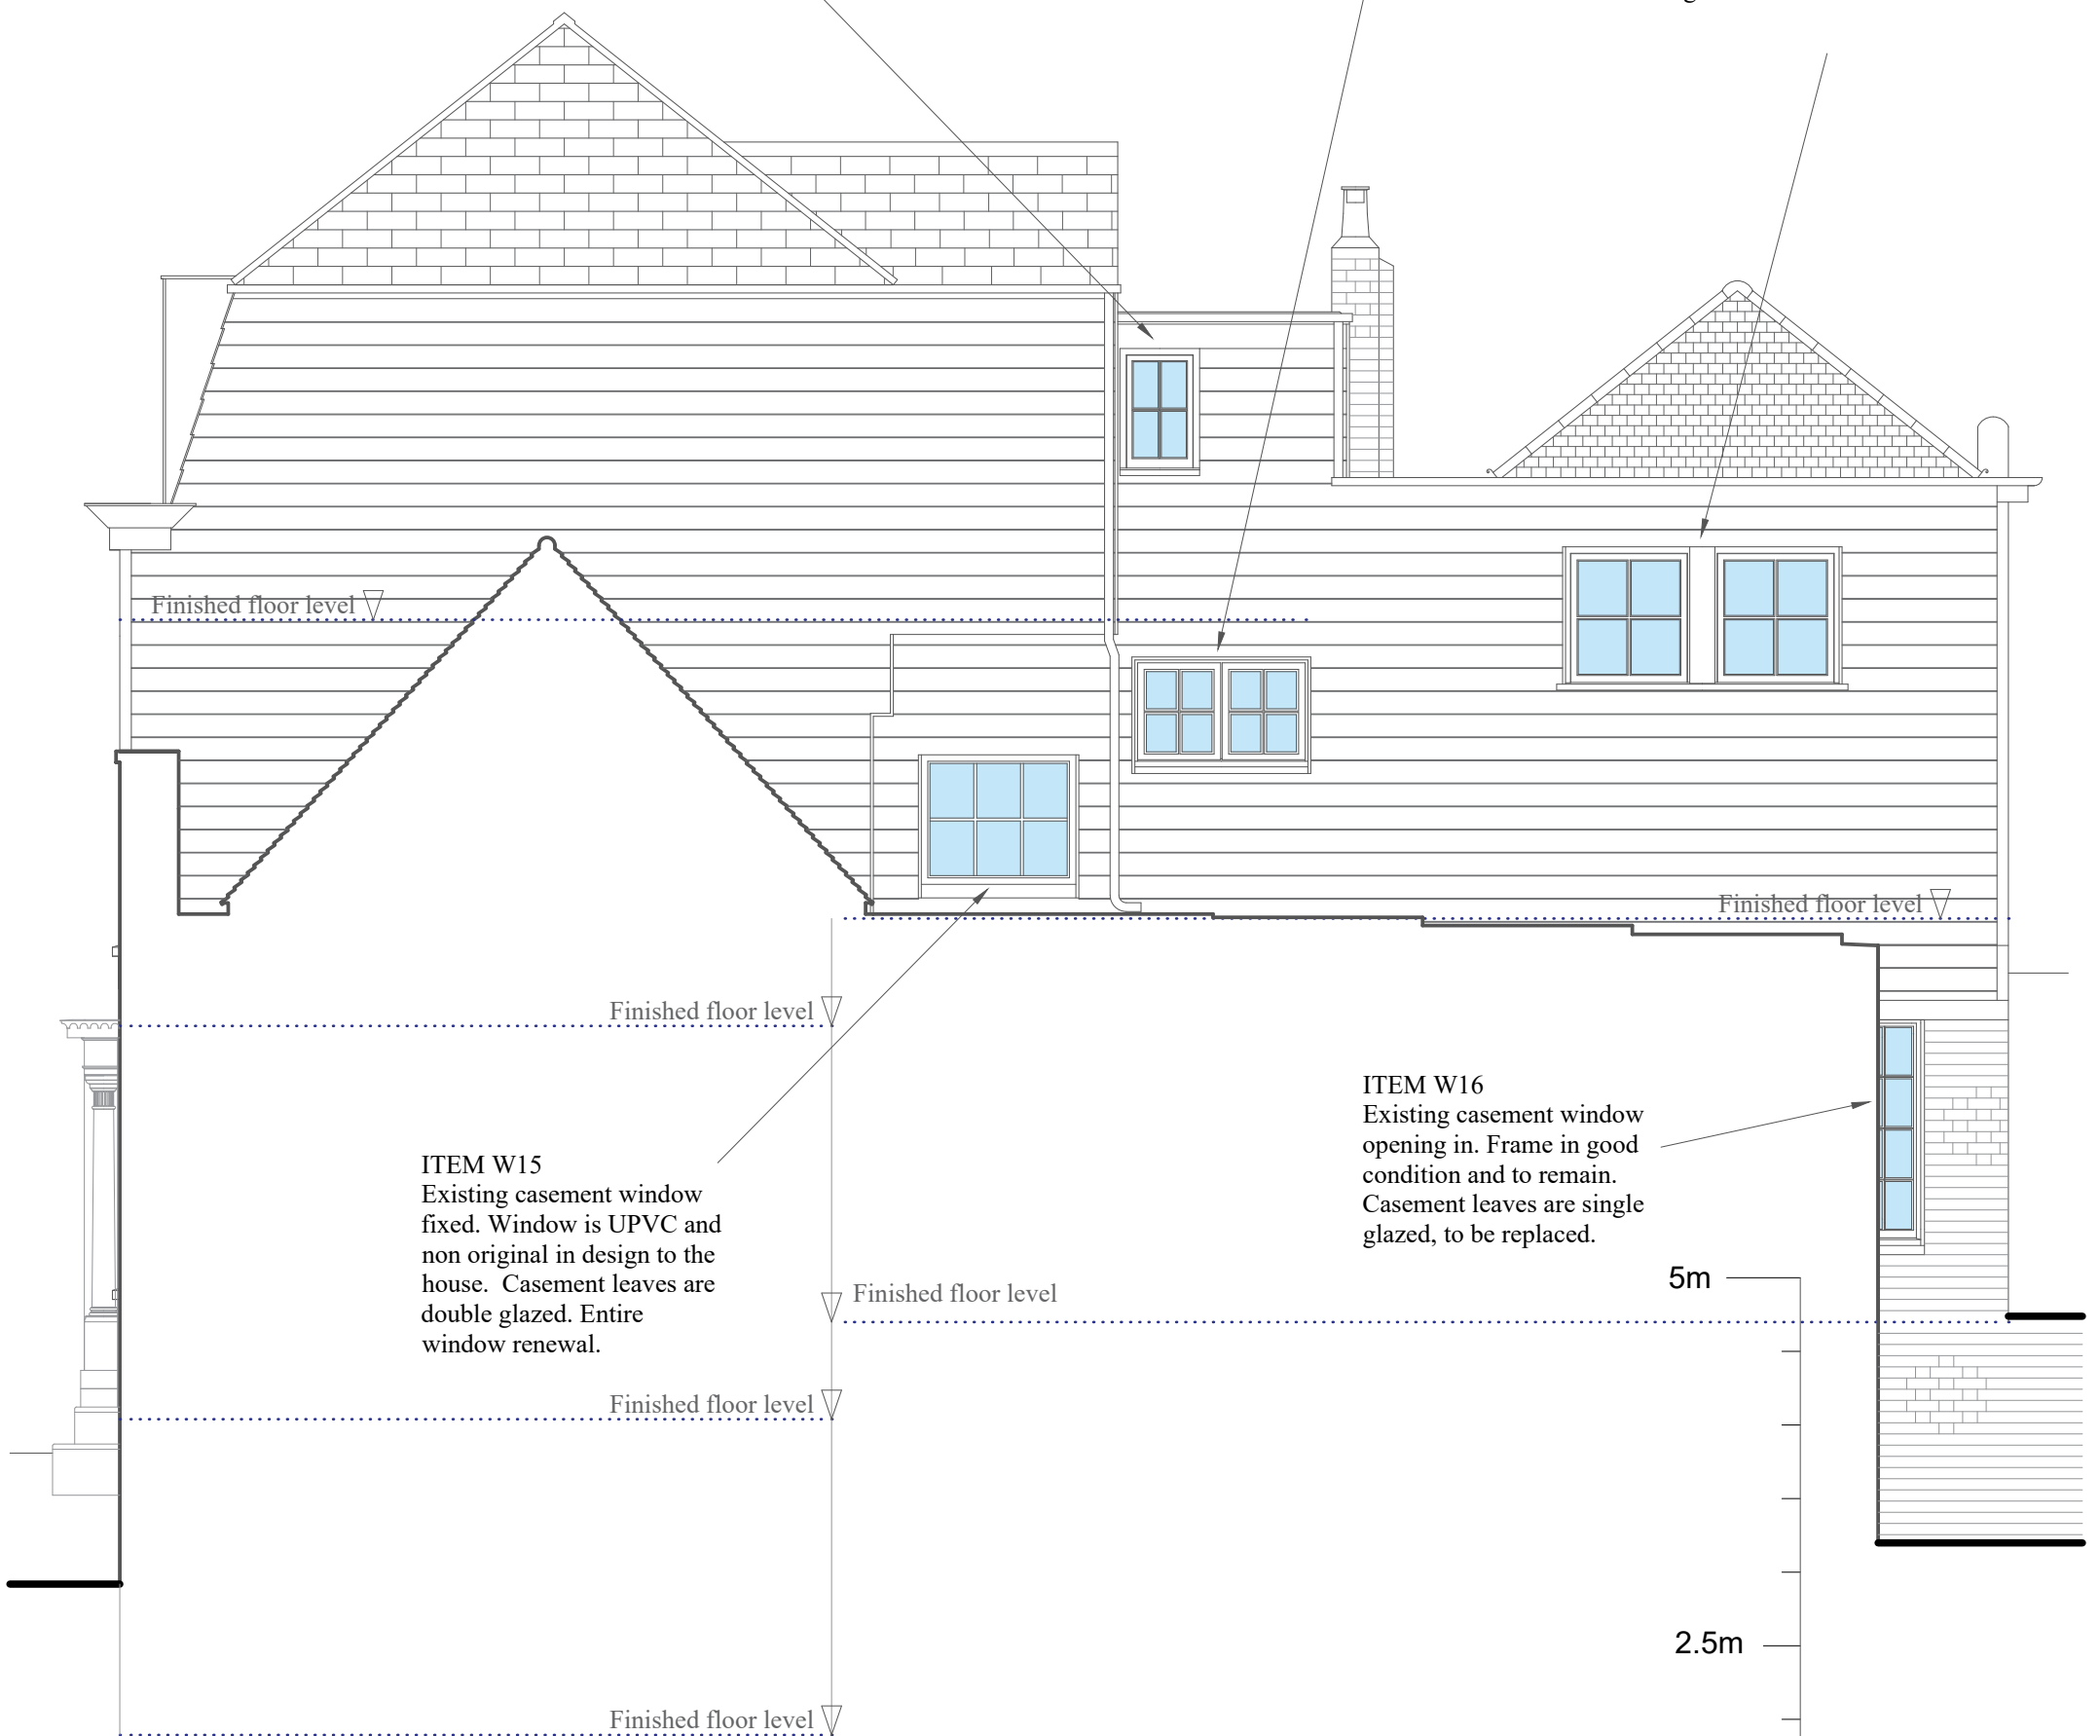
ITEM W03
Existing flush casement window opening out. Frame in good condition and to remain. Casement leaves are single glazed and to be replaced.

ITEM W08
Existing stormproof casement window opening out. Frame in good condition, but a non original design to the house. Casement leaves are double glazed. Entire window renewal.

ITEM W09
Existing flush casement window opening out. Left hand leaf is missing after damage from wind. Frame damaged. Casement leaves are single glazed. Entire window renewal

ITEM W15
Existing casement window fixed. Window is UPVC and non original in design to the house. Casement leaves are double glazed. Entire window renewal.

ITEM W16
Existing casement window opening in. Frame in good condition and to remain. Casement leaves are single glazed, to be replaced.
