MS CLARE PARKER  
13 FORE STREET  
HATFIELD  
HERTS AL9 5AN

Drawn by: C JEWISS  
Scale: N/A  
Date: MAY 2024  
Drawing: No.51

PHOTOGRAPHS

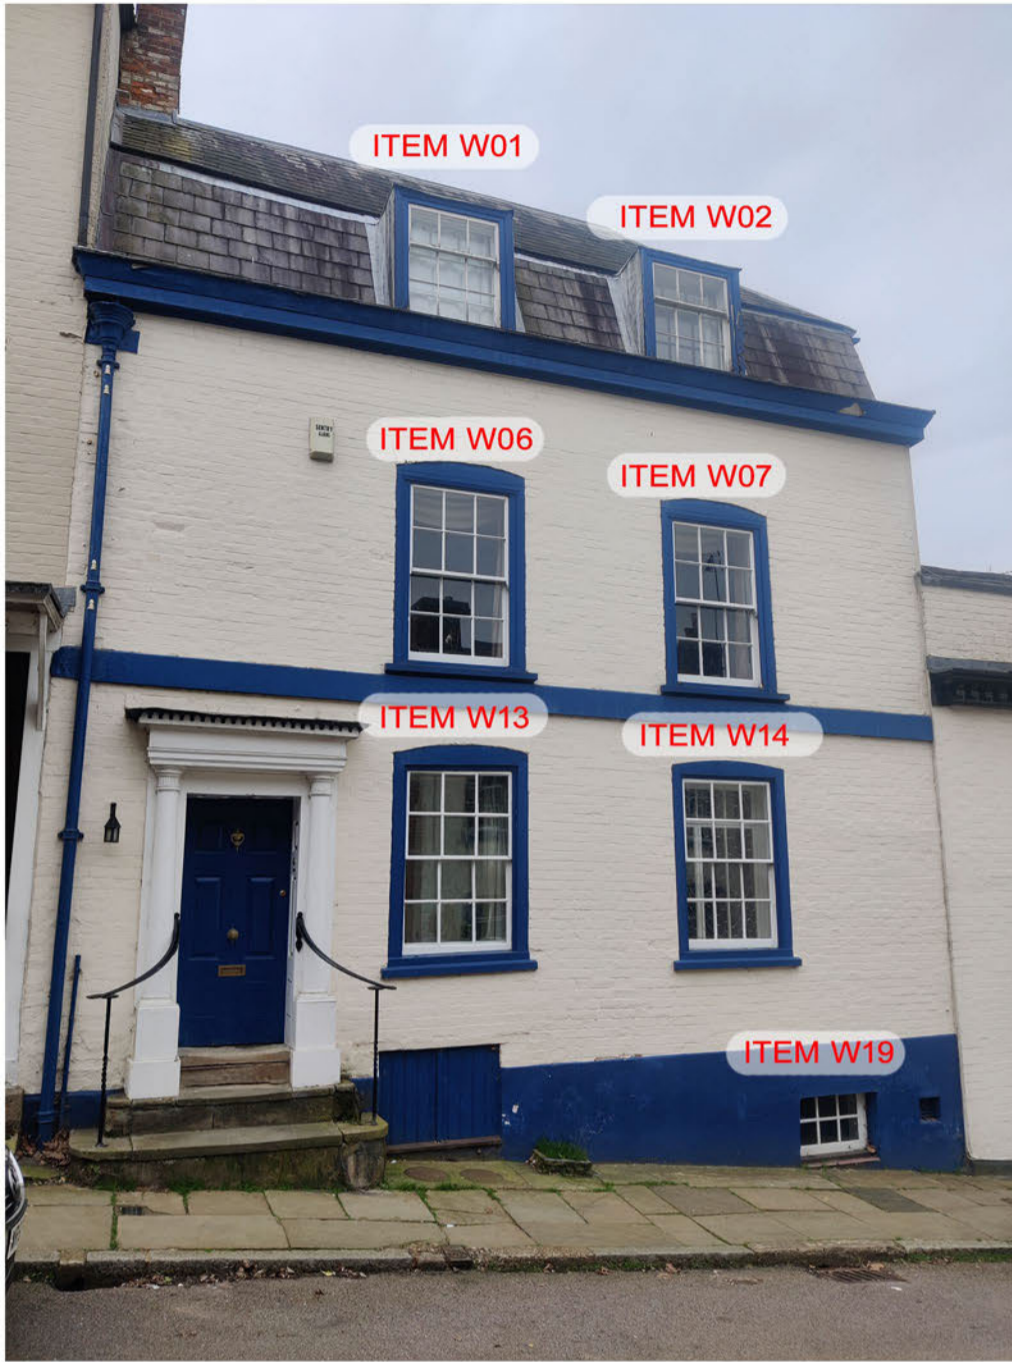
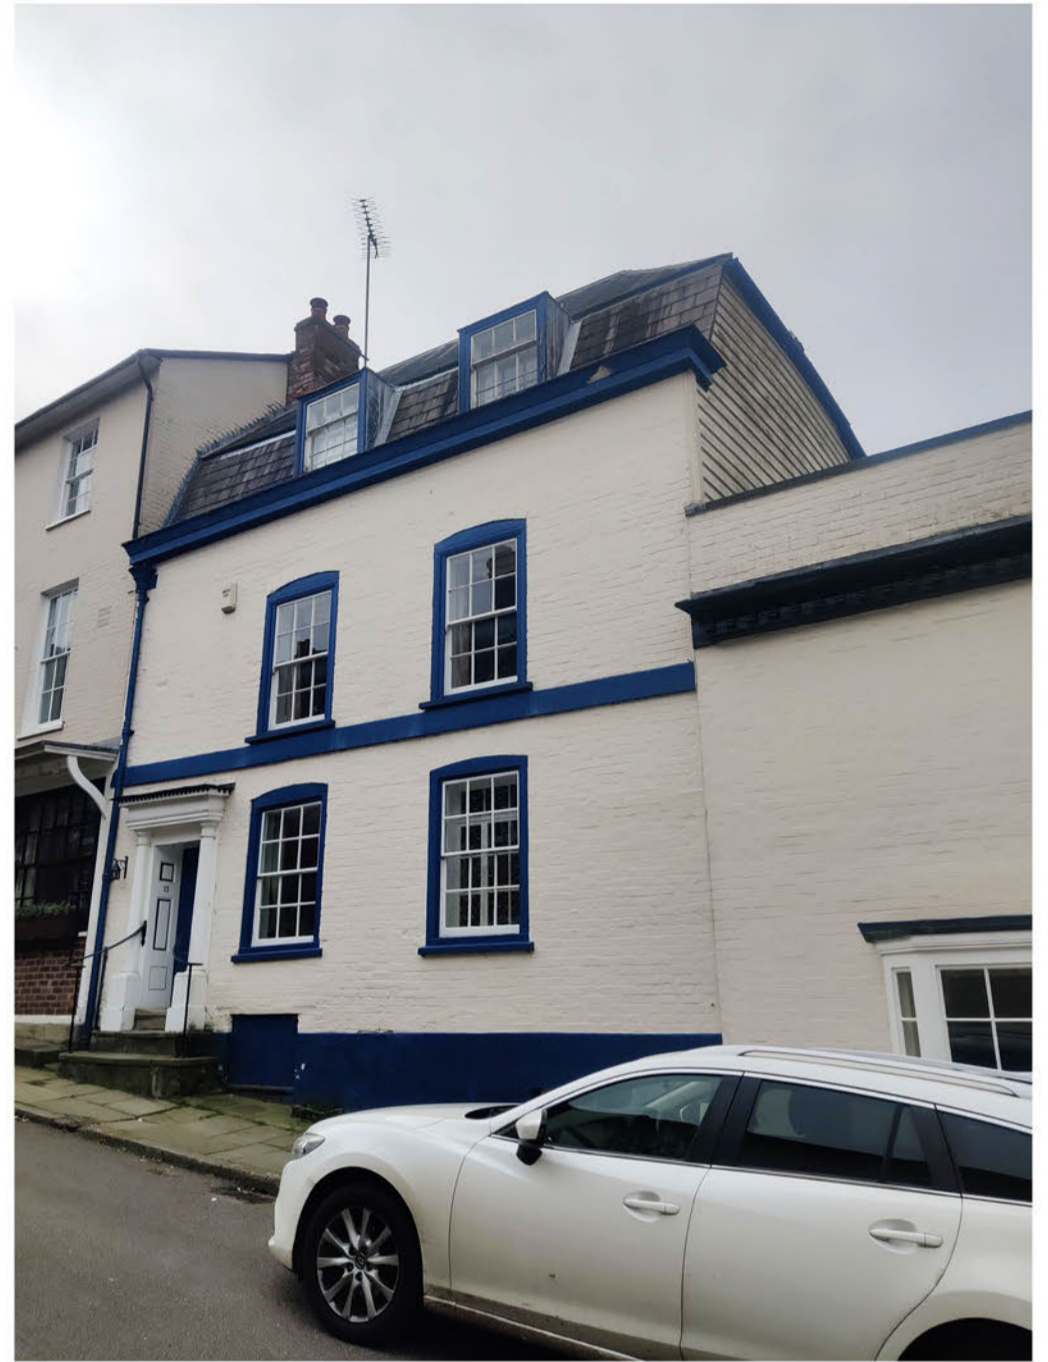
Front elevation of house

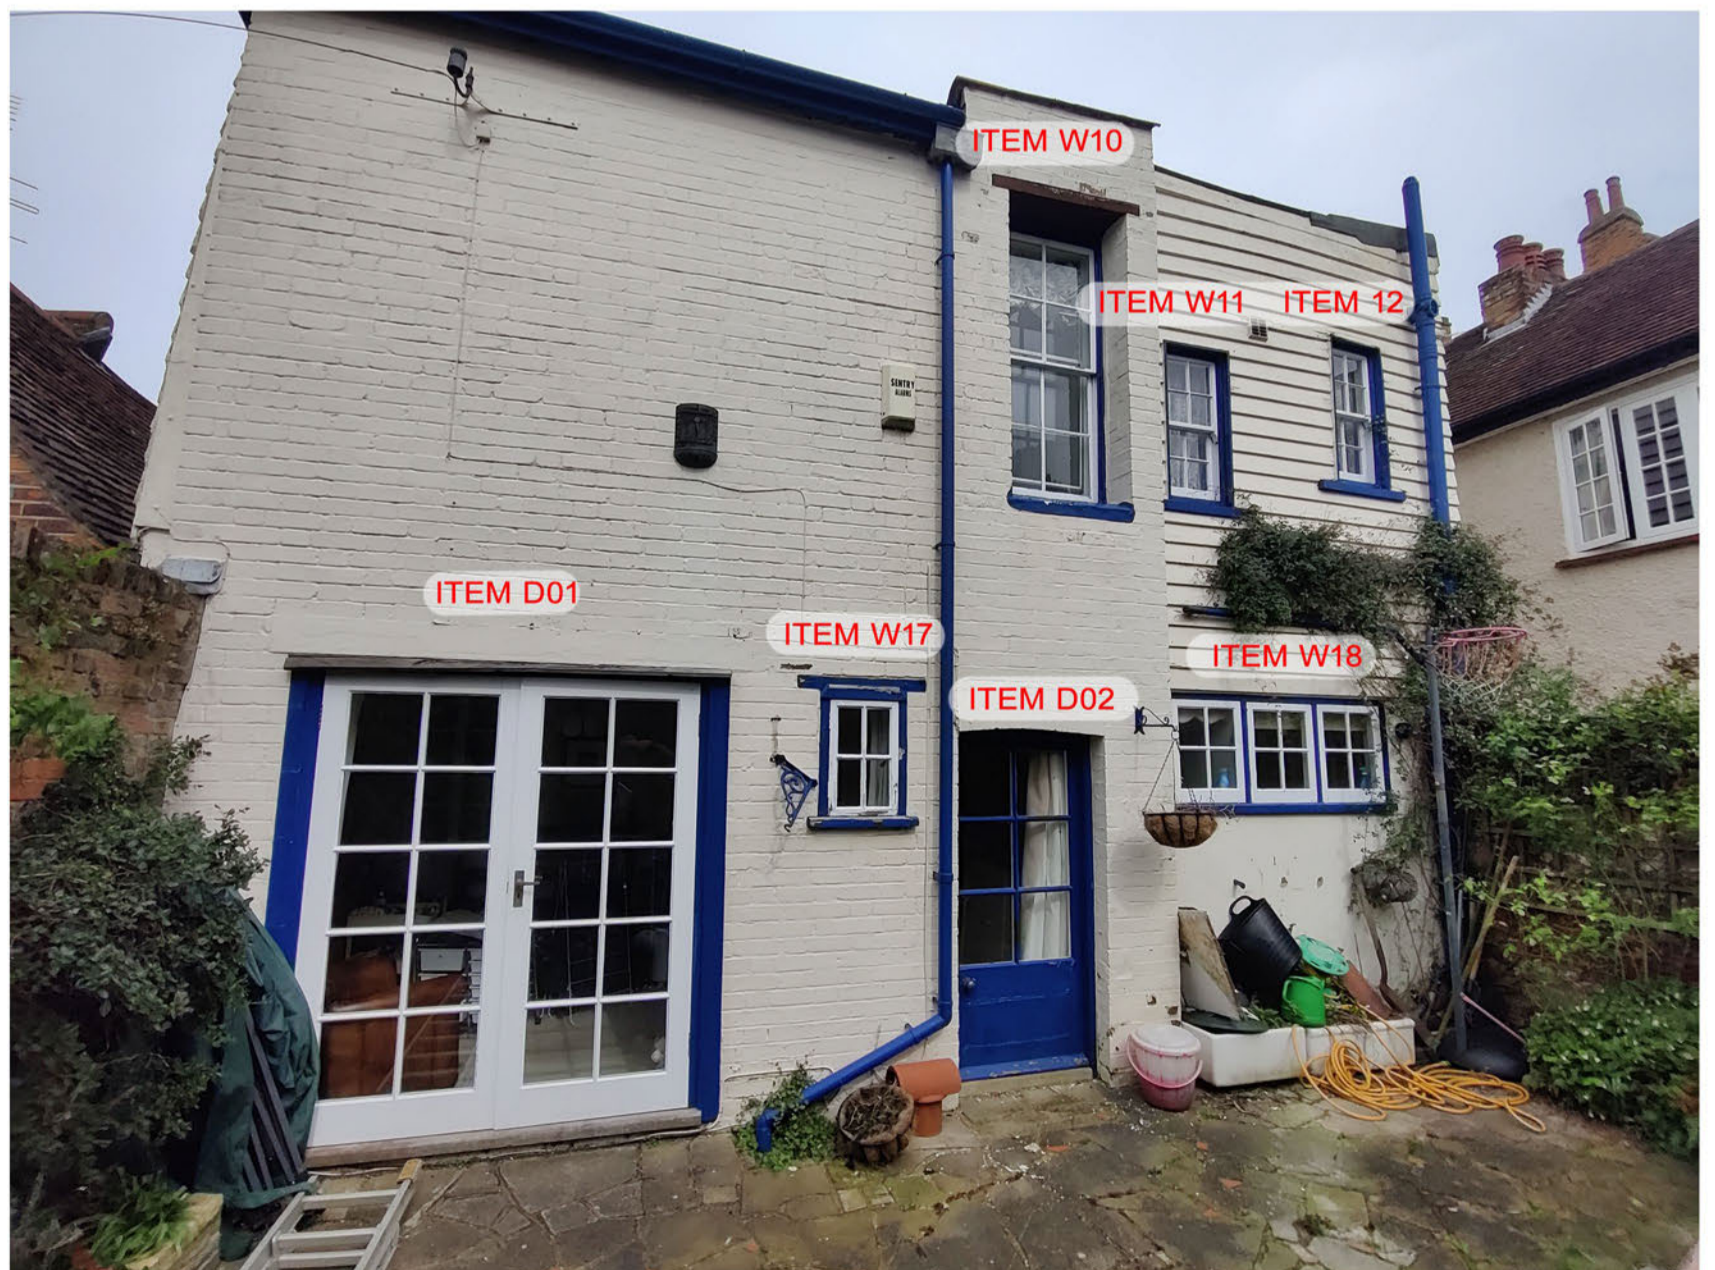
Rear elevation of house

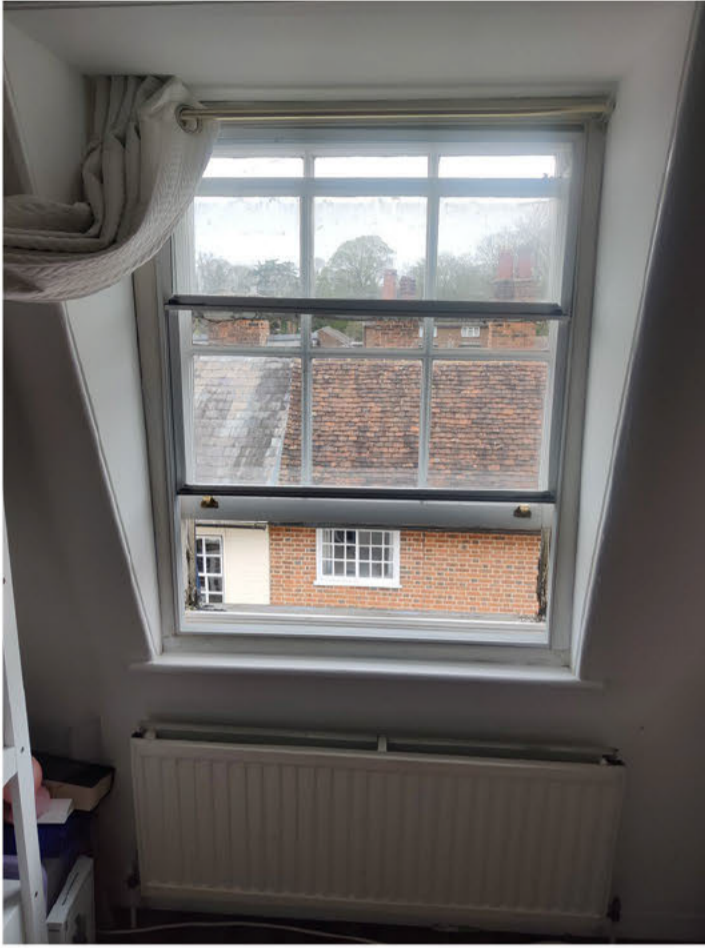
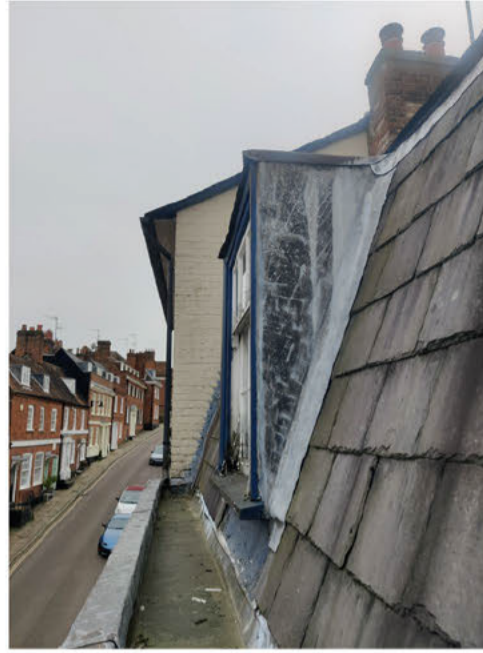
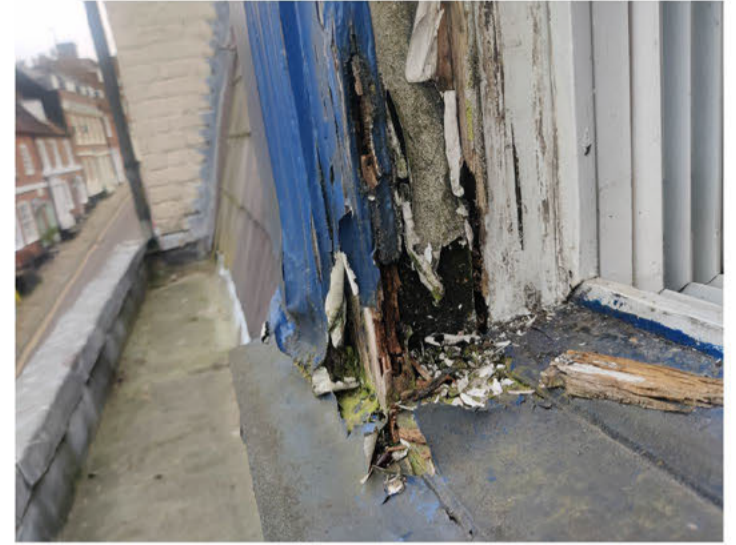
ITEM W01 & W02 - BOX SASH WINDOWS, SPIRAL BALANCE HUNG. THE FRAMES HAVE SIGNIFICANT ROT WITH SERIOUS STRUCTURAL ISSUES AND POTENTIAL DORMER STRUCTURE DEGRADATION. WINDOWS SUFFER FROM WATER INGRESS AND LEAD TO DORMER MAY NEED RENEWING. COMPLETE NEW SASH WINDOWS TO BE FITTED. REVERT TO TRADITIONAL CORD HUNG WITH WEIGHTS. GLAZING PATTERN TO MATCH EXISTING. CURRENTLY GLAZING BARS 20mm WIDE, NEW TO BE 24mm WIDE. CURRENT GLAZING IS SINGLE GLAZED, NEW DOUBLE GLAZED WITH A SLIMLINE WHITE SPACER. PAINTED WHITE SASHES EXTERNALLY WITH ALL FRAMES AND CILL BLUE AS EXISTING.

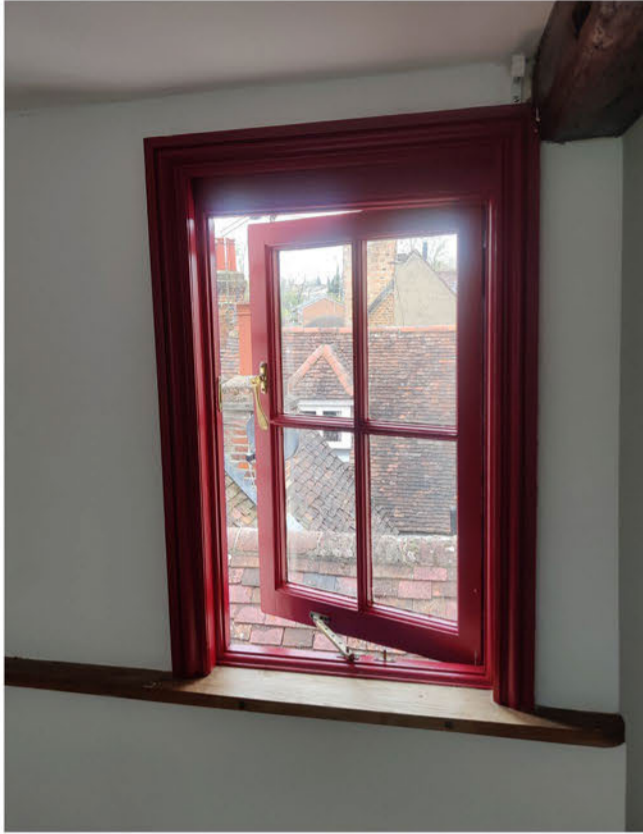
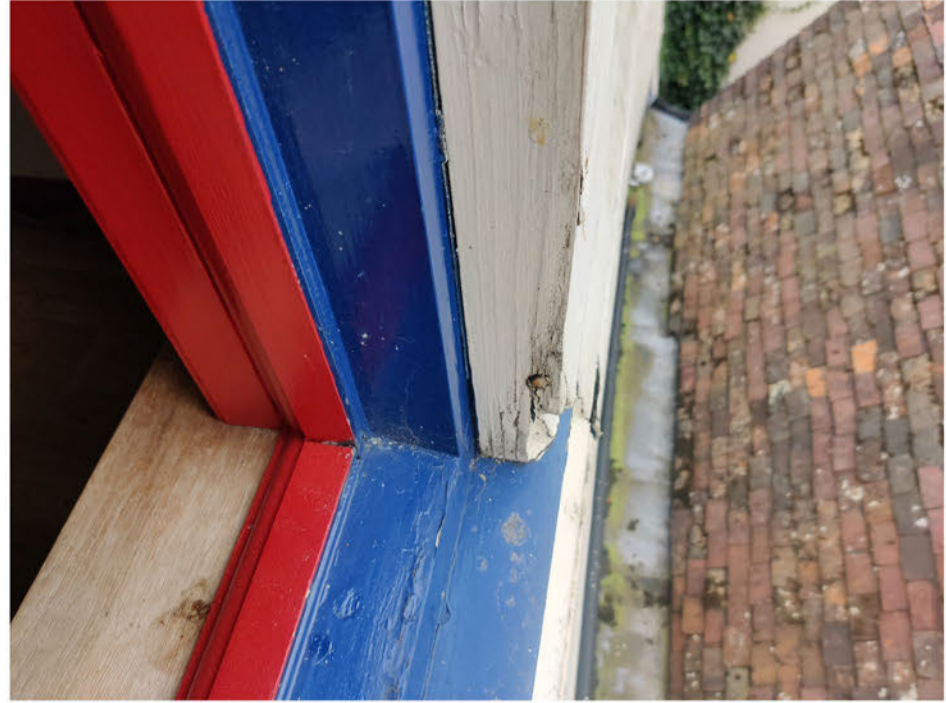
ITEM W03 - CASEMENT WINDOW OPENING OUT. THE FRAME IS IN GOOD CONDITION AND CAN REMAIN. SMALL DEGREE OF ROT TO THE EXTERNAL LININGS TO BE REPAIRED. NEW CASEMENT LEAF FITTED GLAZING PATTERN TO MATCH EXISTING. CURRENT GLAZING BARS 22mm WIDE, NEW TO BE 24mm WIDE. CURRENT GLAZING IS SINGLE GLAZED, NEW DOUBLE GLAZED WITH A SLIMLINE WHITE SPACER. PAINTED WHITE SASHES EXTERNALLY WITH ALL FRAMES AND CILL BLUE AS EXISTING.

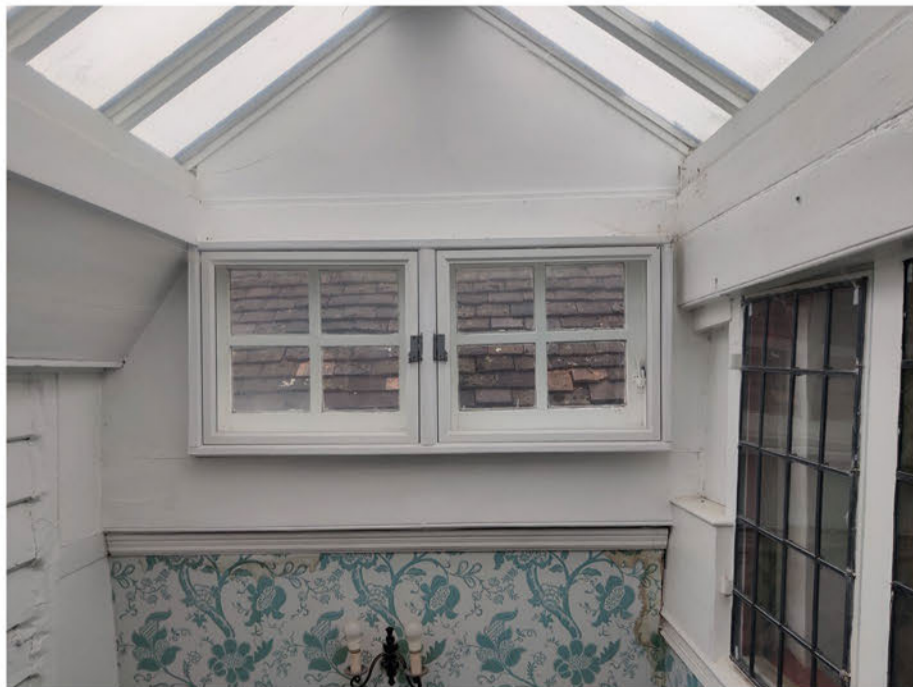
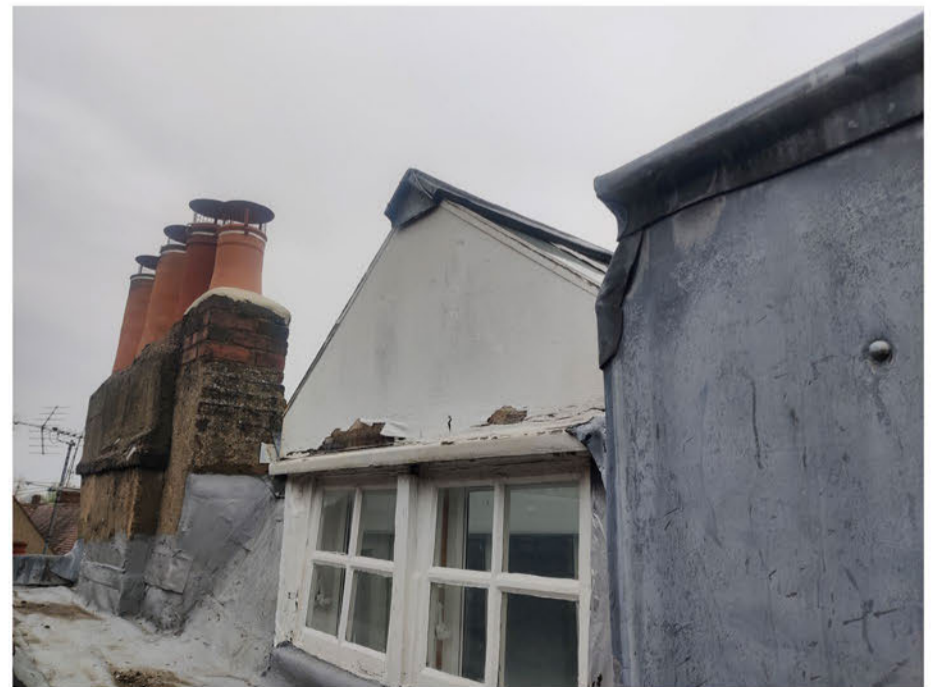
ITEM W04 - CASEMENT WINDOW OPENING OUT (FIXED). THIS WINDOW FRAME IS IN POOR CONDITION WITH ROT AND POSSIBLE WATER DAMAGE. EXTERNAL LEAD OR FELT DRESSING TO CILL WOULD LIKELY NEED RENEWING. COMPLETE NEW CASEMENT WINDOW TO BE FITTED. GLAZING PATTERN TO MATCH EXISTING. CURRENT GLAZING BARS 30mm WIDE, NEW TO BE 24mm WIDE. CURRENT GLAZING IS SINGLE GLAZED, NEW DOUBLE GLAZED WITH A SLIMLINE WHITE SPACER. PAINTED WHITE SASHES EXTERNALLY AND FRAMES AS EXISTING.

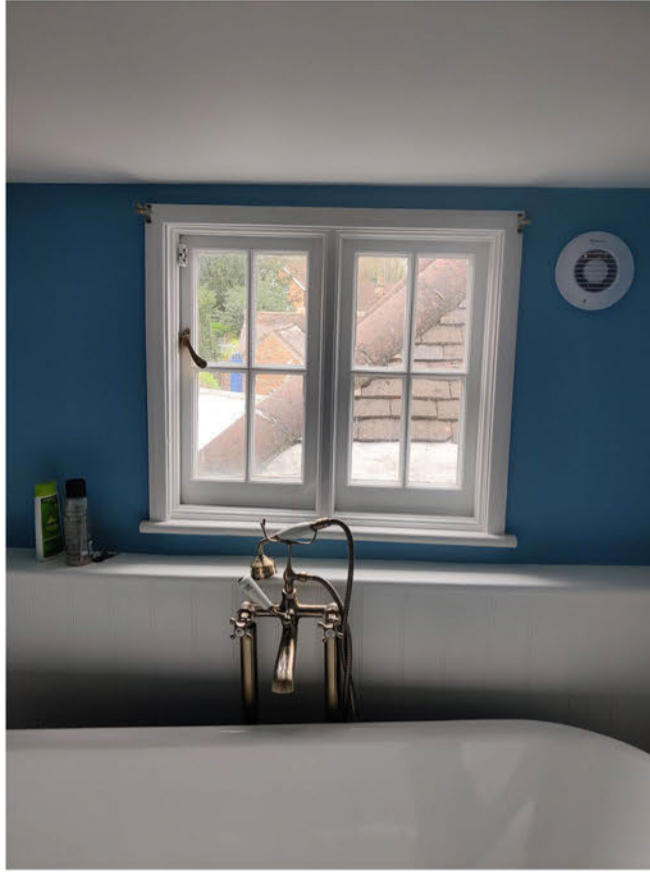
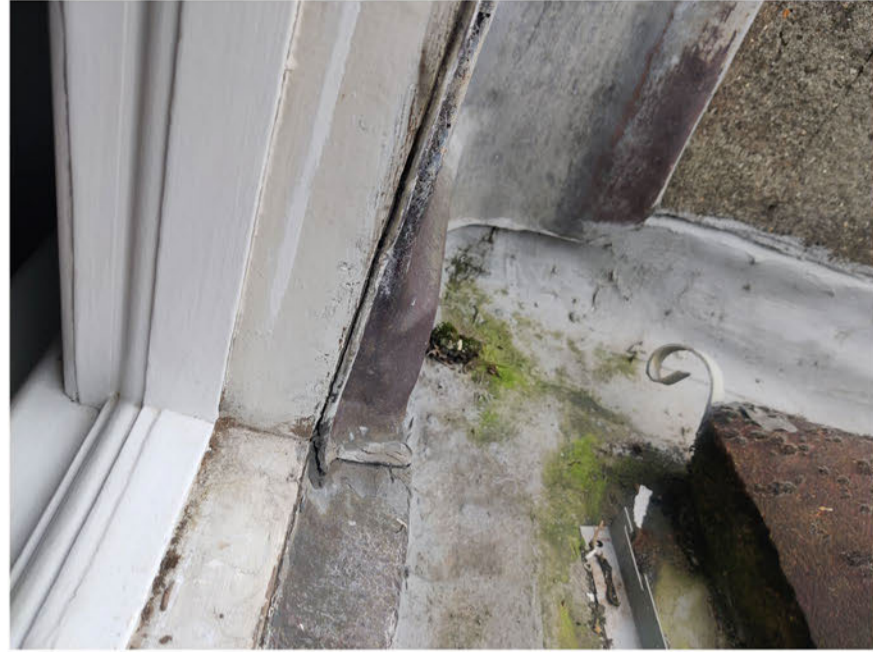
ITEM W05 - CASEMENT WINDOW OPENING OUT. THE FRAME IS IN GOOD CONDITION AND CAN REMAIN. NEW CASEMENT LEAF FITTED GLAZING PATTERN TO MATCH EXISTING. CURRENT GLAZING BARS 22mm WIDE, NEW TO BE 24mm WIDE. CURRENT GLAZING IS SINGLE GLAZED, NEW DOUBLE GLAZED WITH A SLIMLINE WHITE SPACER. PAINTED WHITE SASHES EXTERNALLY AND FRAMES AS EXISTING.

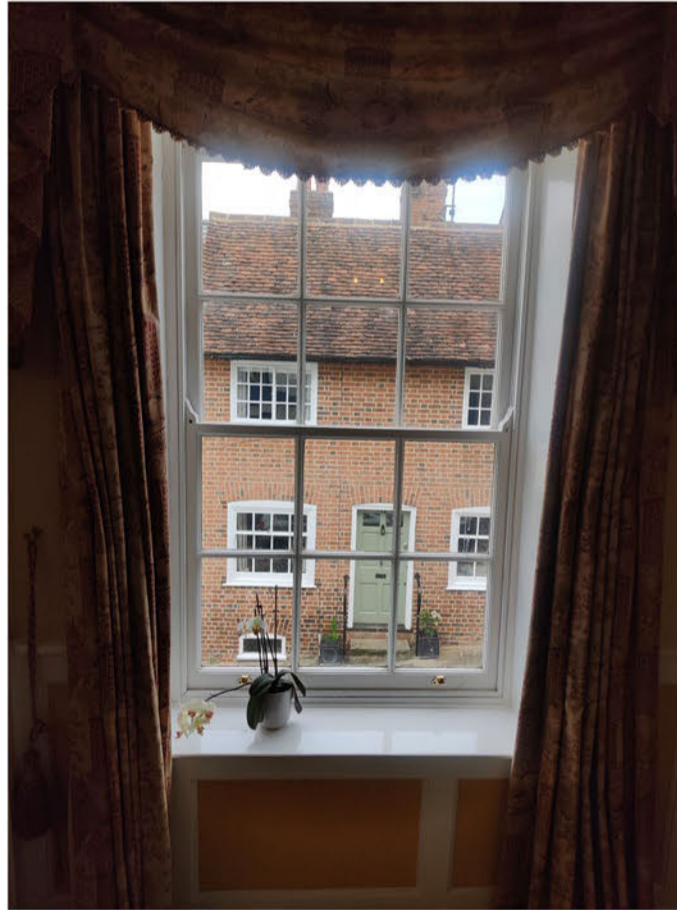
ITEM W06 & W07 - BOX SASH WINDOWS, SPIRAL BALANCE HUNG. FRAMES HAVE SOME DEGREE OF ROT, BUT ARE REPAIRABLE, MAINLY ON THE OUTER JAMBS AND CILLS. SPIRAL BALANCES ARE CURRENTLY BROKEN. NEW SASHES FITTED TO THE EXISTING FRAMES. GLAZING PATTERN TO MATCH EXISTING. CURRENT GLAZING BARS 20mm WIDE, NEW TO BE 24mm WIDE. CURRENT GLAZING IS SINGLE GLAZED, NEW DOUBLE GLAZED WITH A SLIMLINE WHITE SPACER. PAINTED WHITE SASHES EXTERNALLY WITH ALL FRAMES AND CILL BLUE AS EXISTING.

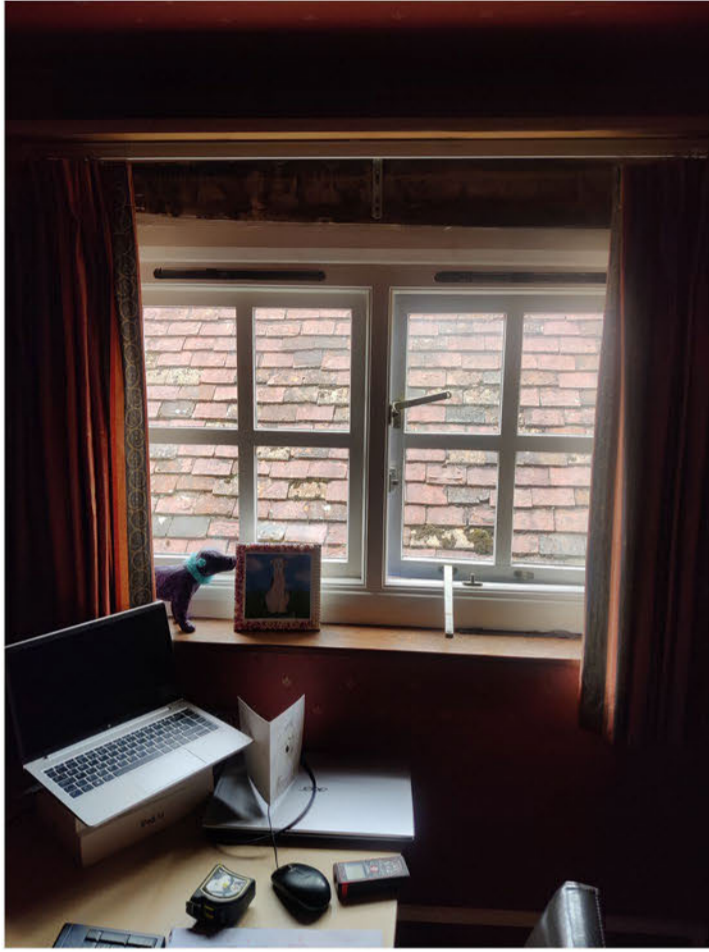
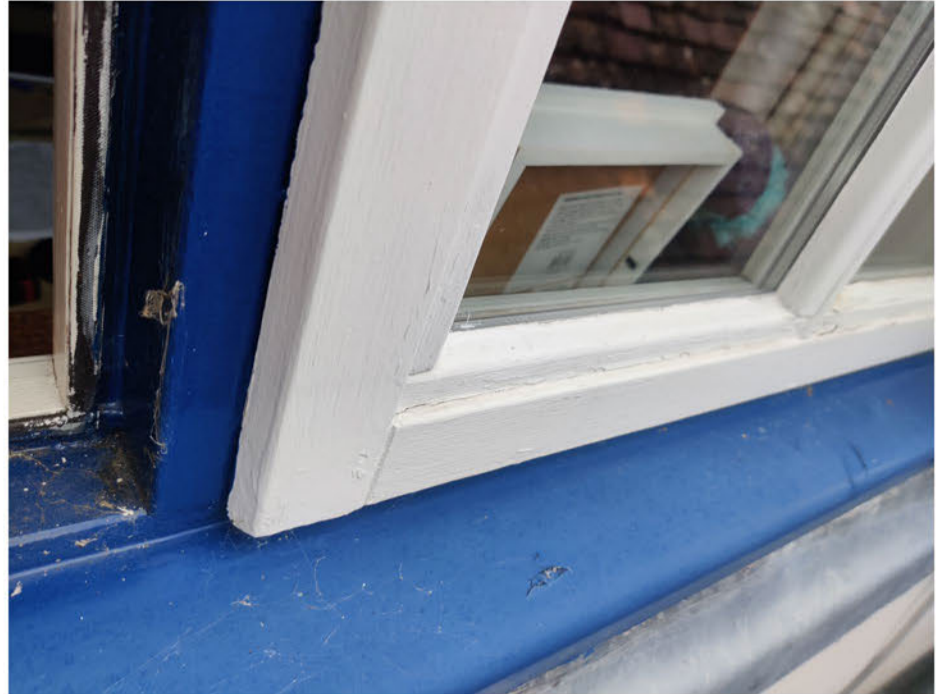
ITEM W08 - CASEMENT WINDOW OPENING OUT STORMPROOF. THIS IS A NON TRADITIONAL WINDOW IN DESIGN AND NOT SUITED TO THE HOUSE. IT HAS STORMPROOF REBATES TO THE STILES AND BOTTOM RAILS. COMPLETE NEW CASEMENT TO BE FITTED, FLUSH DESIGN AS IS TRADITIONAL. GLAZING PATTERN TO MATCH EXISTING. CURRENT GLAZING BARS 40mm WIDE, NEW TO BE 24mm WIDE. CURRENT GLAZING IS DOUBLE GLAZED WITH AN ALUMINIUM SPACER. NEW DOUBLE GLAZED WITH A SLIMLINE WHITE SPACER. PAINTED WHITE SASHES EXTERNALLY WITH ALL FRAMES AND CILL BLUE AS EXISTING.

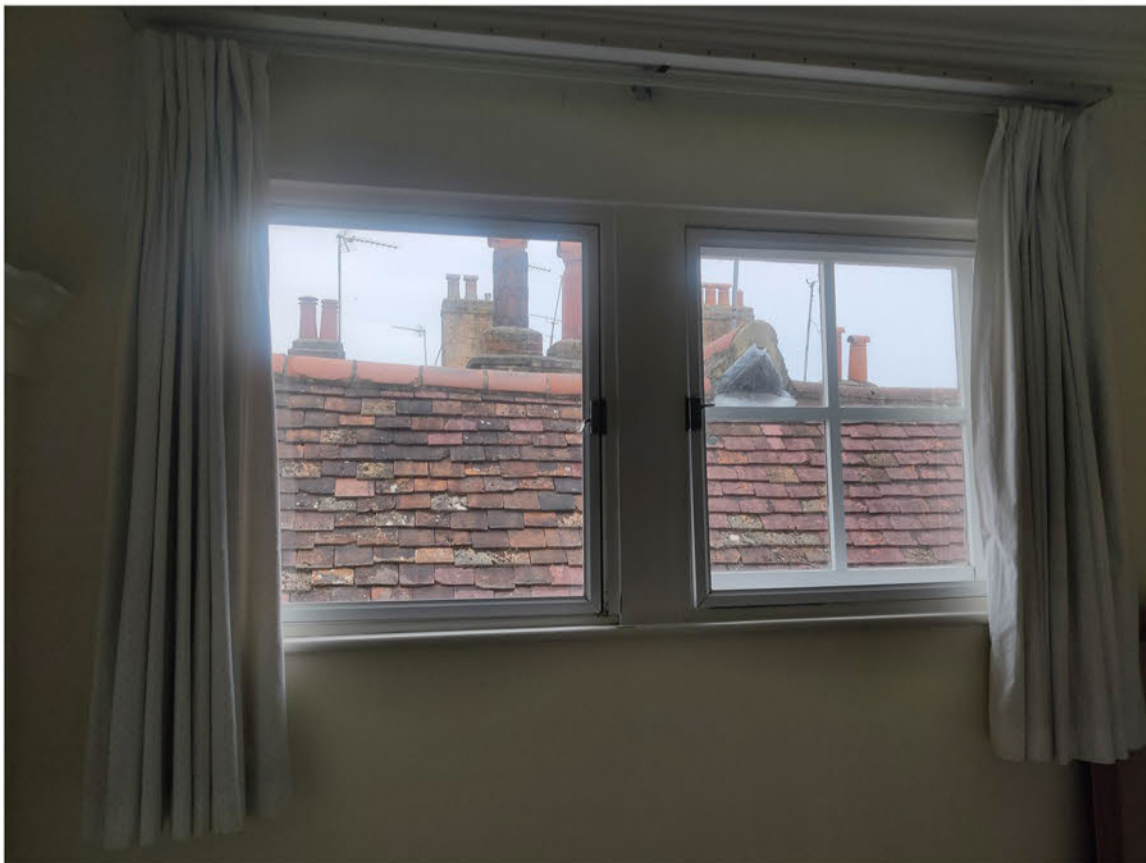
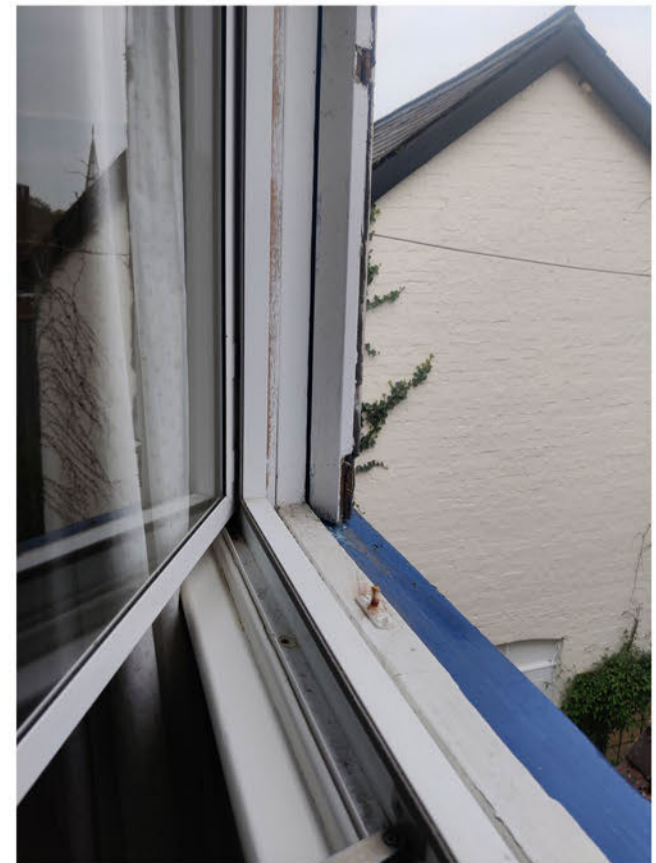
ITEM W09 - CASEMENT WINDOW OPENING OUT. THIS WINDOW HAS A BROKEN CASEMENT SASH AND THE FRAME HAS SIGNS OF ROT. COMPLETE NEW CASEMENT WINDOW TO BE FITTED. GLAZING PATTERN TO MATCH EXISTING. CURRENT GLAZING BARS 30mm WIDE, NEW TO BE 24mm WIDE. CURRENT GLAZING IS SINGLE GLAZED, NEW DOUBLE GLAZED WITH A SLIMLINE WHITE SPACER. PAINTED WHITE SASHES EXTERNALLY WITH ALL FRAMES AND CILL BLUE AS EXISTING.

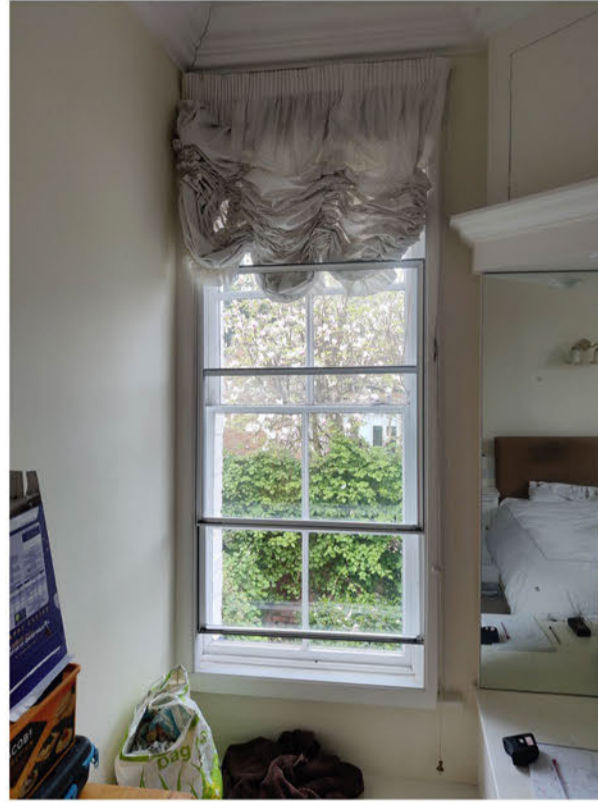
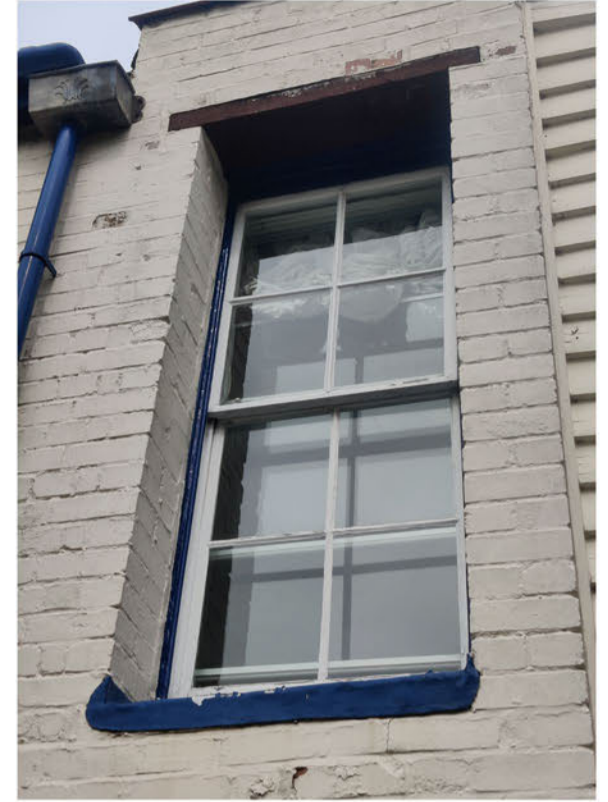
ITEM W10 - BOX SASH WINDOW, CORD HUNG. THE FRAMES ARE IN REASONABLE CONDITION AND CAN REMAIN. NEW SASHES FITTED TO THE EXISTING FRAMES. GLAZING PATTERN TO MATCH EXISTING. CURRENT GLAZING BARS 22mm WIDTH ON THE TOP SASH AND 16mm WIDTH ON THE BOTTOM SASH, NEW TO BE 24mm WIDE. CURRENT GLAZING IS SINGLE GLAZED, NEW DOUBLE GLAZED WITH A SLIMLINE WHITE SPACER. PAINTED WHITE SASHES EXTERNALLY WITH ALL FRAMES AND CILL BLUE AS EXISTING.

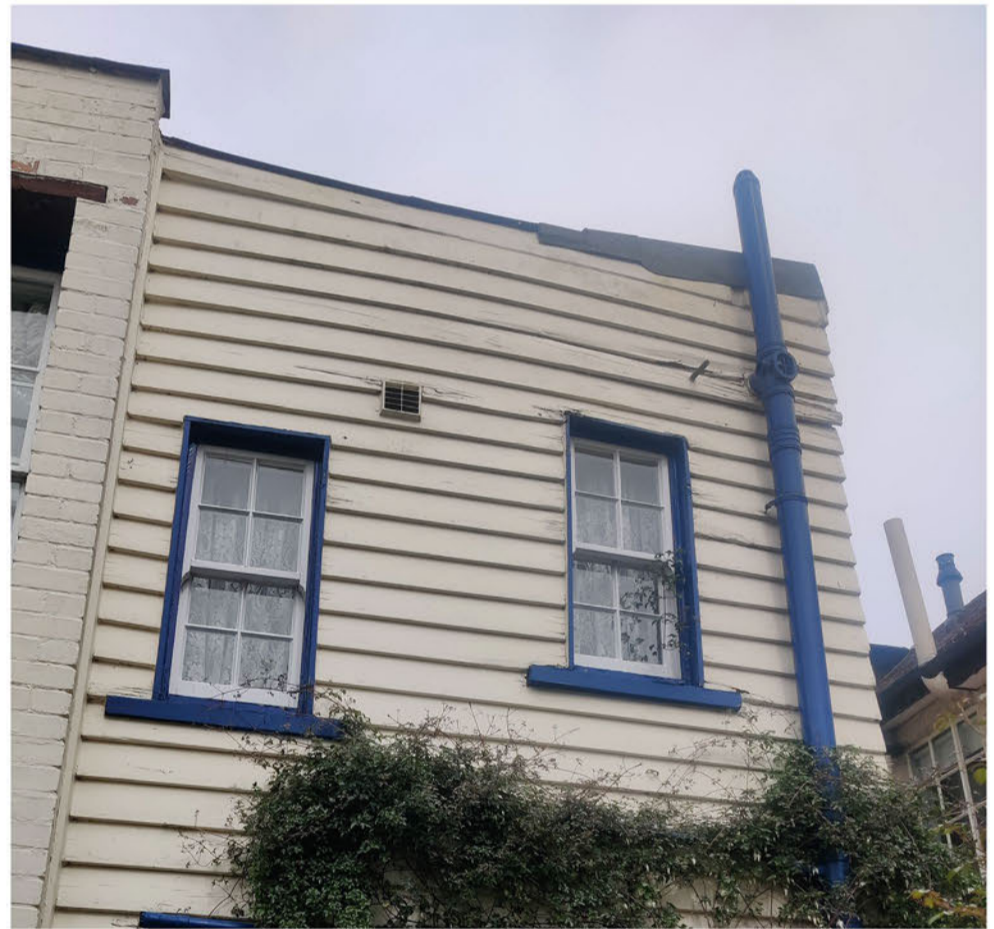
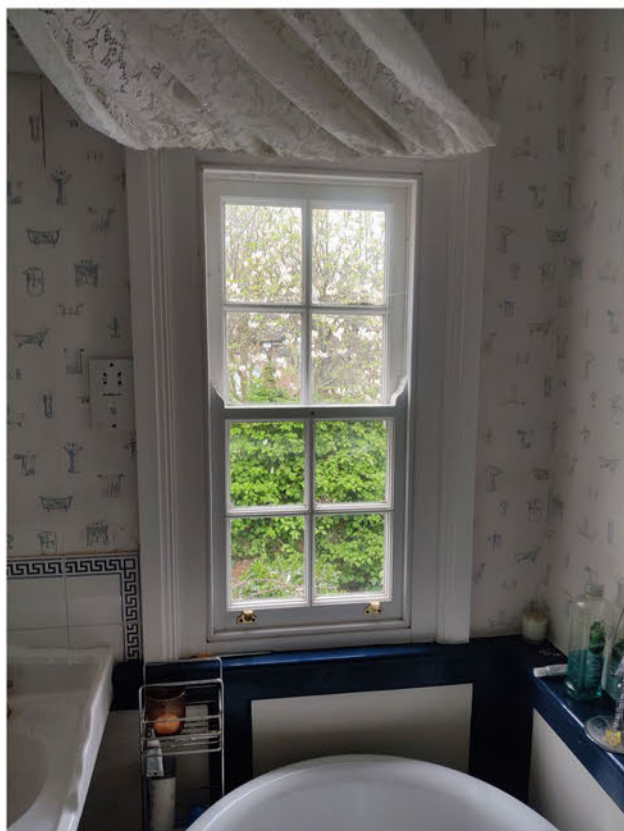
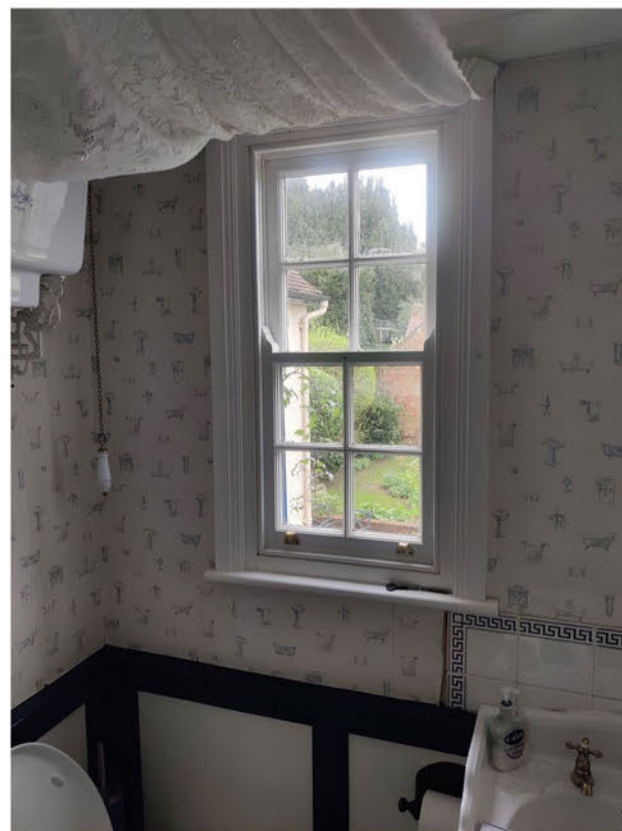
ITEM W11 & W12 - BOX SASH WINDOWS, CORD HUNG. THE FRAMES WILL REQUIRE MODERATE REPAIRS INCLUDING TO THE OUTER JAMBS AND CILLS. THE FRAMES CAN REMAIN. NEW SASHES FITTED TO THE EXISTING FRAMES. GLAZING PATTERN TO MATCH EXISTING. CURRENT GLAZING BARS 20mm WIDE, NEW TO BE 24mm WIDE. CURRENT GLAZING IS SINGLE GLAZED, NEW DOUBLE GLAZED WITH A SLIMLINE WHITE SPACER. PAINTED WHITE SASHES EXTERNALLY WITH ALL FRAMES AND CILL BLUE AS EXISTING.

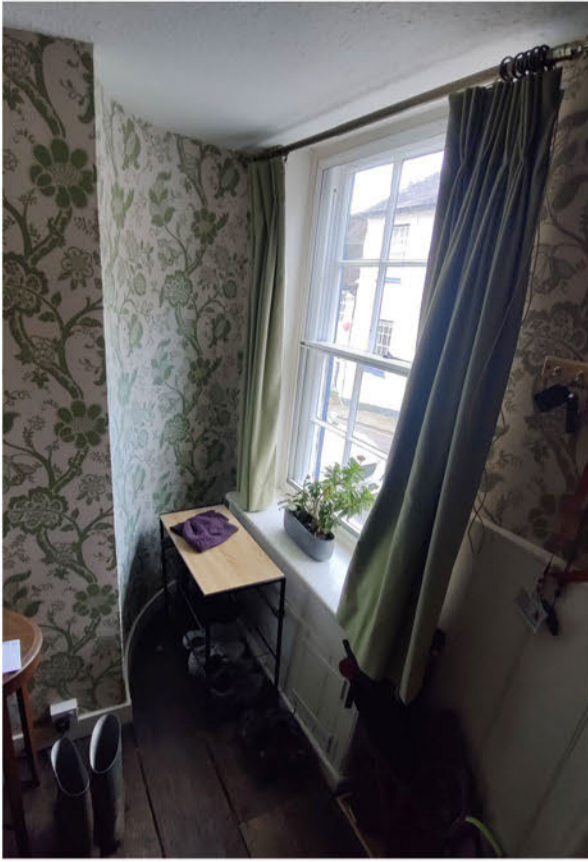
ITEM W13

ITEMS W13 & W14 - BOX SASH WINDOW, CORD HUNG. FRAMES ARE IN REASONABLE CONDITION AND CAN REMAIN SECONDARY GLAZED CASEMENT IN FRONT OF ITEM W14 TO BE REMOVED. NEW SASHES FITTED TO THE EXISTING FRAMES. GLAZING PATTERN TO MATCH EXISTING. CURRENT GLAZING BARS 20mm WIDE, NEW TO BE 24mm WIDE. CURRENT GLAZING IS SINGLE GLAZED, NEW DOUBLE GLAZED WITH A SLIMLINE WHITE SPACER. PAINTED WHITE SASHES EXTERNALLY WITH ALL FRAMES AND CILL BLUE AS EXISTING.

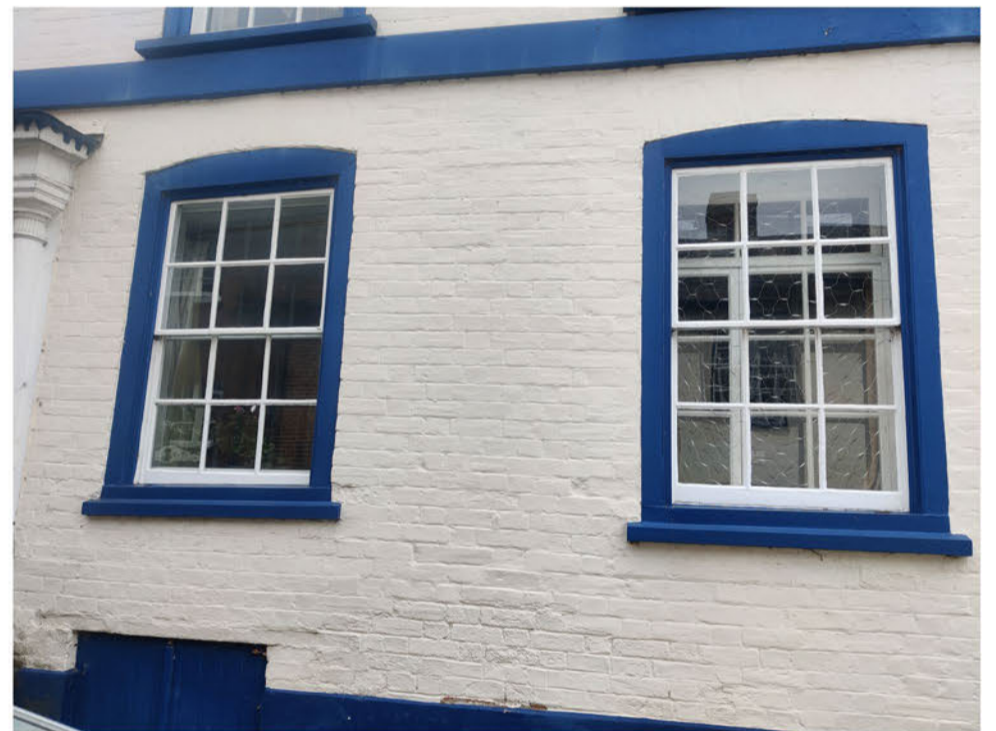
ITEM W15 - UPVC WINDOW, FIXED. NON TRADITIONAL TO OTHER WINDOWS IN THE HOUSE. TO BE REPLACED WITH A COMPLETE NEW CASEMENT WINDOW, TIMBER TO MATCH THE OTHER WINDOWS. GLAZING PATTERN TO MATCH EXISTING. CURRENT GLAZING BARS ARE INTERNAL MOCK BARS 20mm WIDE, NEW TO BE 24mm WIDE. CURRENT GLAZING IS DOUBLE GLAZED. NEW DOUBLE GLAZED WITH A SLIMLINE WHITE SPACER. PAINTED WHITE SASHES AND FRAMES EXTERNALLY AS EXISTING.

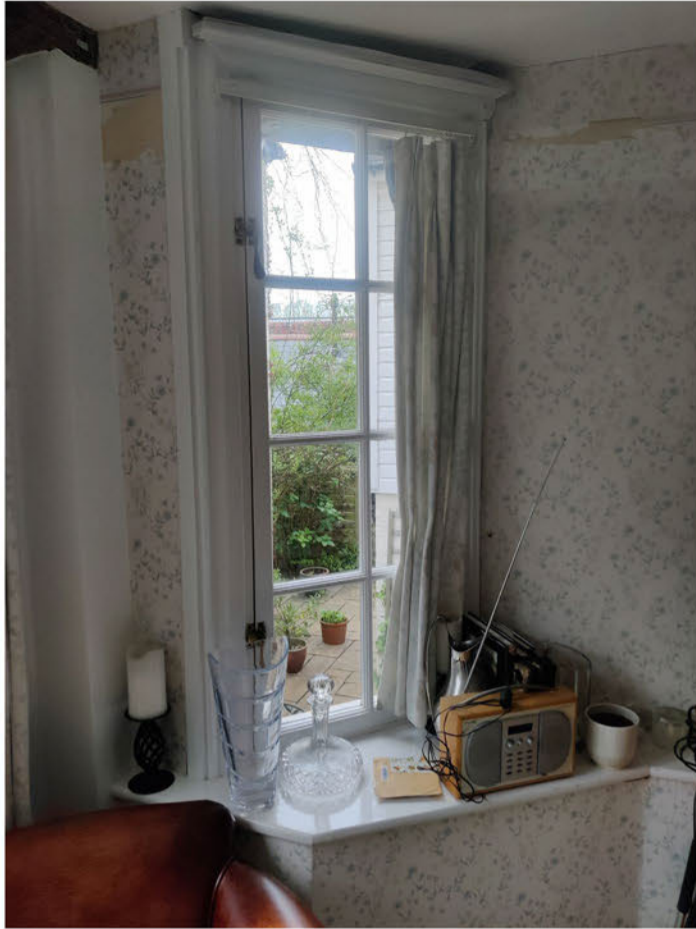
ITEM W16 - CASEMENT WINDOW OPENING IN. THE FRAME IS IN GOOD CONDITION AND CAN REMAIN. NEW CASEMENT LEAF FITTED GLAZING PATTERN TO MATCH EXISTING. CURRENT GLAZING BARS 25mm WIDE, NEW TO BE 24mm WIDE. CURRENT GLAZING IS SINGLE GLAZED, NEW DOUBLE GLAZED WITH A SLIMLINE WHITE SPACER. PAINTED WHITE SASHES AND FRAME EXTERNALLY AS EXISTING.

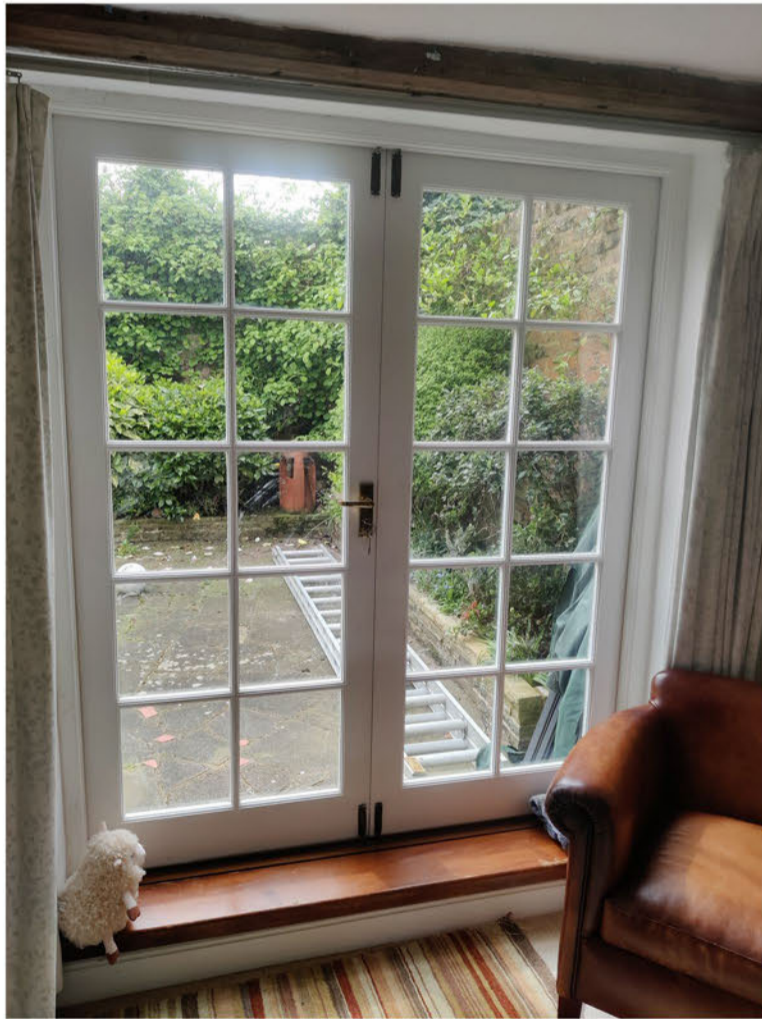
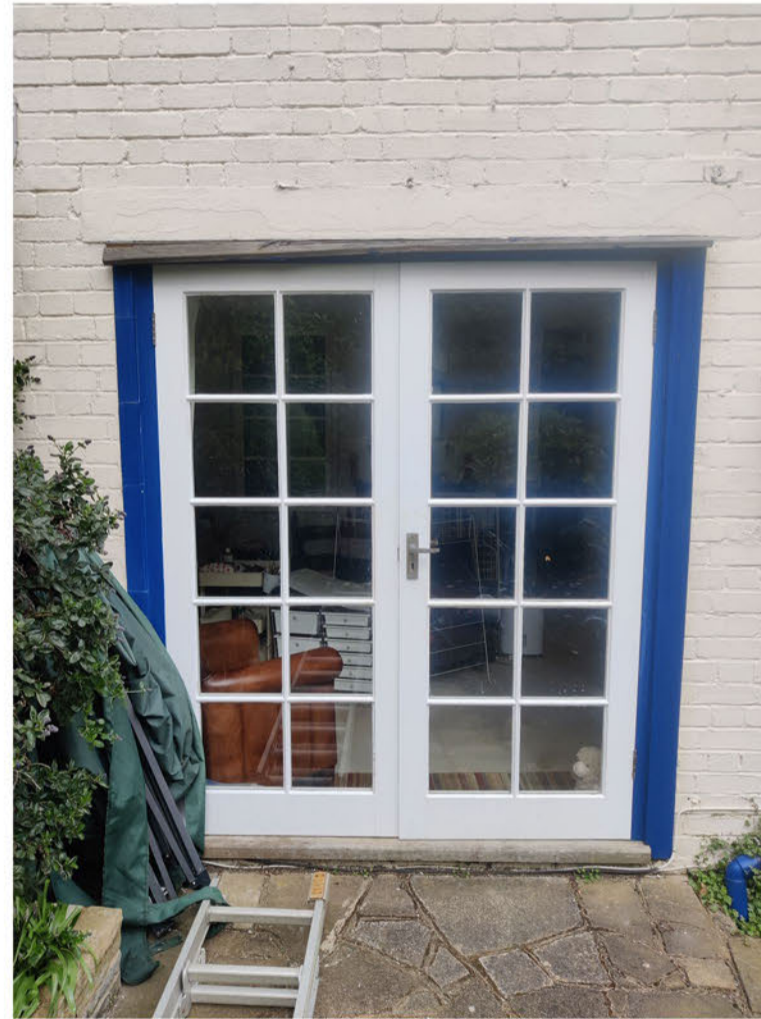
ITEM D01 - FRENCH DOORS OPENING OUT. NEW DOOR LEAVES ARE NOT PRACTICAL TO FIT TO EXISTING FRAME, AS HARD TO WEATHERSEAL AND LOCK SECURELY. COMPLETE NEW DOORS TO BE FITTED. GLAZING PATTERN TO MATCH EXISTING. CURRENT GLAZING BARS ARE 25mm WIDE, NEW TO BE 24mm WIDE. CURRENT GLAZING IS SINGLE GLAZED. NEW DOUBLE GLAZED WITH A SLIMLINE WHITE SPACER. PAINTED WHITE SASHES EXTERNALLY WITH ALL FRAMES AND CILL BLUE AS EXISTING.

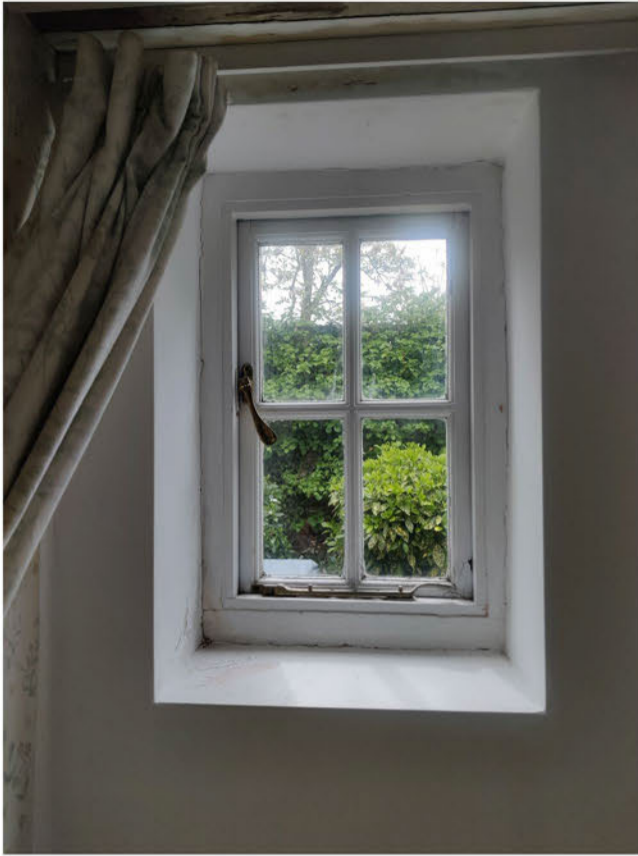
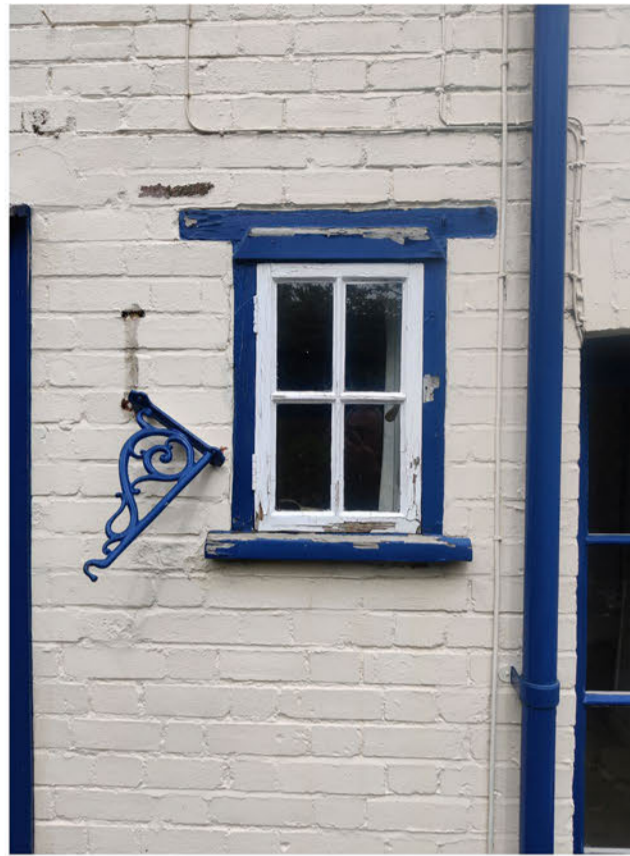
ITEM W17 - CASEMENT WINDOW OPENING OUT. FRAME HAS ROT AND IS NOT PRACTICAL TO RETAIN. COMPLETE NEW COMPLETE NEW CASEMENT WINDOW TO BE FITTED. GLAZING PATTERN TO MATCH EXISTING. CURRENT GLAZING BARS 25mm WIDE, NEW TO BE 24mm WIDE. CURRENT GLAZING IS SINGLE GLAZED, NEW DOUBLE GLAZED WITH A SLIMLINE WHITE SPACER. PAINTED WHITE SASHES EXTERNALLY WITH ALL FRAMES AND CILL BLUE AS EXISTING.
