MS CLARE PARKER  
13 FORE STREET  
HATFIELD  
HERTS AL9 5AN

Drawn by: C JEWISS  
Scale: N/A  
Date: MAY 2024  
Drawing: No.51

PHOTOGRAPHS

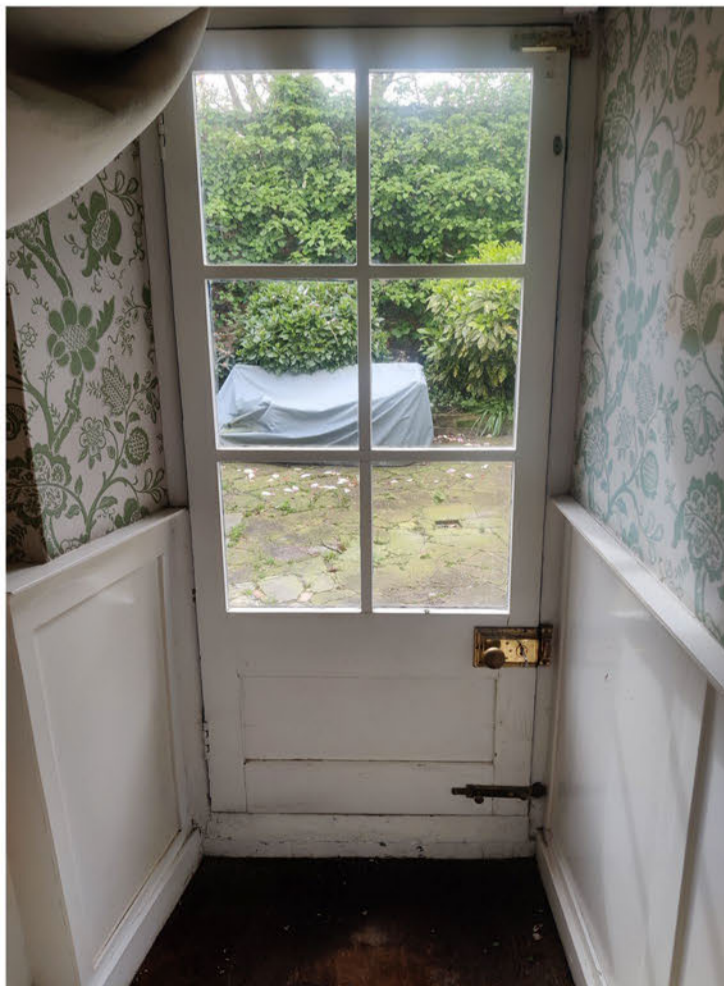
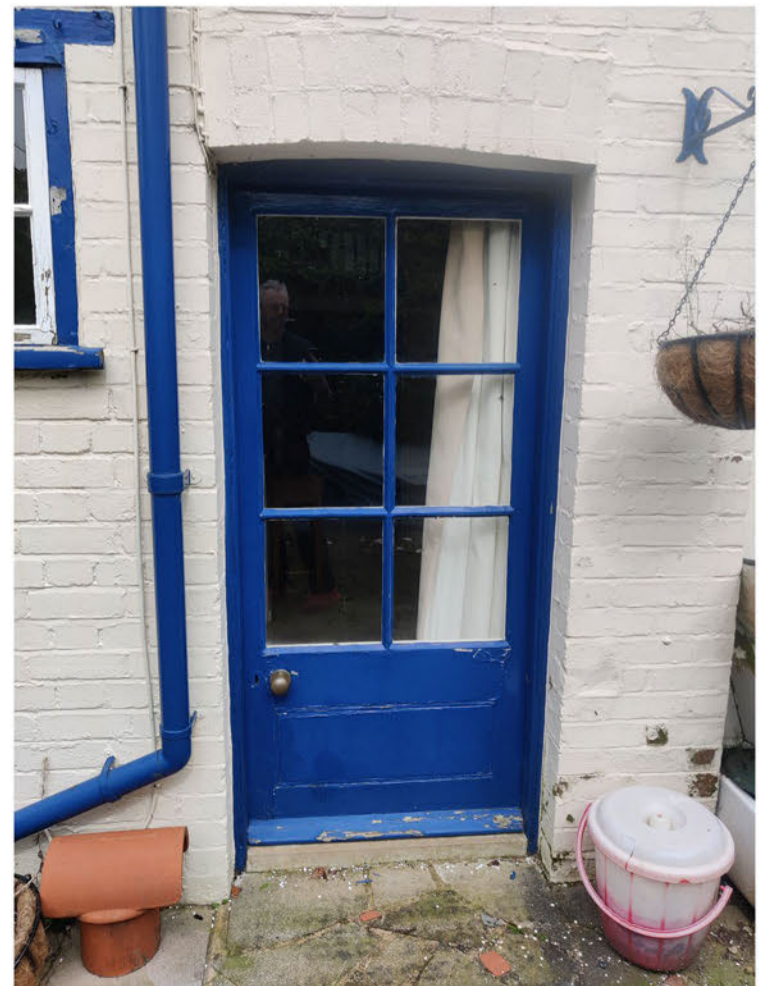
ITEM D02 - SINGLE DOOR OPENING OUT. NEW DOOR LEAF IS NOT PRACTICAL TO FIT TO EXISTING FRAME, AS HARD TO WEATHERSEAL AND LOCK SECURELY. COMPLETE NEW DOORS TO BE FITTED. GLAZING PATTERN TO MATCH EXISTING. CURRENT GLAZING BARS ARE 30mm WIDE, NEW TO BE 24mm WIDE. CURRENT GLAZING IS SINGLE GLAZED. NEW DOUBLE GLAZED WITH A SLIMLINE WHITE SPACER. PAINTED WHITE SASHES EXTERNALLY WITH ALL FRAMES AND CILL BLUE AS EXISTING.

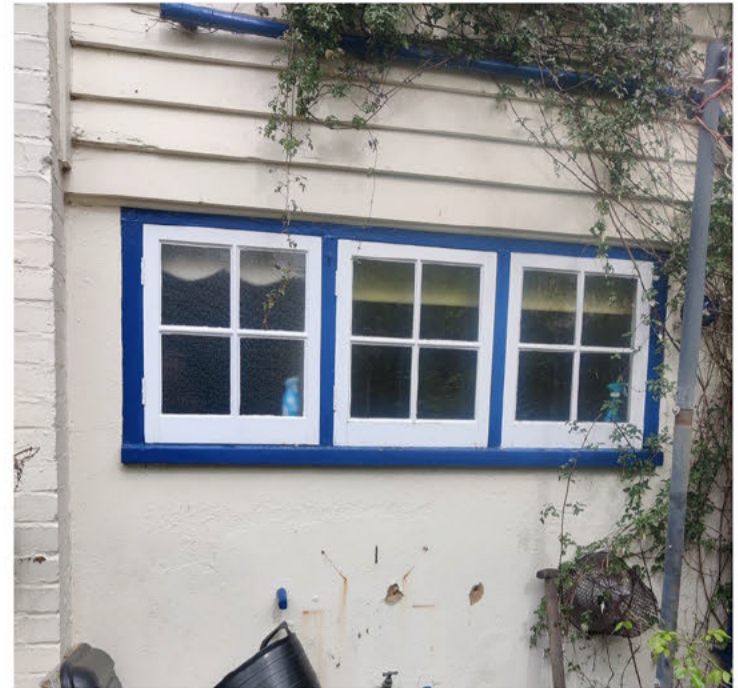
ITEM W18 - CASEMENT WINDOW OPENING OUT. THIS WINDOW HAS INTERNAL WALL SEPERATING IT INTO TWO. THE FRAME IS IN GOOD CONDITION AND CAN REMAIN. NEW CASEMENT LEAVES FITTED GLAZING PATTERN TO MATCH EXISTING. CURRENT GLAZING BARS 25mm WIDE, NEW TO BE 24mm WIDE. CURRENT GLAZING IS SINGLE GLAZED, NEW DOUBLE GLAZED WITH A SLIMLINE WHITE SPACER. PAINTED WHITE SASHES EXTERNALLY AND FRAMES AS EXISTING.

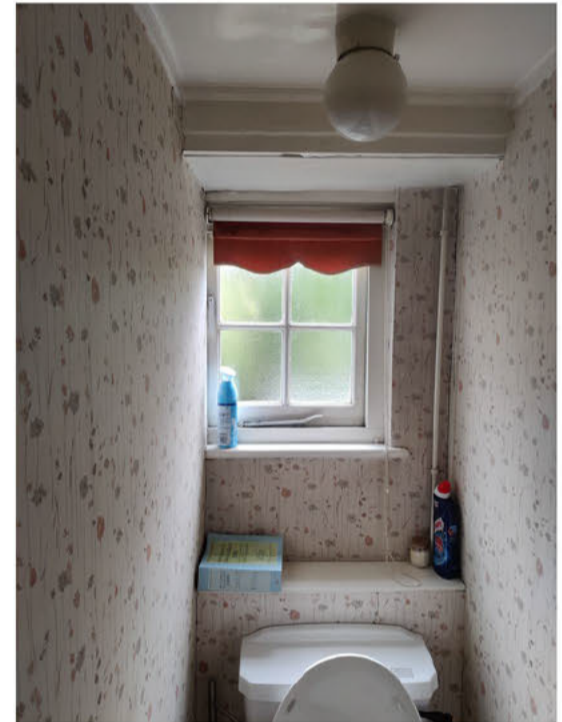
ITEM W19 - CASEMENT WINDOW OPENING OUT (FIXED). FRAME HAS ROT AND IS NOT PRACTICAL TO RETAIN. COMPLETE NEW COMPLETE NEW CASEMENT WINDOW TO BE FITTED. GLAZING PATTERN TO MATCH EXISTING. CURRENT GLAZING BARS 25mm WIDE, NEW TO BE 24mm WIDE. CURRENT GLAZING IS SINGLE GLAZED, NEW DOUBLE GLAZED WITH A SLIMLINE WHITE SPACER. PAINTED WHITE SASHES AND FRAME EXTERNALLY AS EXISTING.
