CRITTALL WINDOW SURVEY

Comet Hotel - Hatfield
Crittall Window condition survey

Rev: - V-00 14th May 2018 GA
Rev: - V-01 21st May 2018 GA

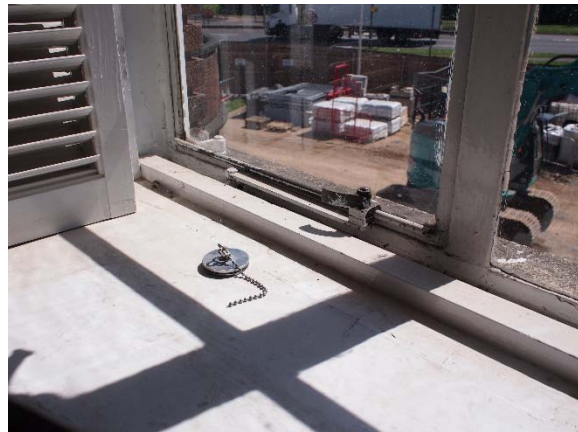
GW.19	Room locked off. Crittall glazed window set 2,200 x 1,100 TBC	No of panels WxH - 3 x 1 [2 in centre] Opening lights - 2 side hung, 1 top hung Ironmongery - mix of stays, sliding stays and gear to open/latches part missing TBC	Poor decorative order would need shot blasting back to bare metal and bringing forward again. Ironmongery in poor state would need taking off and refurbishing. This looks like a replacement as it doesn't match GW.18 and has render panels above and below.	P5142171					1
First floor									
FW.1	Crittall glazed window set 990 x 940	No of panels WxH - 2 x 3 Opening lights - 1 side hung, 1 top hung Ironmongery - mix of stays, sliding stays and gear to open/latches part missing	Poor decorative order would need shot blasting back to bare metal and bringing forward again. Ironmongery in poor state would need taking off and refurbishing.	Detail P5142282 Detail P5142239 Detail P5142238	1

FW.2	Crittall glazed window set 990 x 940	No of panels WxH - 2 x 3 Opening lights - 1 side hung, 1 top hung Ironmongery - mix of stays, sliding stays and gear to open/latches part missing	Poor decorative order would need shot blasting back to bare metal and bringing forward again. Ironmongery in poor state would need taking off and refurbishing.	Detail P5142282 Detail P5142239 Detail P5142238	1				
FW.3	Crittall glazed window set 990 x 940	No of panels WxH - 2 x 3 Opening lights - 1 side hung, 1 top hung Ironmongery - mix of stays, sliding stays and gear to open/latches part missing	External view as blocked off internally. Poor decorative order would need shot blasting back to bare metal and bringing forward again. Ironmongery in poor state would need taking off and refurbishing.	Detail P5142282 Detail P5142239 Detail P5142238	1

D no W no	Dimension WxH mm approx.	Description	Condition	Photograph	Repair potential: -				
FW.4	Crittall glazed window set 990 x 940	No of panels WxH - 2 x 3 Opening lights - 1 side hung, 1 top hung Ironmongery - mix of stays, sliding stays and gear to open/latches part missing	Poor decorative order would need shot blasting back to bare metal and bringing forward again. Ironmongery in poor state would need taking off and refurbishing.	Detail P5142282 Detail P5142239 Detail P5142238	1				
FW.5	Crittall glazed window set 990 x 940	No of panels WxH - 2 x 3 Opening lights - 1 side hung, 1 top hung Ironmongery - mix of stays, sliding stays and gear to open/latches part missing	Poor decorative order would need shot blasting back to bare metal and bringing forward again. Ironmongery in poor state would need taking off and refurbishing.	Detail P5142282 Detail P5142239 Detail P5142238	1				
FW.6	Crittall glazed window set 2,000 x 940	No of panels WxH - 4 x 3 Opening lights - 2 side hung, 0 top hung Ironmongery - mix of stays, sliding stays and gear to open/latches part missing	Poor decorative order would need shot blasting back to bare metal and bringing forward again. Ironmongery in poor state would need taking off and refurbishing.	Detail P5142282 Detail P5142239 Detail P5142238	1

FW.7	Crittall glazed window set 2,000 x 940	No of panels WxH - 3 x 3 Opening lights - 2 side hung, 0 top hung Ironmongery - original stays, sliding stays and gear to open/latches part missing	Poor decorative order would need shot blasting back to bare metal and bringing forward again. Ironmongery in poor state would need taking off and refurbishing.	P5142237 Detail P5142282	1				
FW.8	Crittall glazed window set 2,000 x 940	No of panels WxH - 3 x 3 Opening lights - 2 side hung, 0 top hung Ironmongery - original stays, sliding stays and gear to open/latches part missing	Poor decorative order would need shot blasting back to bare metal and bringing forward again. Ironmongery in poor state would need taking off and refurbishing.	Detail P5142282 Detail P5142239 Detail P5142238	1				
FW.9	Crittall glazed window set 2,000 x 940	No of panels WxH - 3 x 3 Opening lights - 2 side hung, 0 top hung Ironmongery - original stays, sliding stays and gear to open/latches part missing	Poor decorative order would need shot blasting back to bare metal and bringing forward again. Ironmongery in poor state would need taking off and refurbishing.	Detail P5142282 Detail P5142239 Detail P5142238	1

FW.16	Crittall glazed door set 770 x 2,100	No of panels WxH - 1 x 7 Opening lights - 1 side hung Ironmongery - latch and bolts top & bottom parts missing	Poor decorative order would need shot blasting back to bare metal and bringing forward again. Ironmongery in poor state would need taking off and refurbishing.	Detail P5142258	1				
FW.17	Crittall glazed window set 2,000 x 940	No of panels WxH - 3 x 3 Opening lights - 2 side hung, 0 top hung Ironmongery - part original stays, sliding stays and gear to open/latches part missing	Poor decorative order would need shot blasting back to bare metal and bringing forward again. Ironmongery in poor state would need taking off and refurbishing.	Detail P5142282 Detail P5142239 Detail P5142238	1				
FW.18	Crittall glazed window set 2,000 x 940	No of panels WxH - 3 x 3 Opening lights - 2 side hung, 0 top hung Ironmongery - part original stays, sliding stays and gear to open/latches part missing	Poor decorative order would need shot blasting back to bare metal and bringing forward again. Ironmongery in poor state would need taking off and refurbishing.	Detail P5142282 Detail P5142239 Detail P5142238	1

D no W no	Dimension WxH mm approx.	Description	Condition	Photograph	Repair potential: -					
					High	Med	Low	Nil	Replace	
FW.33	Crittall frosted glazed window set 990 x 940	No of panels WxH - 2 x 3 Opening lights - 1 side hung, 1 top hung Ironmongery - part original stays, sliding stays and gear to open/latches part missing	Poor decorative order would need shot blasting back to bare metal and bringing forward again. Ironmongery in poor state would need taking off and refurbishing.	Detail P5142282 Detail P5142239 Detail P5142238	1					
FW.34	Crittall frosted glazed window set 990 x 940	No of panels WxH - 2 x 3 Opening lights - 1 side hung, 1 top hung Ironmongery - part original stays, sliding stays and gear to open/latches part missing	Poor decorative order would need shot blasting back to bare metal and bringing forward again. Ironmongery in poor state would need taking off and refurbishing.	Detail P5142282 Detail P5142239 Detail P5142238	1

FW.37	Crittall frosted glazed window set 990 x 940	No of panels WxH - 2 x 3 Opening lights - 1 side hung, 1 top hung Ironmongery - part original stays, sliding stays and gear to open/latches part missing	Poor decorative order would need shot blasting back to bare metal and bringing forward again. Ironmongery in poor state would need taking off and refurbishing.	Detail P5142282 Detail P5142239 Detail P5142238	1					
FW.38	Crittall frosted glazed window set 990 x 940	No of panels WxH - 2 x 3 Opening lights- 1 side hung, 1 top hung Ironmongery - part original stays, sliding stays and gear to open/latches part missing	Poor decorative order would need shot blasting back to bare metal and bringing forward again. Ironmongery in poor state would need taking off and refurbishing.	Detail P5142282 Detail P5142239 Detail P5142238	1					
FW.39	Crittall frosted glazed window set 500 x 940	No of panels WxH - 1 x 3 Opening lights - 1 side hung, 1 top hung Ironmongery - part original stays, sliding stays and gear to open/latches part missing	Poor decorative order would need shot blasting back to bare metal and bringing forward again. Ironmongery in poor state would need taking off and refurbishing.	Detail P5142282 Detail P5142239 Detail P5142238	1

FW.40	Crittall frosted glazed window set 990 x 940	No of panels WxH - 2 x 3 Opening lights - 1 side hung, 1 top hung Ironmongery - part original stays, sliding stays and gear to open/latches part missing	Poor decorative order would need shot blasting back to bare metal and bringing forward again. Ironmongery in poor state would need taking off and refurbishing.	Detail P5142282 Detail P5142239 Detail P5142238	1					
FW.41	Crittall frosted glazed window set 500 x 940	No of panels WxH - 1 x 3 Opening lights - 1 side hung, 1 top hung Ironmongery - part original stays, sliding stays and gear to open/latches part missing	Poor decorative order would need shot blasting back to bare metal and bringing forward again. Ironmongery in poor state would need taking off and refurbishing.	Detail P5142282 Detail P5142239 Detail P5142238	1					
FW.42	Crittall frosted glazed window set 990 x 940	No of panels WxH - 2 x 3 Opening lights - 1 side hung, 1 top hung Ironmongery - part original stays, sliding stays and gear to open/latches part missing	Poor decorative order would need shot blasting back to bare metal and bringing forward again. Ironmongery in poor state would need taking off and refurbishing.	Detail P5142282 Detail P5142239 Detail P5142238	1

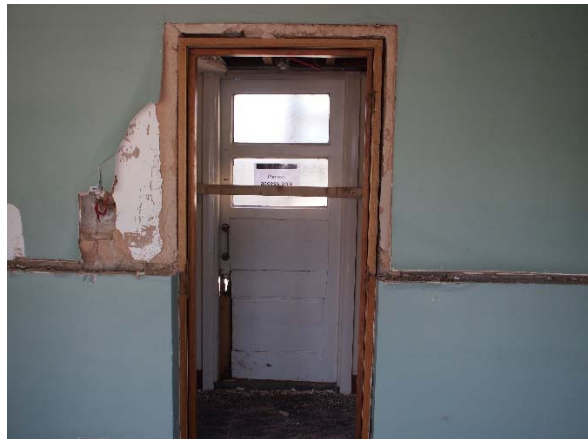
FD.34a	Timber glazed door set 820 x 2,040	No of panels WxH - 1 x 4 Opening lights - 1 side hung Ironmongery - latch and bolts missing	Roof service area access. Not original recommend change to Crittall system, but with obscured glazing, subject to check on original design intention.	Detail P5142244					1	
FW.35	Crittall frosted glazed window set 990 x 940	No of panels WxH - 2 x 3 Opening lights - 1 side hung, 1 top hung Ironmongery - part original stays, sliding stays and gear to open/latches part missing	Poor decorative order would need shot blasting back to bare metal and bringing forward again. Ironmongery in poor state would need taking off and refurbishing.	Detail P5142282 Detail P5142239 Detail P5142238	1					
FW.36	Crittall frosted glazed window set 990 x 940	No of panels WxH - 2 x 3 Opening lights - 1 side hung, 1 top hung Ironmongery - part original stays, sliding stays and gear to open/latches part missing	Poor decorative order would need shot blasting back to bare metal and bringing forward again. Ironmongery in poor state would need taking off and refurbishing.	Detail P5142282 Detail P5142239 Detail P5142238	1

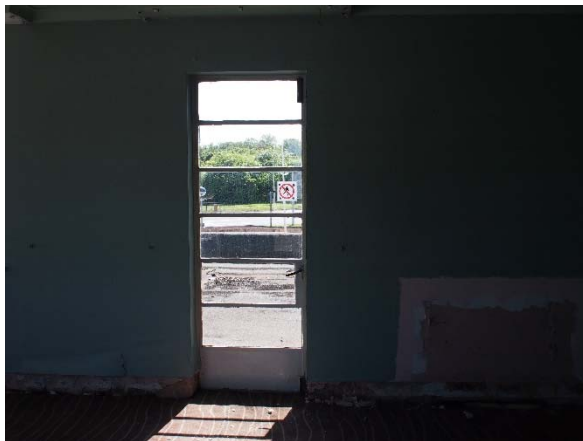
FW.10	Crittall glazed window set 2,000 x 940	No of panels WxH - 3 x 3 Opening lights - 2 side hung, 0 top hung Ironmongery - mix of stays, sliding stays and gear to open/latches part missing	Poor decorative order would need shot blasting back to bare metal and bringing forward again. Ironmongery in poor state would need taking off and refurbishing.	Detail P5142282 Detail P5142239 Detail P5142238	1				
FW.11	Crittall glazed window set 2,000 x 940	No of panels WxH - 3 x 3 Opening lights - 2 side hung, 0 top hung Ironmongery - original stays, sliding stays and gear to open/latches part missing	Poor decorative order would need shot blasting back to bare metal and bringing forward again. Ironmongery in poor state would need taking off and refurbishing.	Detail P5142282 Detail P5142239 Detail P5142238	1				
FW.12	Crittall glazed door set 770 x 2,100	No of panels WxH - 1 x 7 Opening lights - 1 side hung Ironmongery - latch and bolts top & bottom parts missing	Poor decorative order would need shot blasting back to bare metal and bringing forward again. Ironmongery in poor state would need taking off and refurbishing.	Detail P5142258	1

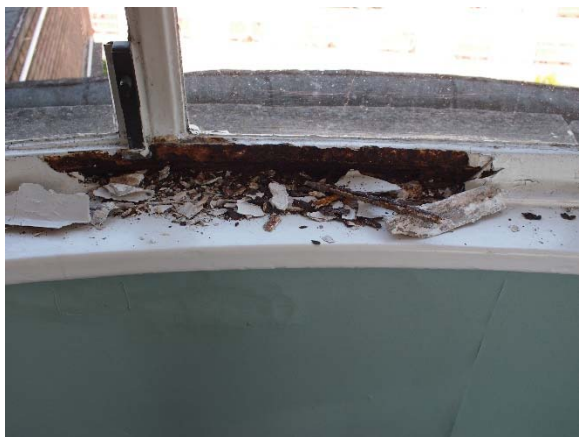
FW.13	Crittall glazed window set 2,220 x 1,250	No of panels WxH - 4 x 3 Opening lights - pair of side hung on centre line Ironmongery - mix of stays, sliding stays and gear to open/latches part missing	Poor decorative order would need shot blasting back to bare metal and bringing forward again. Ironmongery in poor state would need taking off and refurbishing.	Detail P5142282 Detail P5142239 Detail P5142238	1				
FW.14	Crittall glazed window set 2,740 x 1,250	No of panels WxH - 5 x 3 Opening lights - 1 side hung and a pair of side hung on centre line Ironmongery - mix of stays, sliding stays and gear to open/latches part missing	Poor decorative order would need shot blasting back to bare metal and bringing forward again. Ironmongery in poor state would need taking off and refurbishing.	Detail P5142282 Detail P5142261	1				
FW.15	Crittall glazed window set 2,220 x 1,250	No of panels WxH - 4 x 3 Opening lights - pair of side hung on centre line Ironmongery - mix of stays, sliding stays and gear to open/latches part missing	Poor decorative order would need shot blasting back to bare metal and bringing forward again. Ironmongery in poor state would need taking off and refurbishing.	Detail P5142282 Detail P5142263	1

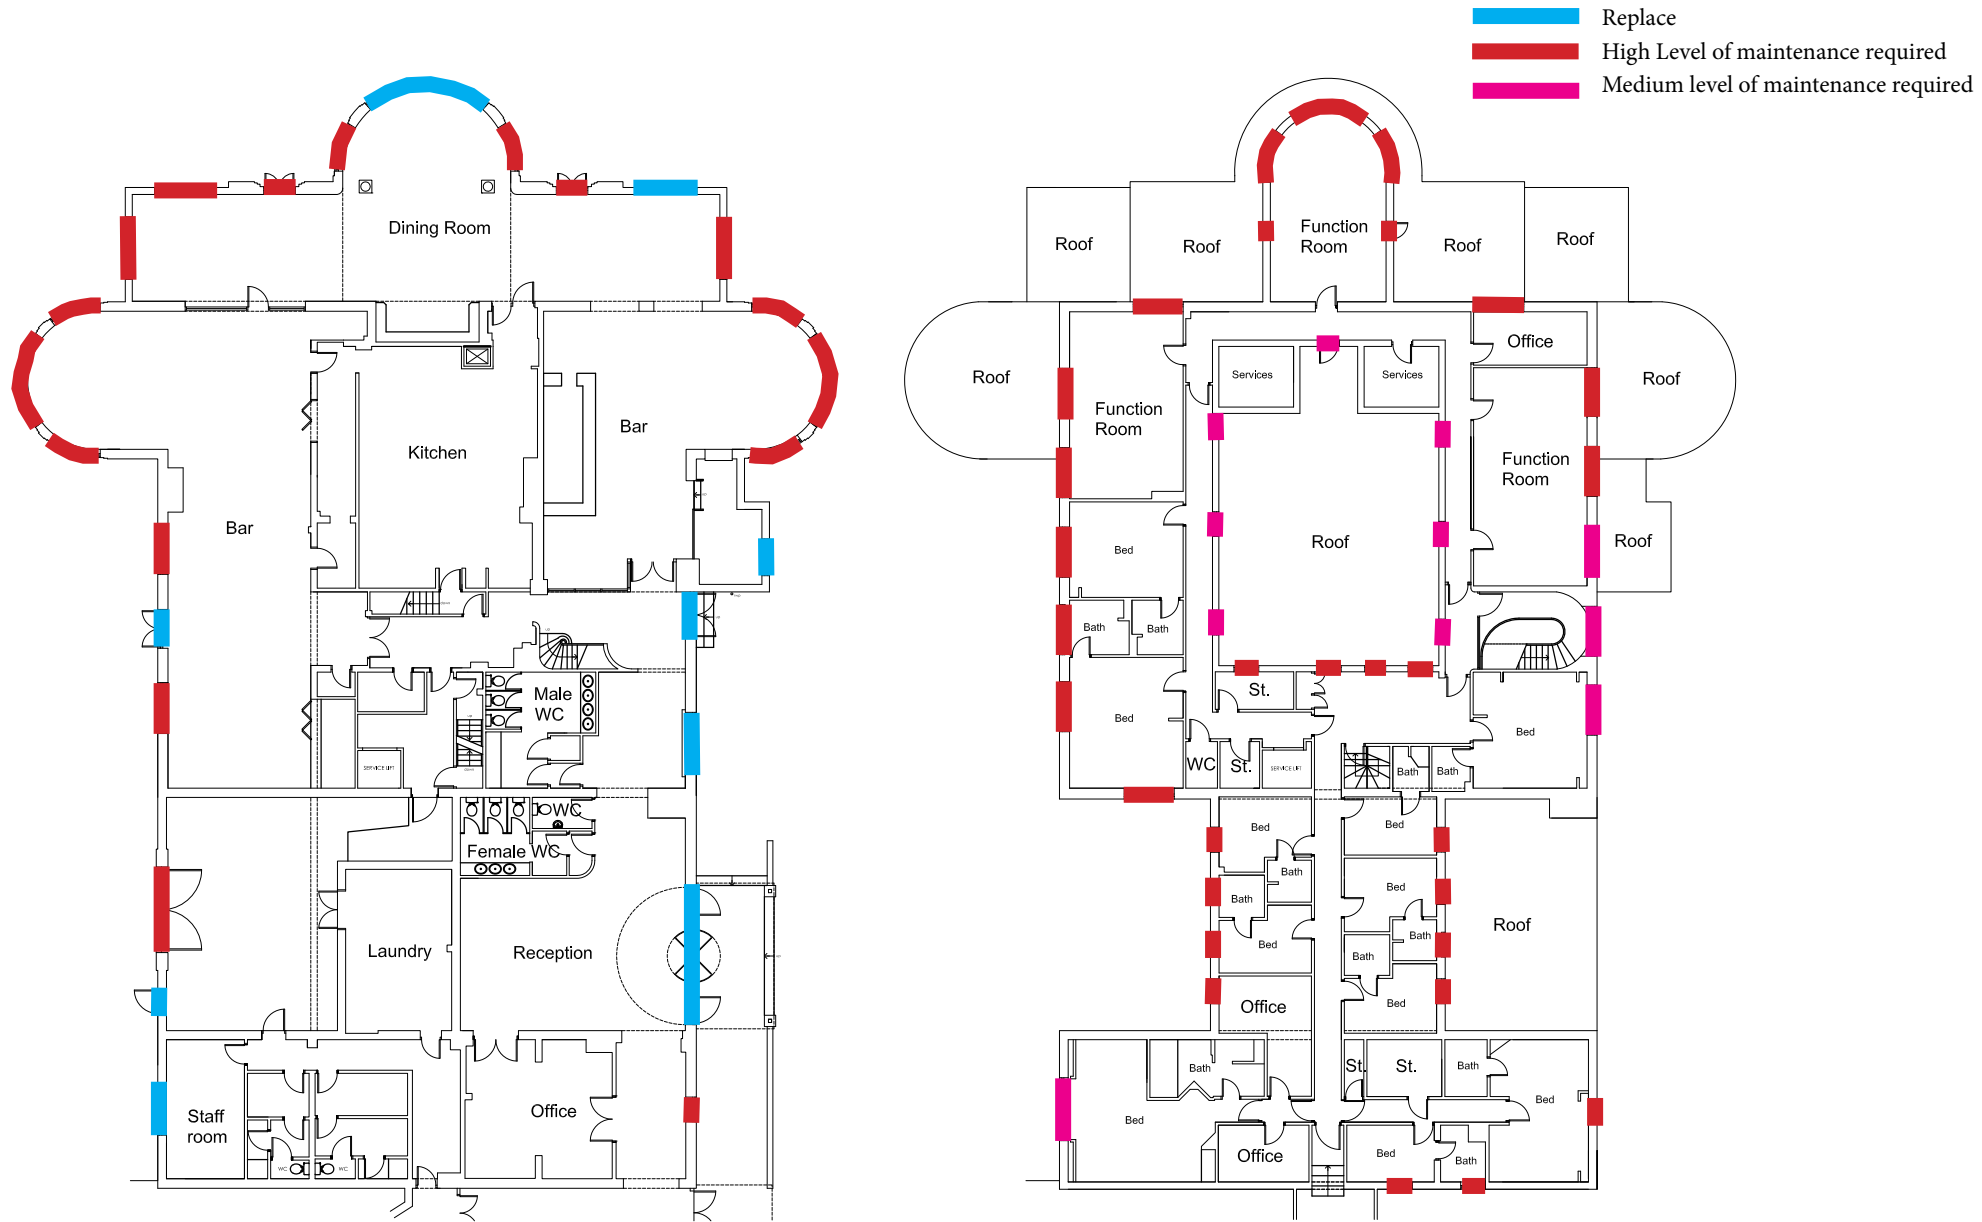
Title: Condition of windows
 Project: Comet Hotel
 Client: Fusion Residential
 Date: 24-05-18

PLAN SHOWING SURVEY FINDINGS
