**BAT SURVEY & MITIGATION
RECOMMENDATIONS FOR PROPOSED
DEMOLITION & REDEVELOPMENT**

**17 – 23 Church Lane,
Old Hatfield, Hertfordshire**

OCTOBER 2011

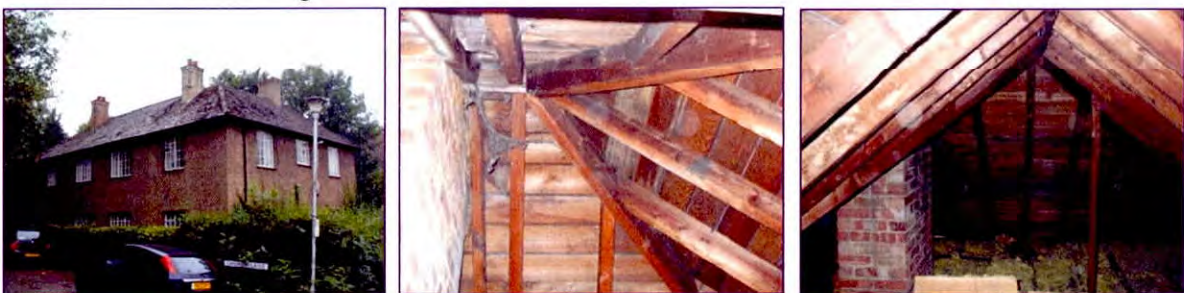
The building has brick cavity walls with pebble dash rendering. The roof voids are of timber construction with sarking and tiles.

Left – right: Eastern and northern elevations of the building; loft interior of number 23 Church Lane.

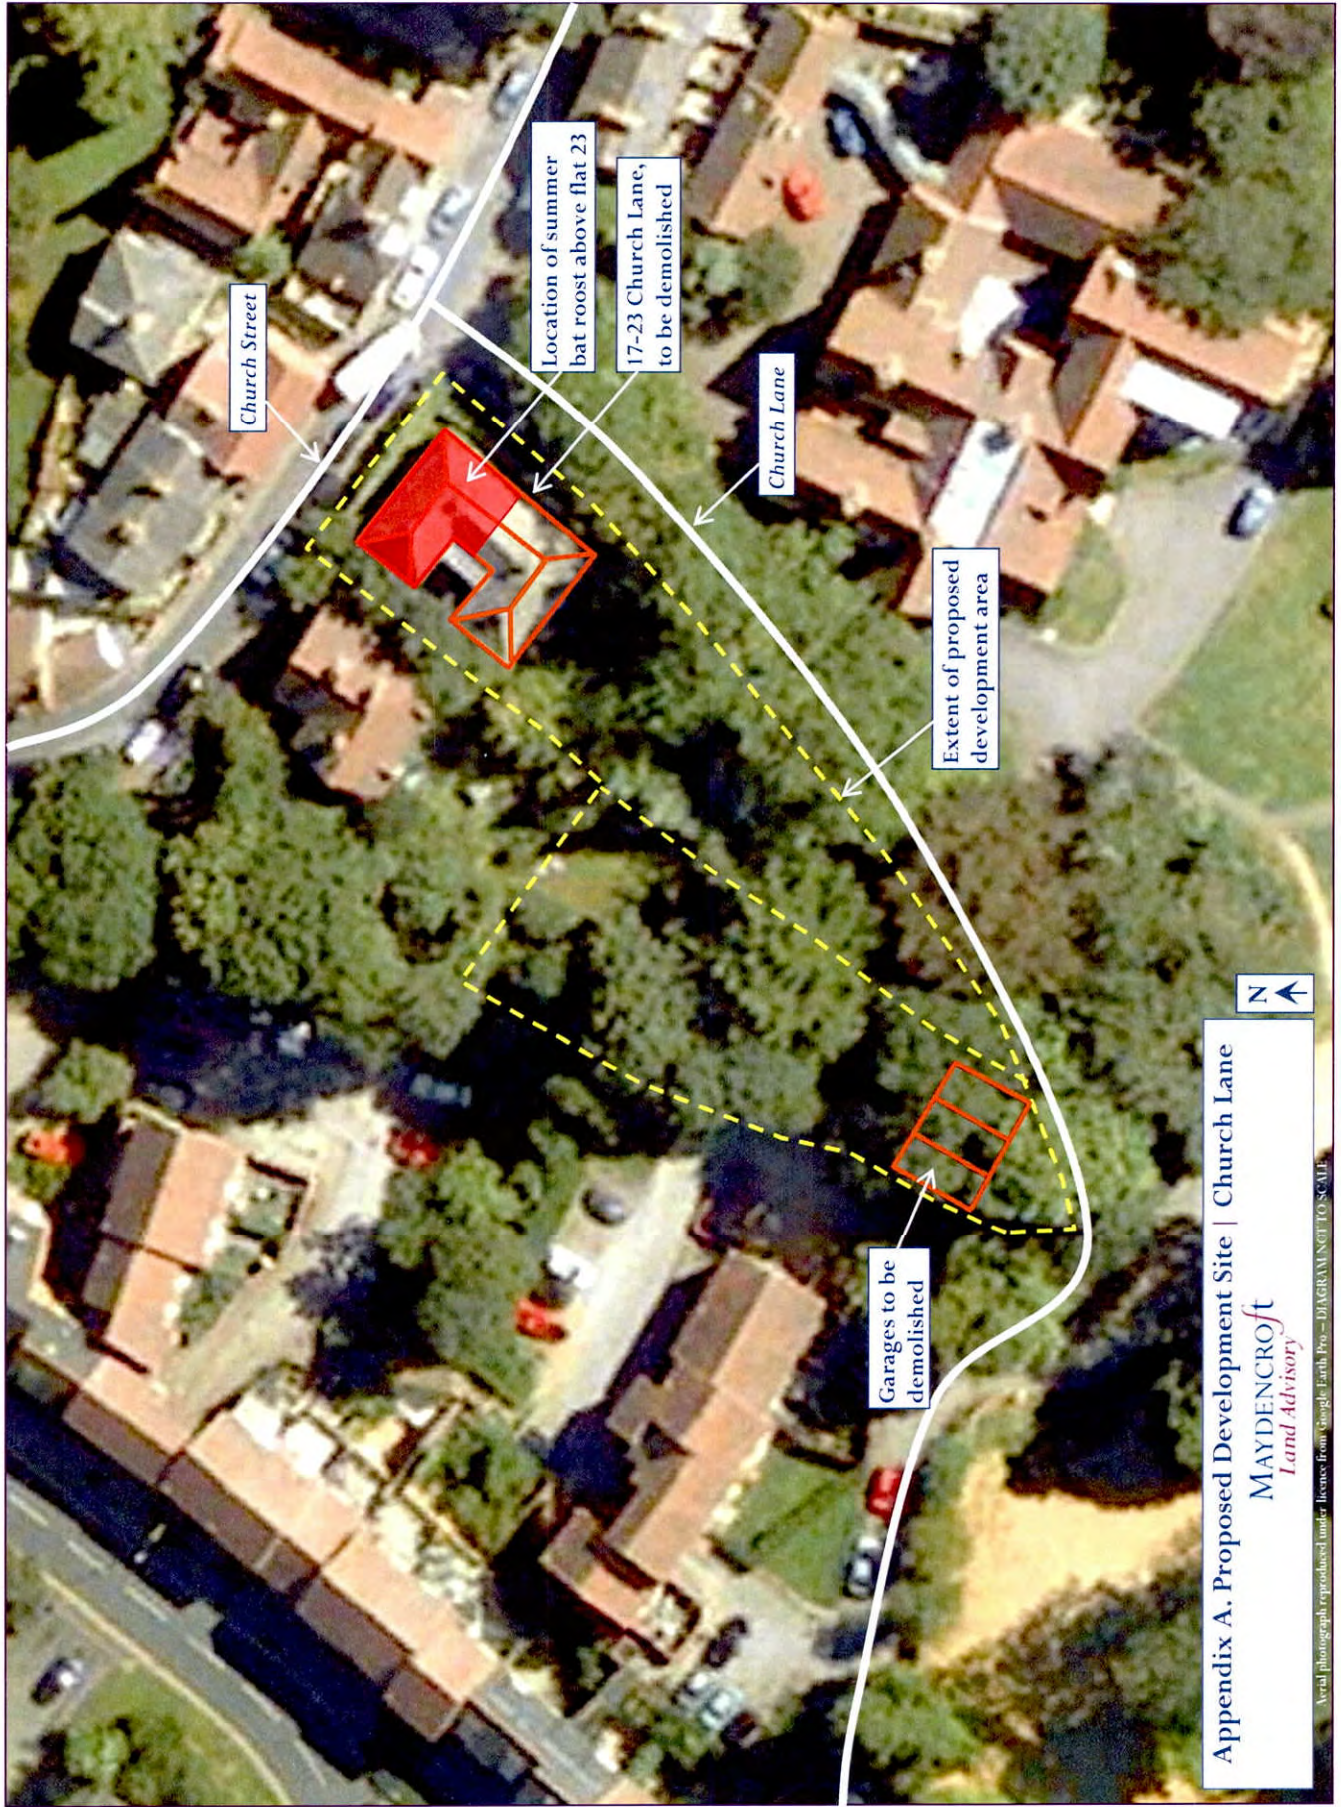
Appendix B. Proposed Development with Bat Mitigation Locations | Church Lane

Areas for bat mitigation measures

- Suitable bat access points are to be created in the new roof of the property closest to the position of the existing building to be demolished. These could take the form of artificial raised tiles or “bat slates” created from lead. Four tiles should be installed in different locations, with one located in a position to replicate the position of the roost in the demolished building as marked on the site plan in *Appendix B*. An example Bat Slate can be seen in *Appendix C*.

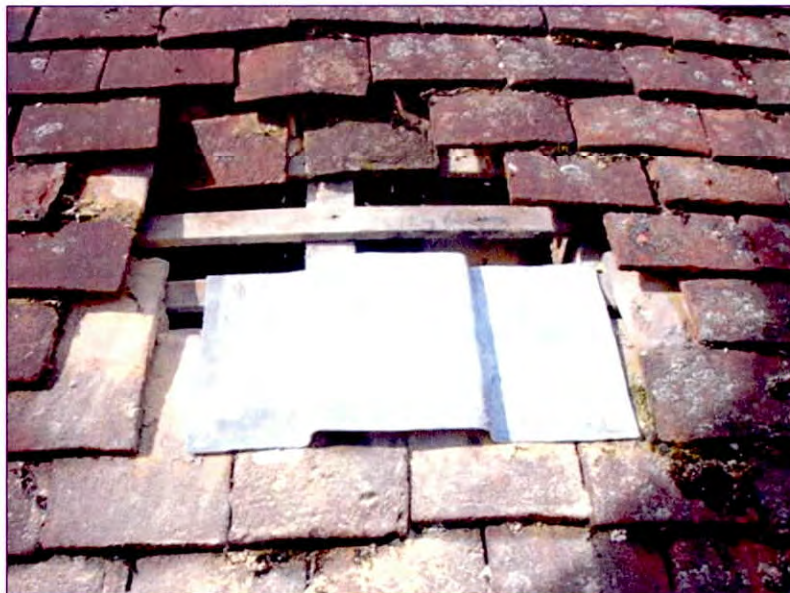
Appendix C. The 'Morris' Bat Slate

The Morris Bat Slate is a specially designed 'slate' that will allow bats access to a roof void.

Some species of bat, such as Pipistrelles, are quite happy living between the roofing felt and the tiles/slates, and never actually enter the roof void. Other species, such as the Brown Long-Eared Bat prefer the openness of the attic or loft. The species of bat identified (by an expert) dictates a very important factor in fitting a Bat slate. All modern and 'refurbished' properties will have roofing felt. For species of bats that use the inside of the attic, a hole will need to be established in the felt to allow bats free access into and out of the loft. The hole need not be large - 75mm x 30mm is more than ample, but it is very important to establish it immediately adjacent to a rafter or wall to allow bats to climb back out. A hole in the middle of the felt will be difficult to find, difficult to land near and unlikely to be used. Some species of bat use the cavity wall, and access to here from the loft will be required.

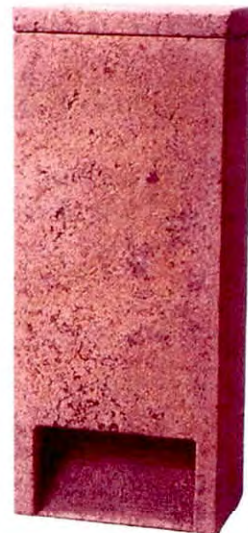
Bat Tube 2FR

For creation of spaces for larger bat colonies, with optional access to other roosting areas from the rear of the product

Dimensions as 1FR, but possible to link as multiple units, as shown above, due to transverse connecting holes
