## **Report on the XRD and supporting chemical analysis of 1No. sample of hardened potential lime mortar**

**Site:** Comet Hotel, Hatfield

**Our ref.:** 58467/CH

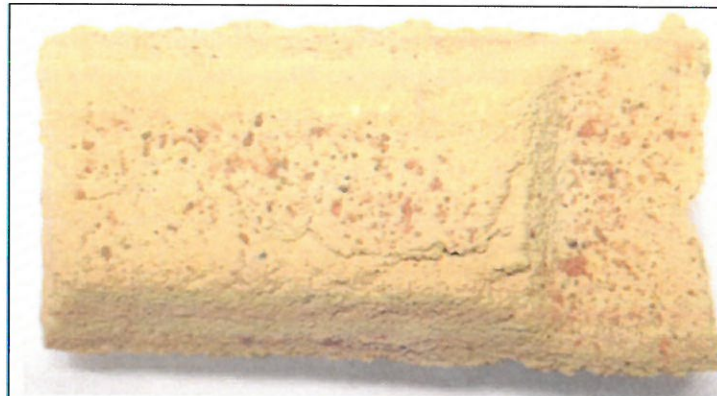
**58467/1** "as received" sample showing brick contact surfaces

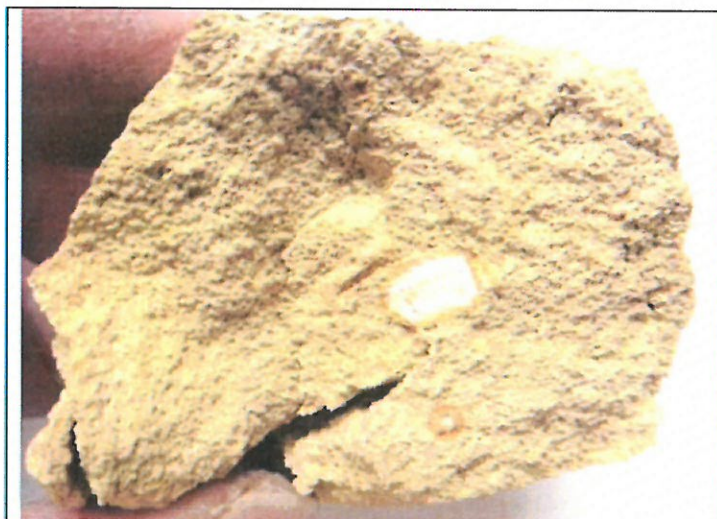
**58467/1**

Freshly fractured surface through the thickness of the sample. Although the mortar seems to have been made using a very fine sand, a single coarse (sandstone) aggregate particle (5.3mm size) was noted within the sample
