**APPENDIX E**  
**SUPPORTING DESK STUDY INFORMATION**

## Environmental Search Report

<b>Ref No:</b>	<b>29266</b>
<b>Site Name:</b>	<b>Salisbury Square</b>
<b>Site Address:</b>	<b>Salisbury Square, Great North Road, Old Hatfield, Herts AL9 5AD</b>
<b>Report Prepared For:</b>	<b>RSK STATS Geoconsult Ltd</b>
<b>Contact:</b>

**Site:**  
Salisbury Square, Old Hatfield

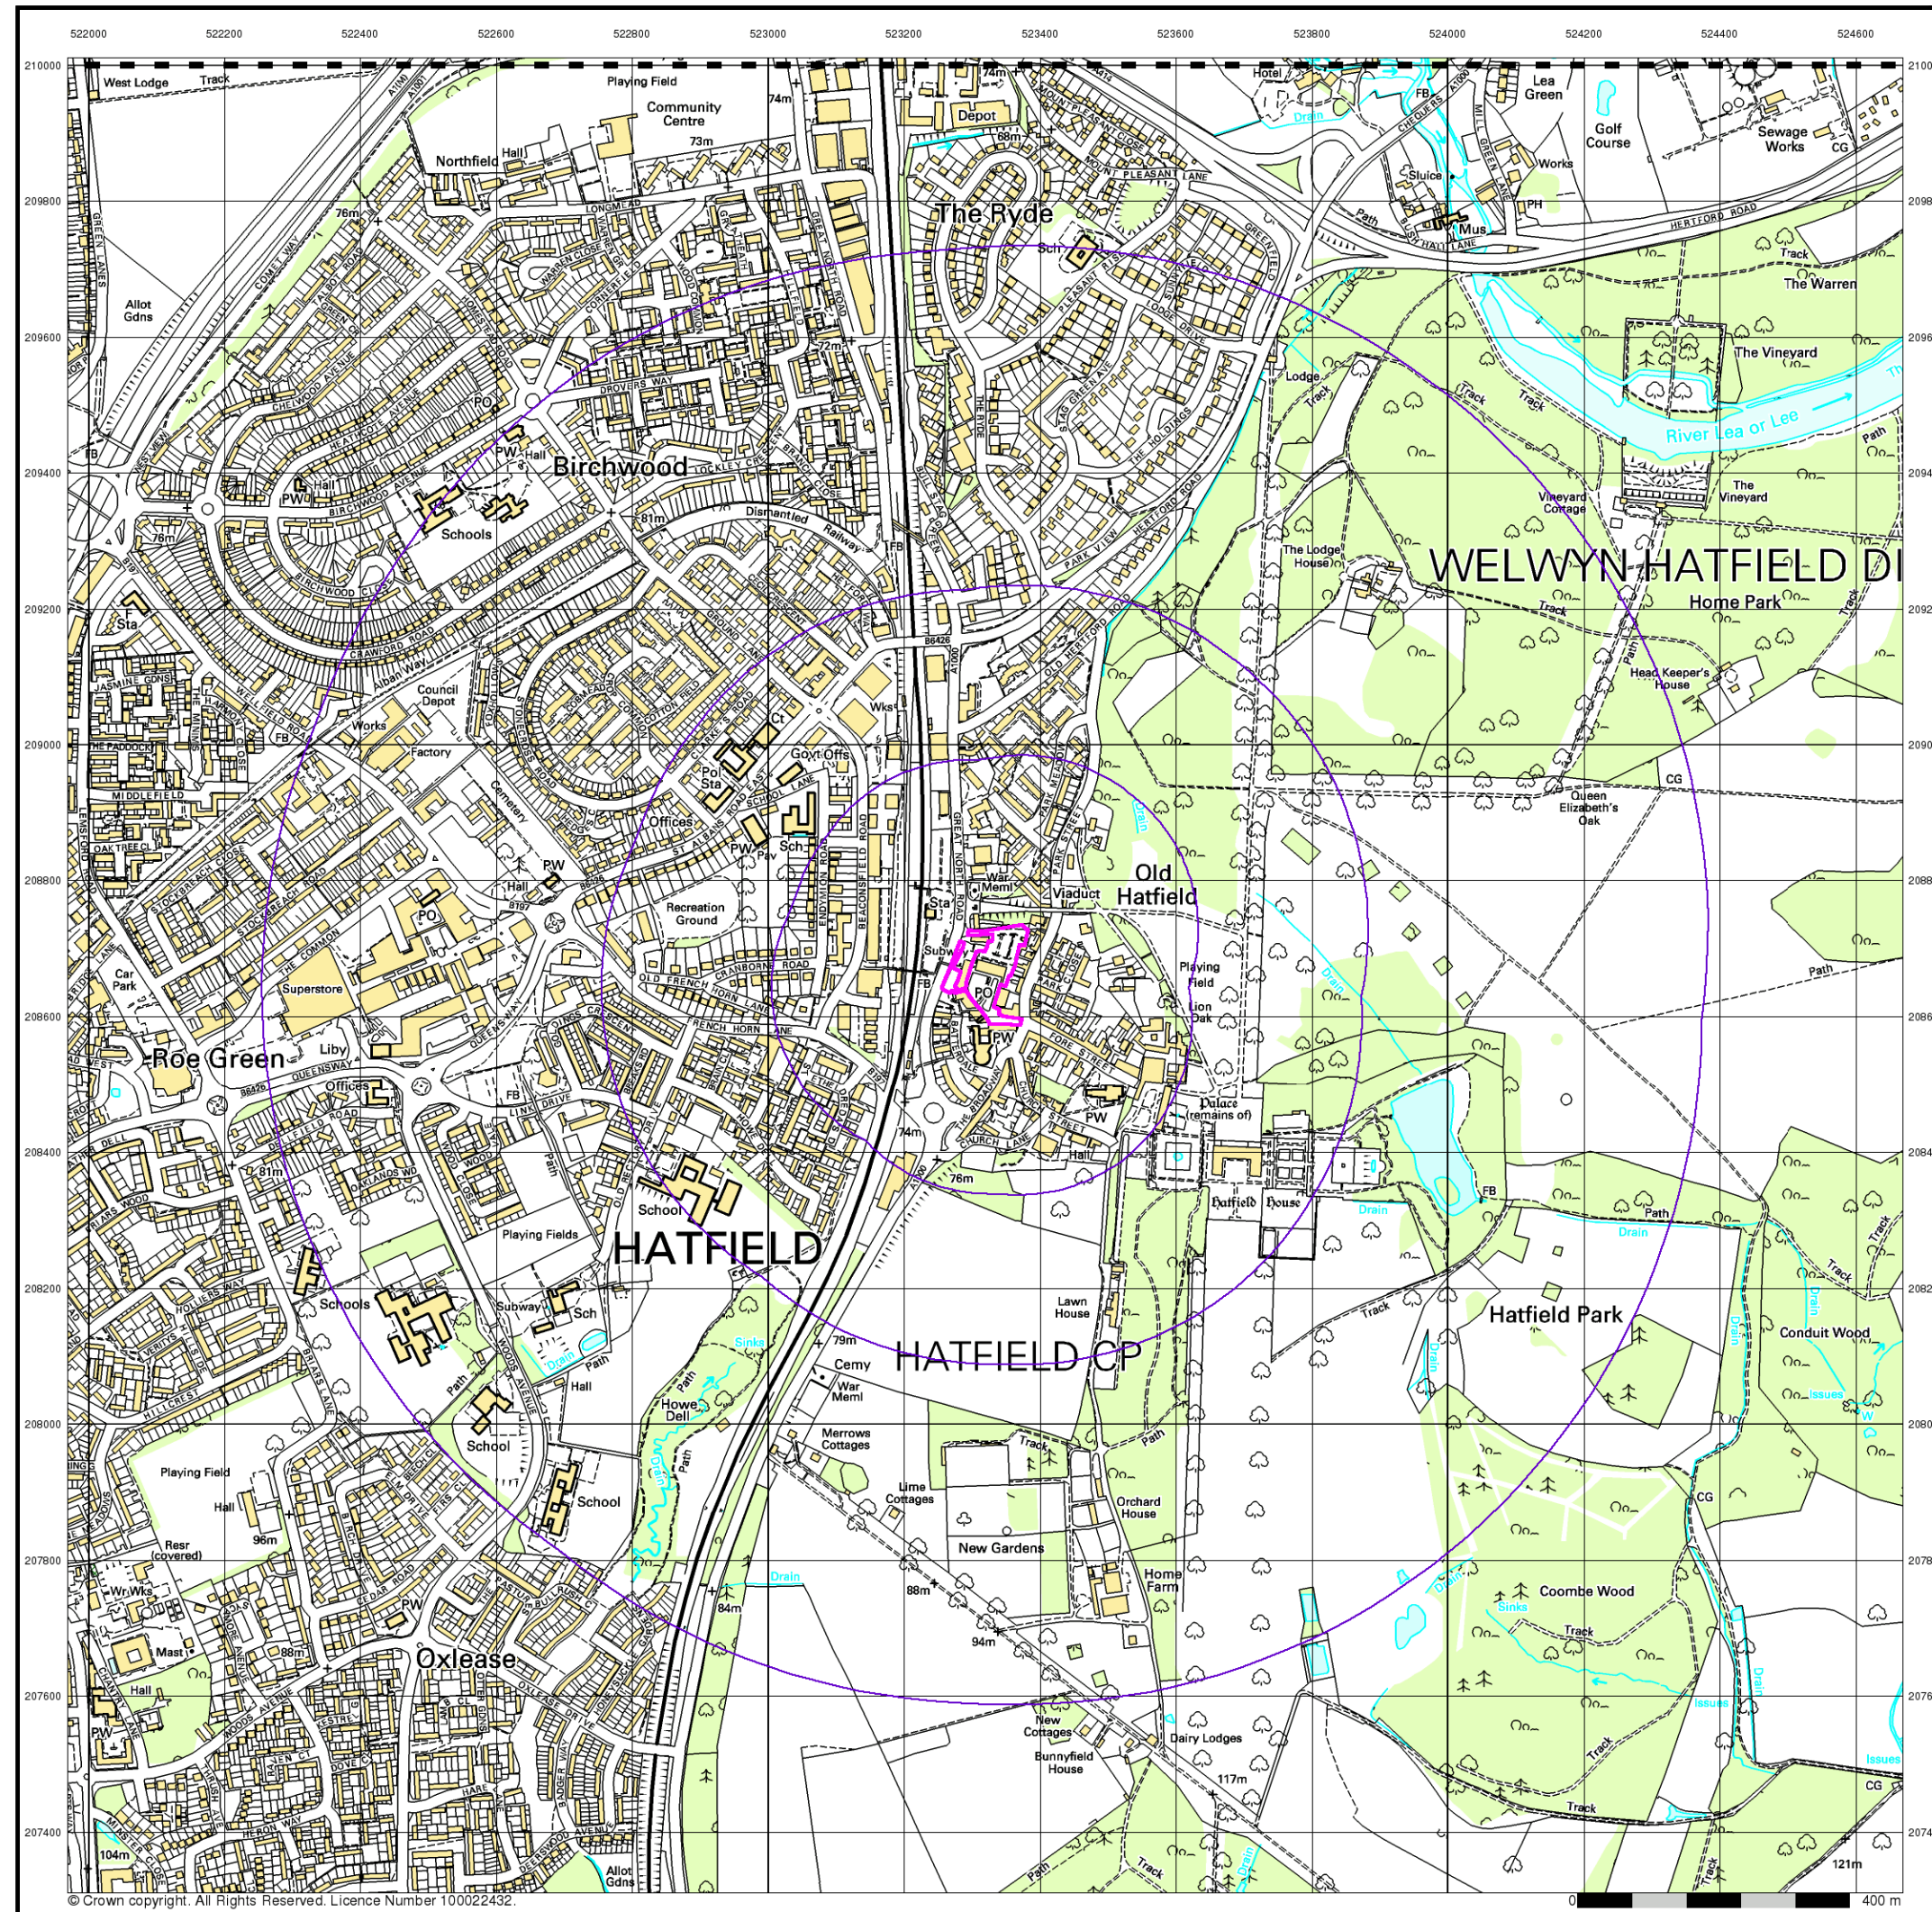
**Historical Map - Slice A**

**10k Raster Mapping**

**Published 2006**

**Source map scale - 1:10,000**

The historical maps shown were produced from the Ordnance Survey's 1:10,000 colour raster mapping. These maps are derived from Landplan which replaced the old 1:10,000 maps originally published in 1970. The data is highly detailed showing buildings, fences and field boundaries as well as all roads, tracks and paths. Road names are also included together with the relevant road number and classification. Boundary information depiction includes county, unitary authority, district, civil parish and constituency.

TL21SW	2006	1:10,000
TL20NW	2006	1:10,000

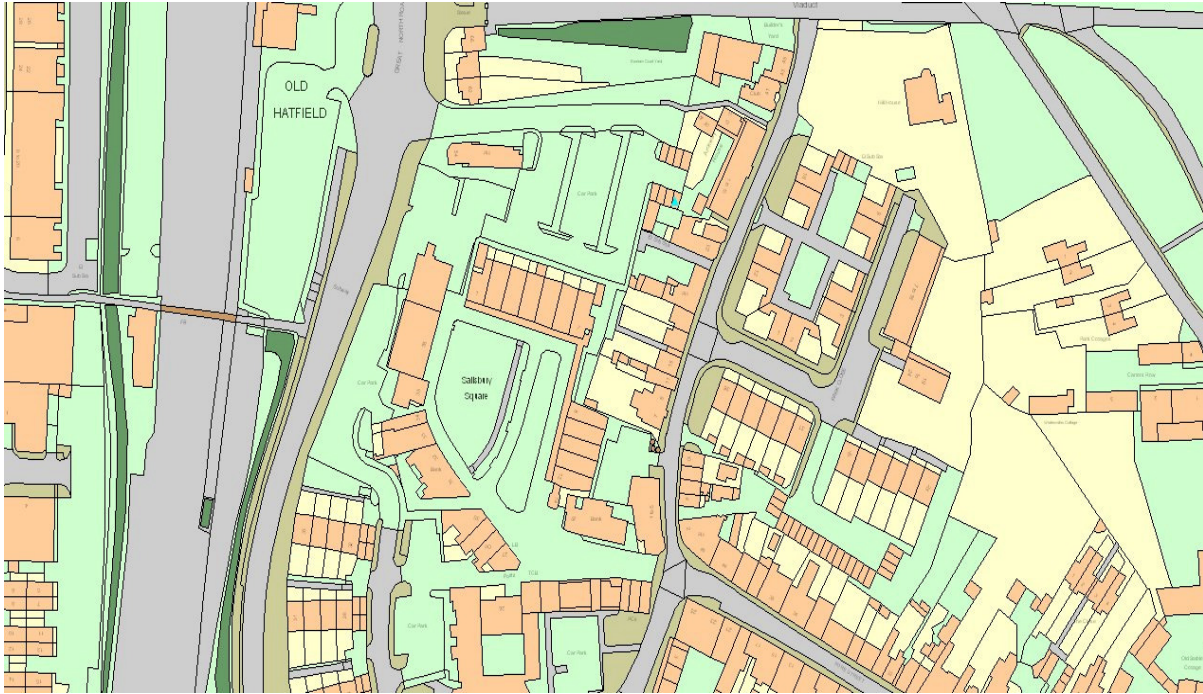
<b>Request Received date:</b>	<b>01.02.11</b>
<b>Request Received by:</b>	<b>PHI</b>
<b>Invoice Issued:</b>	<b>01.02.11</b>
<b>Report Prepared on:</b>	<b>07/02/11</b>
<b>Report Prepared by:</b>	<b>PEH</b>
<b>Site Map: Grid Ref TL:</b>	<b>2332 0867</b>

**Known Contamination Issues:** None on record but possible issues related to use of part of site as Hatfield Brewery.

**Operational Dates:** Brewery opened circa 1800, closed 1920
