Client	Gascogne Estates				
Project Name	Salisbury Square, Hatfield				
Description	Site Location Plan

Exploration Location Plan: Additional Ground Investigation

Geotechnical and Geoenvironmental  
Report

Document Title: Geotechnical and Geoenvironmental Report  
Salisbury Square, Old Hatfield

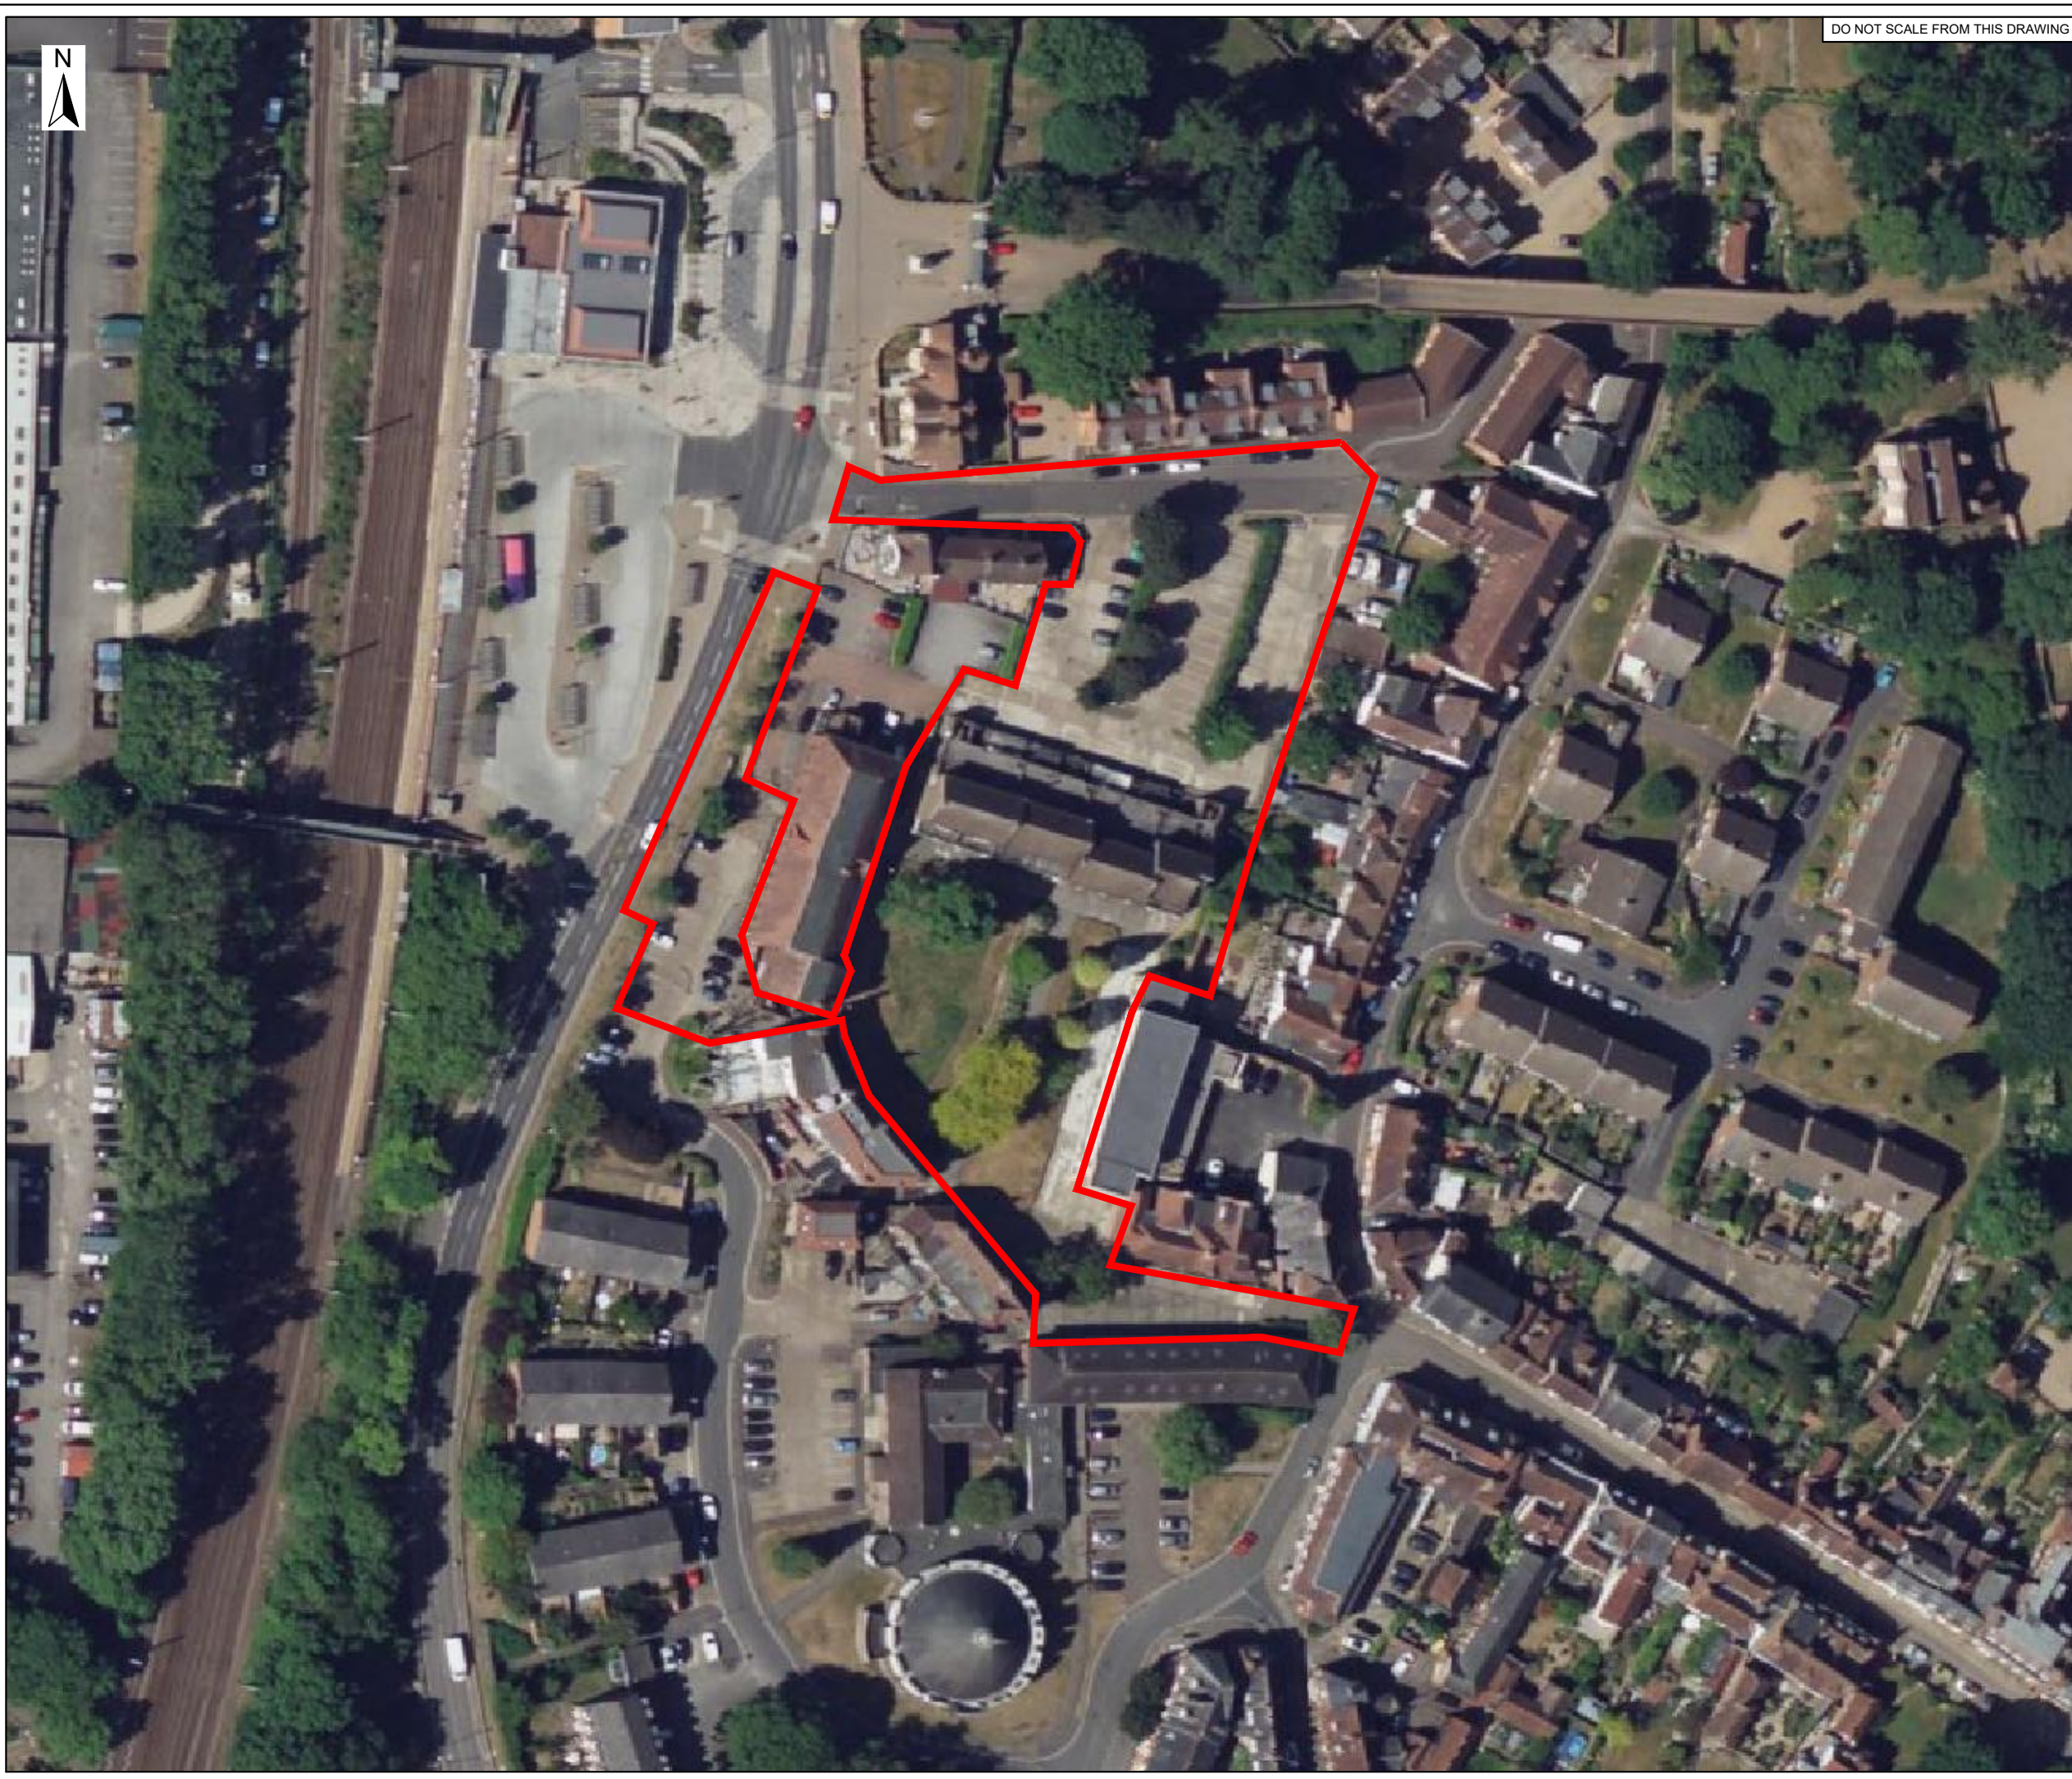
**Figure 2 SITE LAYOUT PLAN**

— Site boundary

Description  
 Site Layout Plan

The site covers approximately 0.9 hectares and comprises ground-level car parking within the northern portion of the site and Salisbury Square with surrounding retail and commercial units in the south. The parade of shops separating the car park to the north from Salisbury Square to the south includes a launderette, two takeaway food outlets, a newsagent and an insurance brokers. A plan of the site is shown on **Figure 2**. The area around the site contains a mixture of both commercial and residential elements, as detailed below:
